# **Investigation of the Wind-borne Debris Regions in ASCE 7-22**

## **Final Report**

Florida Department of Business and Professional Regulation

University of Florida (UF)

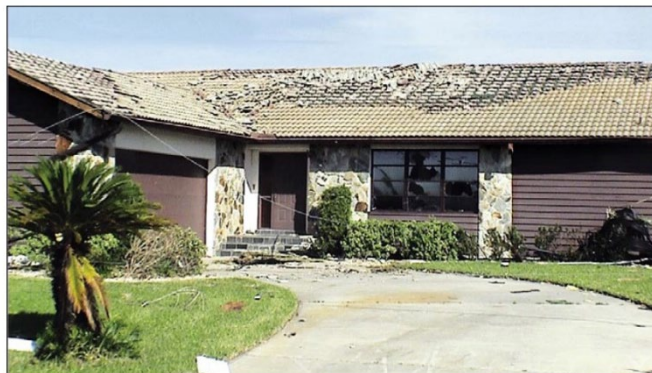
Figure 5. Extensive damage of pre-2001 FBC home. Broken windows caused by wind-borne debris during Hurricane Charley (2004).

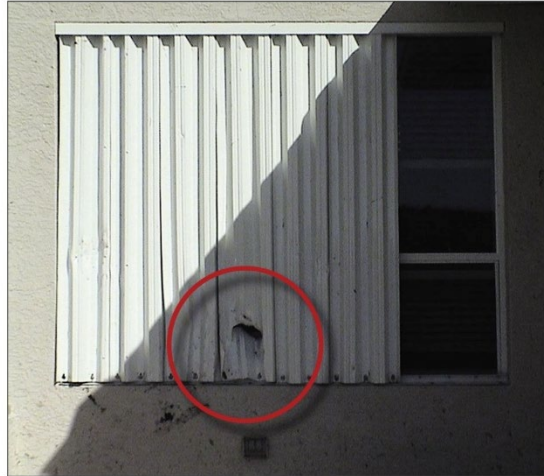
Figure 6. A roof tile punctured a Miami-Dade County approved shutter in Punta Gorda Florida during Hurricane Charley (2004).

Significant damage was frequently observed in areas with clay and concrete roof tiles and in neighborhoods where wood structural members were released as missiles. Many buildings with mortar-set tiles lost significant roof cover (Figure 5). Figure 6 shows the impact of a roof tile that punctured a Miami-Dade County-approved shutter and broke the window.

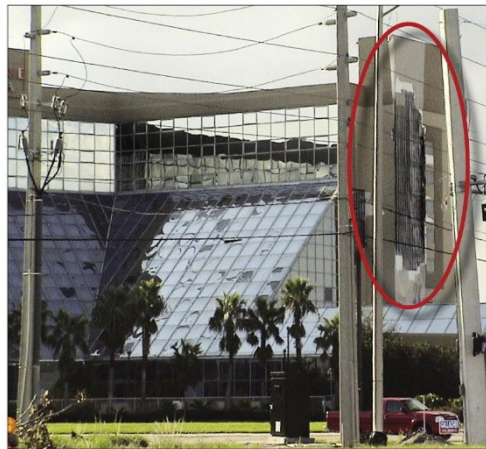
Figure 7. Damage to glass atrium in Orlando caused by wind-borne debris during Hurricane Charley (2004).

The importance of the height at which debris was released was also evident as far inland as the Orlando area. When a piece of debris is released into the wind field at a significant height, there is greater potential for that debris to remain aloft and accelerate. An example of this was observed in the atrium of the hotel shown in Figure 7.

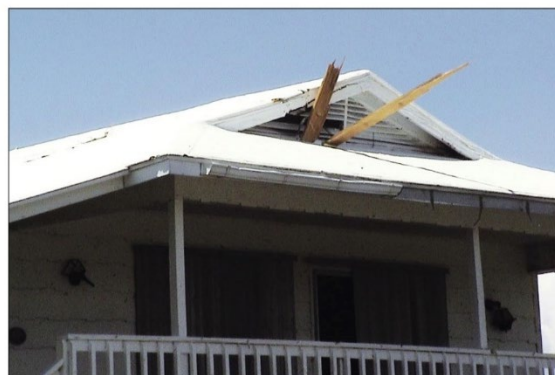
Figure 10. Impact of structural wood in the gable end in Pine Island during Hurricane Charley (2004)

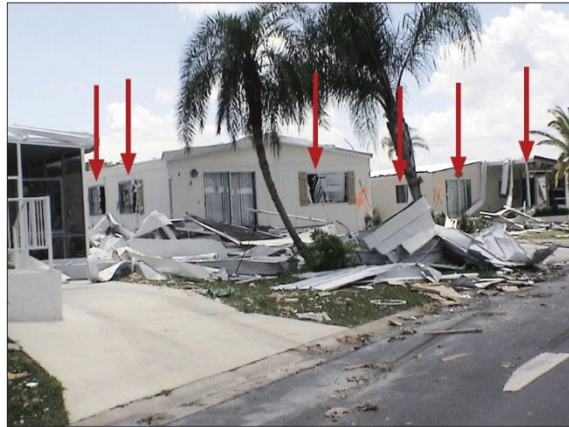
Figure 11. Wind-borne debris damage on windows caused metal roof panel and siding in Port Charlotte during Hurricane Charley (2004).

While the Florida Building Code does not apply directly to manufactured homes, a significant amount of aluminum and sheet metal debris from attached structures that failed and glazing damage was observed even in inland mobile home parks. A manufactured home park observed with homes spaced considerable distances apart appeared to have greater wind-borne debris damage (Figure 11).

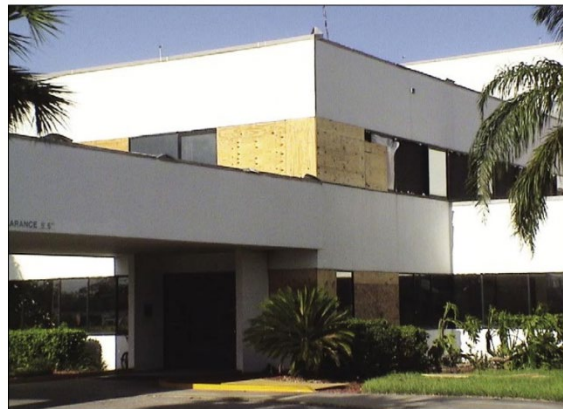
Figure 12. Damage in the windows in a hospital in Arcadia during Hurricane Charley (2004).  
EWS = 110-120 mph.

Investigations at hospitals and other buildings with aggregate roof ballast revealed that the aggregate caused damage to windows on the debris-source building. Damage to windows in the intensive care unit of the hospital in Arcadia (Figure 12) is an example of this effect.

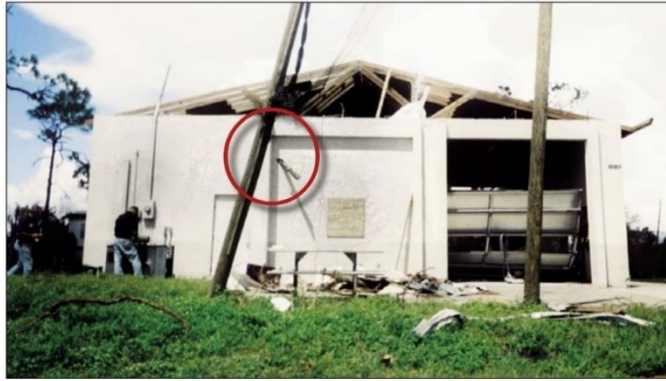
Figure 13. Fire station with a missile (in the red circle) caused by Hurricane Charley (2004), in Punta Gorda.

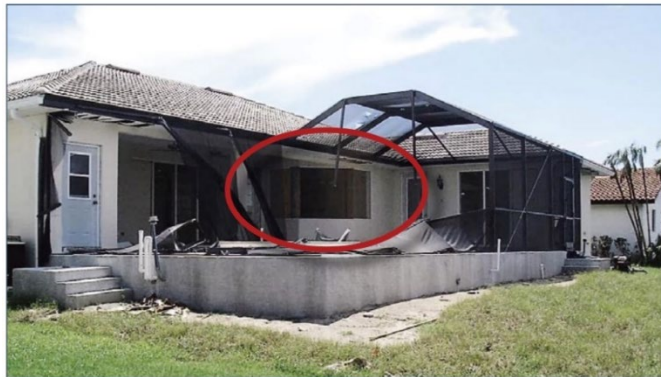
Figure 14. Broken window from debris (in the red circle) caused by Hurricane Charley (2004), in Punta Gorda.

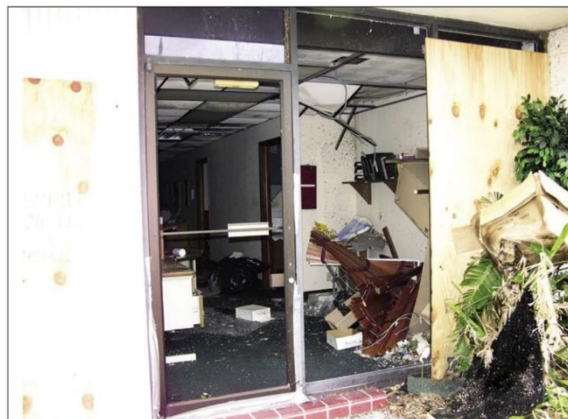
Figure 15. Broken windows in an office caused by Hurricane Charley (2004) in Punta Gorda.

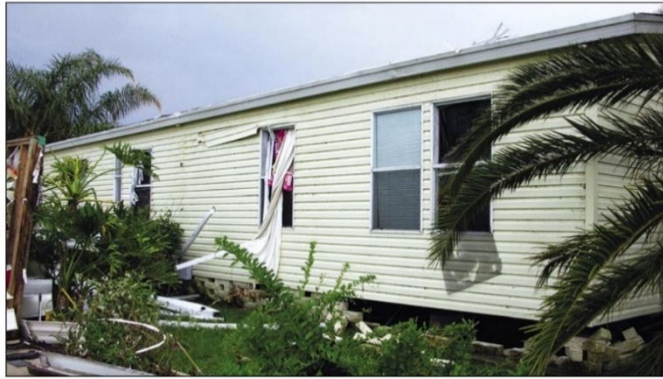
Figure 16. Windows broken in a manufactured home by wind-borne debris during Hurricane Charley (2004) at the east of Port Charlotte.

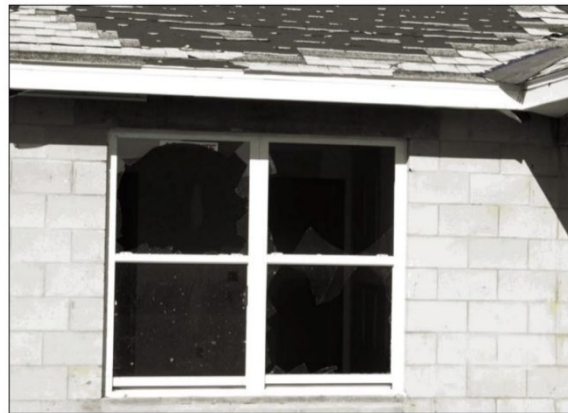
Figure 17. Broken window by wind-borne debris during Hurricane Charley (2004), in Deep Creek.

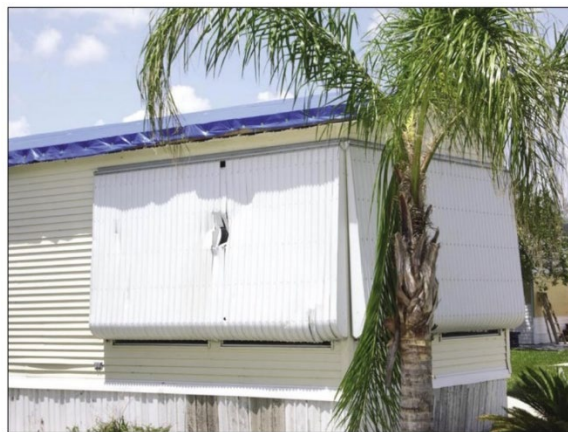
Figure 18. Metal awning shutter penetrated by a missile in Zolfo Springs during hurricane Charley (2004).

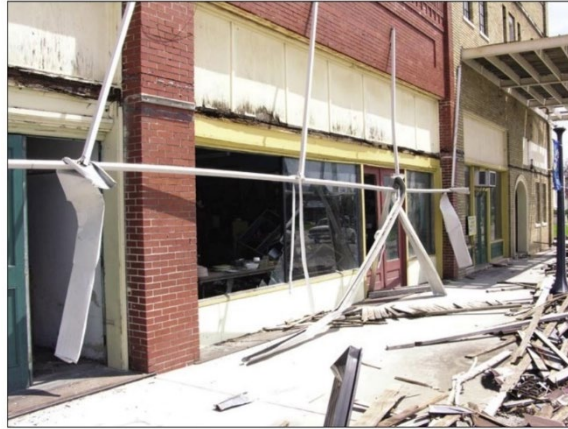
Figure 19. Broken glass windows caused by wind-borne debris during hurricane Charley (2004) in Wauchula.

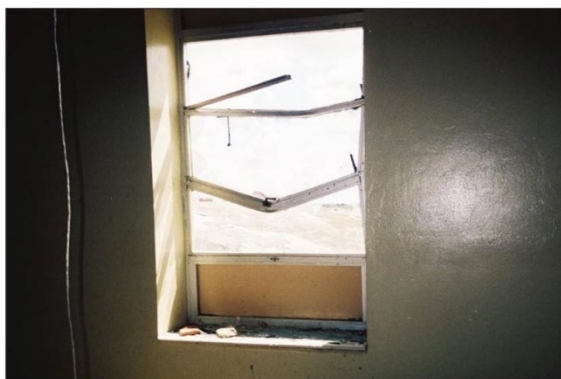
Figure 21. Broken window caused by wind-borne debris in a high school in Punta Gorda during Hurricane Charley (2004).

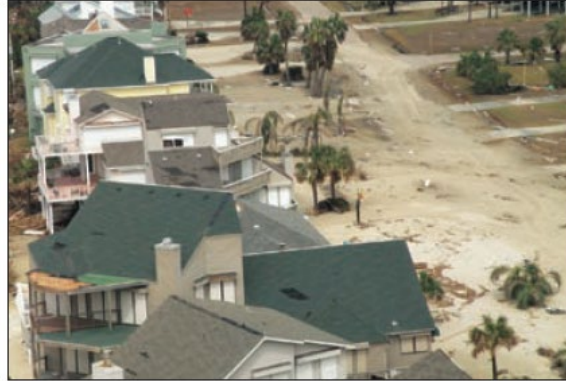
Figure 22. Siding and roofing materials blew off these West Galveston houses during hurricane Ike (2008) becoming potential projectiles.

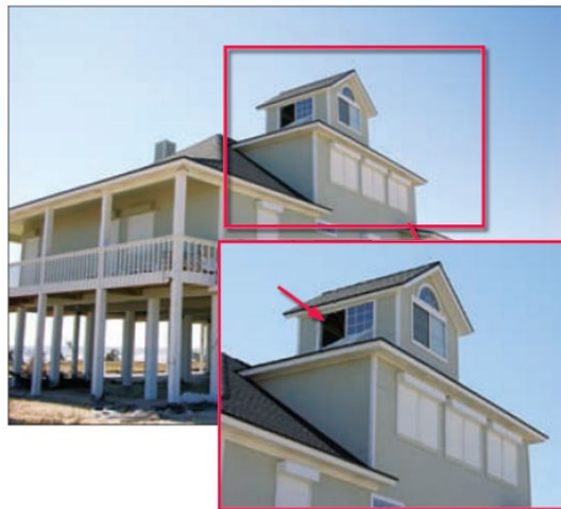
Figure 23. Window vulnerable to wind-borne damage due to improper installation of shutters.

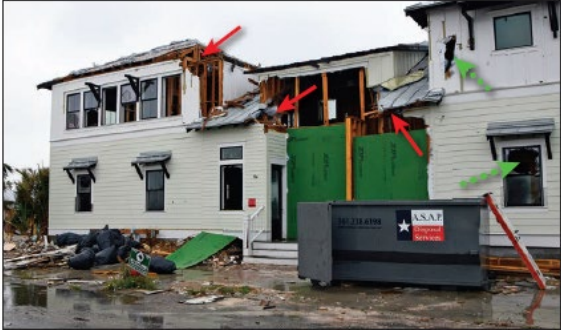
Figure 24. Damage caused by wind-borne debris (green arrows) and wind uplift damage (red arrows) in a house in Rockport during Hurricane Harvey (2017). EWS = 130 mph, exposure C.

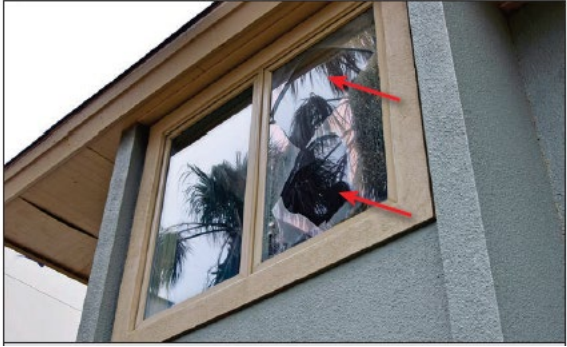
Figure 25. Damage in a window caused by the impact of wind-borne in a Key Allegro house during Hurricane Harvey (2017).

25 illustrates glazing damage from wind-borne debris. Such debris caused significant component and cladding (C&C) failures, including damage to metal roofing, the loss of window eyebrow roofs, and extensive water infiltration. Figure 26 shows a garage door damaged by debris impact.

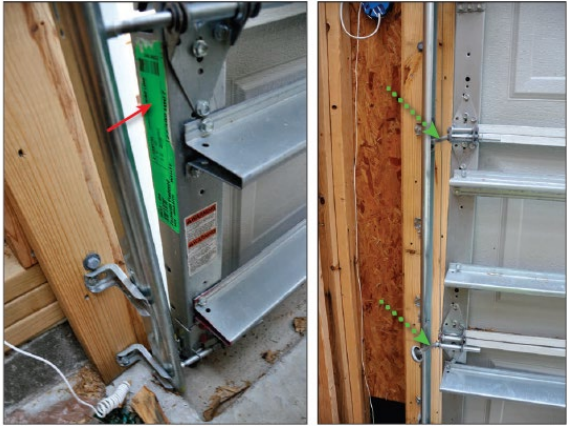
Figure 26. Damage caused by debris impact resulting in two bent rollers in Fulton during Hurricane Harvey (2017). EWS = 130 mph, exposure B.

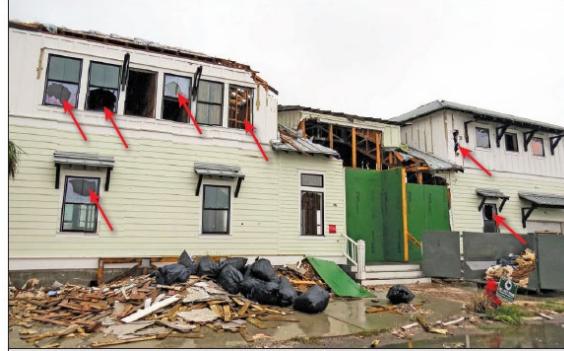
Figure 27. Damage in a post-2009 home caused by the impact of wind-borne debris (red arrows) in a Key Allegro house during Hurricane Harvey (2017). EWS = 140 mph, exposure C.

The MAT documented widespread debris impacts throughout the affected areas, as illustrated in Figure 27 through Figure 32. These observations emphasized the importance of impact-resistant materials, robust MWFRS connections, and proper installation to mitigate wind and debris damage.

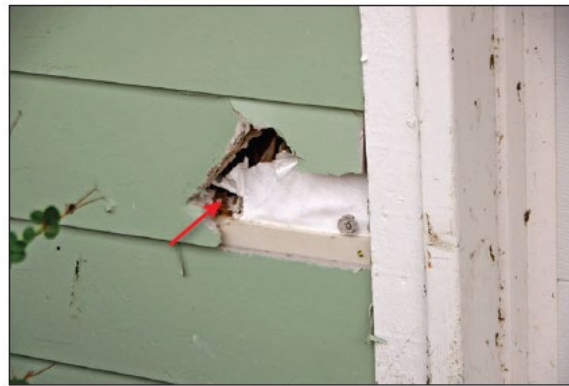
Figure 28. Damage on fiber cement siding (red arrow) caused by the impact of wind-borne debris in a Key Allegro house during Hurricane Harvey (2017). EWS = 120 mph, exposure C.

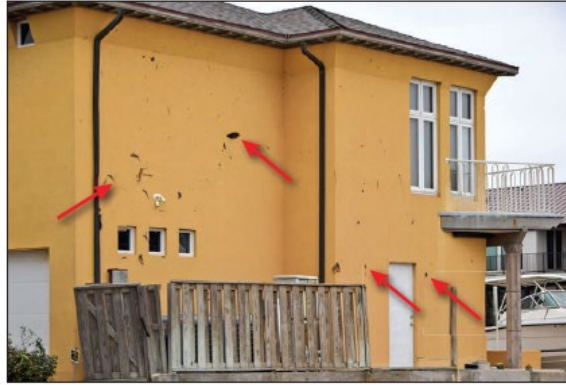
Figure 30. Damage on stucco walls (red arrows) caused by small debris impact in Key Allegro. EWS = 120 mph, exposure C.

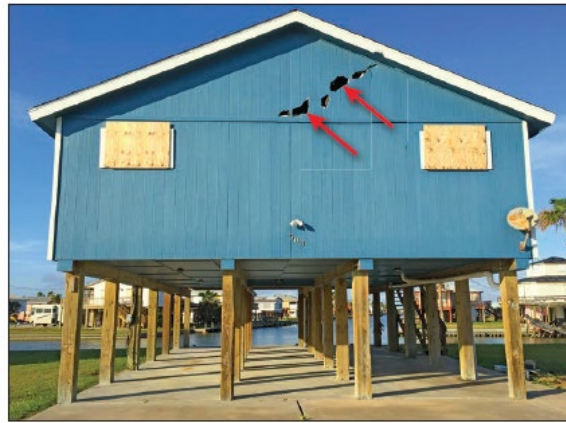
Figure 31. Damage on hardboard siding (red arrow) caused by multiple impact of debris in a Holiday Beach house during Hurricane Harvey (2017). EWS = 120 mph, exposure C.

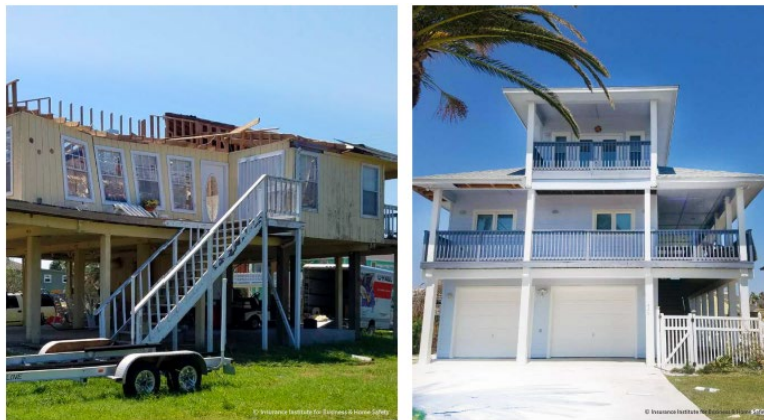
Figure 35. Port Aransas North: Two homes located 250 ft apart that experienced similar wind speeds during hurricane Harvey (2017). 1987 construction (left), 2006 construction (right).

The IBHS team noted generally better performance of both residential and commercial buildings in areas of newer construction compared to older construction. Examples are shown in Figure 35 and Figure 36.

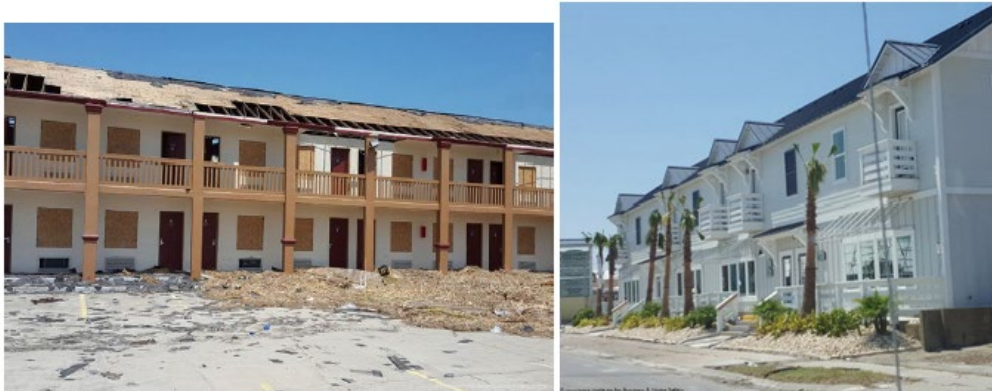
Figure 36. Port Aransas North: Two commercial buildings located 1 mile apart that experienced similar wind speeds during hurricane Harvey (2017). 1984 construction (left), 2007 construction (right).

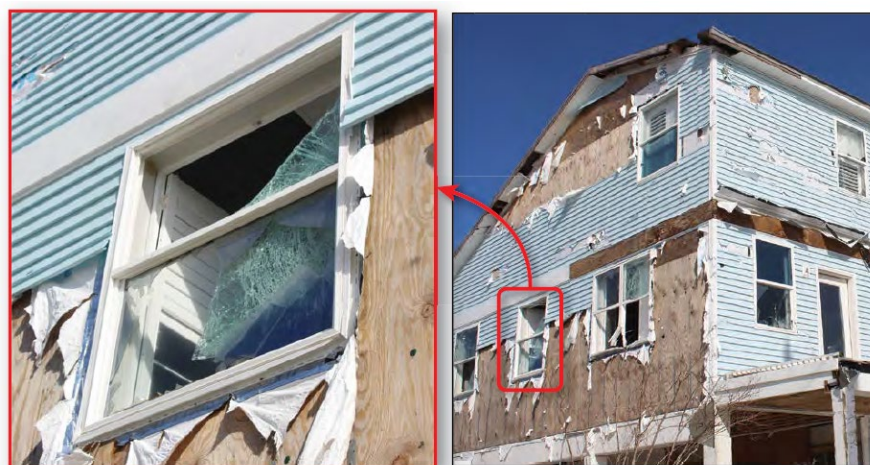
Figure 40. Impact resistant window after Hurricane Michael (2018) in a house built in 2010, located in Mexico Beach. Estimated wind speeds (150 mph) exceeded the design wind speeds (130 mph).

Many communities along the track of Hurricane Michael experienced wind speeds that exceeded design level wind speeds. Wind speeds in excess of ASCE 7-10 design levels occurred in Bay, Calhoun, Gadsden, Gulf, Jackson, and Liberty Counties (see Figure 37). In some locations, the wind speeds produced by Hurricane Michael exceeded ASCE 7 Risk Category II wind speeds by more than 10 percent. The highest wind gust recorded on land was 129 mph at a mobile weather station at Tyndall Air Force Base. This mobile weather station was installed by the University of Florida/Weatherflow in the hours preceding landfall. Shortly after recording the gust of 129 mph, the mobile weather station failed. A wind gust of 102 mph was recorded at the airport in Marianna, FL, near the state line with Georgia; the weather station at the airport remained in operation throughout the event. The mitigation assessment team report from FEMA found some wind-borne debris in residential buildings in Mexico Beach and Panama City (Figure 38). In those cases, the estimated wind speed exceeded the design wind speed. However, the observations correspond to areas not considered as wind-borne debris areas according to ASCE-7 because the observations were beyond 1-mile of the coast (Figure 39 to Figure 44).

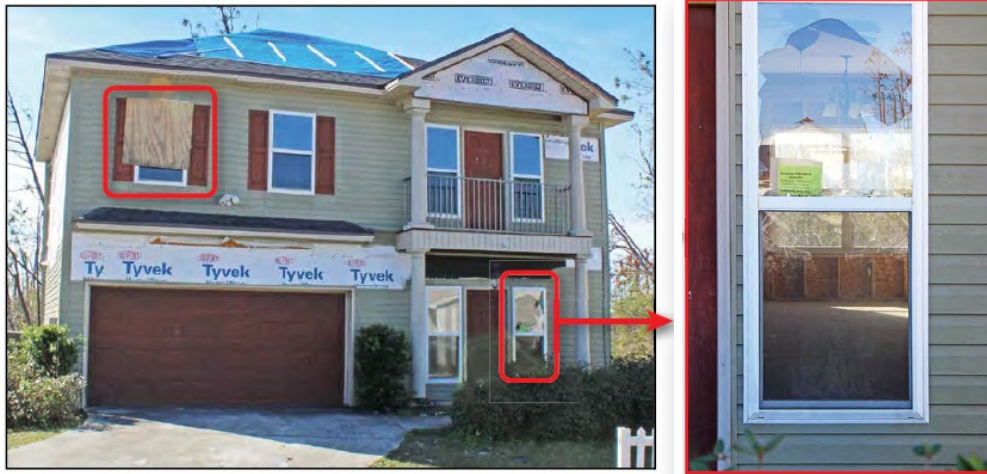
Figure 41. Glazed opening damage after Hurricane Michael (2018) in a house built in 2005, located in Panama City. Estimated wind speeds (128 mph) approached the design wind speed (133 mph).

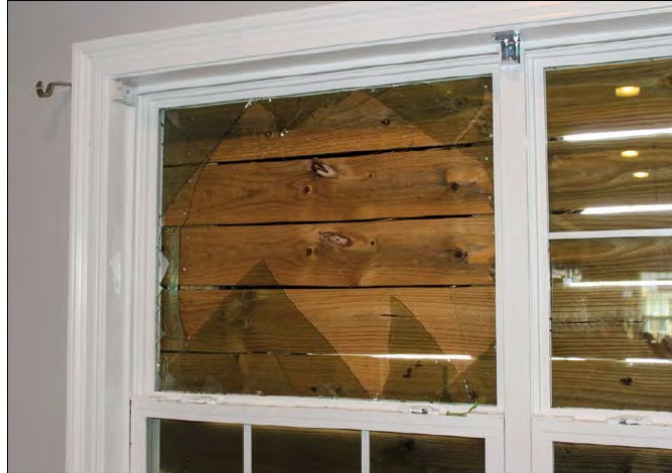
Figure 43. Glazed opening damage caused by an asphalt shingle after Hurricane Michael (2018) in a house built in 2012, located in Panama City. Estimated wind speeds (150 mph) exceeded the design wind speeds (126 mph).

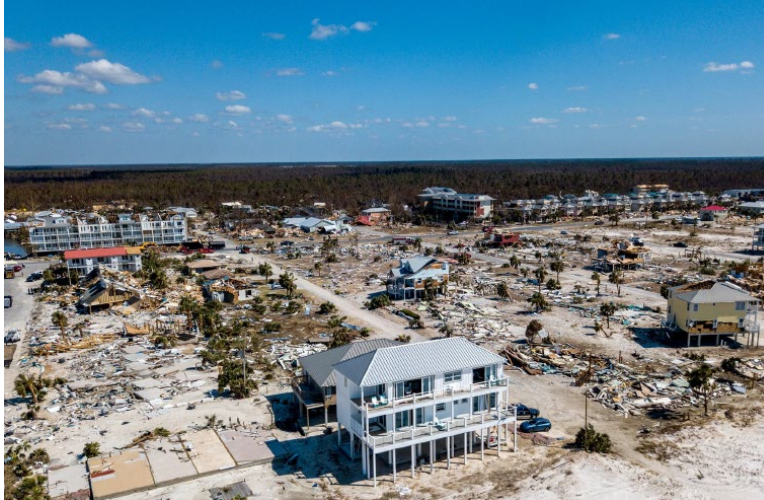
Figure 45. Widespread devastation to wood-framed single and multi-family residences in Mexico Beach with few survivors in areas with highest inundations (Source: New York Times)

The StEER Hurricane Michael Preliminary Virtual Assessment Team Report (StEER, 2018) analyzed the impacts of Hurricane Michael. The report highlighted extensive wind and storm surge damage, with wind speeds exceeding design levels and storm surge causing catastrophic destruction, particularly in Mexico Beach (Figure 45). Older structures, especially those built before the 2002 Florida Building Code, experienced significant failures, including roof and wall collapses, while newer buildings fared better but still suffered damage to cladding, windows, and roof systems.

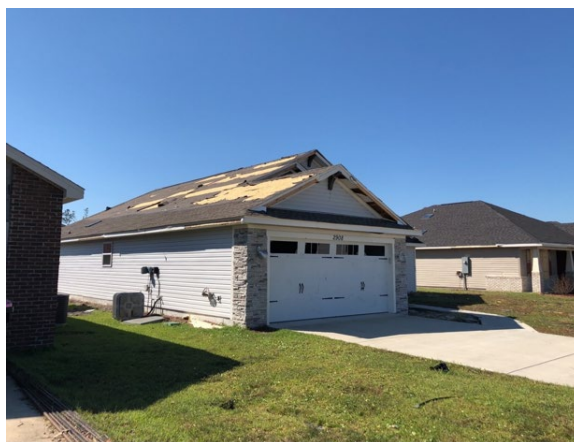
Figure 46. Damage to roof and garage door in Panama City during Hurricane Michael (2018). House was built between 2000-2009 and located 3.39 miles from St. Andrew Bay. Estimated wind speeds (129-150 mph) might have exceeded the design wind speeds (135 mph).

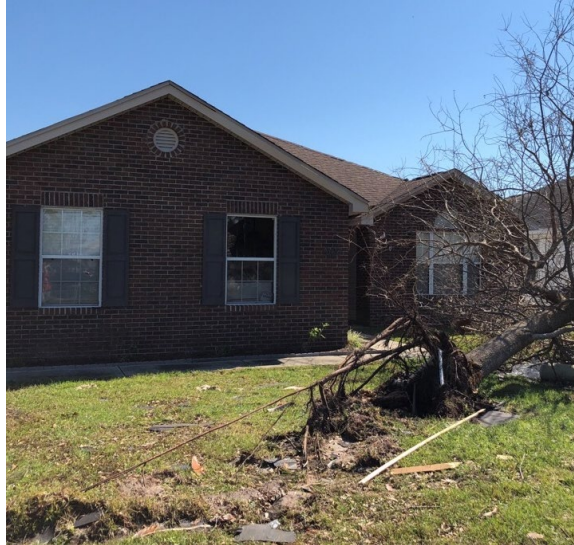
Figure 47. Damage to a window cause by wind-borne debris in Panama City during Hurricane Michael (2018). House was built between 2000-2009 and located 3.27 miles from St. Andrew Bay. Estimated wind speeds (129-150 mph) might have exceeded the design wind speeds (135 mph).

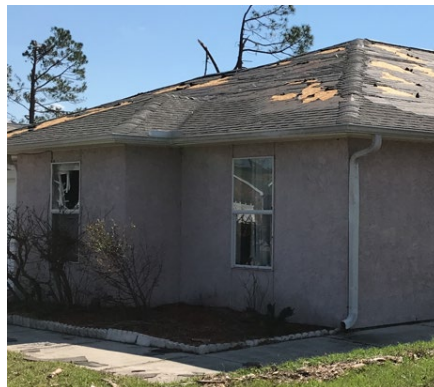
Figure 48. Damage to windows in a house located in Panama City during Hurricane Michael (2018). House was built between 1990-1999 and located 3.25 miles from St. Andrew Bay. Estimated wind speeds (129-150 mph) might have exceeded the design wind speeds (135 mph).

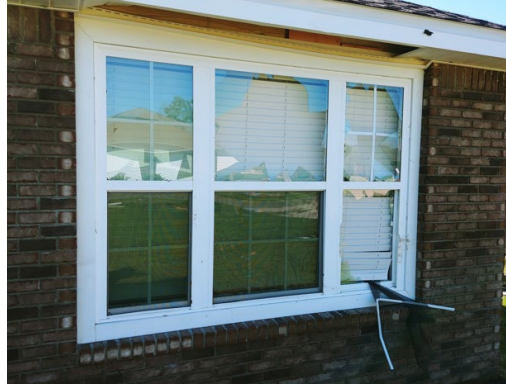
Figure 49. Damage to a window in Panama City during Hurricane Michael (2018). House was built between 2010-2019 and located 3.39 miles from St. Andrew Bay. Estimated wind speeds (129-150 mph) might have exceeded the design wind speeds (135 mph).

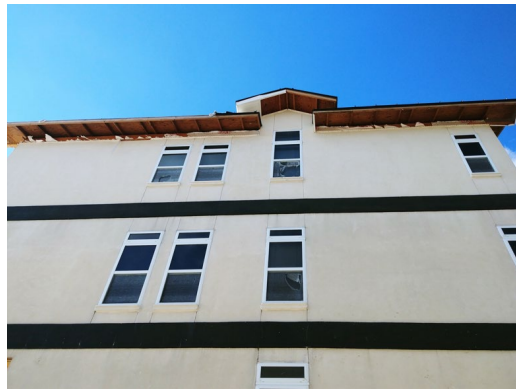
Figure 50. Damage to a few windows in the shoreline of Mexico Beach during Hurricane Michael (2018). House was built between 2000-2009. Estimated wind speeds (150 mph) exceeded the design wind speeds (136 mph).

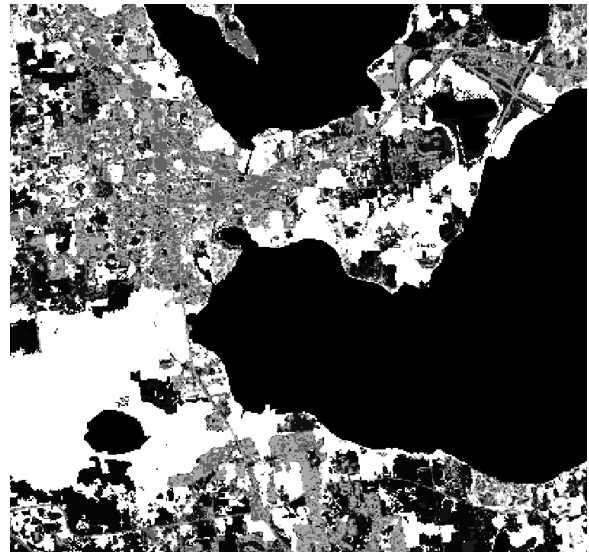
a) Google Earth Imagery of Big Lake Harris

b) NLCD Zo Raster of Big Lake Harris

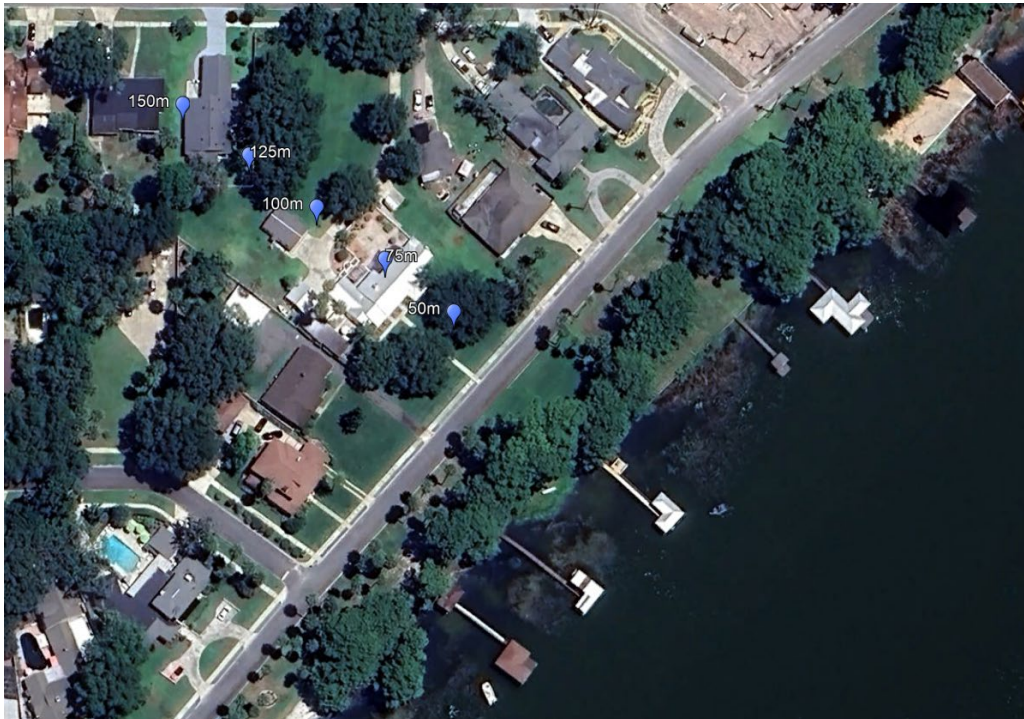
Figure 58. Locations of the origin point for Big Lake Harris sensitivity analysis.

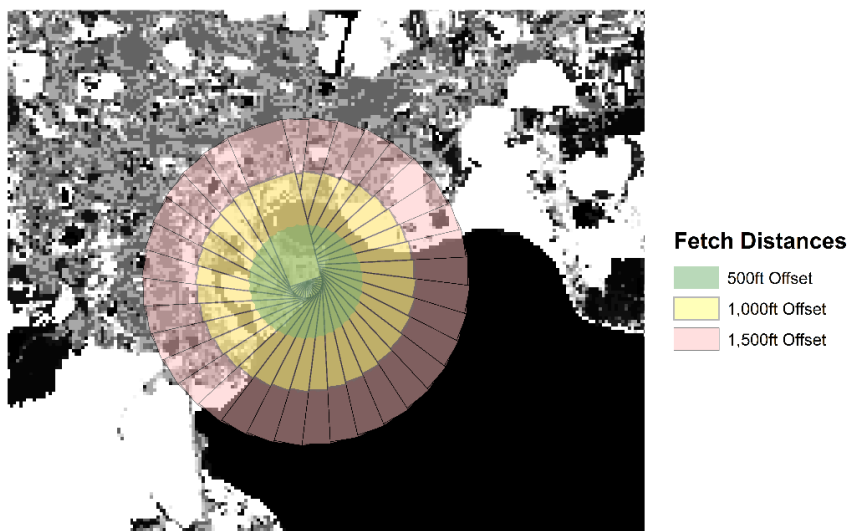
Figure 60. Extent of fetch distances analyzed on the  $Z_o$  raster.

The upstream fetch distance used to calculate the directional  $Z_o$  values was determined through a sensitivity analysis that considered three different fetch lengths: 500m, 1,000m, and 1,500m. Figure 60 illustrates circular areas corresponding to these three different fetch distances overlaid for all analyzed directions at the same origin point in the Big Lake Harris neighborhood. Figure 61 plots the resulting average  $Z_o$  values by direction for each fetch distance showing the variability in average  $Z_o$  by direction.

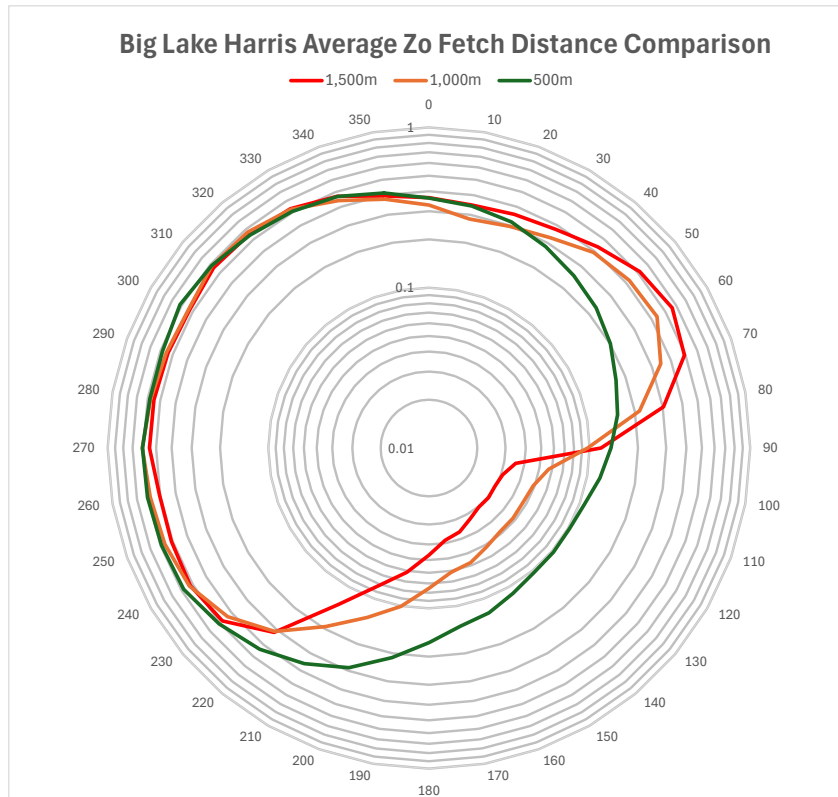
Figure 61. Comparison of average  $Z_o$  by fetch distance.

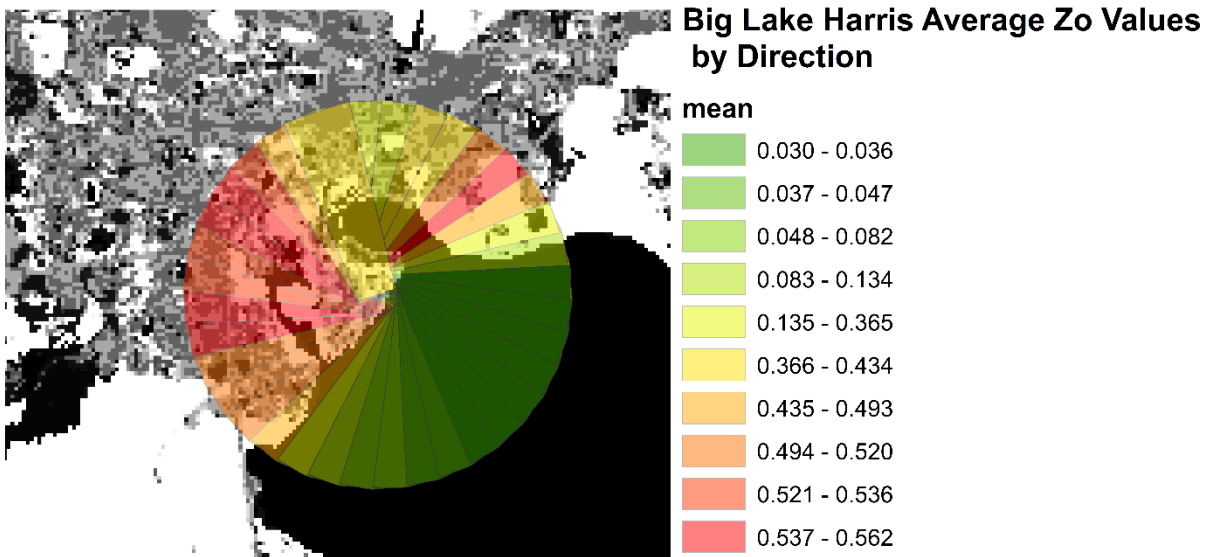
Figure 62. Average  $Z_0$  (in meters) for 1,500-meter upstream fetch distance at 10-degree intervals.

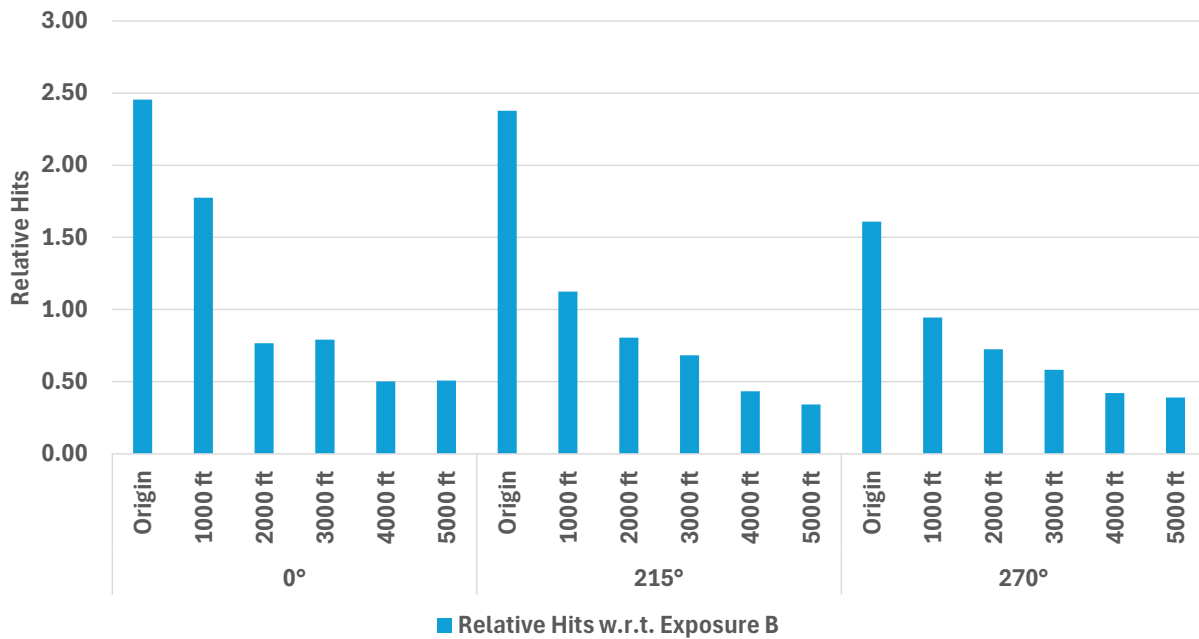
Figure 67. Relative mean WBD hits with respect to 140 mph Exposure B for three relative wind directions for the Big Lake Harris neighborhood.

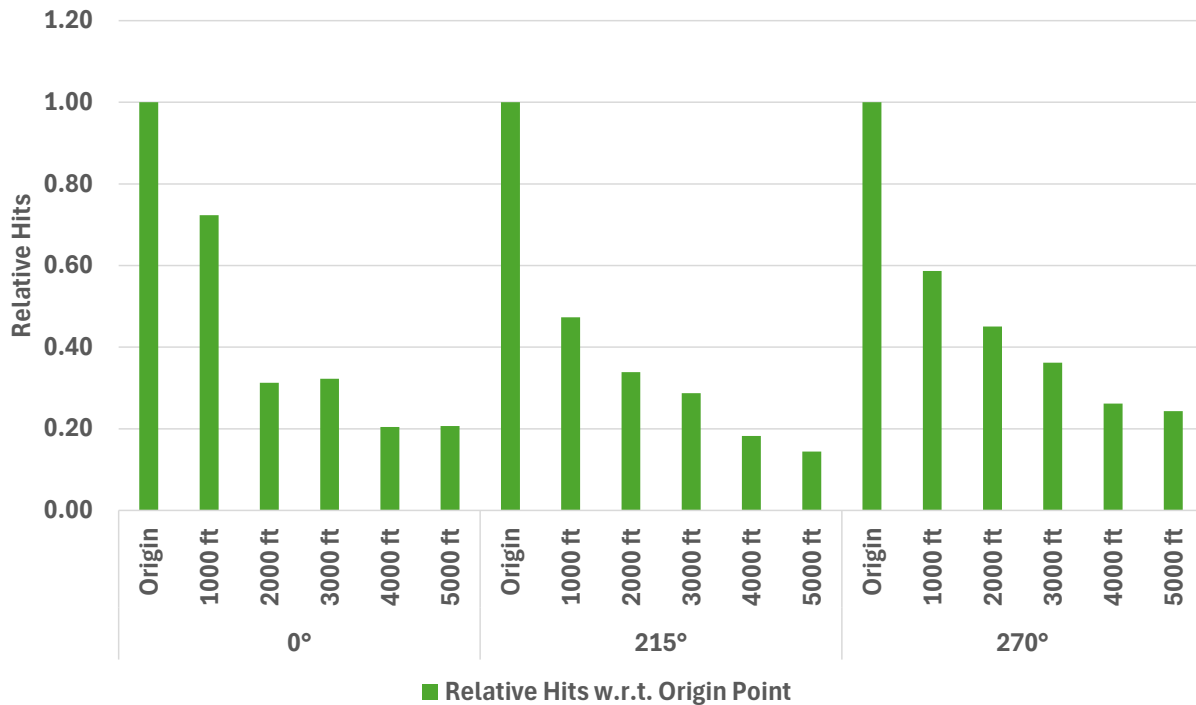
Figure 68. Mean number of hits relative to the origin point for three relative wind directions for the Big Lake Harris neighborhood.

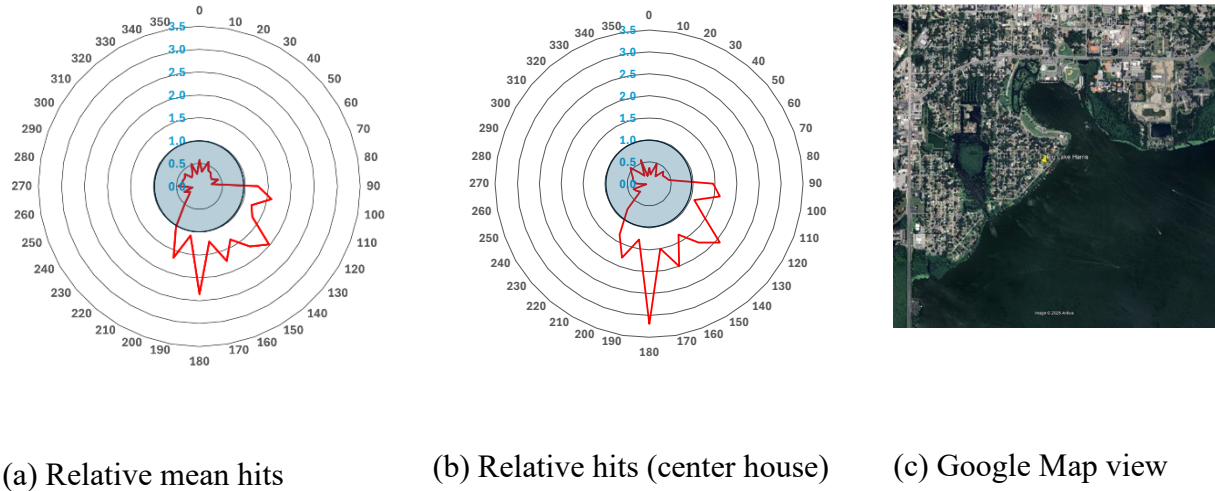
Figure 69. Relative hits by direction for Big Lake Harris location.

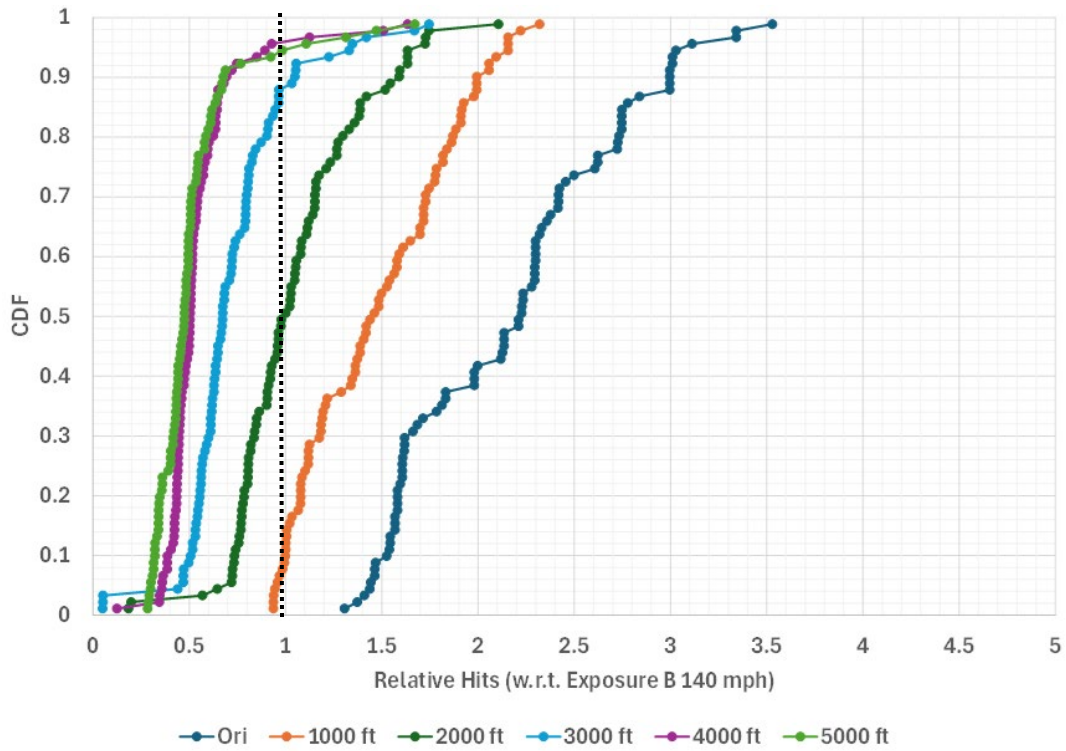
Figure 73. CDF of relative mean hits at origin and offset distances for 30 locations based on 130 mph reference wind speed.
