**TEST REPORT**

**Report No.:** E4545.04-801-44

**GLASSCRAFT DOOR COMPANY**  
Houston, Texas

**PRODUCT TYPE:** Inswing and Outswing 8'0" Triple Fiberglass Door Glazed  
**SERIES/MODEL:** Inswing and Outswing 8'0" Triple Fiberglass Door Glazed  
In-Swing (Specimen #1) Out-Swing (Specimen #2)

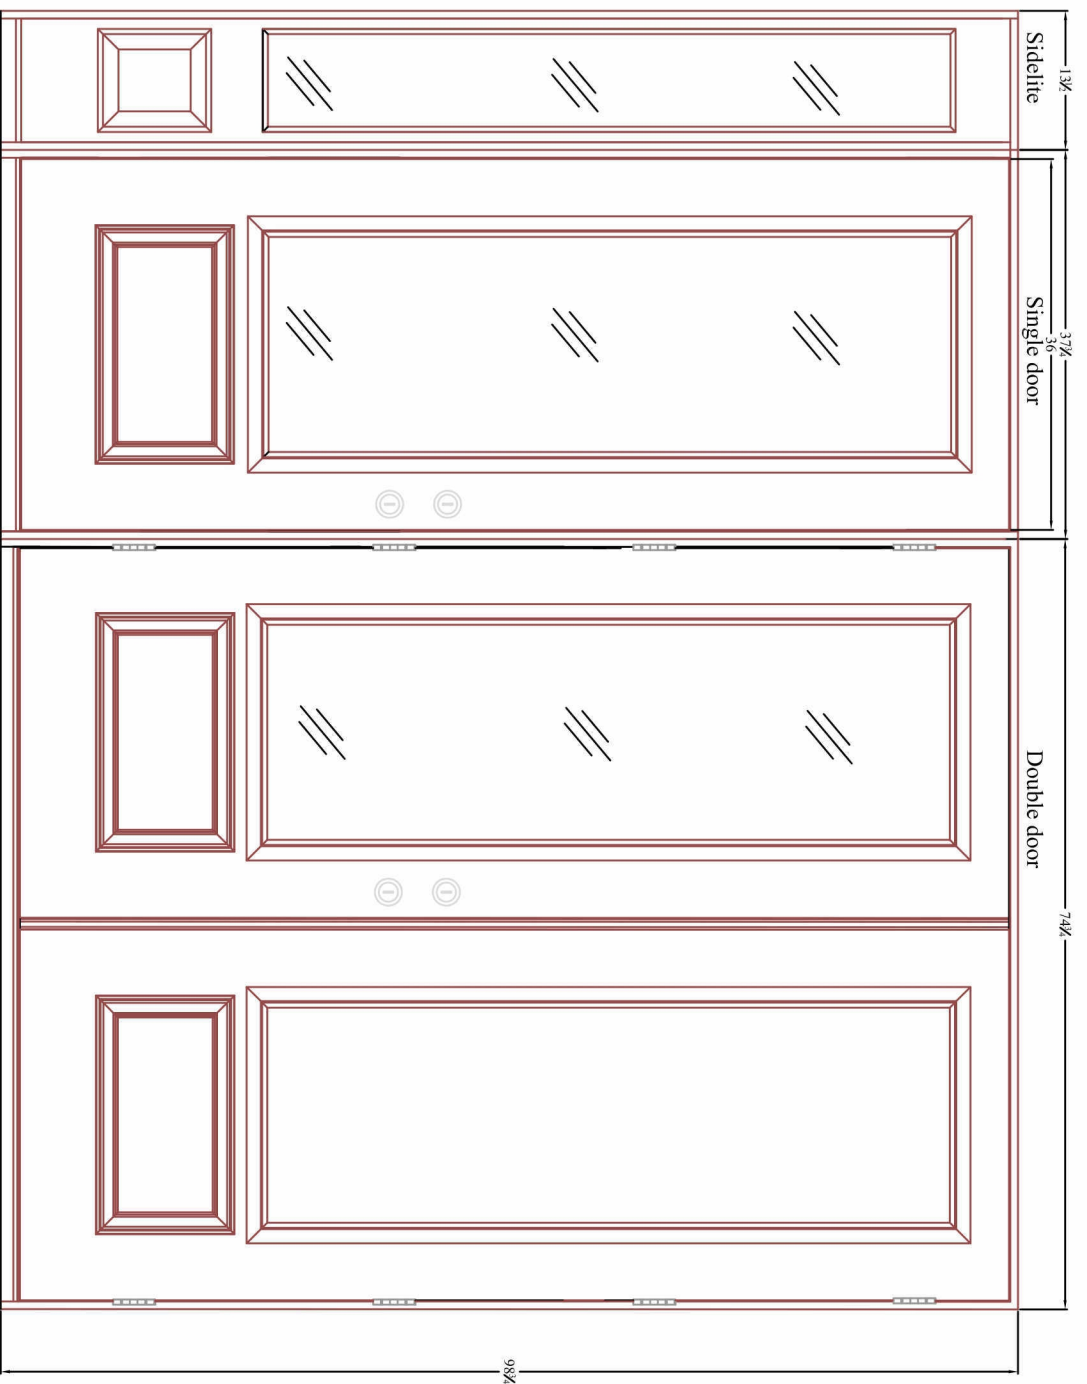
In Swing  
ELEVATION

Fiberglass Glazed Doors

Penrond 4"x4" 5/8" Radius Hinge

Install (2) 3" #8 Wood  
Screws Per Hinge.

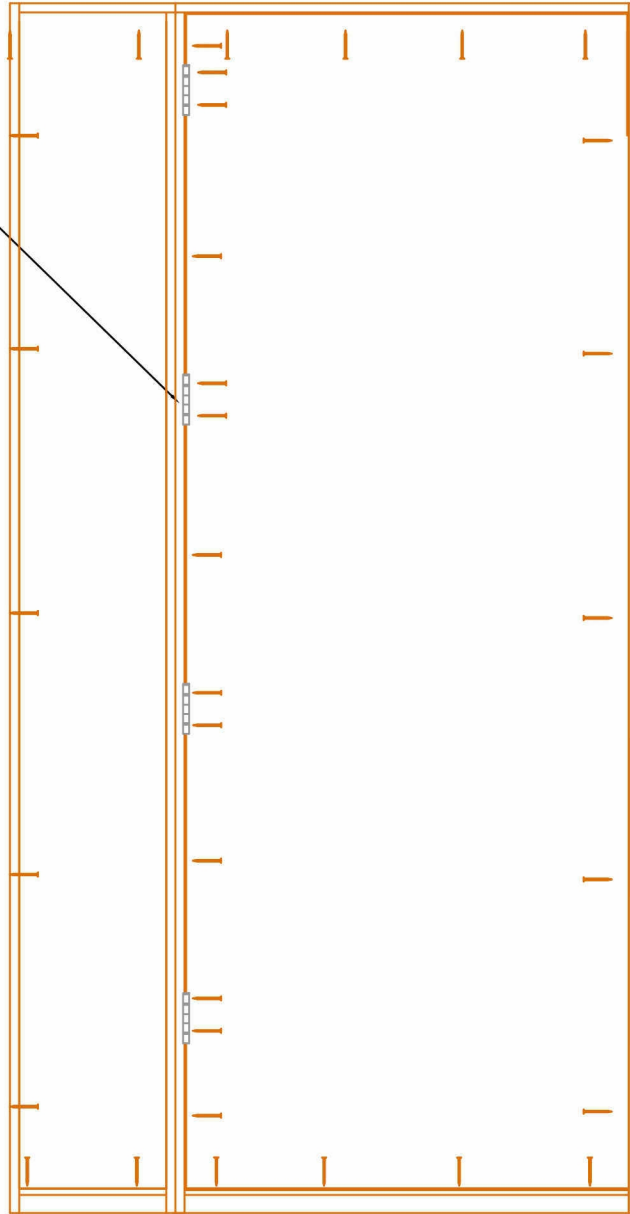
## ANCHORING LOCATION

Single Door with Sidelites I/Sing

Location	Anchor Description	Anchor Location
Jambs	#9 x 3" wood screws	12" from corners and center; through top and bottom mounting holes of hinges
Head and threshold	#9 x 3" wood screws	4" from corners, 12" on center thereafter

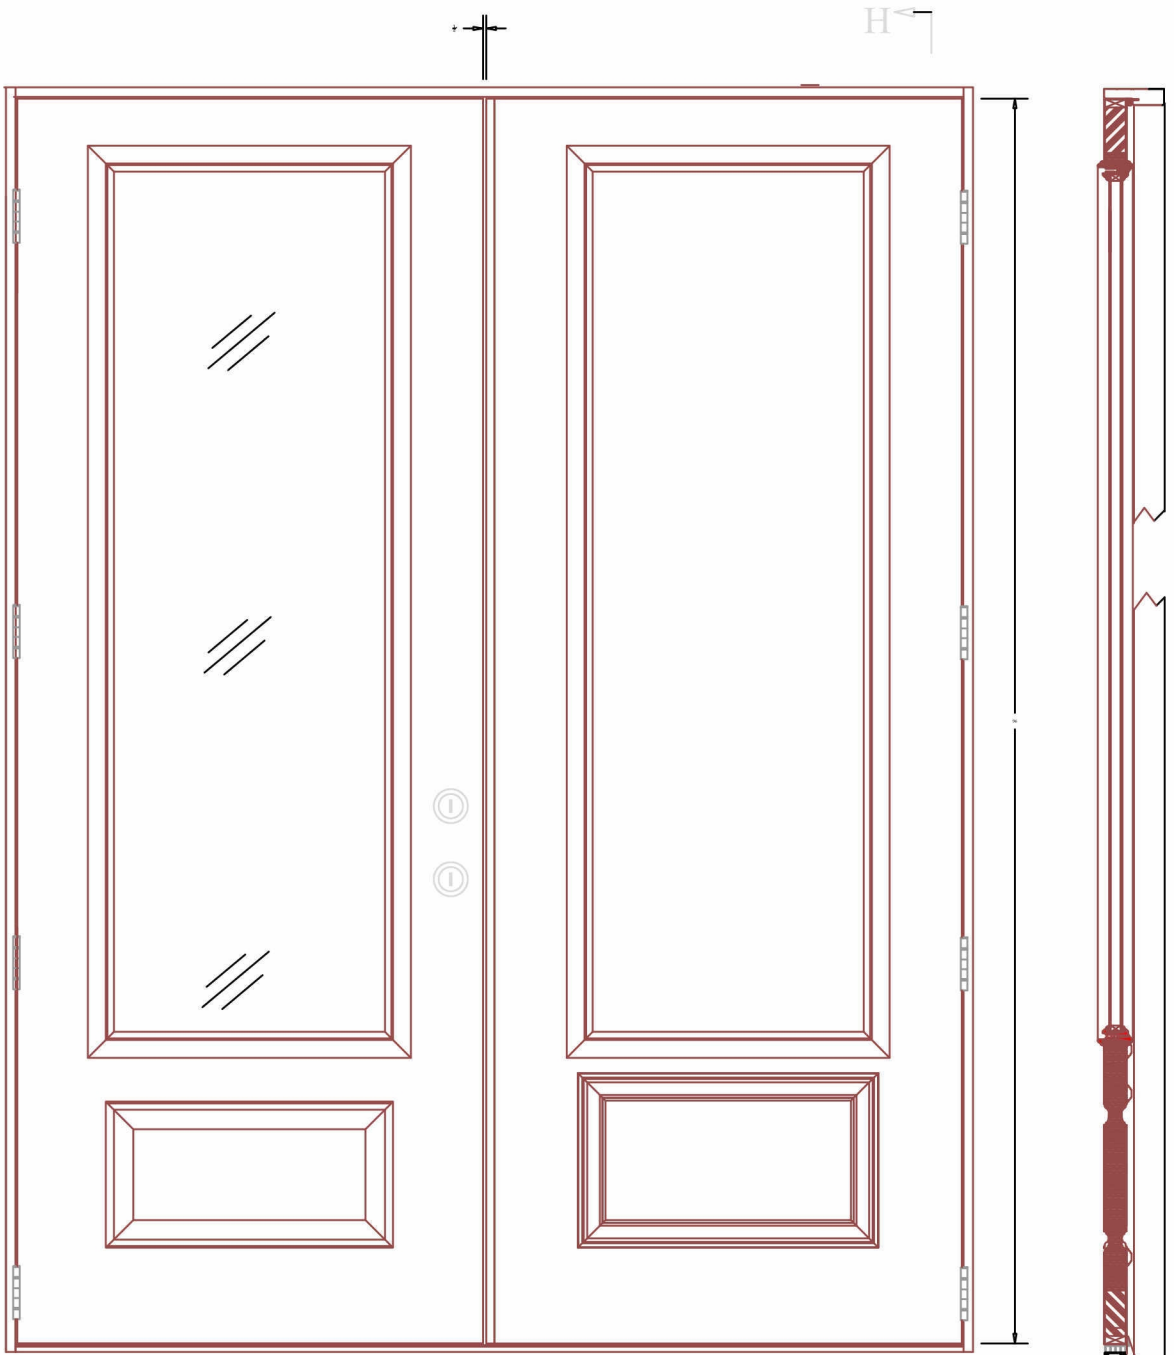
ELEVATION

Section  
H-H

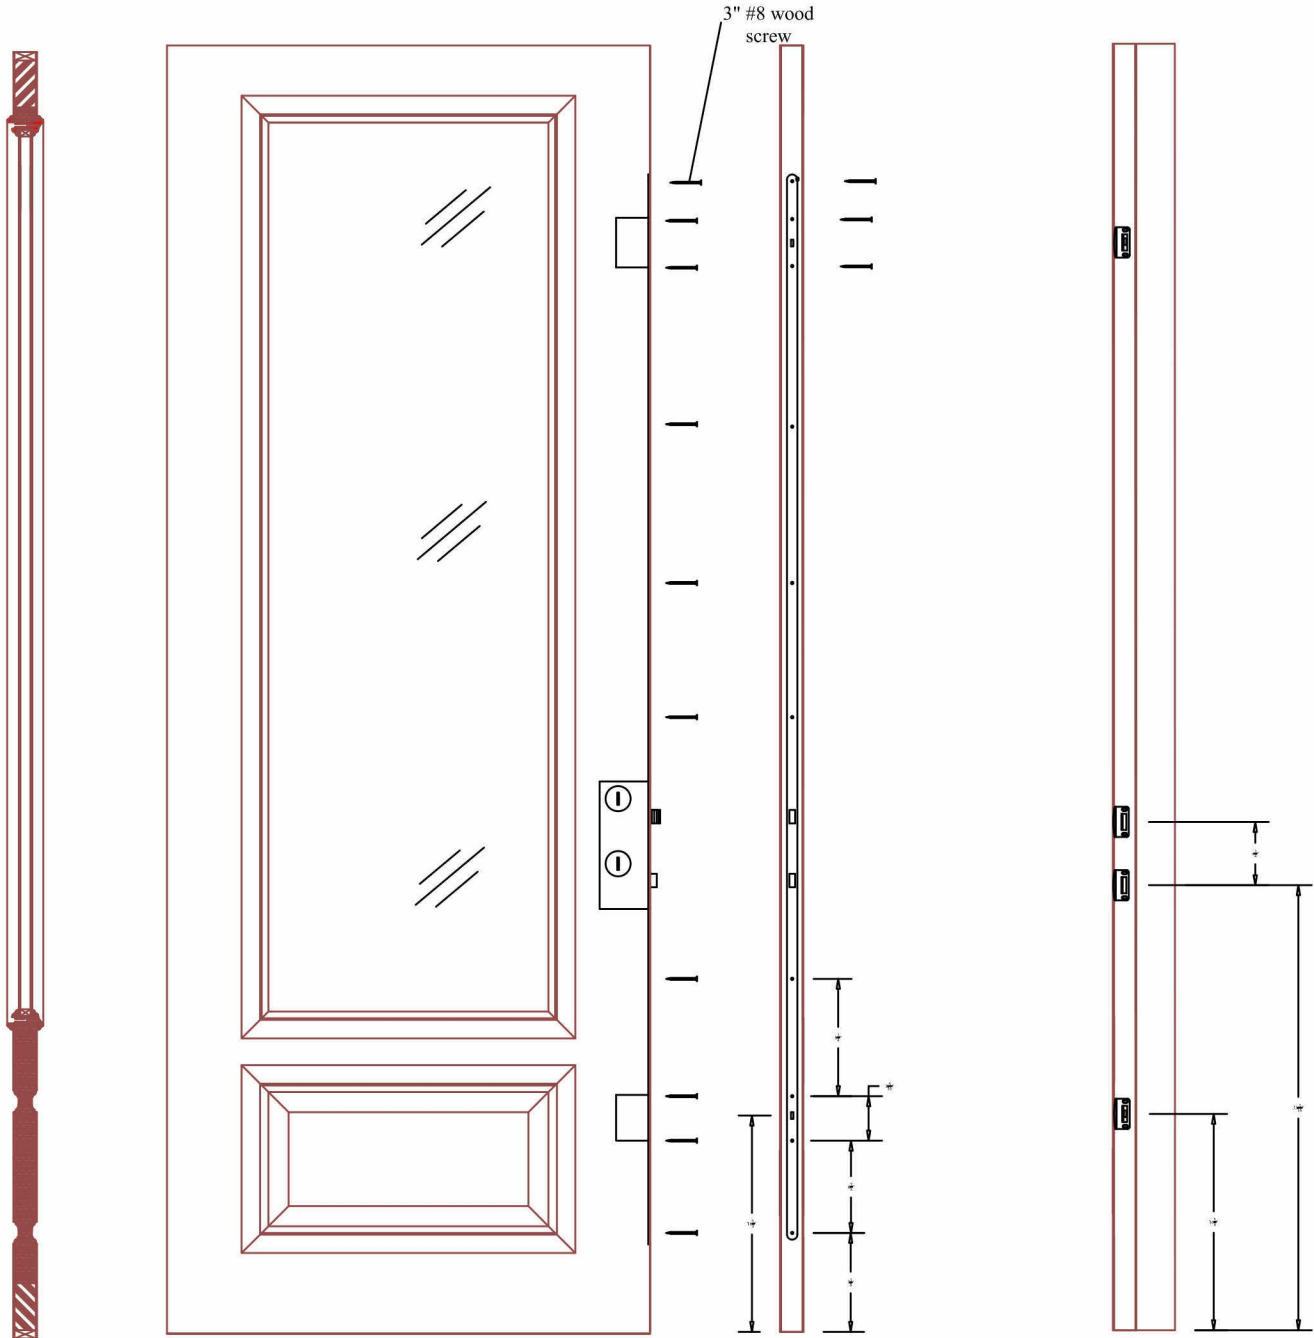
Three point lock set screw  
location and strike plate

Description	Quantity	Location
Door hinge	12	12" and 28" from bottom; 9" and 34-1/2" from top; attached with two #9 x 3" and two #9 x 1" wood screws
3 point lock set	2	Inserted into lock stile of operable leaf, secured with nine #8 x 3" wood screws at 7-3/8", 14-1/4", 17-9/16", 26-5/16", 45-13/16", 55-13/16", 62-3/16", 65-7/16" and 72-3/4" from bottom
Strike plate	12	On lock jamb in line with 3 point lock and dead bolt; secured with two #9 x 3" wood screws each
Flush Bolt	4	Top and bottom of each operable door leaf

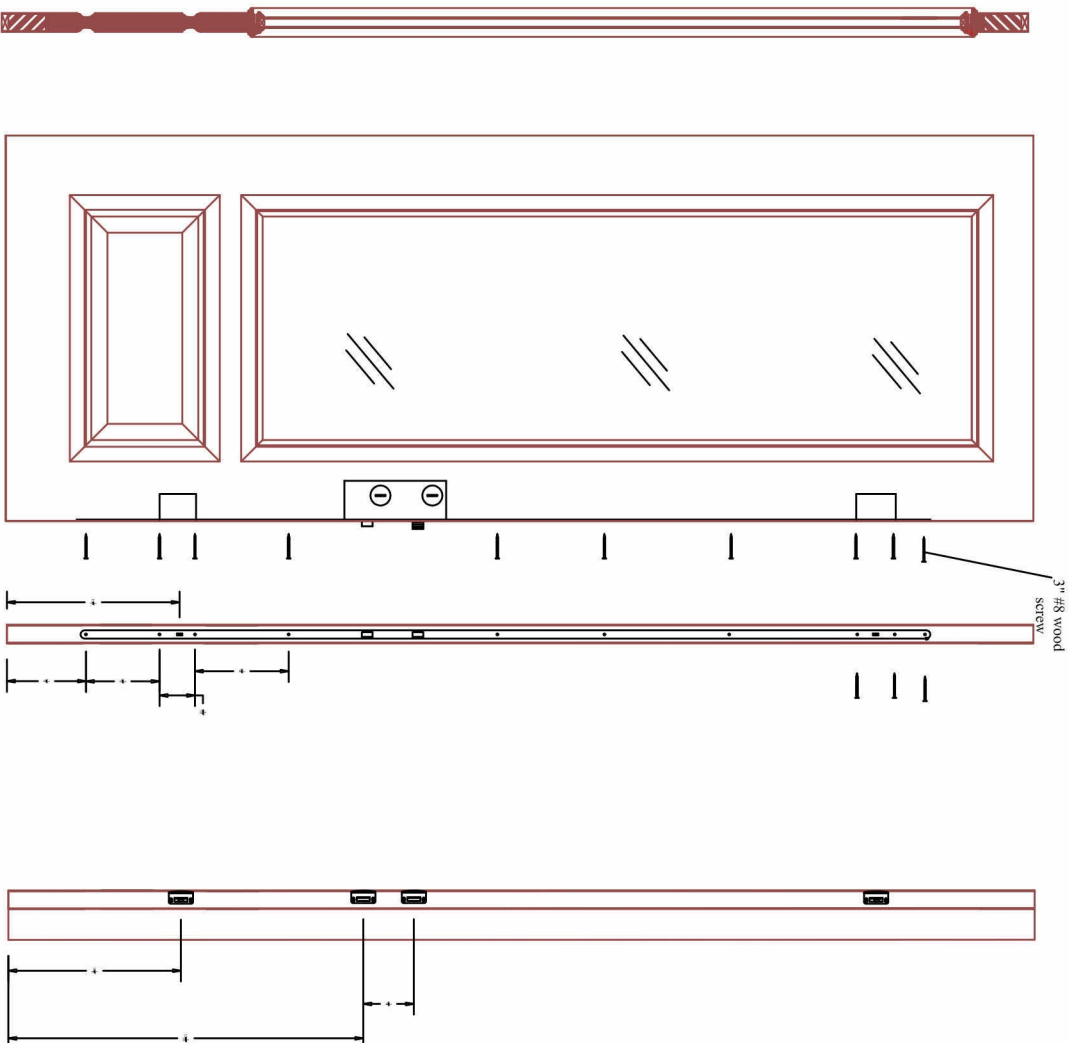
Three point lock set screw  
location and strike plate

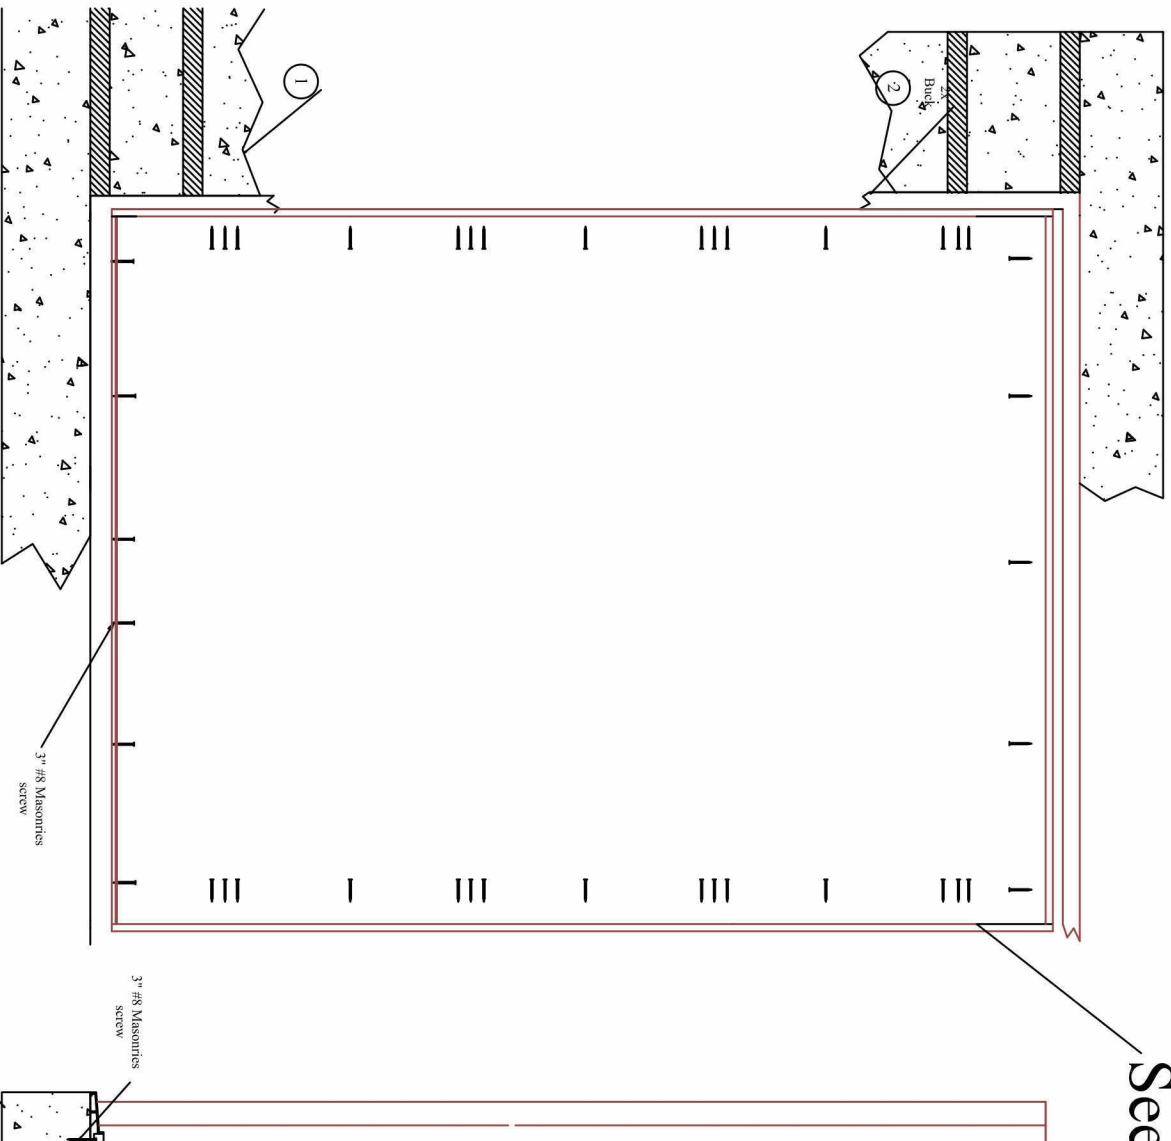
ANCHORING LAYOUT

Set frame sill

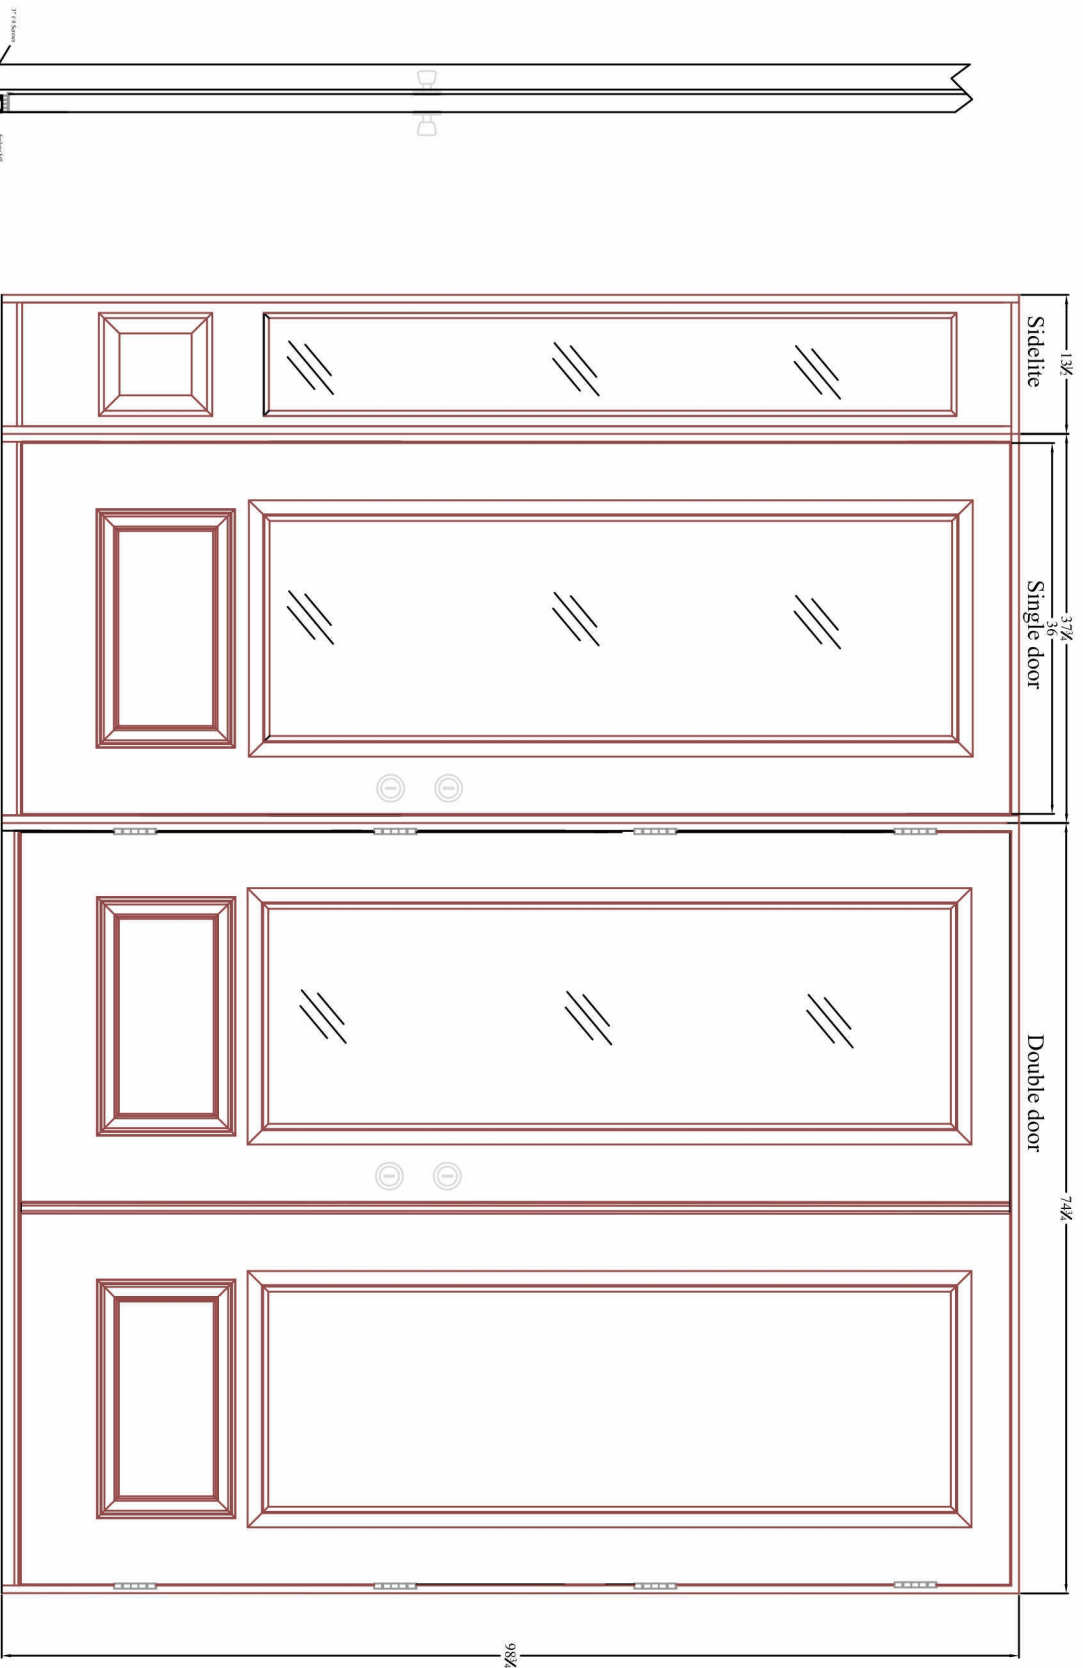
ELEVATION

Out Swing

Penrond 4"x4" 5/8" Radius Hinge

Install (2) 3" #8 Wood  
Screws Per Hinge.

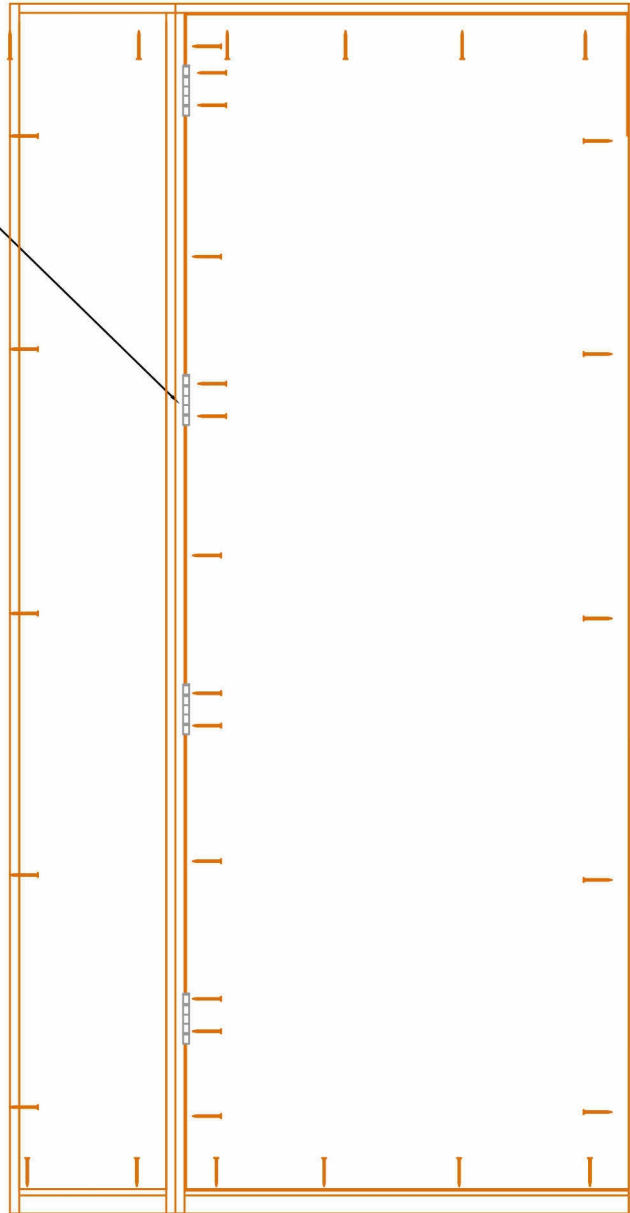
## ANCHORING LOCATION

Single Door with Sidelites O/Sing

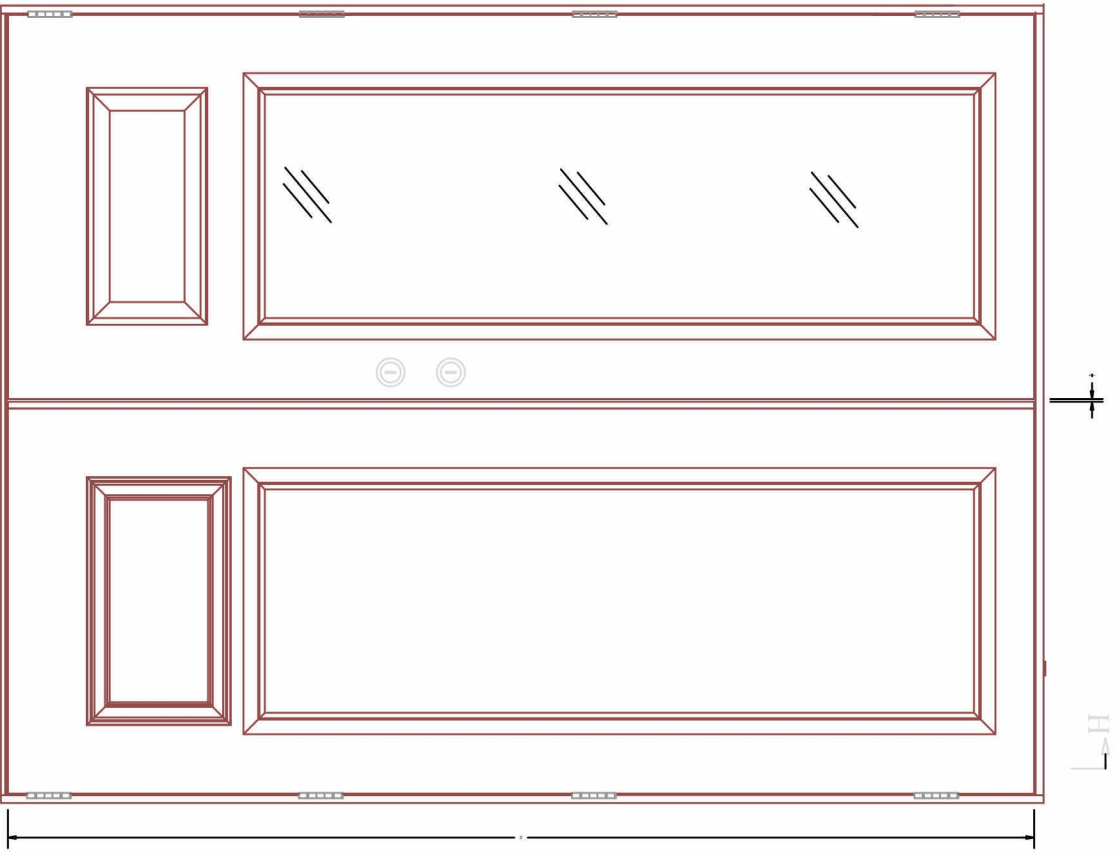
ELEVATION

Section  
H-H

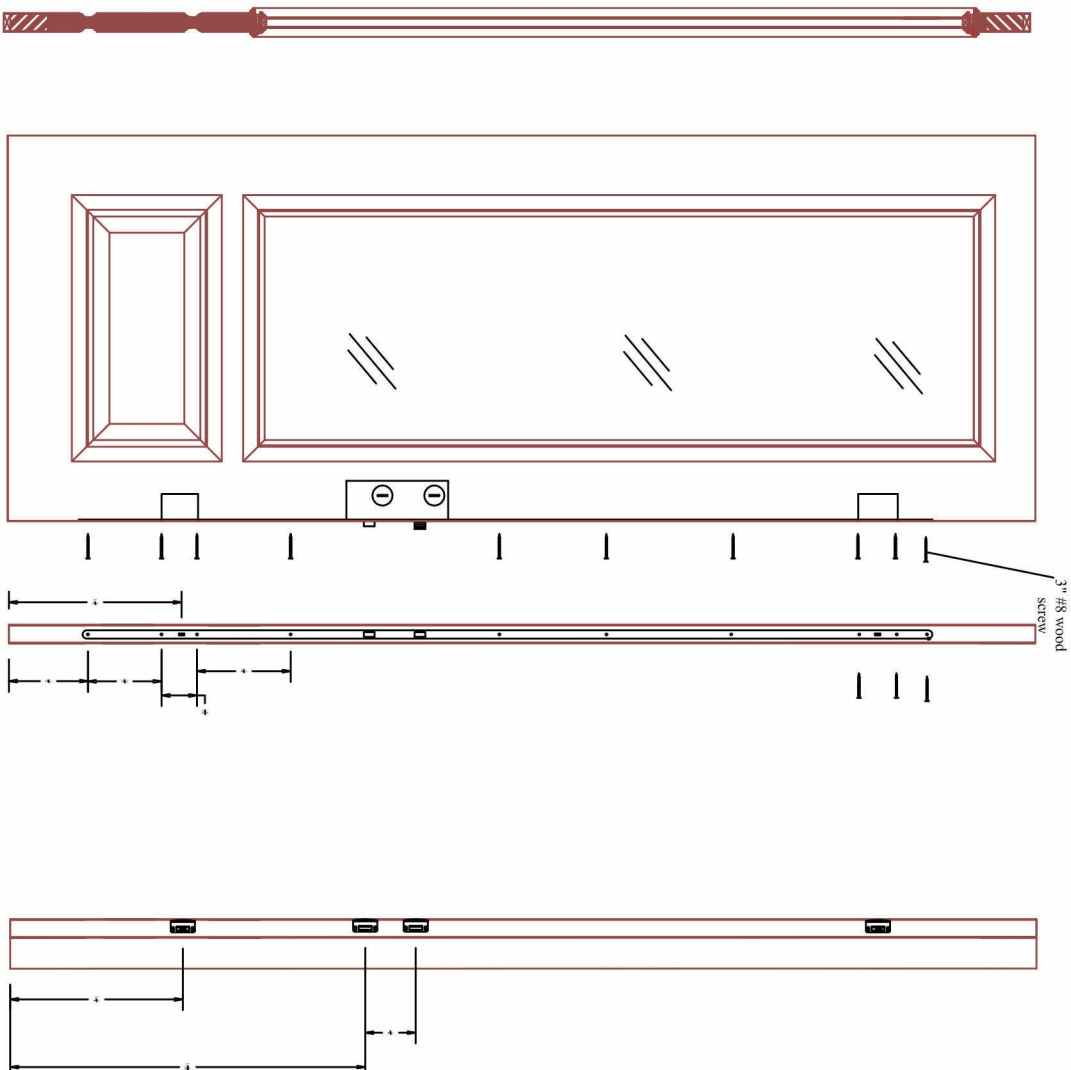
Three point lock set screw  
location and strike plate

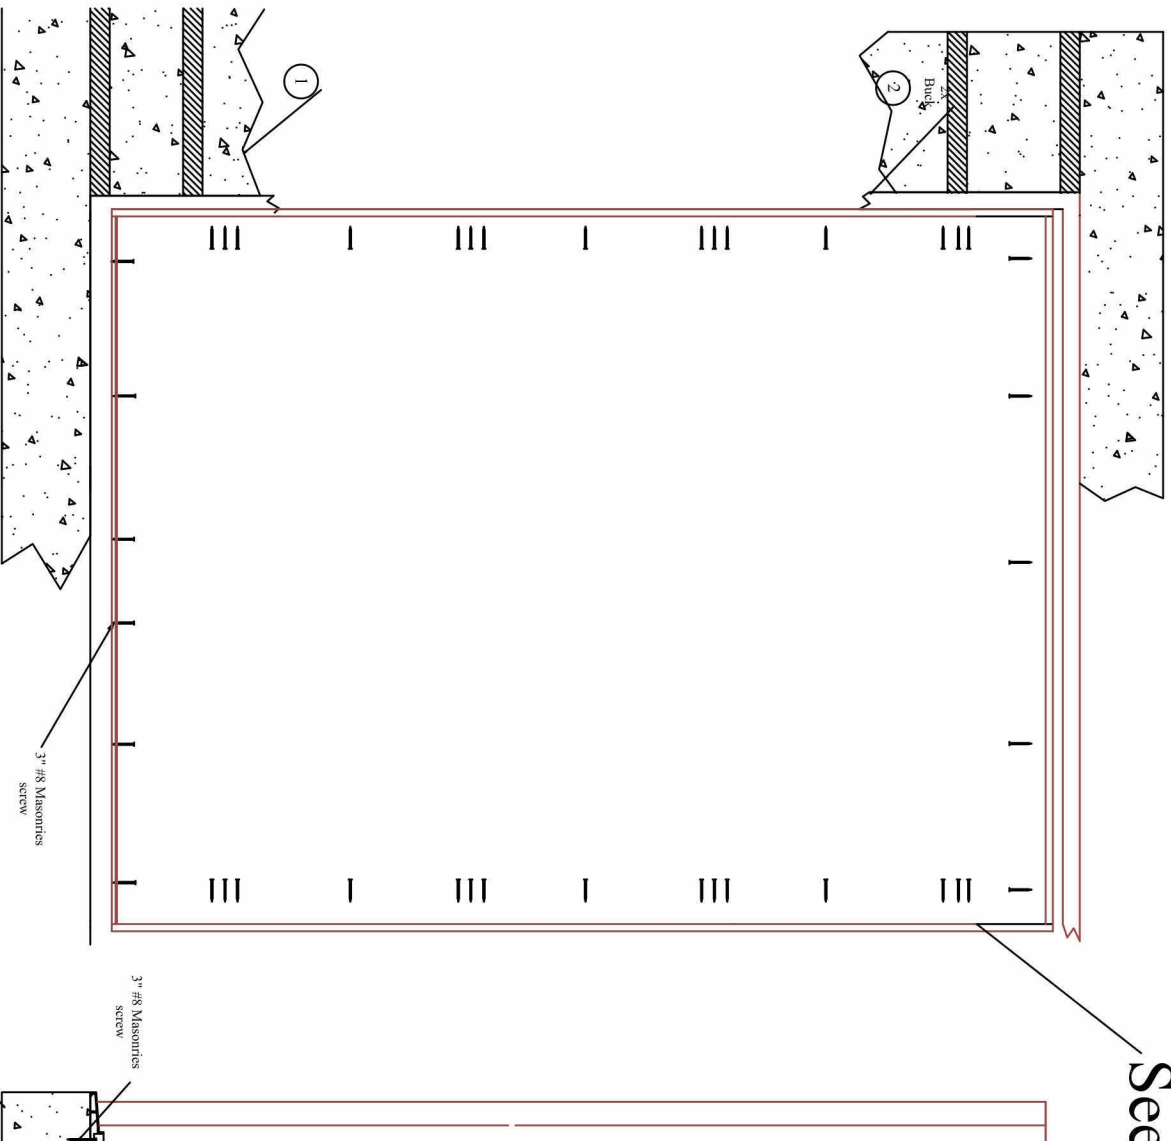
## ANCHORING LAYOUT

3" #8 Masonrics screw

Set frame sill
