American Test Lab, Inc.  
1656 Calvert Road, Brevard, N. C. 28712  
Phone (828) 884-3700 Fax (828) 884-3710  
Web [www.atlnc.com](http://www.atlnc.com) E-Mail [atli@citcom.net](mailto:atli@citcom.net)

**ATLNC # 1013.01-14**

ASTM E 1592-05

**Specimen A, B, C** 20 gauge (.036") Metal Roof Panels over W8 x 13 purlins as shown in Madison Industries Drawing A-1.2

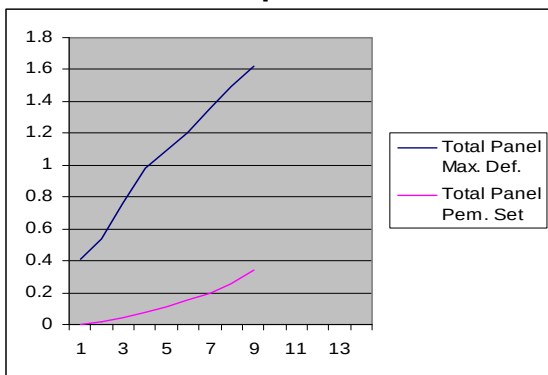
### Positive Side Graph

Note: Specimen failed at 140 psf 5 seconds into test. Specimen failed at center purlin. Deck clips bent and bolt pulled through right center rib.

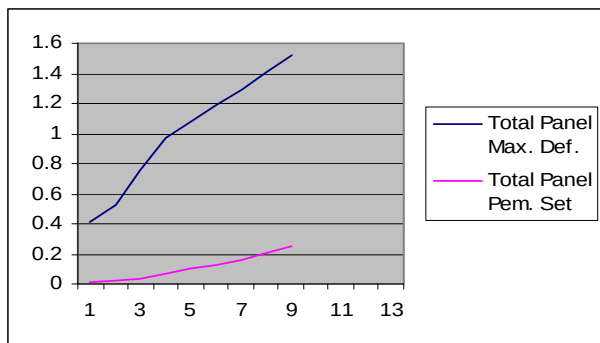
### Positive Side Graph

Note: Specimen failed at 140 psf 35 seconds into test. Specimen failed at center purlin. Deck Clips bent and bolt pulled through right center rib.

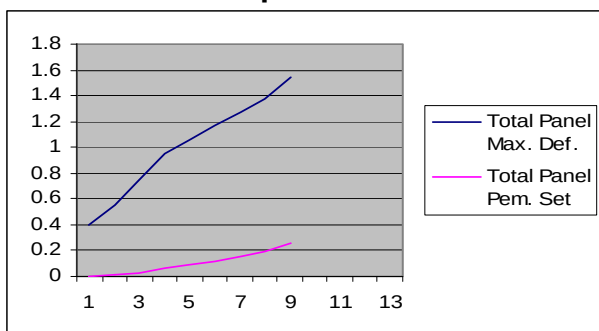
#### Positive Side Graph

Note: Specimen failed at 135 psf. Specimen failed at center purlin, Deck Clips bent and bolt pulled through left center rib.
