**MIAMI-DADE COUNTY PERFORMANCE TEST REPORT**

**Report No.:** F7663.03-109-18

OVERHEAD DOOR CORPORATION – PENNSYLVANIA ROLLING STEEL  
Lewistown, Pennsylvania

**PRODUCT TYPE:** Rolling Steel Door  
**SERIES/MODEL:** 800

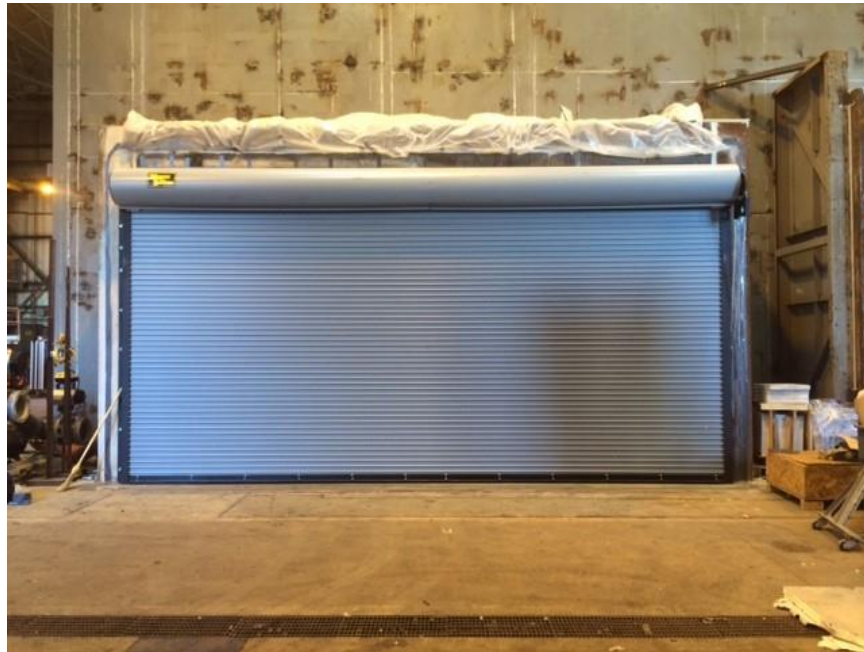
**Photo No. 1**  
**Exterior Mounted Specimen**

**5.4 Installation:** The installation represented an interior mount and an exterior mount. Test specimens #1 and #2 were exterior mounted and test specimens #3 and #4 were interior mounted. The installation angles were secured to the steel column with grade 5, 5/8" diameter x 1-1/4" long bolts, 6" from the bottom and spaced 18" on center for the first five bolts closest to the sill and 10" on center for the second five bolts furthest from the sill. The "Z" guide was secured to the concrete column with 5/8" diameter by 7" long concrete anchors with 3-1/2" of embedment, 6" from the bottom and spaced 18" on center for the first five bolts closest to the sill and 10" on center for the second five bolts furthest from the sill.
