MIAMI-DADE COUNTY PERFORMANCE TEST REPORT

Report No.: D2662.01-109-18

PRODUCT TYPE: Roll-Up Garage Door **SERIES/MODEL**: Thermiser

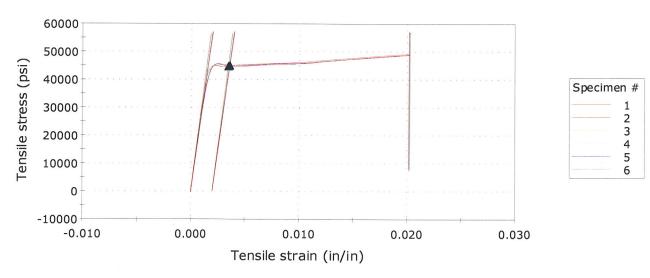
ASTM E8 - 08, Tensile Strength of Metallic Materials Last Updated by: Gary Hartman 06/21/2010 Uses Instron Wedge Grips with appropriate wedges for materials being evaluated.

Specimens 1 to 6

Test Results: The test results for the tensile testing of the garage door slats are provided in Appendix B and summarized in Table 32 below.

Specimen	Yield Strength (psi)	Tensile Load (lbf)	Tensile Strength (psi)	Elongation (%)	Area Reduction (%)
1	45,230	1164	57,478	31.6	27.0
2	44,789	1158	56,722	30.8	25.0
3	44,986	1161	56,918	33.2	27.0
4	44,818	1158	56,787	30.0	24.0
5	45,117	1160	57,000	28.9	25.0
6	45,077	1159	57,103	30.7	29.0
Average	45,003	1,160	57,001	30.9	26.2

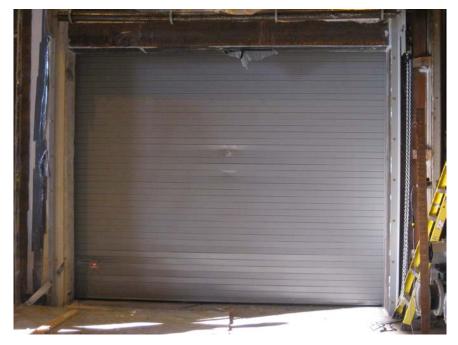
Photo No. 1 12' 4" x 10' Roll-Up Garage Door

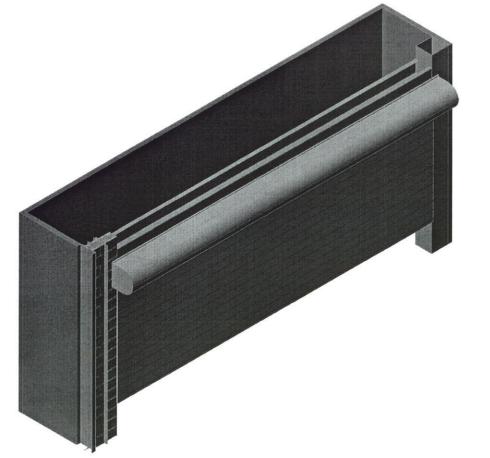
3	/8"	STEEL	CHAMBER	(SEQUENCES	1-10	38	20)
			3/16	" [`] = 1'-0"			,

- **5.2.1 Test Chamber #1**: The steel chamber was constructed with a 3000 psi concrete jamb and a 1/4" thick steel jamb. Both jambs were welded and braced to the base steel test chamber and sealed with sealant to prevent extraneous leakage.
- **5.2.2 Test Chamber #2**: The steel chamber was constructed with a CMU jamb consisting of a double CMU unit and a 1/4" thick steel jamb. Only the CMU cell closest to the opening was filled with grout. Both jambs were welded and braced to the base steel test chamber and sealed with sealant to prevent extraneous leakage.
- **5.3 Garage Door Description**: The garage door utilized a 12' 5" wide distance between guides and a 10' 0" tall door opening height. Test Specimens #1, #3, #4, and #6 were installed using an interior mounting condition. Test Specimens #2, #5, #7, and #8 were installed using an exterior mounting condition.
