TEST REPORT

Report No.: F8186.01-801-44

GLASSCRAFT DOOR COMPANY
Houston, Texas

PRODUCT TYPE: Inswing and Outswing 8'0" Triple Steel Door Glazed
SERIES/MODEL: Inswing and Outswing 8'0" Triple Steel Door Glazed
In-Swing (Specimen #1) Out-Swing (Specimen #2)

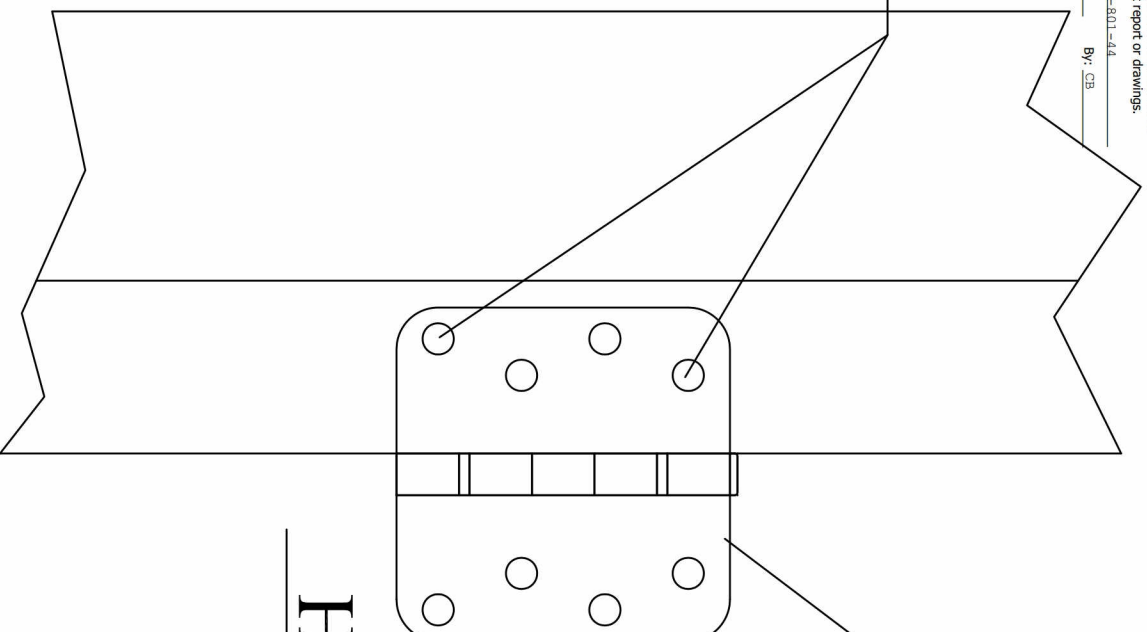
Hinge Detail

Penrond 4"x4" 5/8" Radius Hinge

Install (2) 3" #8 Wood
Screws Per Hinge.

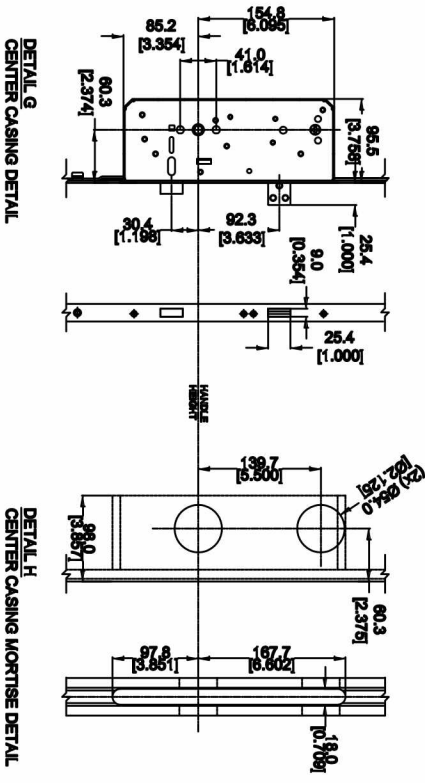
3-point lock set
8'-0"

Rockwill Triple point lock set

Description	Quantity	Location
Door hinge	12	12" and 28" from bottom; 9" and 34-1/2" from top; attached with two #9 x 3" and two #9 x 1" wood screws
3 point lock set	3	Inserted into lock stile of operable leaf, secured with nine #8 x 3" wood screws at 7-3/8", 14-1/4", 17-9/16", 26-5/16", 45-13/16", 55-13/16", 62-3/16", 65-7/16" and 72-3/4" from bottom
Strike plate	12	On lock jamb in line with 3 point lock and dead bolt; secured with two #9 x 3" wood screws each
Flush Bolt	4	Top and bottom of each operable door leaf

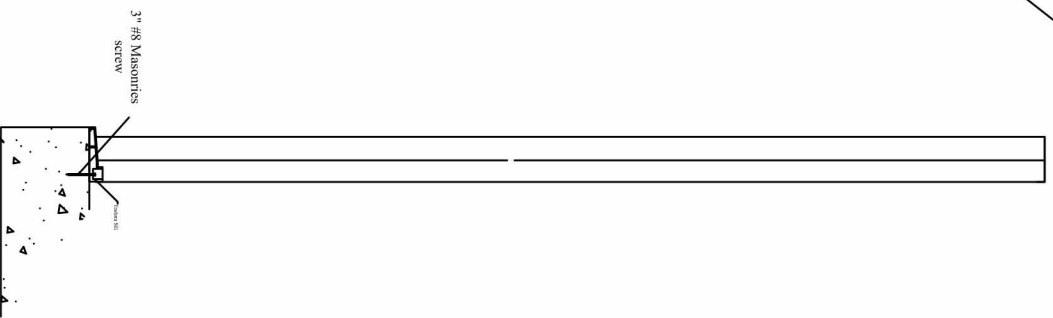
ANCHORING LAYOUT

Set frame sill

Location	Anchor Description	Anchor Location
Jambs	#9 x 3" wood screws	12" from corners and center; through top and bottom mounting holes of hinges
Head and threshold	#9 x 3" wood screws	4" from corners, 12" on center thereafter
