Successfully Retrofitting Buildings for Wind Resistance

FEMA

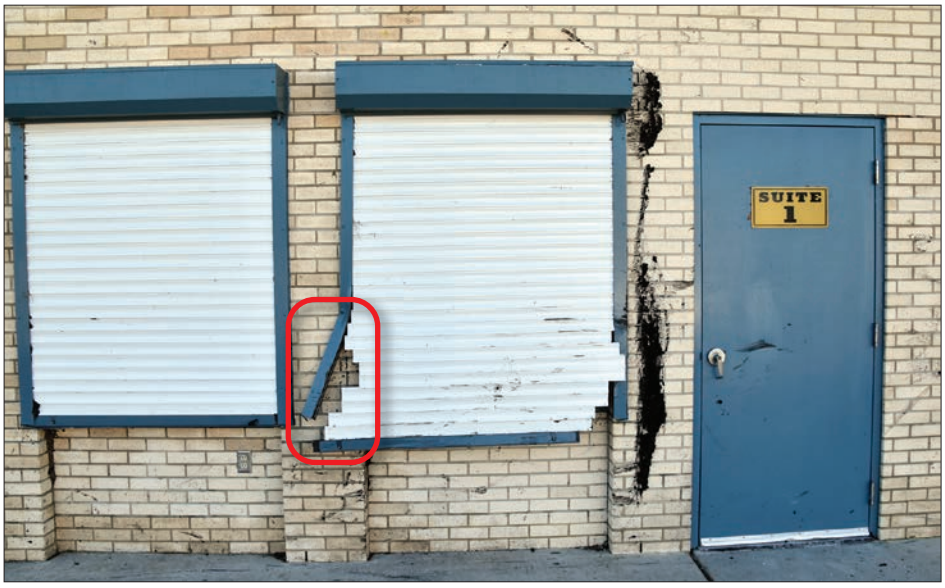
Figure 3 is a view of shutters at the community building, which successfully protected the glazing. The black areas on the brick and both of the shutters are asphalt residue from wind-borne roof membrane debris from the fire station. Note the distorted jamb and sill frame at the right shutter, which was caused by debris impacting the shutter at an angle.

The red arrow indicates wind-borne plywood debris that was lodged between the shutter slats and frame. The black areas on the brick are asphalt roofing residue from wind-borne debris that struck the building.

Figure 2: This shutter was struck by wind-borne debris but protected the glazing

Figure 3: These shutters were struck by wind-borne roof membrane debris; distorted jamb and sill frame indicated by red rectangle

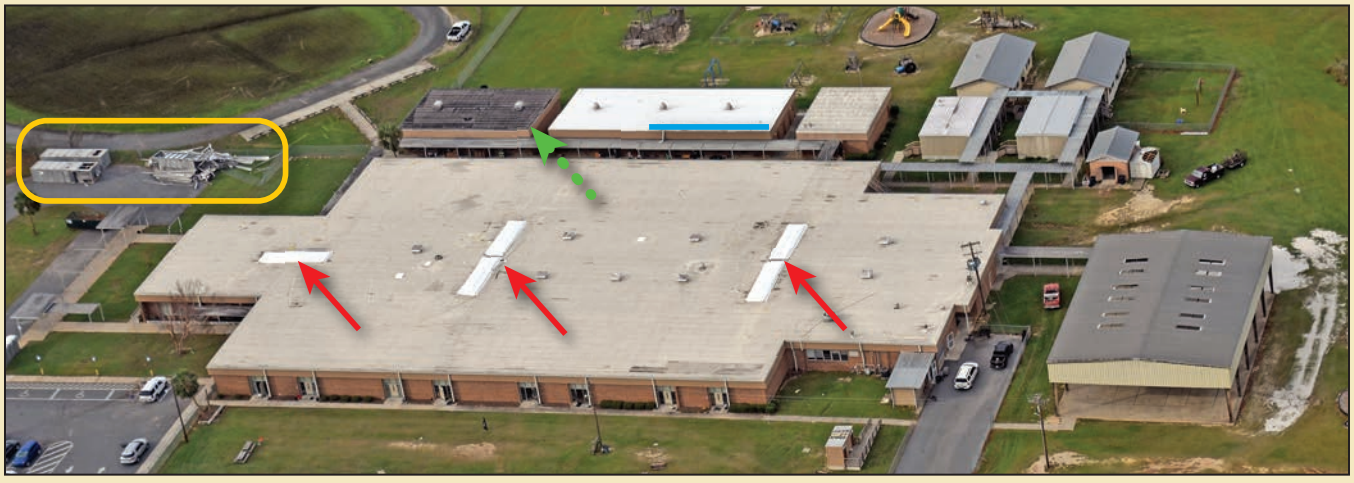
The building had cementitious wood-fiber roof deck panels over steel joists (the same type of deck/structure shown in Figure 5:). The three large HVAC units that blew off their curbs were moved to the area within the yellow rectangle; one unit blew off the roof and damaged the wall of another building, indicated by the green arrow. Water entered the school at the open curbs (shown as white areas [red arrows] where there are temporary patches over the curbs on which the three units sat before the storm) and at several locations where the wind-borne equipment tore the roof membrane. At least one window was broken by wind-borne debris. The blue line indicates where metal edge flashing blew off. Some of the smaller pieces of rooftop equipment were also damaged. There were numerous roof punctures in the main roof area.

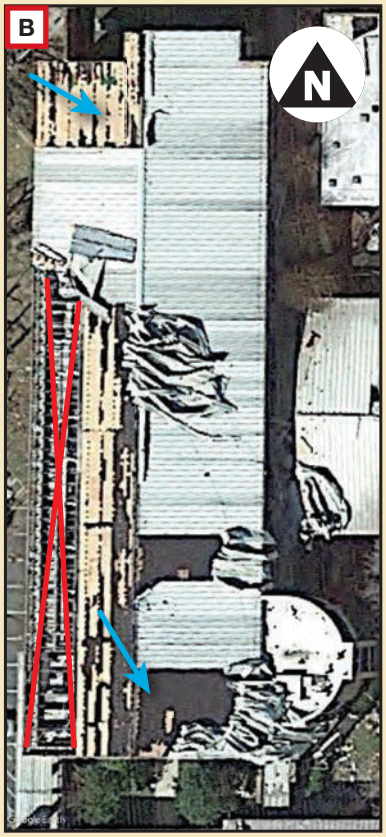
Because building occupants were in the building during the hurricane, it can be assumed the roof failure was unexpected. The failure of the roof offers an example of an unexpected failure that highlights the need for contingency planning. A contingency plan for a building that is occupied during a hurricane such as this one could be used to specify a plan of action should the building become damaged, including relocating occupants to an undamaged portion of the building or evacuation under certain damage conditions.

Photo B.
Aerial view of the school building. The red lines indicate the area where the steel roof deck blew off. The blue arrows indicate where the structural standing seam trapezoidal metal roof panels blew off
