Mitigation Assessment Team Report

# Hurricane Irma in Florida

Building Performance Observations,  
Recommendations, and Technical Guidance

FEMA P-2023 / December 2018

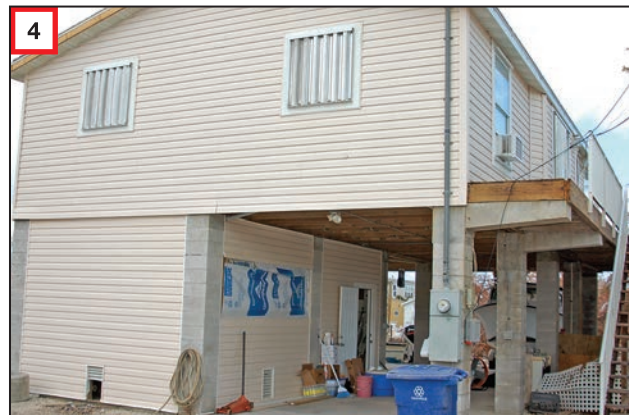
Minor enclosure damage to newer, elevated house situated away from the shoreline.

**Figure 3-3: Typical range in flood damage observed along Avenue D, in order along the street as indicated (Big Pine Key, FL)**

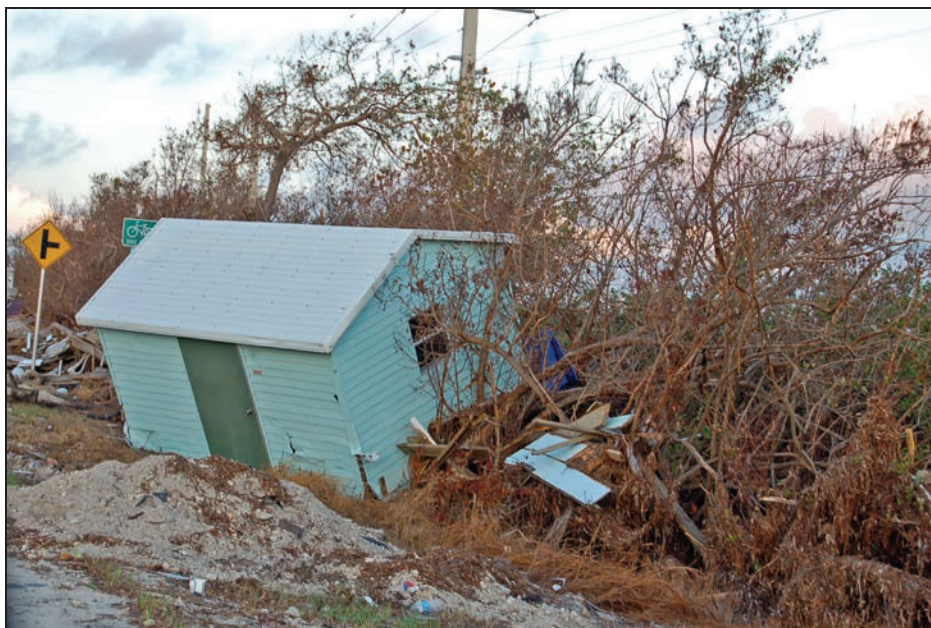
**Figure 3-13:**  
Shed that washed across  
Highway US 1  
(Grassy Key, FL)

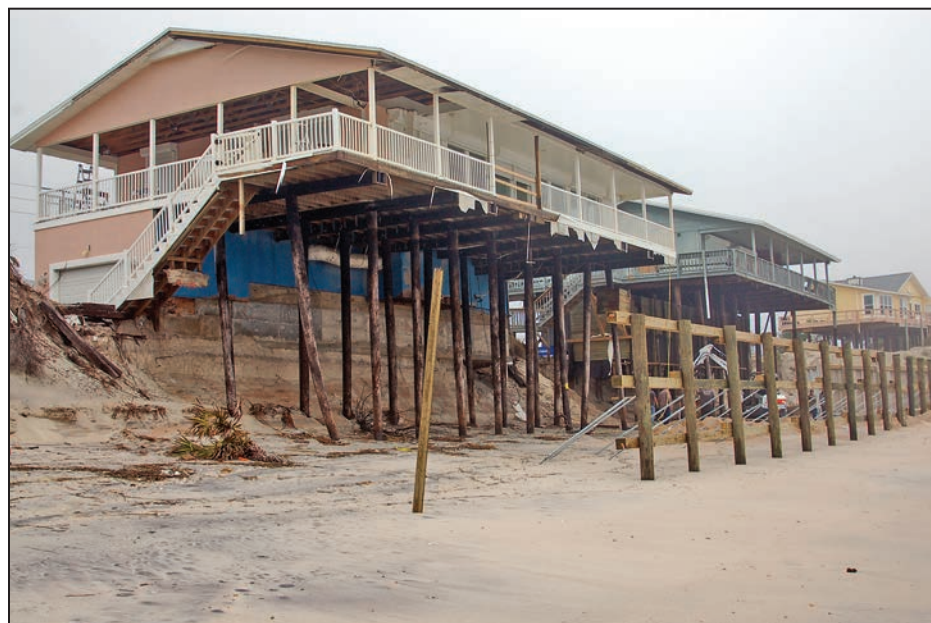
**Figure 3-19:**  
Undermined houses  
constructed on top of the  
dune (Vilano Beach, FL)

These houses survived the undermining, even though approximately 10 to 15 feet of dune height was lost beneath the houses. The pilings farther seaward are for a seawall under construction at the time of the MAT visit (February 2018).

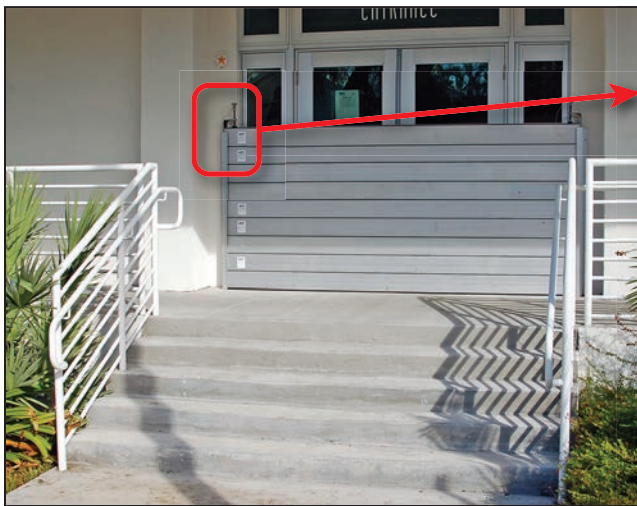
Some dry floodproofing systems were not subject to flooding, but still sustained some minor water accumulation behind them due to rainwater between the floodproofing system and the building face (see Figure 3-30). In one case, significant flooding infiltrated a building as a result of building envelope failure that allowed large quantities of rainwater to enter and become trapped behind the floodproofing system.

Five door openings were covered by flood planks. Hurricane Irma floodwater did not reach the planks; however, wind-driven rain accumulated and entered the building behind one of the barriers deployed at a door without a canopy overhead (the amount of water entry was minor but still a nuisance). System components were lightweight and stored on site. It took two workers 2 hours to deploy. The system was deployed 2 days prior to Irma landfall.

Figure 3-30: Flood plank system deployed at utility company building (Key West, FL)

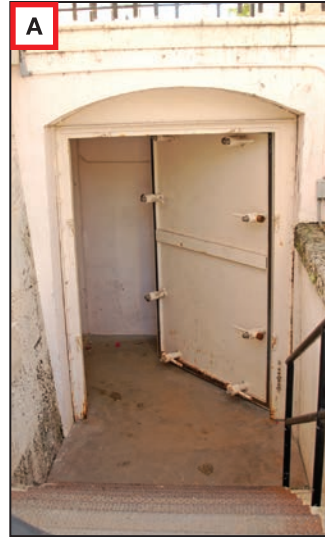
**[A]** Mechanical flood door at one building entrance.

**[B]** Air gasket on aquarium glass door (some air gaskets deflated).

**[C]** Penetration through wall that may have allowed water entry due to improper seal.

Figure 3-32: Floodproofing system components at a historic building (top); parts of the system failed and approximately 3 feet of flooding infiltrated part of the building (Miami, FL)

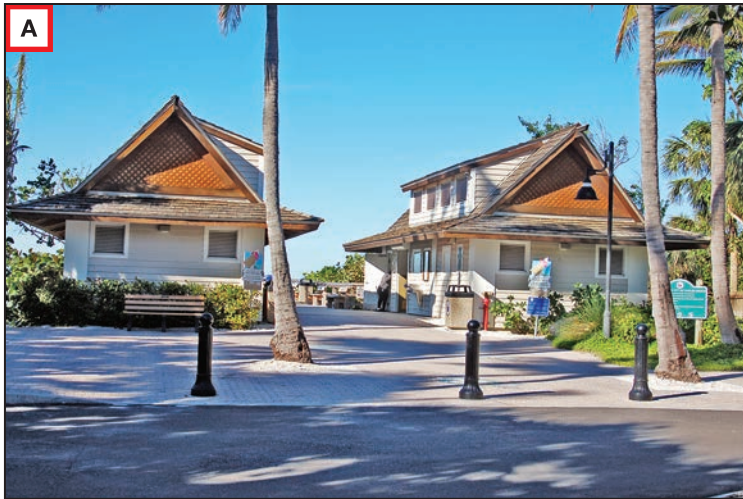
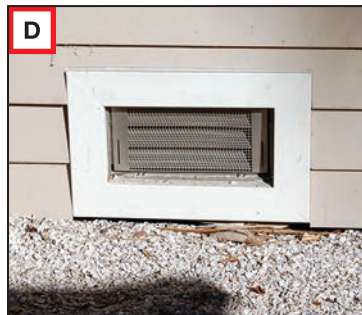
Figure 3-36: Elevated restrooms (Site 4; City of Naples Pier)

- [A]** Photo taken from land side
- [B]** Photo taken from beach
- [C]** Finished floor is below BFE but restroom walls are wet floodproofed to 1 foot above BFE
- [D]** Flood openings have been installed

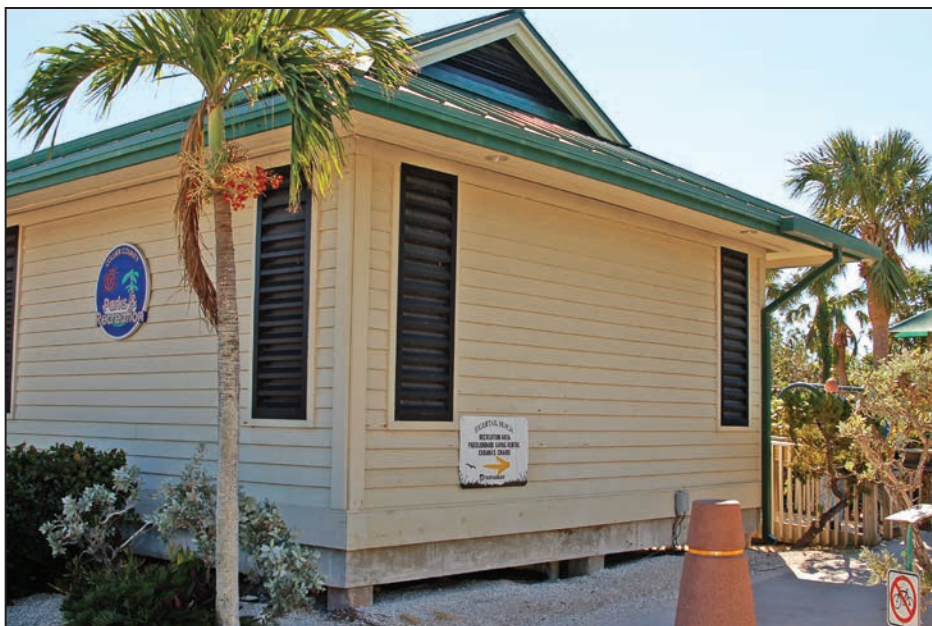
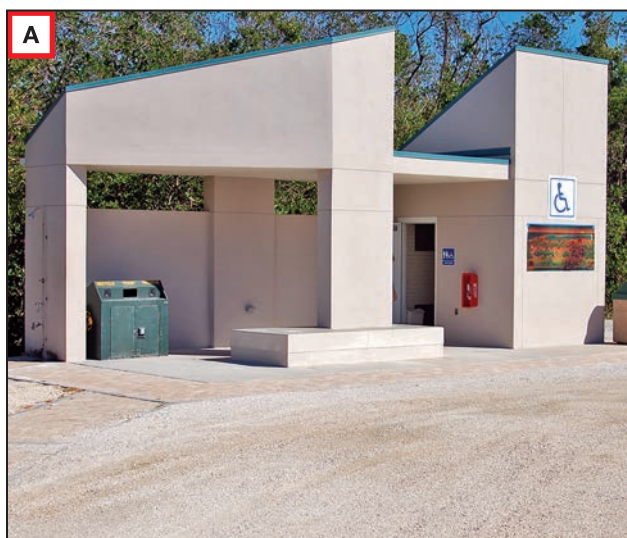
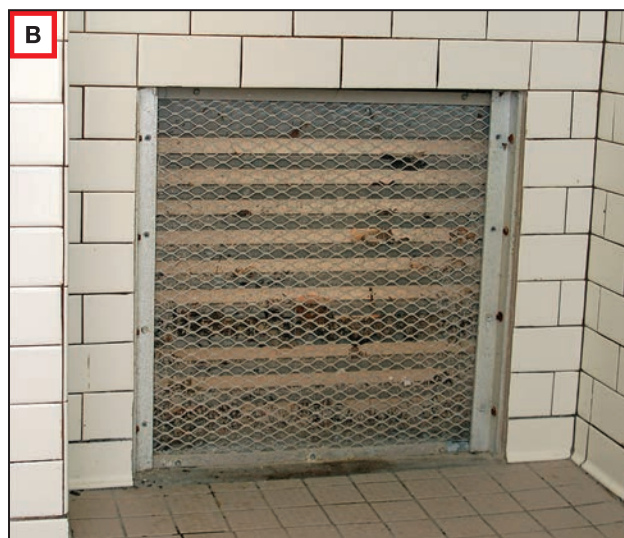
**[A]** Restroom at Tigertail Beach, Marco Island. The estimated flood depth was 1 to 2 feet, and stormwater and surge from Hurricane Irma carried enough velocity to drive parking lot gravel around the restroom.

**[B]** Flood debris in a vent

**Figure 3-38:** Grade-level restrooms at Marco Island (Site 6; Collier County)

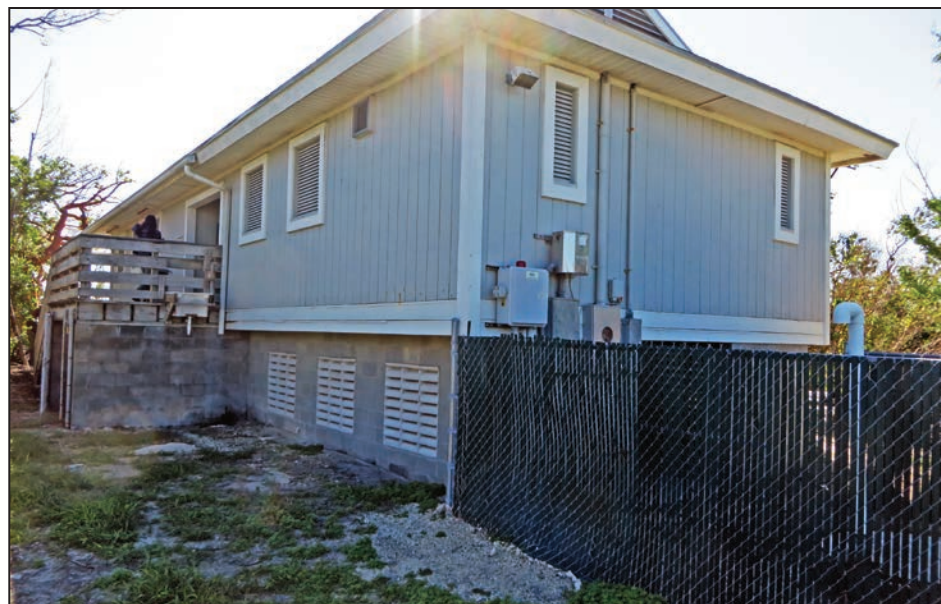
Figure 3-43:  
Elevated restroom at  
Bahia Honda State  
Park, Loggerhead  
(Site 13; Monroe County)

The elevated restroom sustained wind damage.

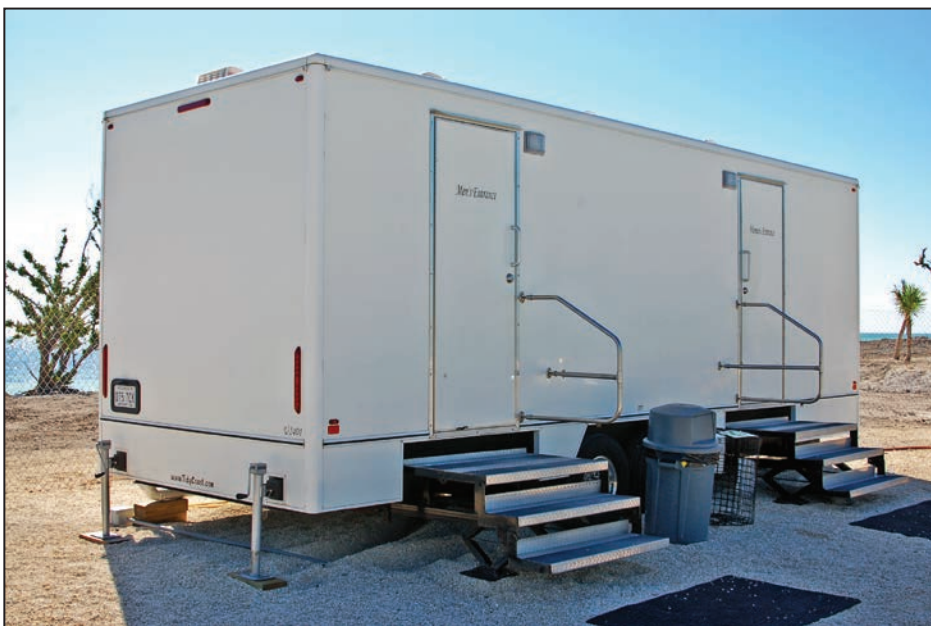
The same site after building demolition, showing temporary mobile restroom building installed for public use (photo taken in December 2017).

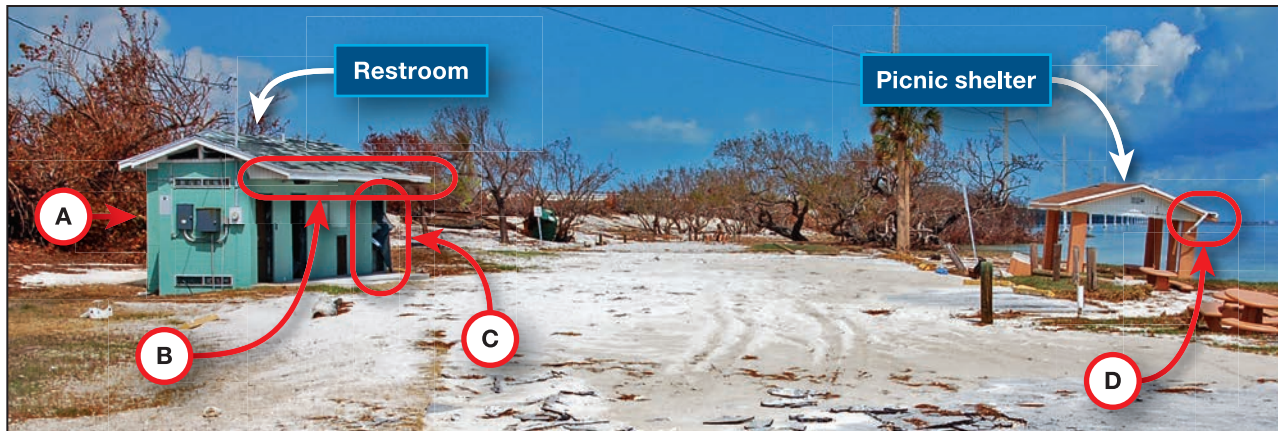
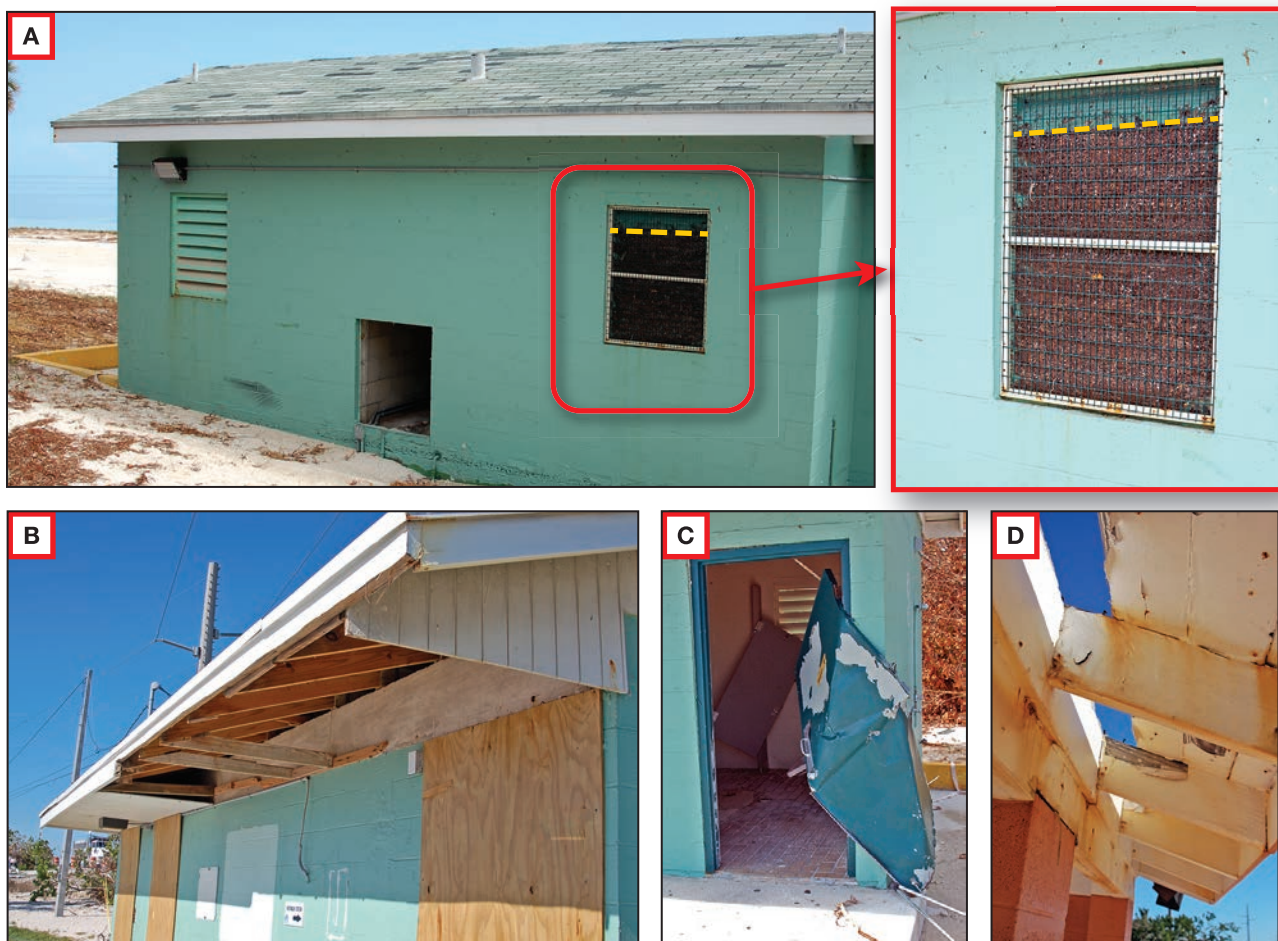
Figure 3-44: Grade-level Veterans Memorial Park restroom that was likely exposed to Zone V conditions (Site 14; Monroe County)

- [A]** Rear of restroom showing debris trapped inside vent—debris level was approximately 7 feet above grade and would have accounted for stillwater plus sloshing waves trapped inside restrooms
- [B]** Wave splash against seaward restroom wall likely damaged soffit
- [C]** Exterior door damaged by waves
- [D]** Wave crests were likely just below the shelter soffit and lifted the roof deck off

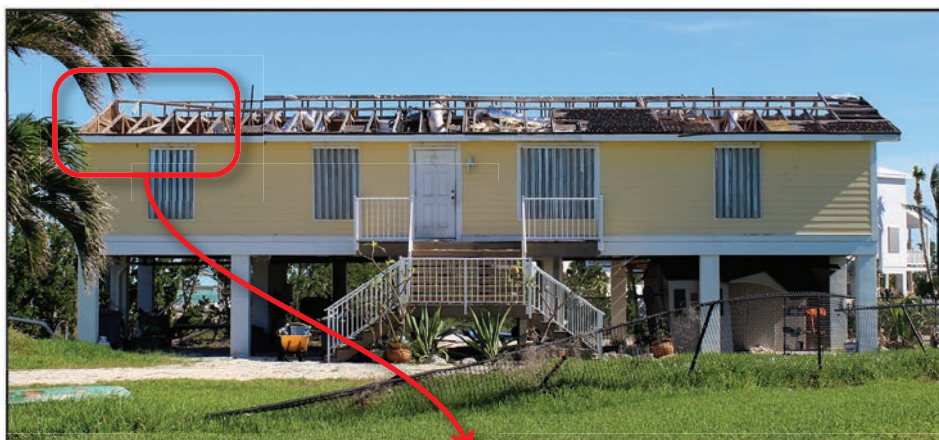
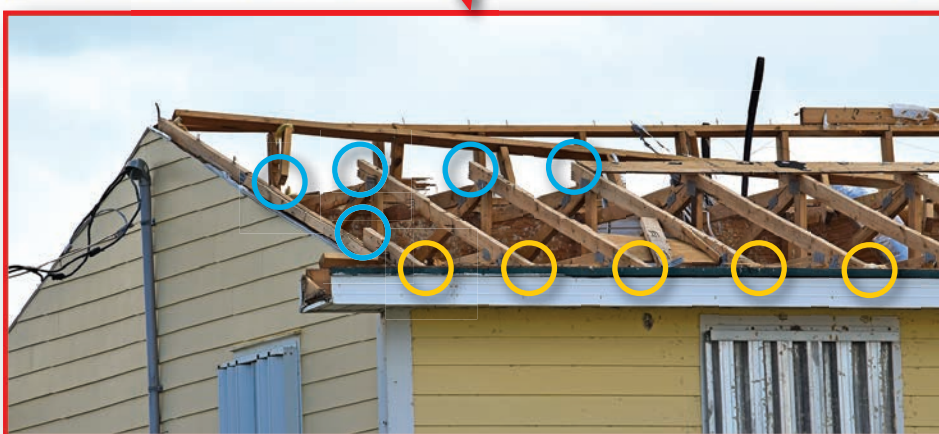
Figure 4-1:  
House with structural  
damage to roof system  
(EWS = 113 mph; EDWS =  
180 mph) (Sugarloaf Key)

Figure 4-1 shows an elevated, single-story, wood-framed house (built in 1988) that lost nearly all its roof sheathing, most likely due to withdrawal of the roof decking-to-framing fasteners. Numerous roof truss top chords located near the roof ridge were also damaged or missing, but roof framing adjacent to the front wall and the roof-to-front wall connections remained intact (see bottom photo in Figure 4-1). The roof truss bottom chords remained in place, providing lateral support that prevented wall collapse.

The close-up shows severed truss upper top chords (blue circles) and intact connection of lower top chord and top of wall (yellow circles).

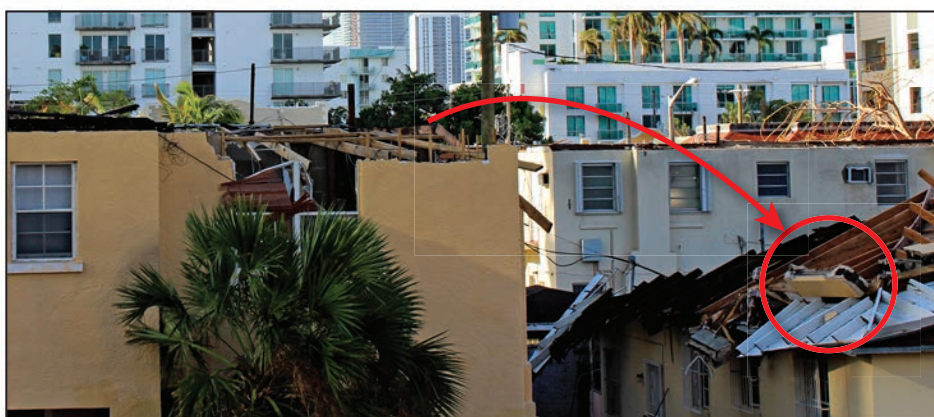
Figure 4-2:  
Residence where a roof-to-  
wall connection failed  
(EWS = 78 mph; EDWS =  
169 mph) (Miami)

Another example of roof damage on a pre-FBC dwelling (built in 1923) in Miami is shown in Figure 4-2, where large sections of roof were picked up by Irma's winds and dropped onto the neighboring house. As shown in the red circle, where connected, the conventional wood frame roof and bond beam separated from the masonry wall.

The failed connection resulted in large sections of roof being blown atop an adjacent structure. The red circle shows a portion of the bond beam attached to the displaced roof section.

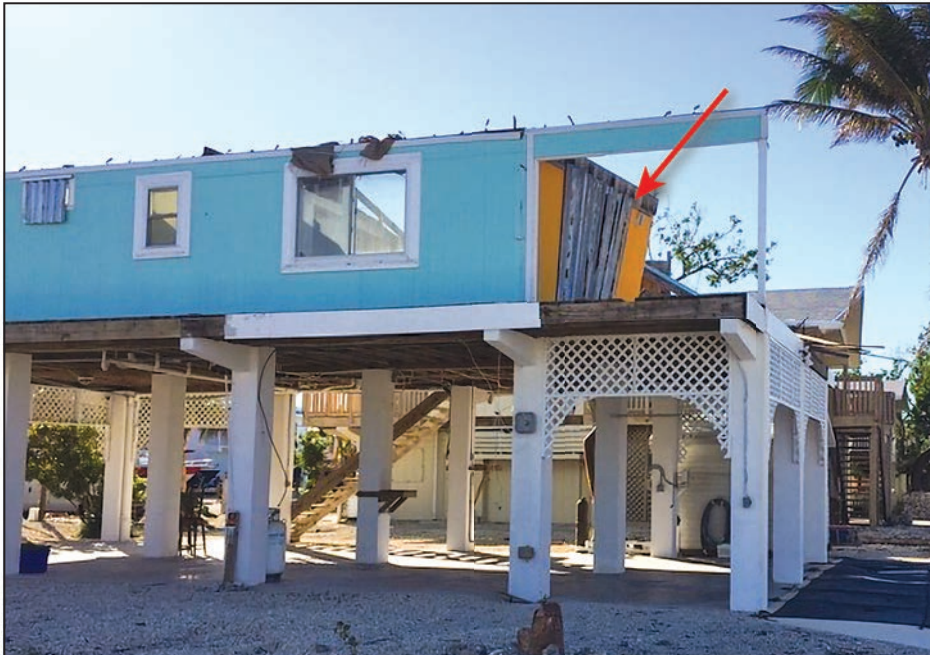
Figure 4-4:  
North end of east-facing wall  
where the roof was (EWS =  
113 mph; EDWS = 180 mph)  
(Cudjoe Key)

One section of the north-facing exterior wall (painted orange, indicated with the red arrow) adjacent to screened porch remained in place. Same house as Figure 4-3.

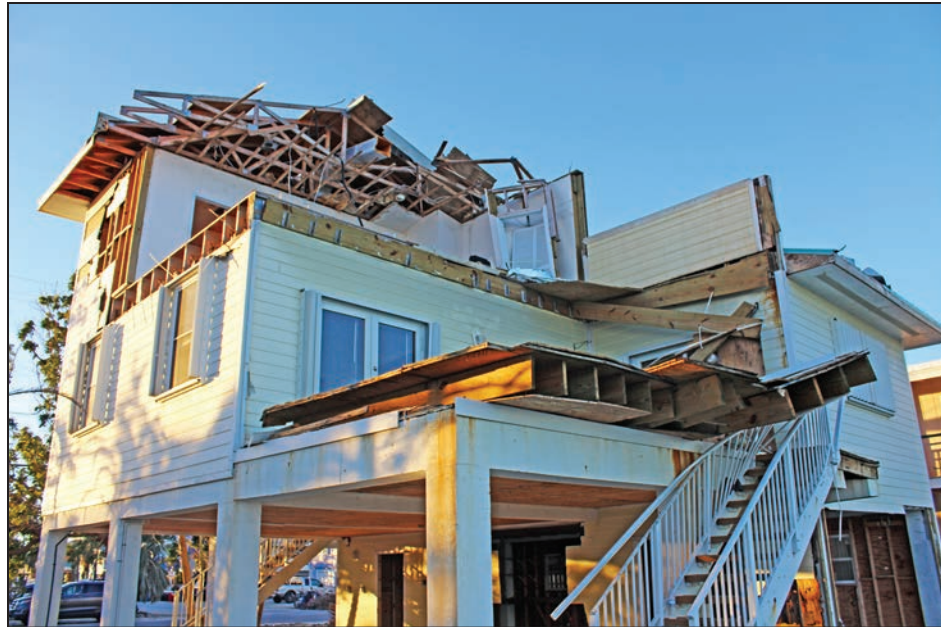
**Figure 4-6:**  
House with roof structure loss and collapse of the second floor exterior wall and adjacent deck (EWS = 113 mph; EDWS = 180 mph) (Ramrod Key)

Another example of wall failure was observed on Ramrod Key, as shown in Figure 4-6. The two-story, wood-framed residence (built in 1990) lost roof trusses above the east-facing (ocean-facing) second floor area; two exterior walls were lost from the room below the missing roof trusses, and the adjacent deck floor collapsed onto the porch floor below.

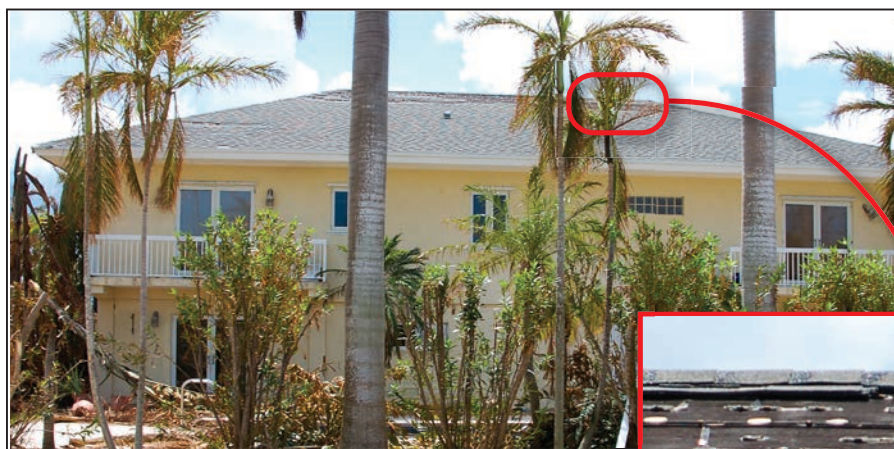
**Figure 4-10:**  
Residence that lost shingles  
near the ridge (EWS = 113 mph;  
EDWS = 180 mph)  
(Sugarloaf Key)

Asphalt shingle loss was limited on the Sugarloaf Key house (built in 1997) shown in Figure 4-10, but the pattern of loss near the ridge remains evident in the inset photo where shingle-to-roof deck nails remain in place. The Figure 4-10 inset photo indicates the shingles were likely installed incorrectly, because the shingle-to-roof deck nails were positioned too close to the top edge of the shingle. As shown in Figure 4-11, asphalt shingle nails in high-wind regions should be positioned close to the centerline of the shingle to secure the shingle underneath and decrease the moment arm of the uniform wind pressure acting on the shingle.

The red oval shows area of inset where remaining shingle-to-roof-deck nails can be seen inside yellow circles.

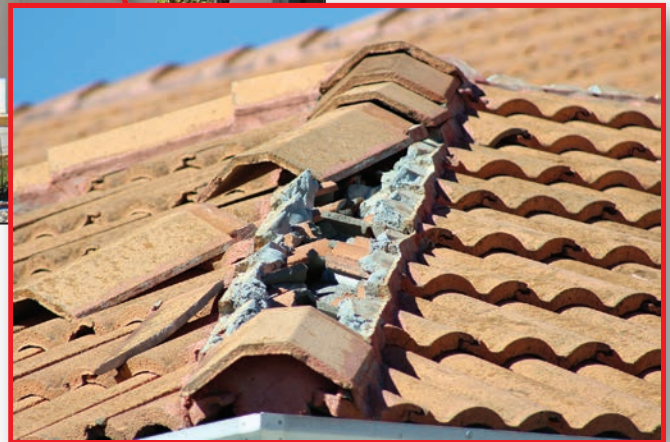
Figure 4-13:  
Roof tile failure (EWS = 113  
mph; EDWS = 180 mph)  
(Cudjoe Key)

Based on MAT observations, damage to roof tile was limited and generally minor. However, the MAT observed failure of several older, pre-FBC roofs with mortar-set roof tiles as described below. The Cudjoe Key house (built in 1989), shown in Figure 4-13, lost a significant number of tiles, particularly at the hips and garage ridge. The Florida's Association of Roofing Professionals / Tile Roofing Institute (FRSA/TRI) *Florida High Wind Concrete and Clay Roof Tile Installation Manual*, Fifth Edition (2012) (FRSA/TRI Manual) requires mortar-set hip and ridge tiles to be fully embedded in mortar. The hip tiles shown in 4-13 were not fully embedded in mortar.

The top image shows damaged hip tiles in the red circle; the inset is a close-up of the same area. Damage to hip and ridge tiles was the most commonly observed damage, but other types of damage in the field area were also noted.

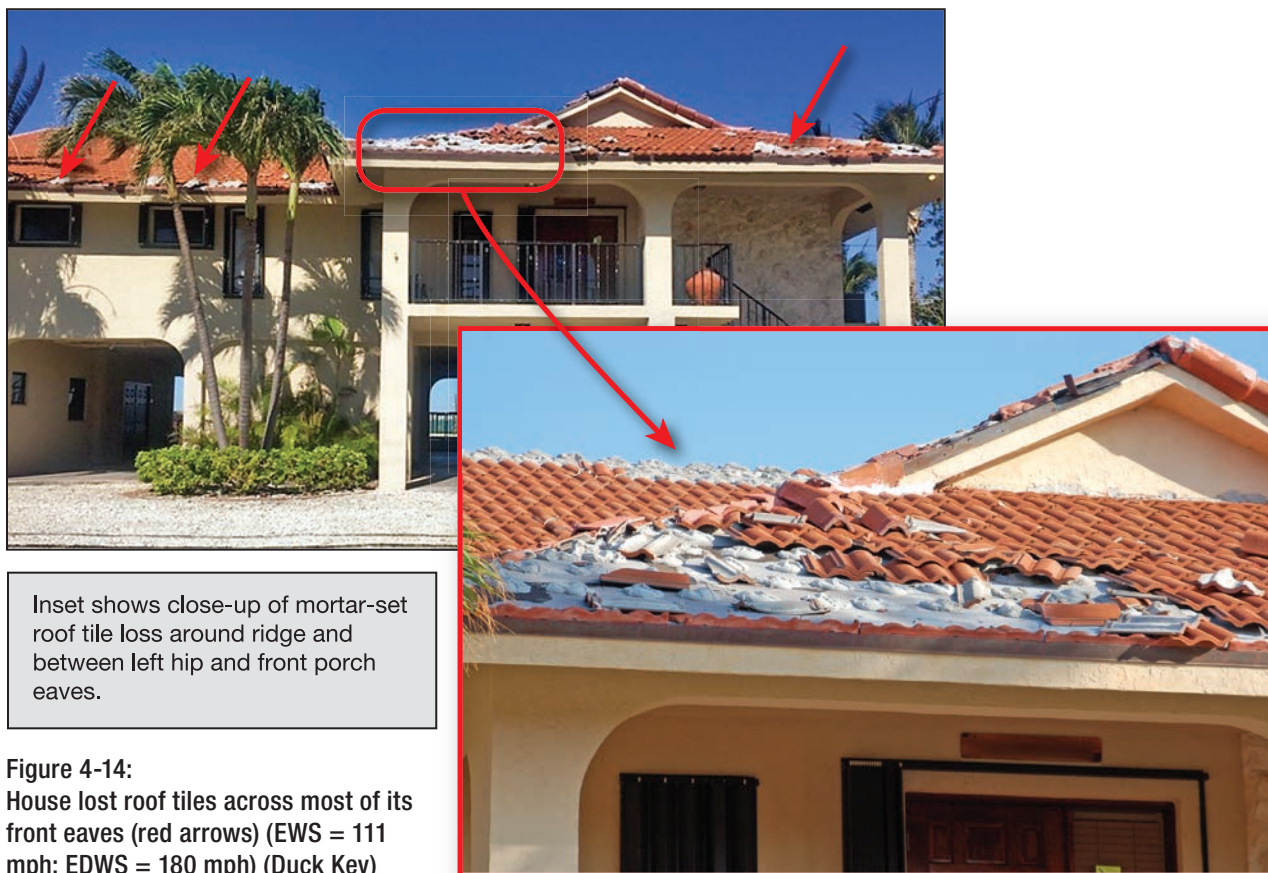
Similar damage was observed along the front eaves, ridge, and area along and adjacent to the left hip over the front porch of the roof on the Duck Key house (built in 1984) shown in Figure 4-14. Although no measurements could be taken, the first course of tile appears to project too far over the eave. The FRSA/TRI Manual specifies that tiles must overhang the eave at least  $\frac{3}{4}$  inch but not more than 2 inches. Additionally, the first course near the eave does not appear to be set in mortar, as the first row of mortar patties are beyond the first course of tile.

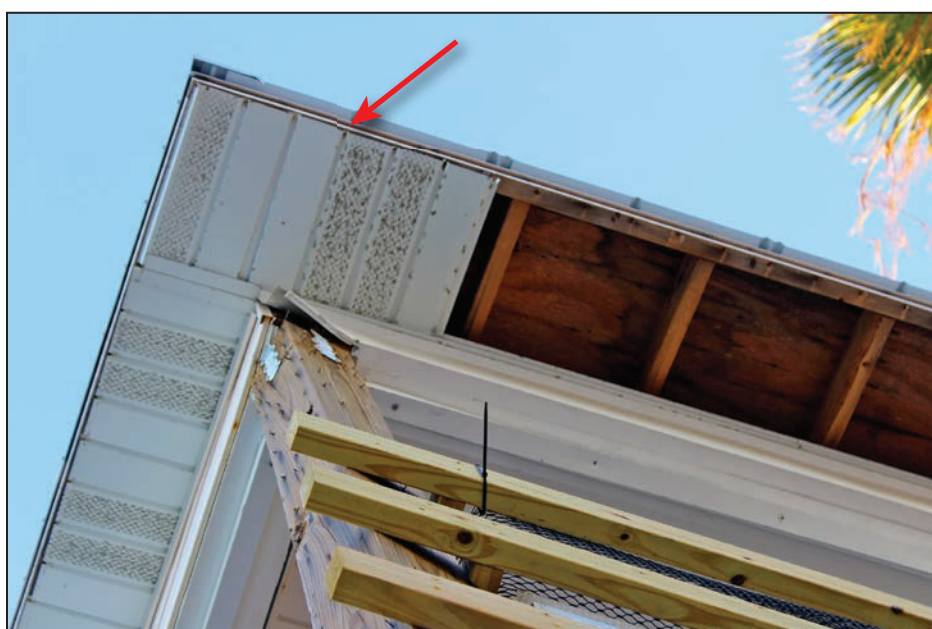
Figure 4-22:  
Metal soffit loss on house  
(EWS = 113 mph; EDWS =  
180 mph) (Ramrod Key)

Figure 4-22 shows metal soffit panel loss along the corner of a Ramrod Key front porch (house built in 2005). The remains of the soffit attachment, which were fastened directly to the nailing strip along the outside edge and held in place by a channel above the porch opening, are indicated by the red arrow. Similar to the damage pattern noted in the previous discussion on vinyl soffits, some metal soffit panels were missing; an example is shown in Figure 4-23, where soffits were missing below the Big Pine Key house's (house built in 1989) screened porch gable end outlooker rafters, directly below an area where the fascia cover had blown away (compare with Figure 4-17).

The red arrow shows direct attachment of soffit to framing along the outside edge of eaves only; panels are secured by a channel only above the porch opening.

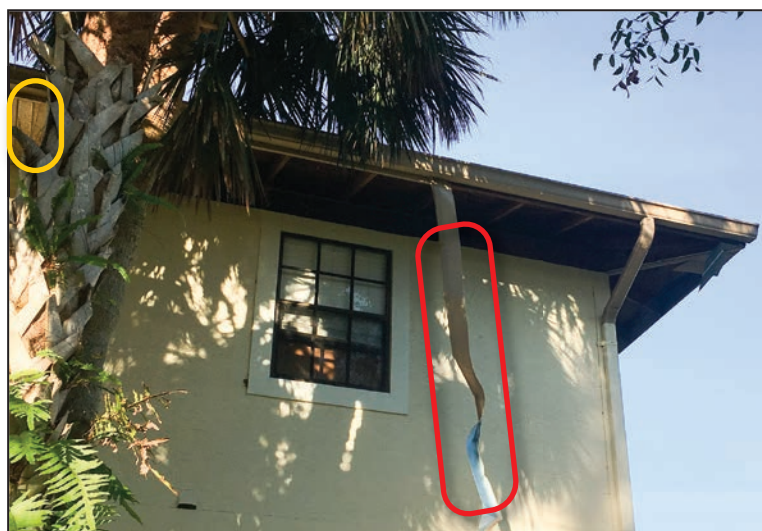
**Figure 4-24: Apartment building with metal soffit panel loss (EWS = 104 mph; EDWS = 166 mph) (Naples)**

In Naples, the MAT observed two apartment buildings with metal soffit panel loss patterns similar to the single-family Florida Keys dwellings shown above. On the left side of Figure 4-24, metal fascia covering can still be seen hanging from the eaves near the corner of the hip-roofed building (built in 1983). Soffit panels remain in place toward the center of the building, but are missing closer to the corner. The right side image of Figure 4-24 shows the adjacent side of the building where fascia covering is completely gone along with most of the metal soffit panels. On a nearby Naples apartment building (built in 1980), metal soffit panels were lost below the front porch gable end outlooker rafters. As shown in Figure 4-25, no damage is apparent along the adjacent fascia of the building.

Dangling fascia cover (red outline) is shown adjacent to missing metal soffit panels near the corner of a Naples apartment building (yellow outline indicates intact soffit panels).

Missing metal soffit panels are shown below damaged fascia; located on the other side of the corner shown in left image.

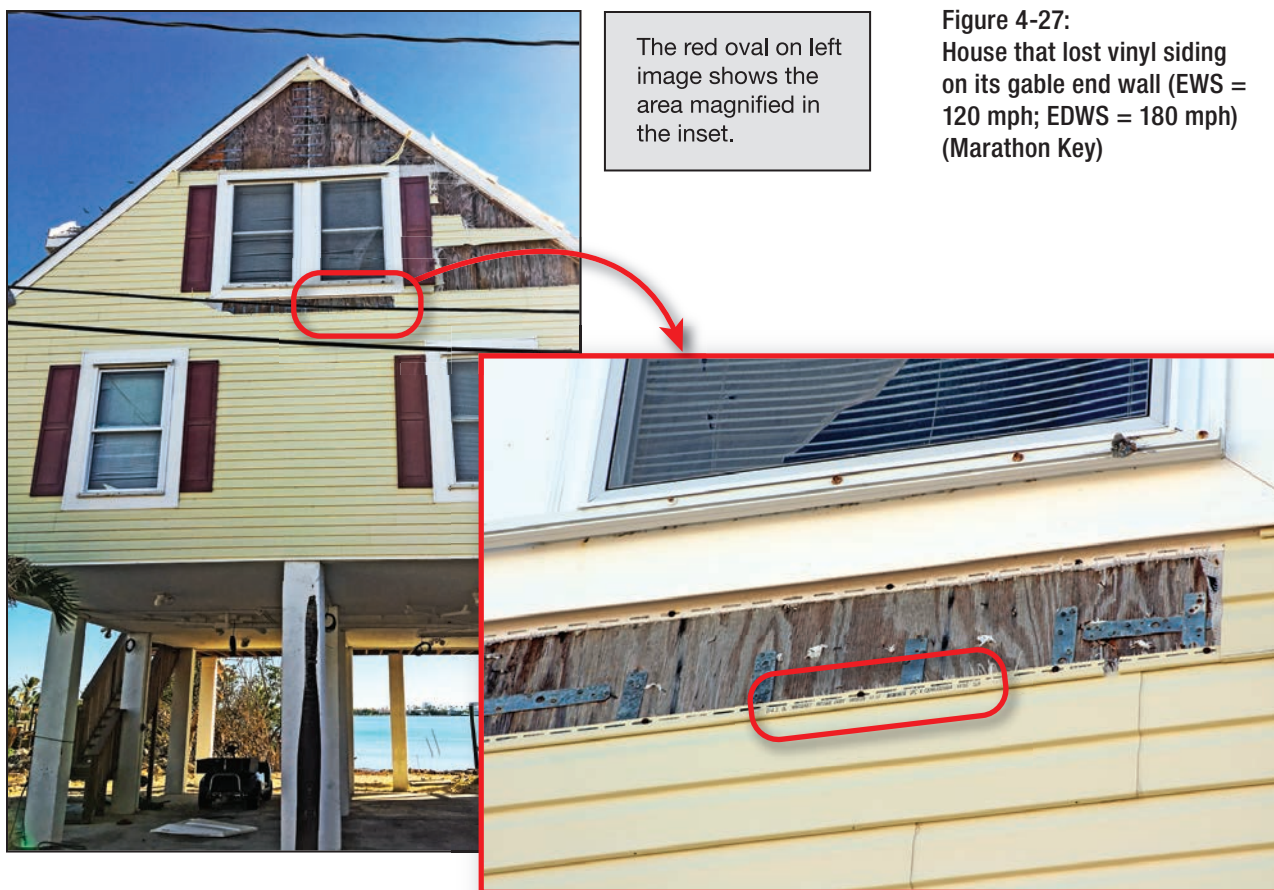
The Marathon Key house (built in 2009) shown in Figure 4-27 lost siding across a significant portion of one gable end wall; based on the product identification shown in the inset, the MAT determined that the product had a design wind pressure rating of  $-55$  psf (refer to Section 4.2.3.2). Using the Risk Category II design wind speed of 180 mph, Exposure Category D, an effective wind area of 10 square feet for Zone 5 (corner zone), enclosed building classification, and approximate mean roof height of 25 feet, the required design pressures are  $+56$  psf and  $-75$  psf. While the design pressure rating is about 27 percent less than the required design pressure, considering the estimated wind speeds at this site, the siding should have resisted wind pressures experienced during Hurricane Irma if it was properly installed. There is no evidence of utility trim under the window, which left the siding vulnerable at that location.

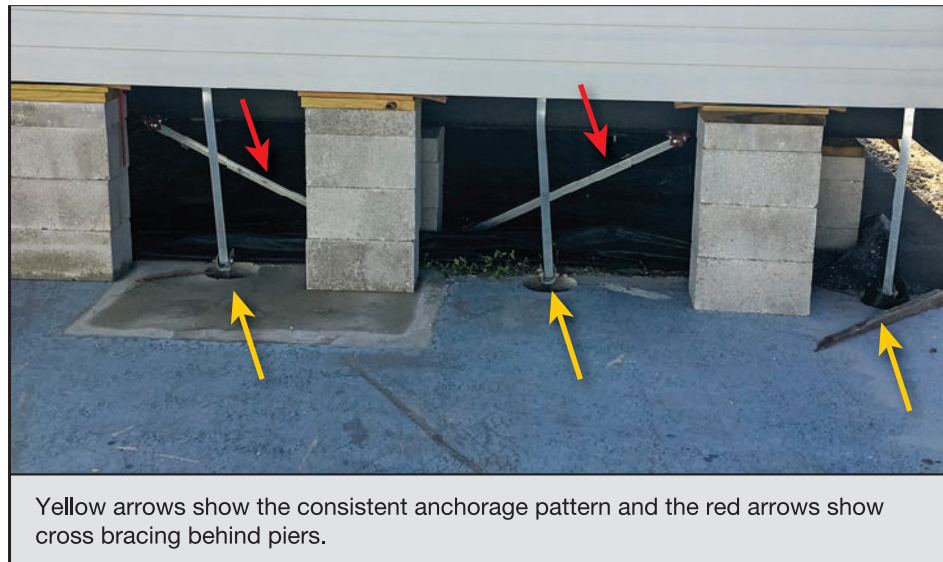
New MH units installed after Irma and observed by the MAT appeared to be anchored much more consistently than older installations. Figure 4-39 and Figure 4-40 show two examples of post-Irma anchorage. Note both units' metal anchor straps are tight, aligned at the top and bottom, spaced 3 feet or less on center, and attached to the base of the wall. One exception to post-Irma anchorage consistency is shown in Figure 4-41, where straps are misaligned from top to bottom.

**Figure 4-39:**  
Anchorage on a new MH unit installation (EWS = 105 mph; EDWS = 164 mph) (Collier County)

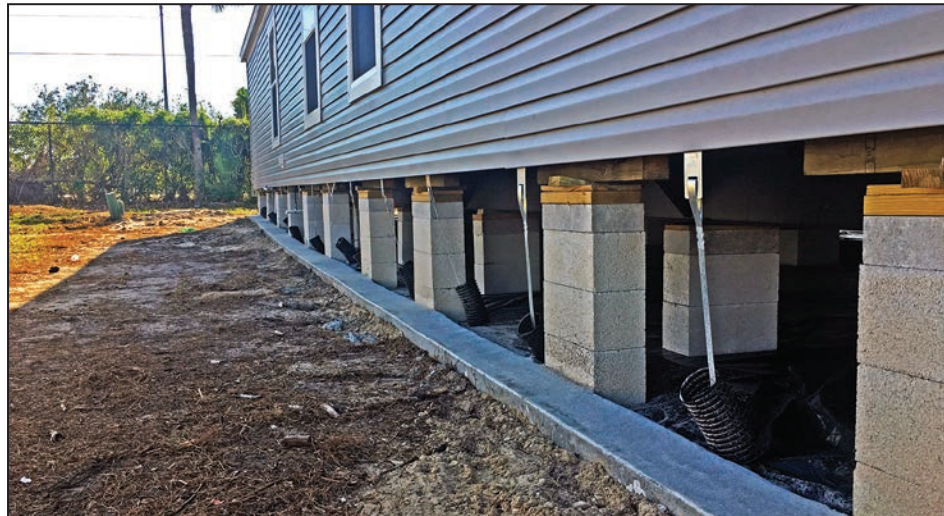
**Figure 4-40:**  
Consistent anchorage pattern observed on a new MH unit installation (EWS = 105 mph; EDWS = 164 mph) (Collier County)

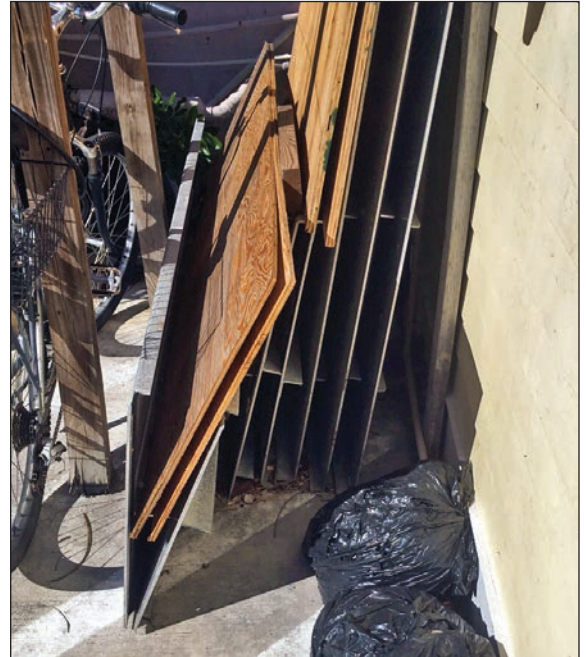
**Figure 2: Flood panels (metal) and window shutters (plywood) were stored together outside a building. Panels and rubber gaskets were exposed to the elements; this storage practice is not recommended.**

**Storage.** Determine an appropriate storage location for the dry floodproofing components, supplies, and equipment. Ensure the location is not open to the elements, as ultraviolet radiation and temperature extremes degrade rubber seals, gaskets, and component identification labels (Figure 2). Ensure this location is secure to prevent theft and vandalism, but is also accessible and labeled for the installer in case of deployment. On-site storage of floodproofing components is preferable. A separate location should be provided for spare parts.

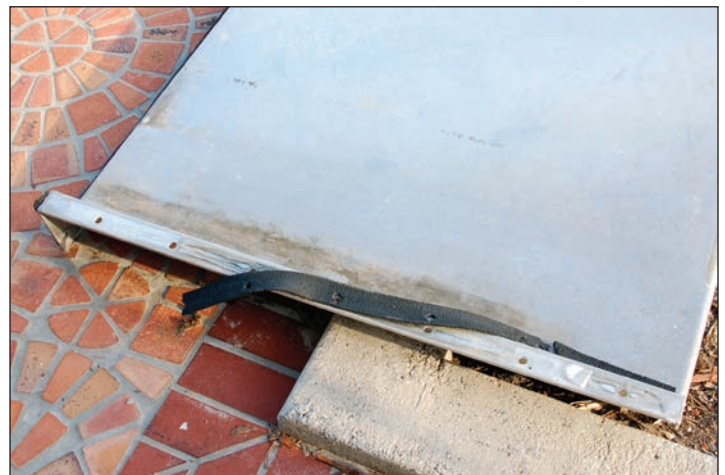
**Figure 3: Torn gasket on metal flood panel after panel was removed. Gasket must be replaced before the next deployment.**

**Regular inspection.** Regularly inspect and maintain shields, doors, gates, pumps, equipment, gaskets, seals, brackets, panels, hardware, etc., and replace immediately if needed, to ensure system performance (Figure 3). Use the equipment list in the operations, maintenance, and testing plan to perform an annual accounting of all component and installation equipment.
