Mitigation Assessment Team Compendium Report

2017 Hurricane Season

Building Performance Observations, Recommendations,
and Technical Guidance

FEMA P-2054 / September 2019

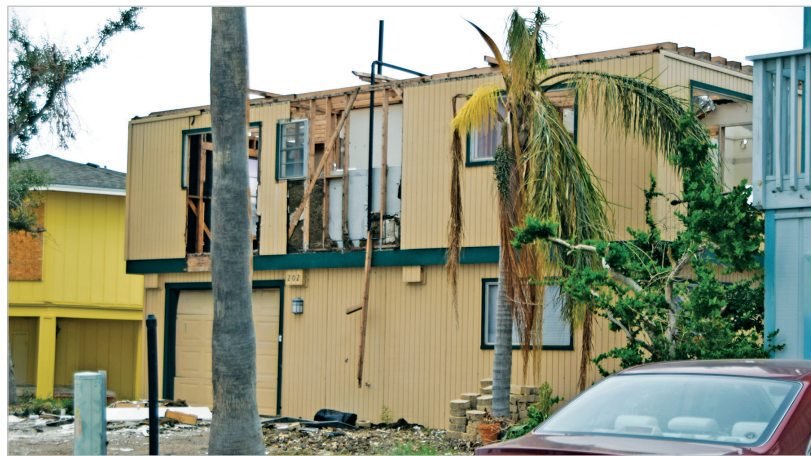
Figure 3-7: Older home with roof failure in Rockport, TX

Connectors and sheathing are critical elements of the MWFRS. Structures in coastal high-wind zones should have robust MWFRS connections to adequately transfer loads from the roof structure to the wall structure and into the foundation's system. Figure 3-7 shows an older home whose roof structure failed due to poor connections of the rafters to the joists.

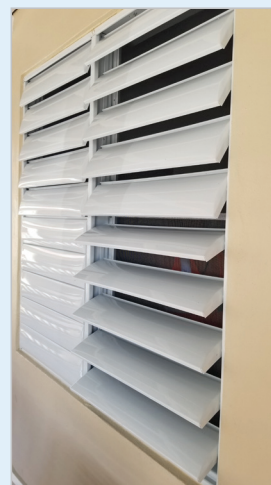
JALOUSIE WINDOWS

Jalousie windows are the most common window system observed in residential buildings in Puerto Rico and the USVI. Jalousie window systems contain panels (louvers) made of metal, glass, or wood that typically are opened or closed by turning a handle to allow natural ventilation to help control the temperature inside the building while limiting sunlight into the building and providing visual privacy. Because they are inherently “open,” non-sealed systems, they allow the passage of wind-driven rain, water, and air into buildings. Wind pressures allowed in through jalousie windows can overload the roof and cause failure. The common use of metal panel jalousie window systems in informally constructed homes contributed to the failure of many roof systems in the residential buildings the MAT observed. The photo above shows a close-up of a jalousie window with metal louvers on a residential building in Puerto Rico.

Impact-resistant shutters cannot prevent water intrusion through jalousie windows, however, which are inherently unable to prevent water from seeping between their operable louvers.

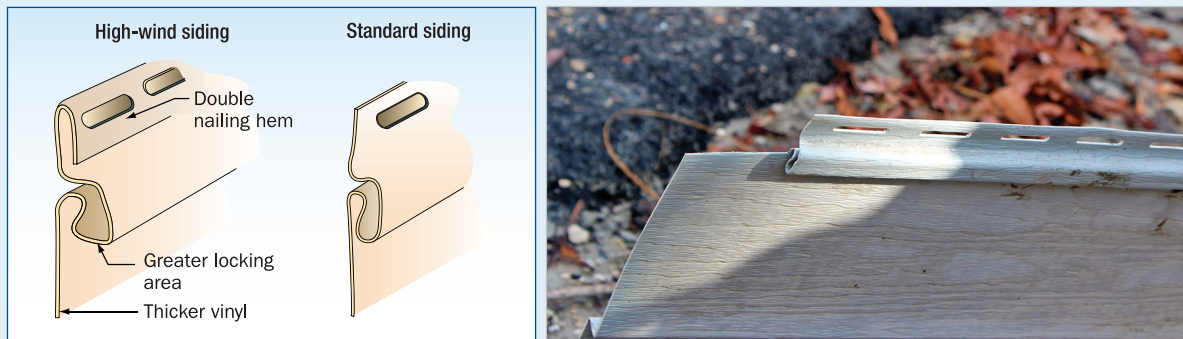
HIGH WIND-RATED VINYL SIDING VS. STANDARD VINYL SIDING

Much of the failed vinyl siding that the Irma MAT observed in Florida did not appear to be rated for high-wind regions. Technical Fact Sheet 5.3, “Siding Installation in High-Wind Regions,” in FEMA P-499, *Homebuilders Guide to Coastal Construction* (2010), includes guidance on vinyl siding installation. The left-side graphic below from Technical Fact Sheet 5.3 demonstrates the basic differences between vinyl siding rated for high-wind regions and standard vinyl siding. The right-side image is siding from one of the damaged houses in Goodland. Note how the detached siding has a standard (single) hem and locking area depicted in the left image (rather than the high-wind siding required by the FBC in the area).
