## **Evaluation of Wind Resistance of Vinyl Siding and Soffit Systems, and Performance during the 2017 Hurricane Irma**

Project #: P0103255

Report No. 01-19

21 June 2019

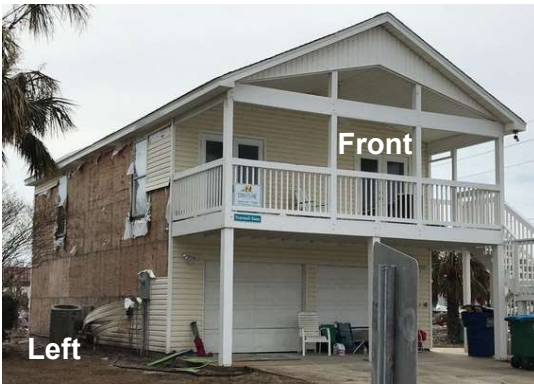
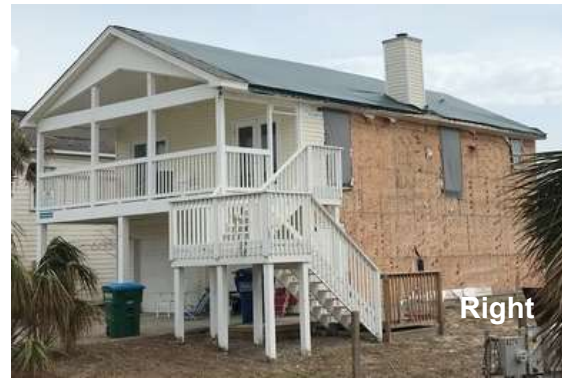
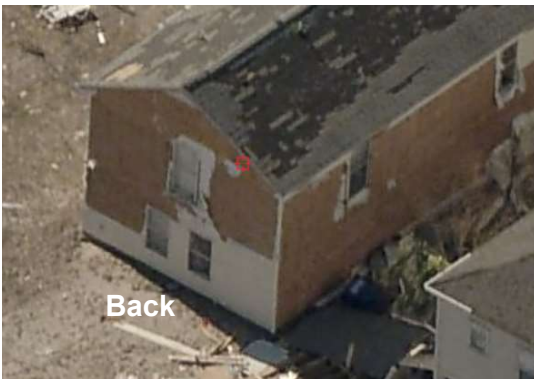
Wall Surface Damage Ratios:

Front (1<sup>st</sup> story): 0%  
 Front (2<sup>nd</sup> story): 0%  
 Left (1<sup>st</sup> story): 80%  
 Left (2<sup>nd</sup> story): 90%  
 Back (1<sup>st</sup> story) : 20%  
 Back (2<sup>nd</sup> story): 95%  
 Right (1<sup>st</sup> story): 90%  
 Right (2<sup>nd</sup> story): 95%

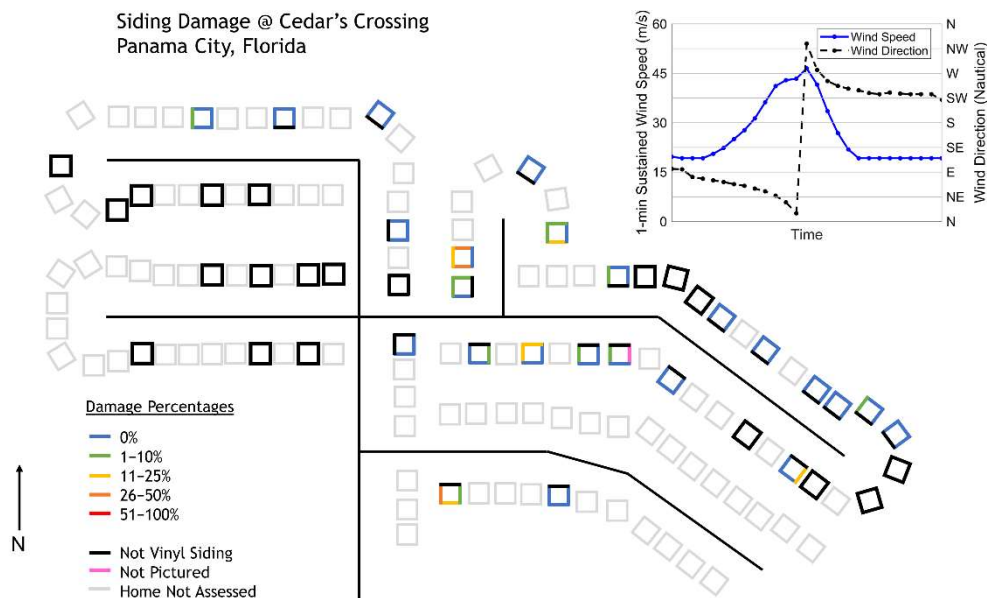
**Figure 16.** Summary of damage to vinyl siding in the Cedar's Crossing neighborhood. The estimated wind speed and direction time history at this location is provided in the inset. The peak 1-minute sustained wind speed at this location was approximately 45 m/s out of the NE to NW.

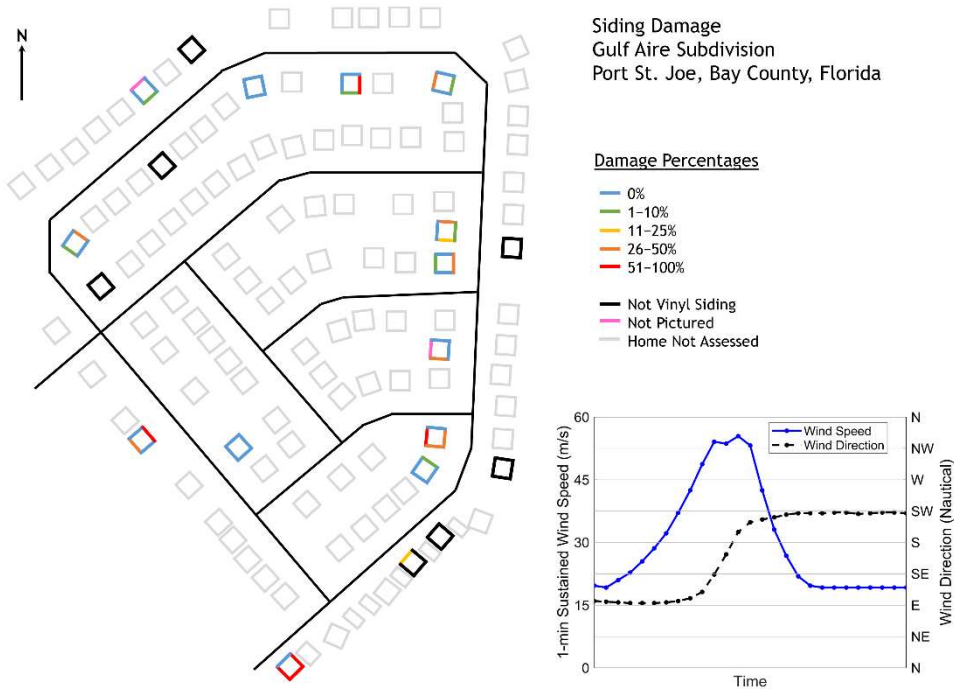
**Figure 17.** Vinyl siding damage classified in Gulf Aire neighborhood. The estimated wind speed and direction time history for the neighborhood is shown in the inset. The estimated peak 1-minute sustained wind speed was 56 m/s, coming out of the SE to SW.

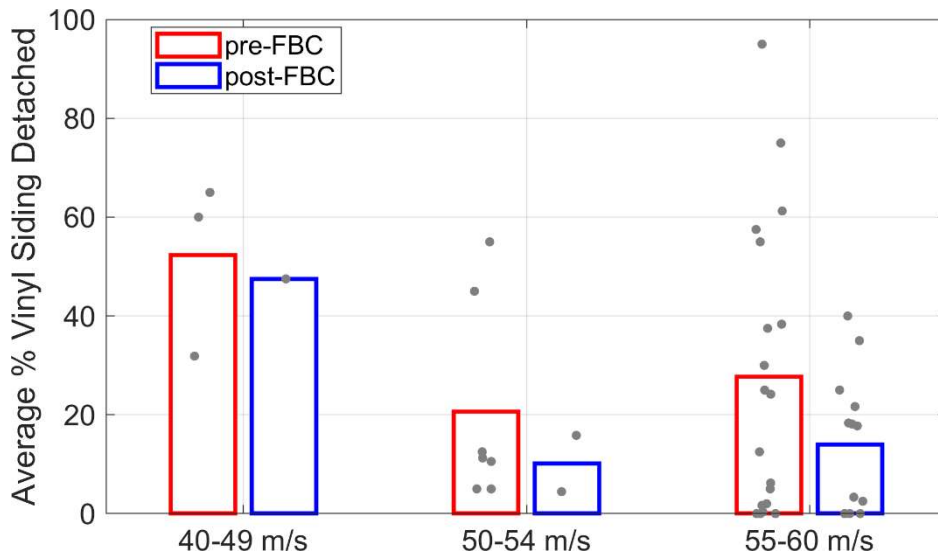
Overall performance of vinyl siding performance was mixed in both Hurricanes Irma and Michael. Figure 18 and Figure 19 provide the percentage of vinyl siding on each home that was damaged, stratified by wind speed. The extent of damage to post-FBC homes observed in Hurricane Irma is concerning given the below design level wind speeds. Failure rates were higher in the Florida Keys for post-FBC homes than in the Gulf Aire neighborhood for pre-FBC homes following Hurricane Michael, despite the design wind speed being exceeded there. The contrast in damage suggests there are other underlying factors beyond the vinyl siding material itself that may be contributing to enhanced probabilities of failures, one potentially being the elevation of homes above the flood plain in the Florida Keys. For example, based on discussions with local building officials in Monroe County, it is unclear whether modular homes (which comprised a significant proportion of the homes in our Irma vinyl siding dataset) take into account the enhanced wind loads that occur on elevated homes as compared to those installed at ground level. Modular homes may be being designed for the correct design wind speed, but not taking into account wind loads which may be as much as 12% higher (per ASCE 7-10 velocity exposure factor) when elevated above the flood plain. Further exploration is needed in this area.

**Figure 18.** Sample performance of pre- and post-FBC vinyl siding in Hurricane Irma stratified by estimated 1-minute sustained wind speeds. Boxes designate the average % vinyl siding detached over all homes within each bin and code classification. Each grey dot represents an individual home.

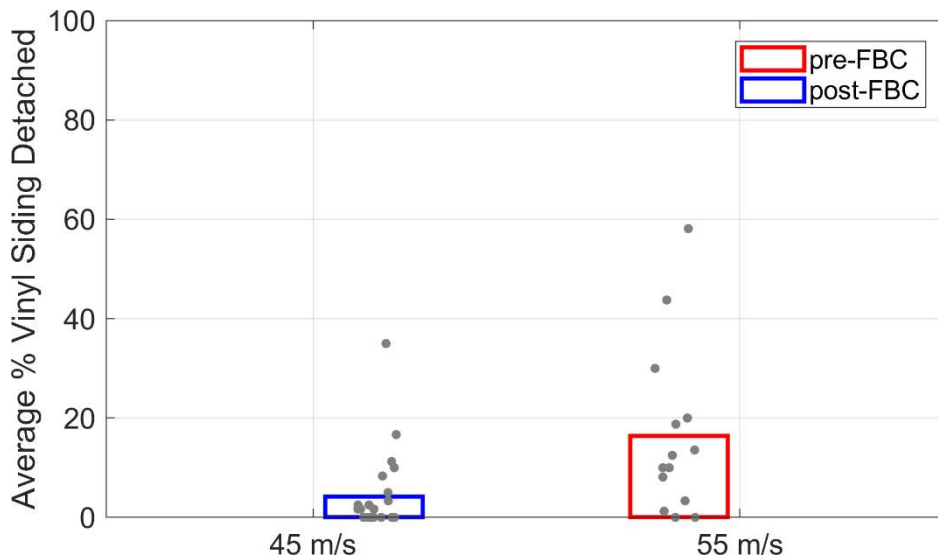
In Cedar's Crossing, vinyl siding was only present on post-FBC homes, making it a good case study for performance. Average siding loss was less than 40% for all homes, and averaged approximately 5%. Nonetheless, significant sections of vinyl siding were lost for multiple wall surfaces at wind loads 30% below design. Failures for individual wall surfaces is discussed more fully in later sections of this report.

**Figure 19.** Sample performance of pre- and post-FBC vinyl siding in Hurricane Michael stratified by estimated 1-minute sustained wind speeds (45 m/s = Cedar's Crossing, 55 m/s = Gulf Aire). Boxes designate the average % vinyl siding detached over all homes within each bin and code classification. Each grey dot represents an individual home.

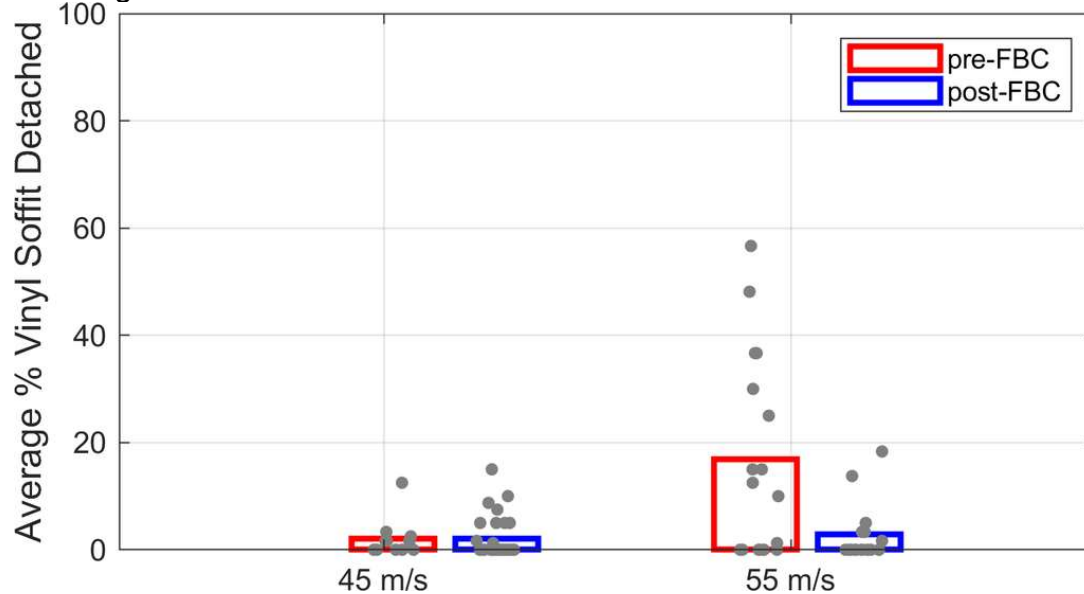
Figure 22 and Figure 23 illustrate the performance of vinyl soffits and fascia systems in pre- and post-FBC homes in the Cedar's Crossing neighborhood and in the Gulf Aire / Beacon Hill neighborhoods. Vinyl soffit damage was more pronounced in pre-FBC homes in Gulf Aire as compared to the post-FBC homes in Gulf Aire and Beacon Hill that experienced approximately the same wind speeds. In Cedar's Crossing, vinyl soffit damage was similar in both pre- and post-FBC homes, while fascia damage was actually higher on average in post-FBC homes.

**Figure 22.** Sample performance of pre- and post-FBC vinyl soffit in Hurricane Michael stratified by estimated 1-minute sustained wind speeds (45 m/s = Cedar's Crossing, 55 m/s = Gulf Aire). Boxes designate the average % vinyl siding detached over all homes within each wind speed and code classification. Each grey dot represents an individual home.

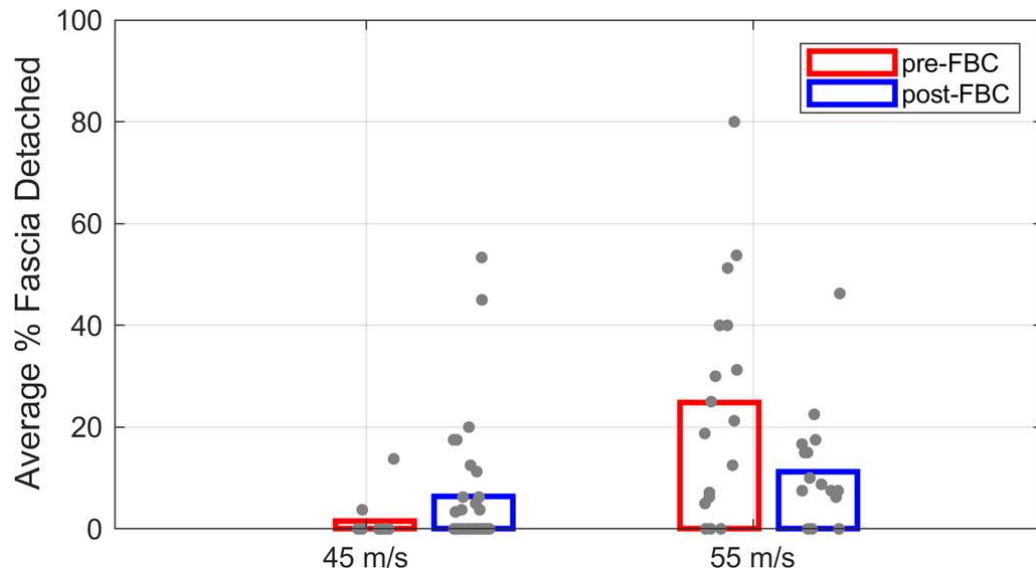
**Figure 23.** Sample performance of pre- and post-FBC fascia in Hurricane Michael stratified by estimated 1-minute sustained wind speeds (45 m/s = Cedar's Crossing, 55 m/s = Gulf Aire). Boxes designate the average % vinyl siding detached over all homes within each wind speed and code classification. Each grey dot represents an individual home.

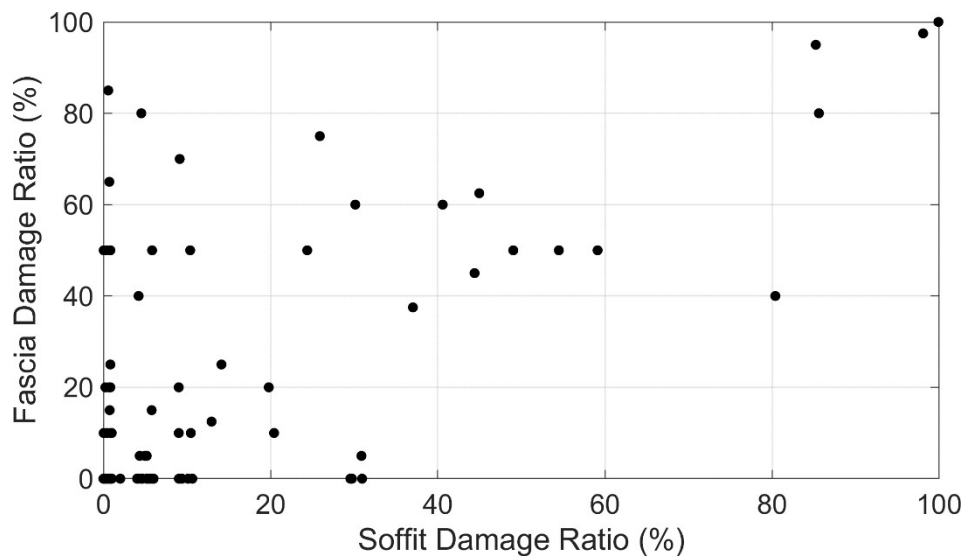
Figure 24 demonstrates the positive correlation between soffit damage and fascia damage on a given wall surface. Soffit damage did occur without corresponding fascia damage, with this failure typically occurring when the soffit separated from the starter strip at the exterior wall. Fascia damage was more common however, often corresponding to soffit failures on the same wall. The correlation coefficient between soffit and fascia failures was 0.67, indicating a moderate positive correlation between the two failures. On average, when soffit failure occurred, 21% of the failures corresponded to fascia failures

at the same locations. Anecdotally, the presence of gutters prevented fascia loss, which in turn mitigated soffit loss.

**Figure 24.** Relationship between soffit damage ratio and fascia damage ratio for each wall surface. Each marker represents a single wall surface for which both soffit and fascia performance could be assessed.

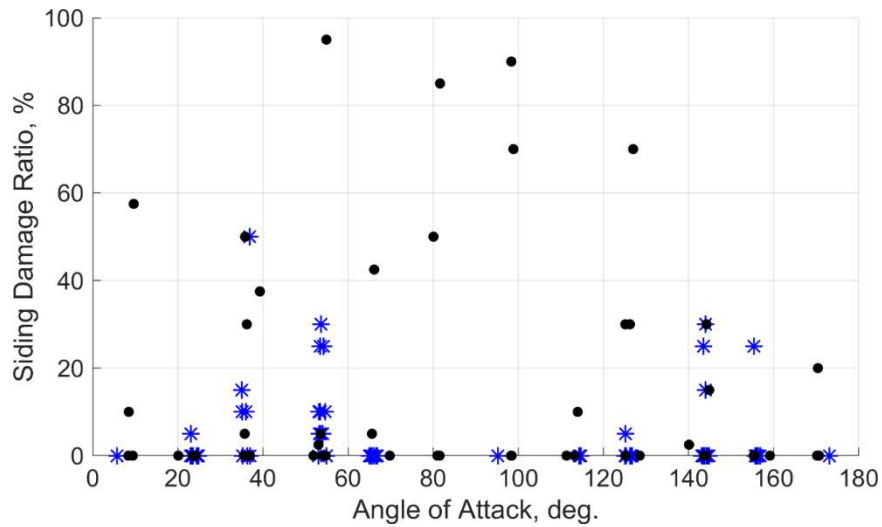
The following set of figures provides the relationship between siding damage, averaged for each wall elevation (1st and 2nd stories for front, back, left and right elevations), and the wind angle of attack relative to the wall surface. Figure 27 presents the results for vinyl siding in the Cedar's Crossing and Gulf Aire neighborhoods impacted by Hurricane Michael. A distinct bi-modal relationship is evident in the Cedar's Crossing neighborhood, but the trend is much noisier, if present at all, in the Gulf Aire homes. Evaluated within the context of the entire wind speed time history for Cedar's Crossing, where the highest winds shifted from NE to NW, the data suggests that vinyl siding failure is most likely to occur in the separation regions associated with cornering flows. More data is needed in neighborhoods with similar homes in order to confirm the trend more strongly.

**Figure 27.** Relationship between siding damage ratio and wind angle of attack for vinyl siding in Cedar's Crossing (blue asterisks) and Gulf Aire (black dots). Each marker represents a single wall elevation in the dataset.

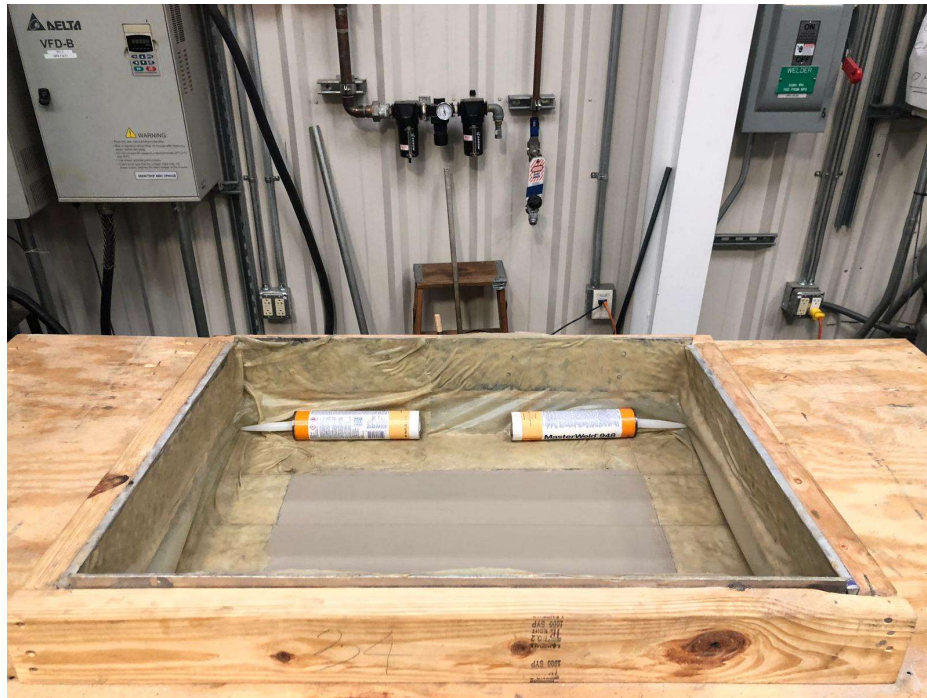
**Figure 43.** Latex sheet adhered over the vinyl siding and to the aluminum plates

The observed failures modes during the adhesive test led to the use of a thicker latex (0.14 in) due to the latex capacity failure during test 4. A wood batten is used to provide a compression plate/ seal along the top edge of the latex sheet to hold it in place against the aluminum plate based on test 3. Additional latex sheet in the exterior of the pressure chamber to provide resistance to the peeling failure based on test 2 and test 5.

At this time, no experimental conclusions can be assessed before performing the tests. From the adhesive test, we have observed that peeling of the latex is the predominant failure mode. A batten is necessary to prevent latex sheet peeling from the aluminum and a thicker latex is also required (0.14 in). The distance the latex sheet is glued to the vinyl siding and the aluminum was increased from 3 inches to 4 inches to provide more peeling resistance. The current experimental set-up utilizes the same HSS aluminum section for two pressure chambers. By using the same HSS section, space between the pressure chamber is limited and it eliminates the option of using the latex to the exterior of the pressure chamber which would provide more resistance to the peeling. Nevertheless, we opted to add another layer of latex bent to the exterior in the corner zones of the chamber. The performance of the latex will dictate if any change is required in the set-up for future testing.
