Final Report:

Survey and Investigation of Buildings Damaged by Category II, III, IV and V Hurricanes in FY 2017-18 – Hurricane Irma 2017

Project #: P0058409

Report No. 06-18
22 June 2018

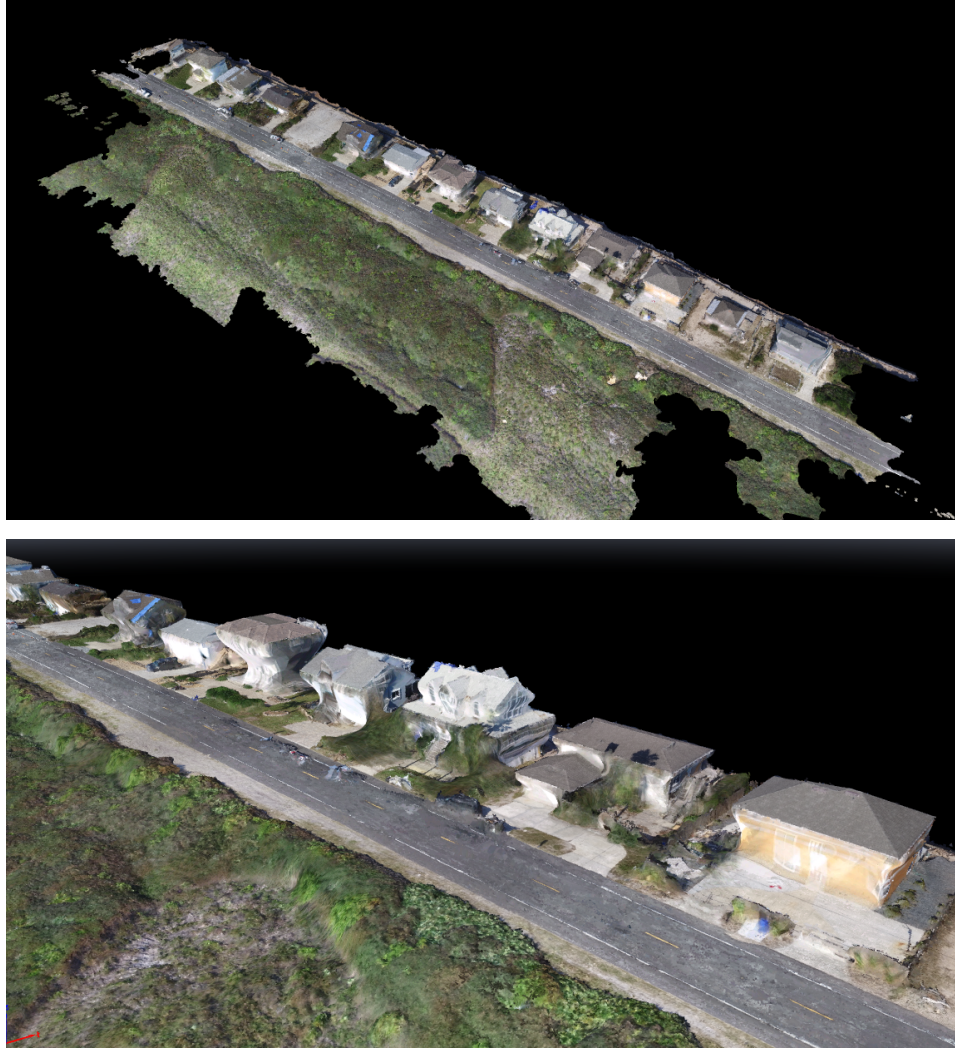
Figure 19. South Ponte Vedra, FL. While the view from steep angle Figure 19(a) provides good resolutions of roofs, when a lower viewpoint is used, some of the detail on the houses is lost due to artifacts made during the processing.

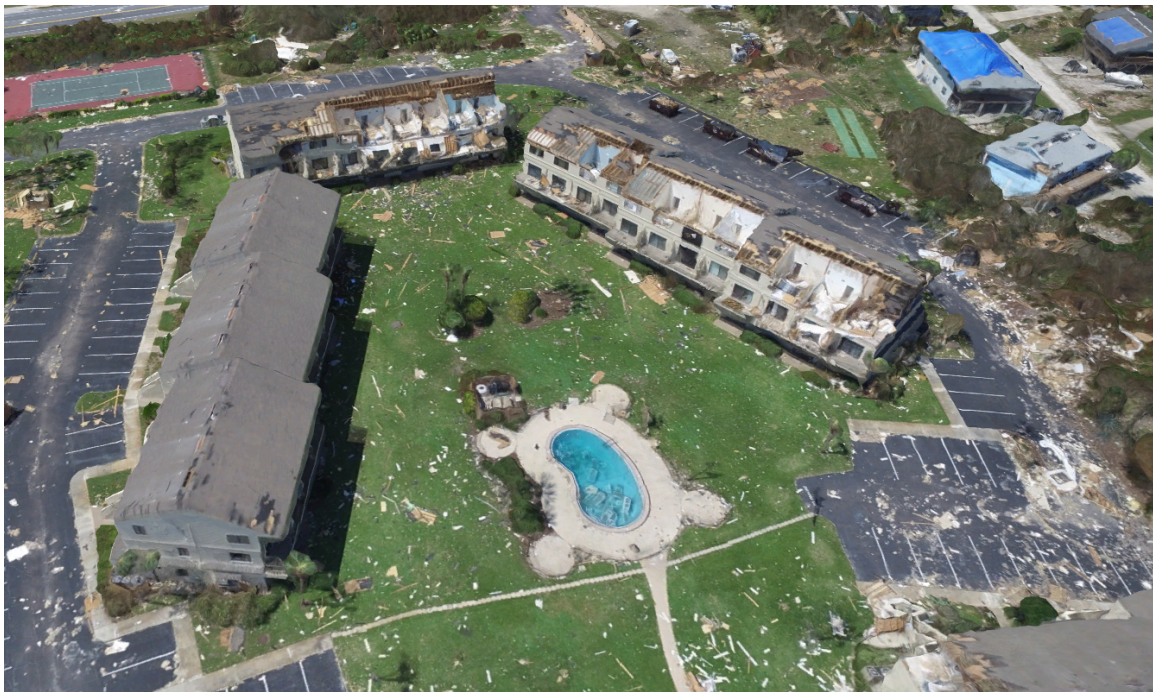
Figure 21. Townhouses in St. Augustine, FL By increasing the number of still images and manipulating the grid size, greater resolution is possible from the 3D Point Cloud in which even the conditions and damage to walls and vertical surfaces can be identified.

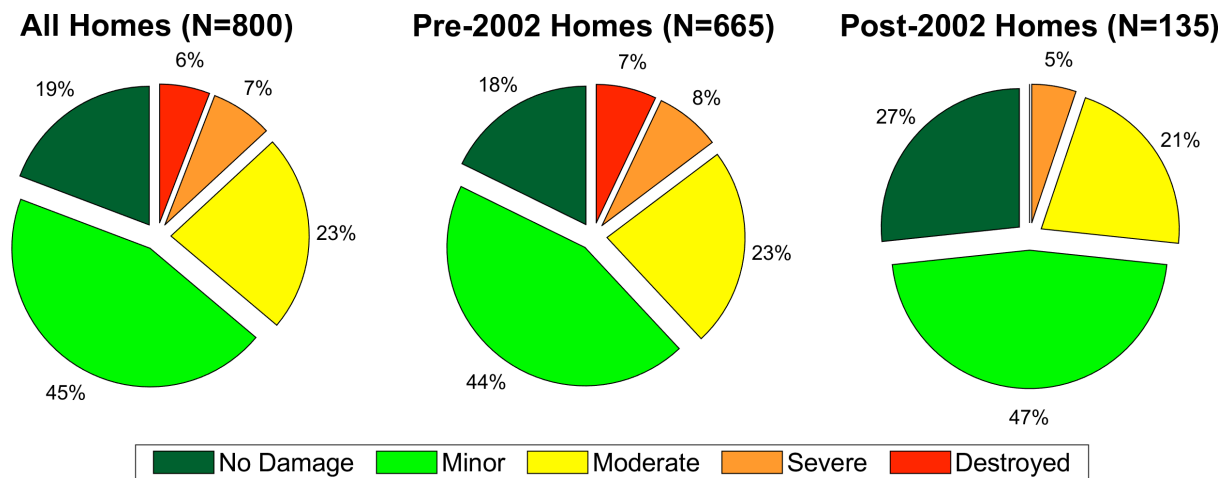
Each assessed home was assigned an overall damage rating of No Damage, Minor, Moderate, Severe, or Destroyed as defined in Table 2. Figure 22 shows that only 26% of post-2001 homes experienced Moderate or greater damage as compared to 38% for pre-2002 homes.

Figure 22. Distribution of overall damage ratings for all structures, pre-2002 and post-2001 structures.

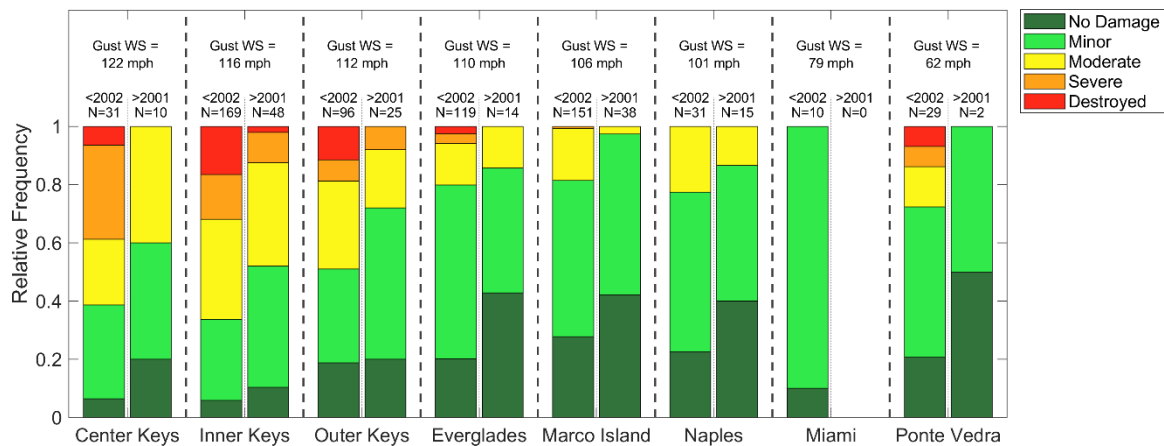
Broken down regionally, Figure 23 shows that the overall trend of higher rates of Moderate or greater damage states in pre-2002 homes holds across all regions and all ranges of hurricane wind speeds. Interestingly, the highest proportion of destroyed homes occurs in the Inner Keys, which is not where the highest gust wind speeds were estimated to have occurred. The anomalous rate of severe and destroyed homes in the Ponte Vedra region is also of interest as the gust wind speeds were only estimated at 62 mph, meaning wind loads were just 23% of the ASCE 7-0 design wind loads for a Category II structure as indicated in Table 5.

Figure 23. Distribution of damage ratings in pre-FBC and post-FBC

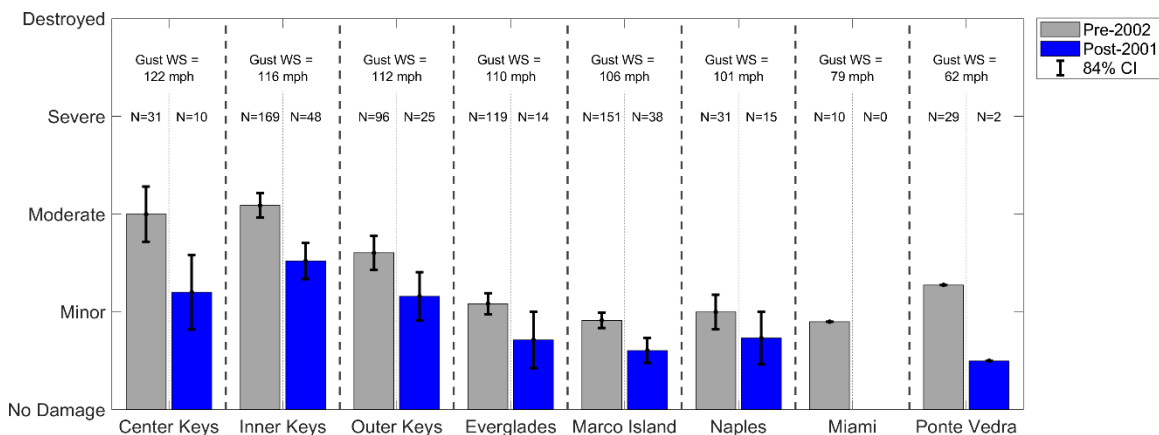
Figure 24 plots the mean damage rating for pre-2002 and post-2001 homes in each region. Damage ratings were converted to numerical values (No Damage = 0, Minor = 1, etc.) to facilitate the analysis, which assumes there is a continuous damage scale underlying the damage ratings. Statistical inference as to the differences between pre-2002 and post-2001 homes is made using 84% confidence intervals. Where confidence intervals do not overlap, the differences are statistically significant at a p-value of 0.05. Payton et al. (2003) show that using 84% confidence

intervals for statistical inference matches well with the use of a p-value of 0.05 in the unpaired student t-test to infer differences between sample means. The statistical analysis indicates that pre-2002 homes have a statistically-significant higher mean damage rating than post-2002 in three of the five regions in which there is sufficient data to conduct the test. In every region containing both pre-2002 and post-2001 homes, the post-2001 homes have a lower mean damage rating. Thus the analysis clearly supports the hypothesis that homes built after the Florida Building Code was enacted statewide are overall less likely to experience wind damage than those built prior.

Figure 24. Median overall damage rating in pre-FBC and post-FBC SFR with confidence intervals for each region.

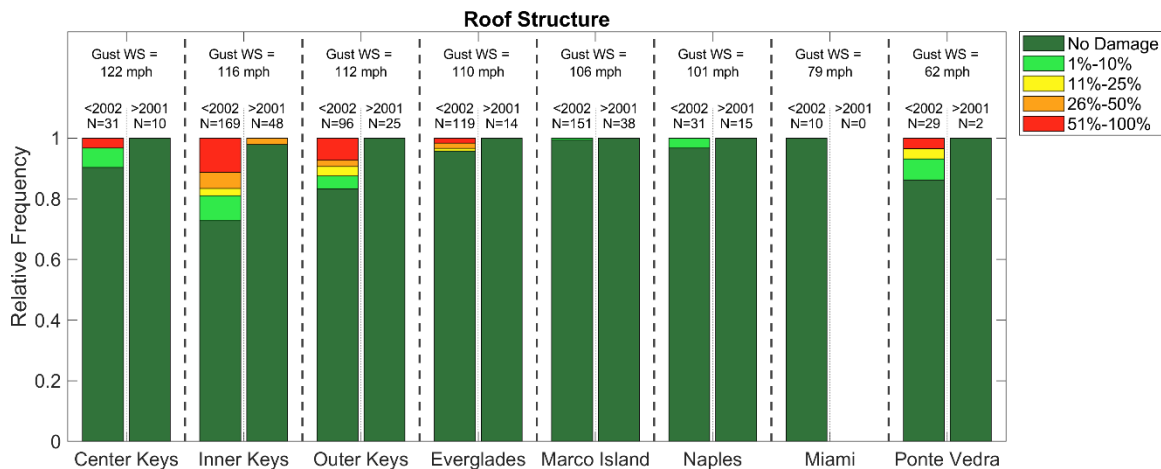
Field observations indicated roof structure performance was excellent in post-2001 homes as demonstrated in Figure 25, with only one apparent failure, which is discussed in more detail below. In pre-2002 homes, roof structure failures most frequently occurred in the Keys. Exact connection details were often not visible, but H2.5 or similar metal straps were observed in 14 of the roofs that experienced structural damage. Exact details of each connection were not accessible.

Figure 25. Frequency of roof structure damage occurring by region relative to FBC adoption.

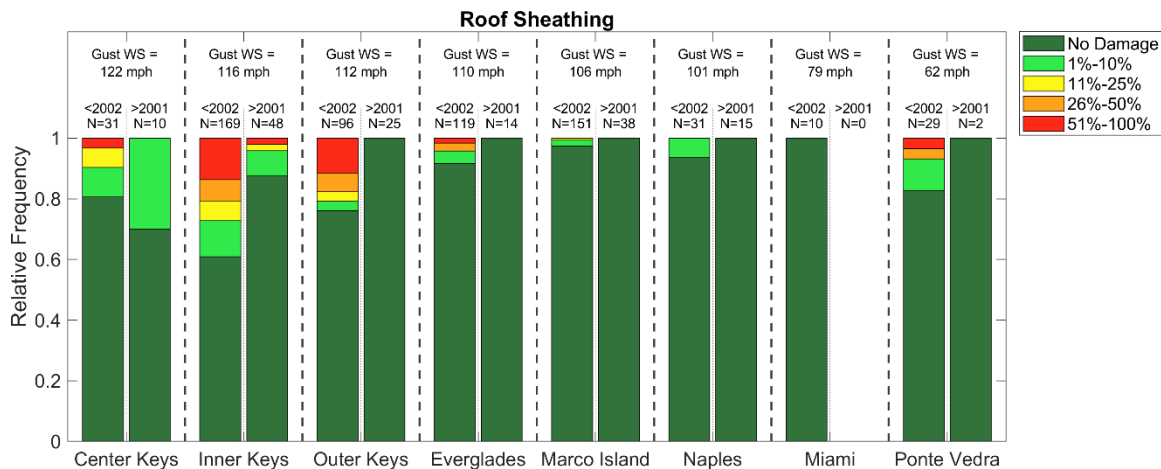
Figure 27 shows the frequency of roof sheathing damage in pre-2002 and post-2001 homes stratified by region. Overall, roof sheathing performance was better in post-2001 homes. However, roof sheathing failures were indicated in nine post-2001 homes, in regions of the Keys that experienced the highest wind speeds. Further review of these homes does not reveal any systemic issues with roof sheathing performance in post-2001 homes. All but two experienced 10% or less damage. Of those that experienced 10% damage, most cannot be definitively confirm with the available aerial imagery. In one of the homes where damaged sheathing is visible, the damage appears to have been due to wind-borne debris impact punching through the panel, not a wind-induced uplift failure. Of the two that experienced greater than 10% roof sheathing damage, one was the 491 W Indies home which had approximately 30% roof structure damage.

In pre-2002 homes, roof sheathing damage was more widespread, with failures being indicated in 124 homes. Out of these 124 homes, 44 (35%) had 10% or less roof sheathing damage and there was typically uncertainty as to whether there was roof sheathing damage or not. Fastening details for the remaining sheathing panels was typically not visible to the field assessment teams, but in a few cases failed sheathing panels were found nearby, showing plywood panels with staples or 6d common nails at variable spacing.

Figure 27. Frequency of roof sheathing damage occurring by region relative to FBC adoption.

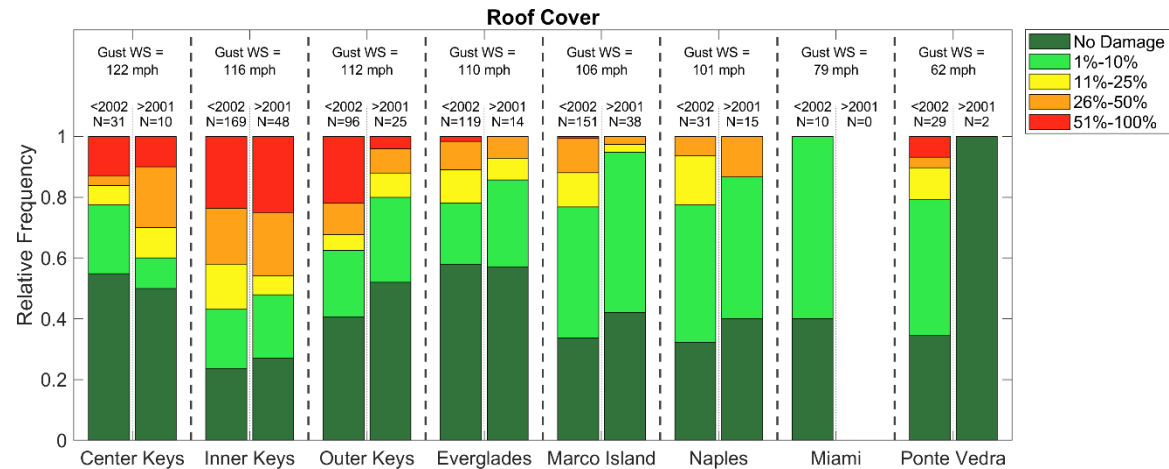
Figure 29. Frequency of roof cover damage occurring by region relative to FBC adoption.

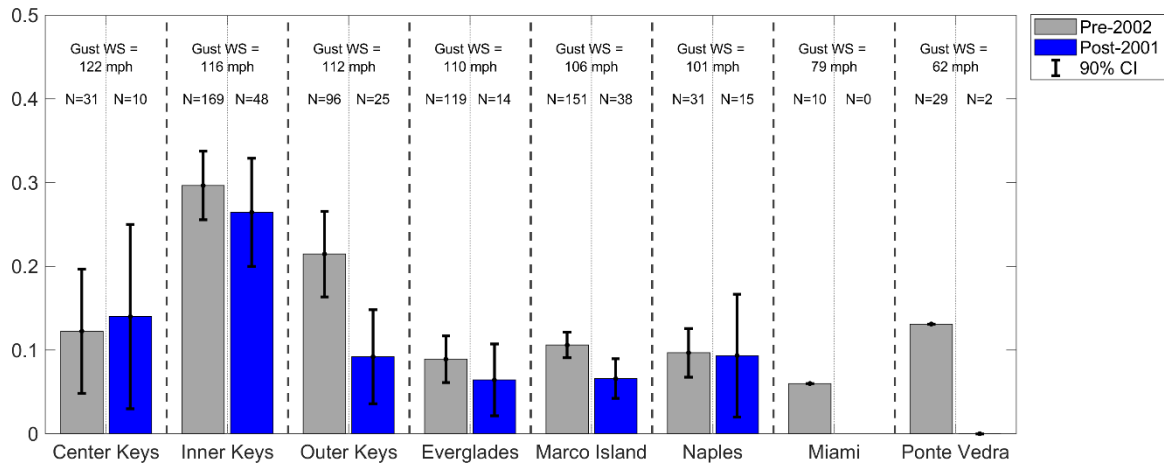
Figure 30. Mean roof cover damage ratio by region relative to FBC adoption.

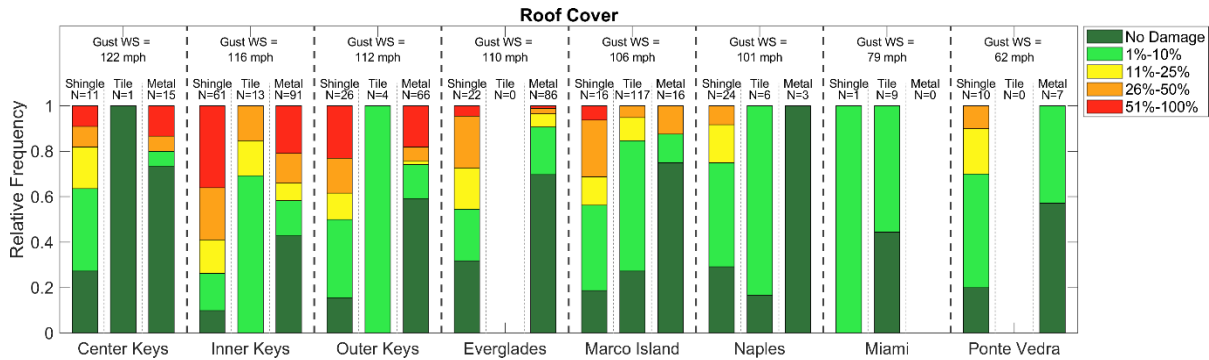
Figure 31 shows roof cover damage rates stratified by type and region. These results are presented as is, but caution should be taken in interpreting too much from any apparent trends as they have not been normalized by the age of the roof. It is possible in certain regions or overall that newer roofs may be biased towards a particular roof cover type, resulting in improved performance that may or may not be material driven.

Figure 31. Roof cover damage stratified by roof cover type and region. Note that biases may exist in these results due to the age of the roof being unknown.

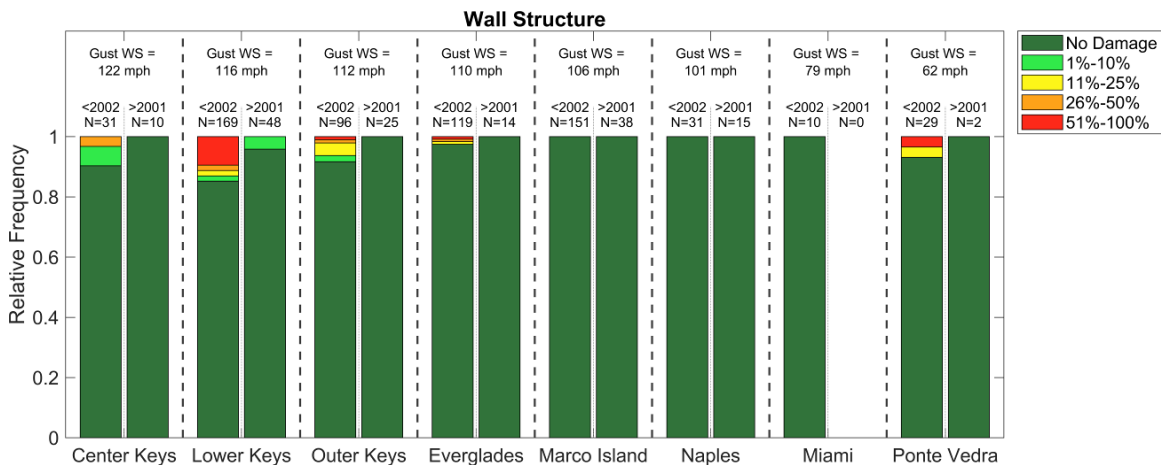
Structural wall failures were infrequently observed, and nearly exclusively occurred in wood-frame, pre-2002 homes. All but two of the 47 homes with wall structure failures also occurred in regions with exposure to direct surge inundation, and the two that were not directly exposed to surge inundation were on the Atlantic coastline in Ponte Vedra, where storm surge washout restructured the shoreline and caused the collapse of several walls of homes. Note that we did not consider damage to breakout walls or other walls around lower level enclosures as wall structure failures, because these are typically not constructed to code.

All but 8 of the homes with wall structure failures also experienced roof structure failure, demonstrating the correlation often found between roof structure failure and subsequent wall structure failure due to the removal of the lateral support along the top edge of the wall.

Figure 32. Frequency of structure wall failures occurring by region relative to FBC adoption. Percentages refer to the percentage of the wall structure that collapsed.

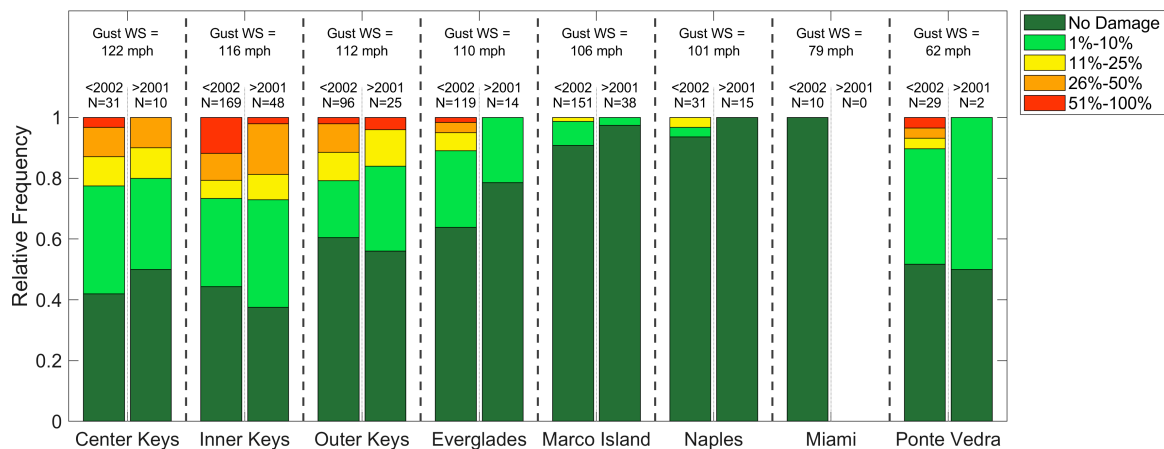
Wall cladding damage was commonly observed, but not as frequently as roof cover damage. Wall cladding damage of some level was observed in 278 homes (35%) compared to 495 homes (62%) for roof cover. The majority of the wall cladding failures were observed in the Keys, due in large part to the prominence of vinyl siding cladding in these regions. Just over half (53%) of the wall cladding failures were associated with homes that used vinyl siding. The FEMA MAT report (FEMA 2018) provides a detailed examination of some specific design and installation failures in vinyl siding that were also observed by the field assessment teams in this study. For example, Figure 34 shows a home at 44 Pelican Ln on Big Pine Key that was constructed in 1993. No building permits were issued following construction that were related to wall cladding, so it is assumed that the failed vinyl siding was the original installed material. Approximately 40% of the wall cladding, including the underlying moisture barrier, was removed. Close-up photos of the failed siding show that it had a standard (single) hem and narrow locking area, which are features of standard siding, not high-wind rated siding.

Figure 33. Frequency of wall cladding failures occurring by region relative to FBC adoption. Percentages refer to the percentage of the wall cladding that failed.

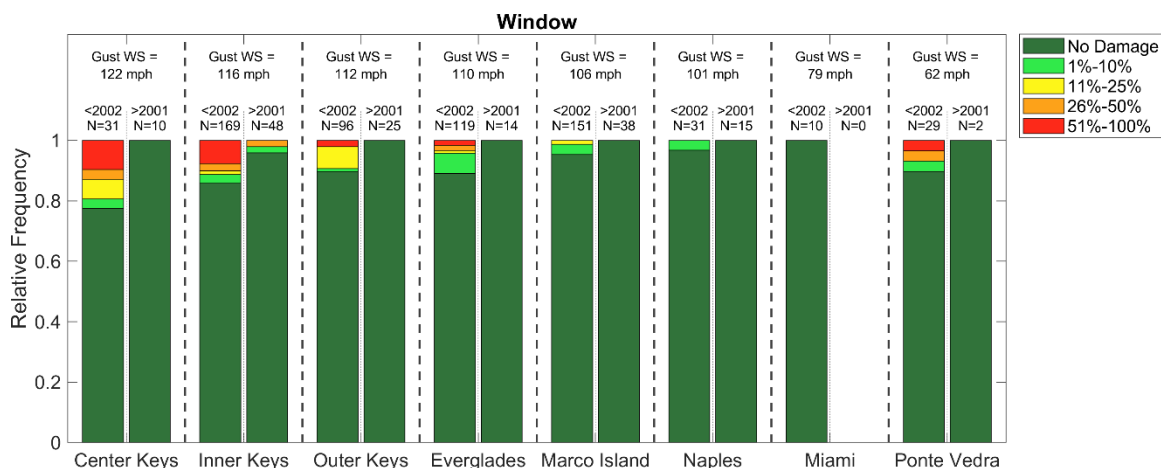
Window failures were observed in just 71 of the 800 homes (9%) assessed in the field survey, and this includes homes where walls containing windows collapsed. Figure 36 shows the frequency of observed window failure rates broken down for each of the major geographic regions. The vast majority (97%) of window failures occurred in pre-2002 homes, but, similar to the issue with roof cover damage, demarcating by year built ignores any retrofitting that may have occurred since the home was built. Anecdotally, we found that building permits were issued fairly often to replace windows or add hurricane shutters in the limited dataset we obtained building permit information for. For example, in the 31 homes that were the subject of the homeowner interviews that we had addresses for, nine of the 31 (29%) had building permits issued prior to Hurricane Irma to either replace windows with impact resistant windows or to install hurricane shutters. All of the nine homes were constructed prior to 2002 and none had window or door damage noted in the field survey or the homeowner interviews.

Figure 36. Frequency of window failures occurring by region relative to FBC adoption. Percentages refer to the percentage of visible windows observed to have failed.

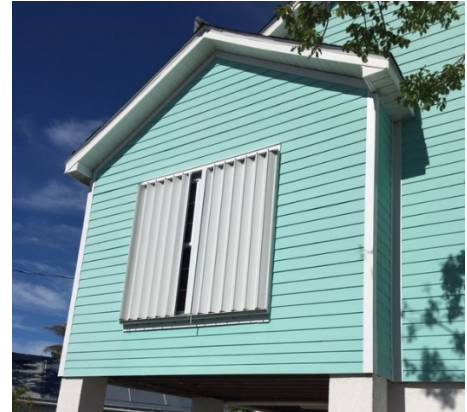
they had hurricane shutters blown away during the hurricane. One was a mobile home on Conch Key. The other was a single-family home on Little Torch Key, but the missing shutters were not visible in the photographs of the home taken by the assessment team. Three other assessments indicated shutters had failed – two for pre-2002 homes and one for a post-2001 home. Examples are shown in Figure 38 and Figure 39.

Figure 39. Home on Big Coppit Key (built in 2005) with a damaged accordion-style hurricane shutter. Wind gusts were estimated at 116 mph.

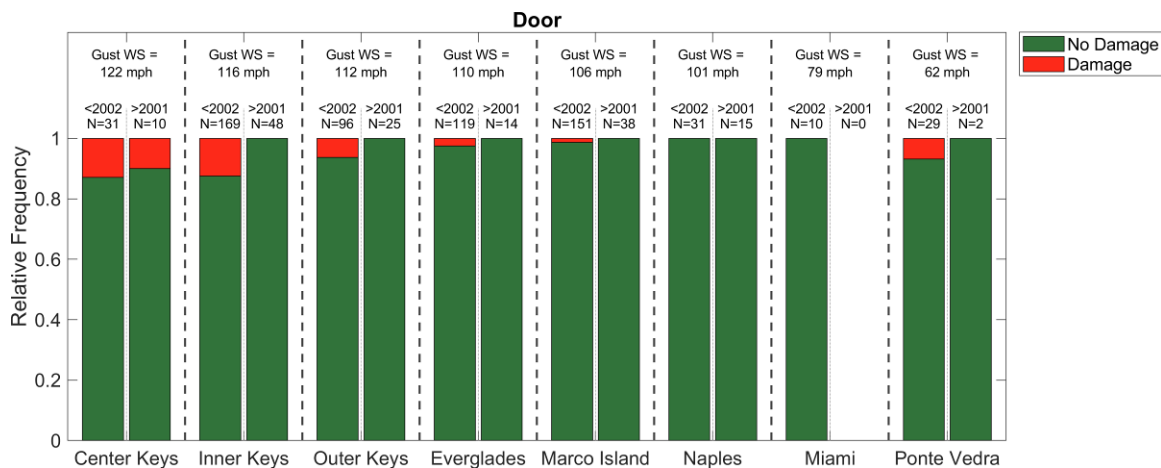
Door failures were only observed in pre-2002 homes and many appeared to be surge-related, although it was difficult to determine in some cases whether the damage was wind- or surge-induced. Eight homes were observed with apparent damage to garage doors, with all but one in areas of the Keys exposed to storm surge inundation. The one failure in Marco Island appears to have been caused by impact from a downed tree. Surge-related door failures are discussed further in Section 4.2.

Figure 40. Frequency of door failures occurring by region relative to FBC adoption.

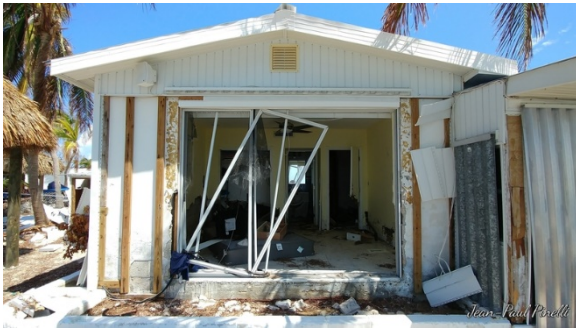
The field assessment teams observed many homes with exterior surge-induced damage. Examples of surge damage included collapsed walls of non-elevated structures, collapse of breakaway walls in elevated structures, stripping away of wall cladding elements, surge washout undermining foundations and more. Figure 43 shows a sliding glass door that was failed by apparent surge inundation. Inspection of the interior of the home indicated water heights of approximately 2.5-3 ft above the floor level. The home was built in 1959 and was not in compliance with the current base flood elevation standards at the time of the hurricane. Figure 44 shows a home apparently destroyed by surge that was built in 1968. This home also was not in compliance to current base flood elevation standards.

Figure 43. Surge-induced failure of a door system in a home in Islamorada, FL.

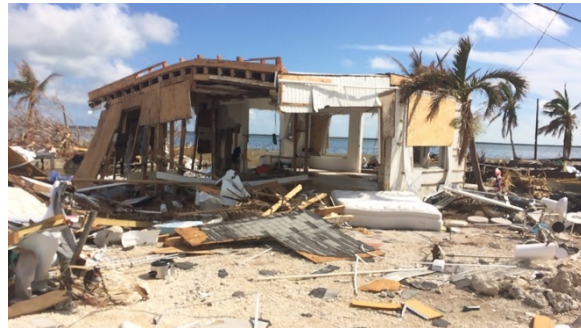
Figure 44. Surge-induced collapsed walls in a home in Big Pine Key, FL.

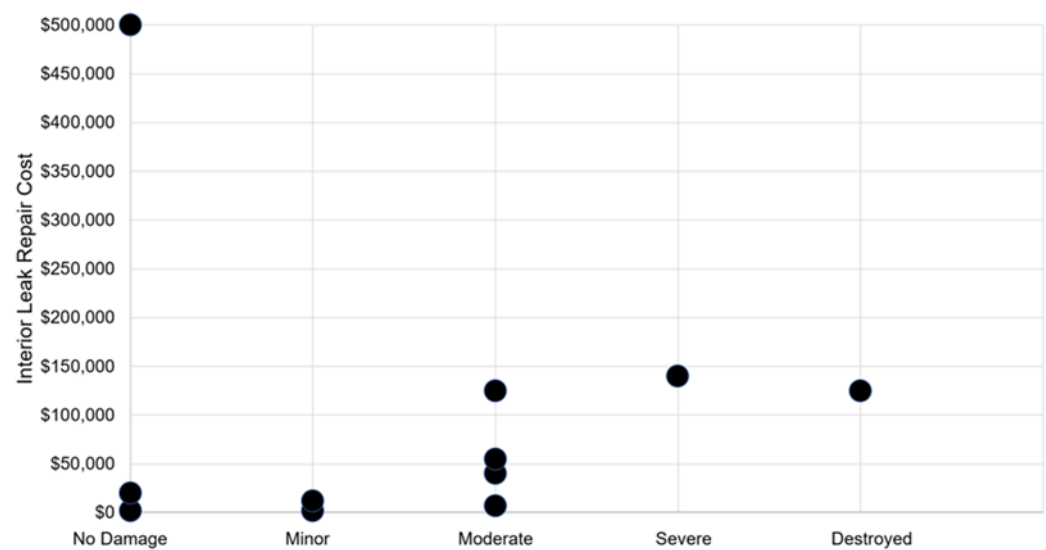
Out of the 32 homeowner interviews, 14 mentioned interior damage and economic losses due to wind-driven rain and/or storm surge inundation or flooding. Nine of the respondents defined wind damage repair cost, including seven that also experienced wind-driven rain or storm surge losses. Figure 50 plots the repair cost due to interior leaks (i.e., wind-driven rain or water ingress through breached openings) against the exterior damage rating assigned by the field assessment teams. The \$500,000 repair cost was reported by a homeowner on Marco Island whose home had a value of around \$3M. Sources of the water leak-induced damage was indicated as water leaks through the roof and flying roof tiles. Figure 51 plots the repair cost due to storm surge inundation or flooding against the exterior damage rating assigned by the field assessment teams. Figure 52 plots the repair cost due to wind damage against the exterior damage rating assigned by the field assessment teams.

From each of these plots, a general trend of increasing interior repair costs with increasing exterior damage rating is observed. Some of the high repair costs were associated with homes rated as having No Damage or Minor Damage in the field assessments.

Figure 50. Exterior damage rating assigned by assessment teams and homeowner-indicated repair costs due to water leaks.

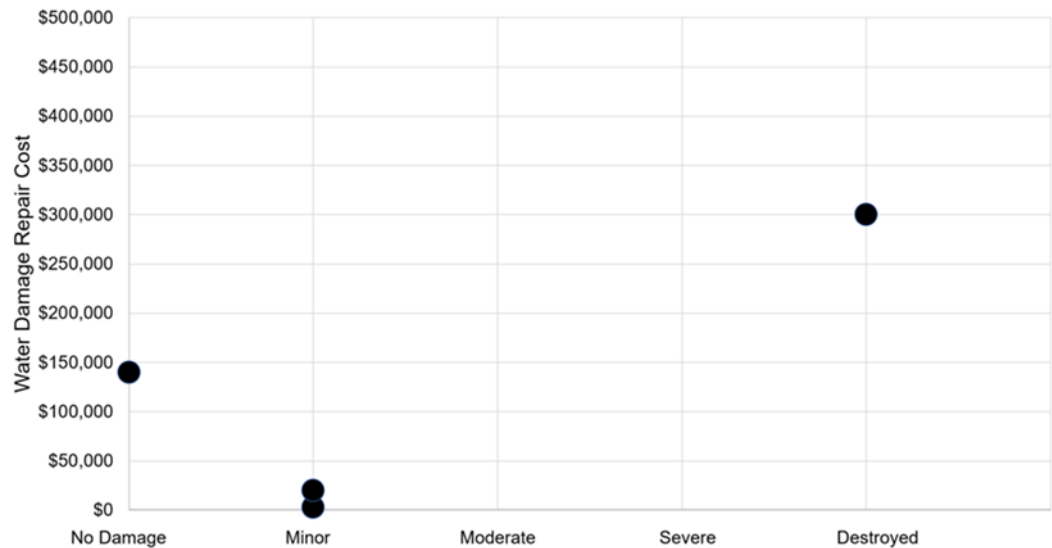
Figure 51. Exterior damage rating assigned by assessment teams and homeowner-indicated repair costs due to storm surge inundation or flooding.

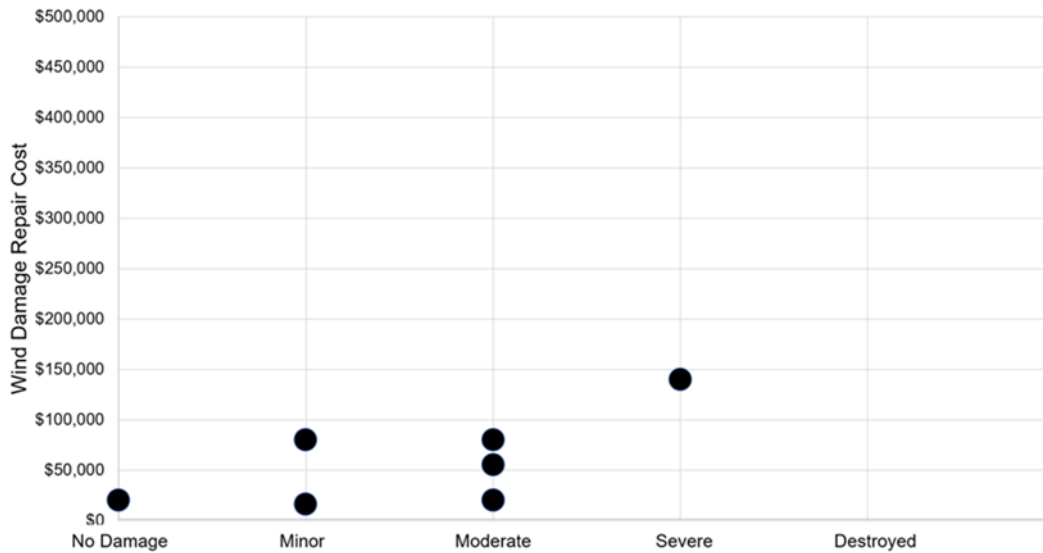
Figure 52. Exterior damage rating assigned by assessment teams and homeowner-indicated repair costs due to wind damage.
