# Hurricane Irma in Florida

Building Performance Observations,  
Recommendations, and Technical Guidance

FEMA P-2023 / December 2018

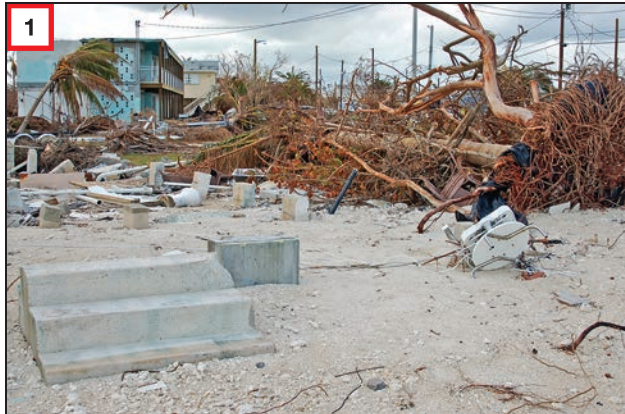
House near shoreline and subject to wave action/ high water velocity was washed off its foundation and destroyed.

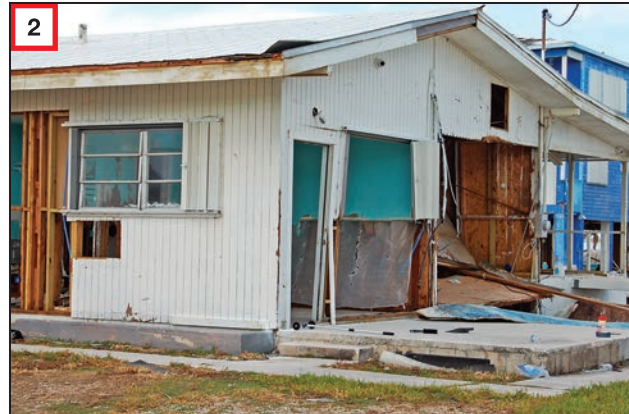
Inundation, water velocity, and debris damage to buildings situated farther from the shoreline.

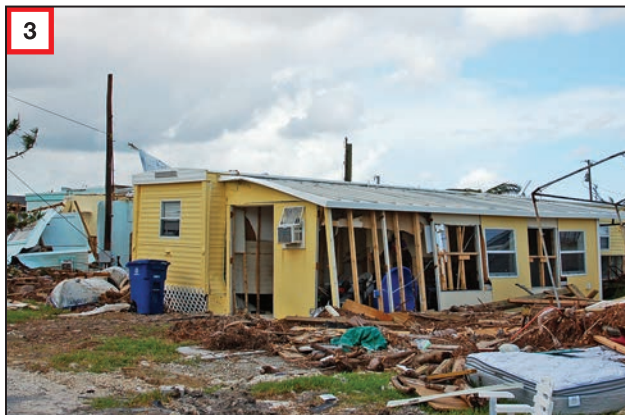
Inundation, water velocity, and debris damage to buildings situated farther from the shoreline.

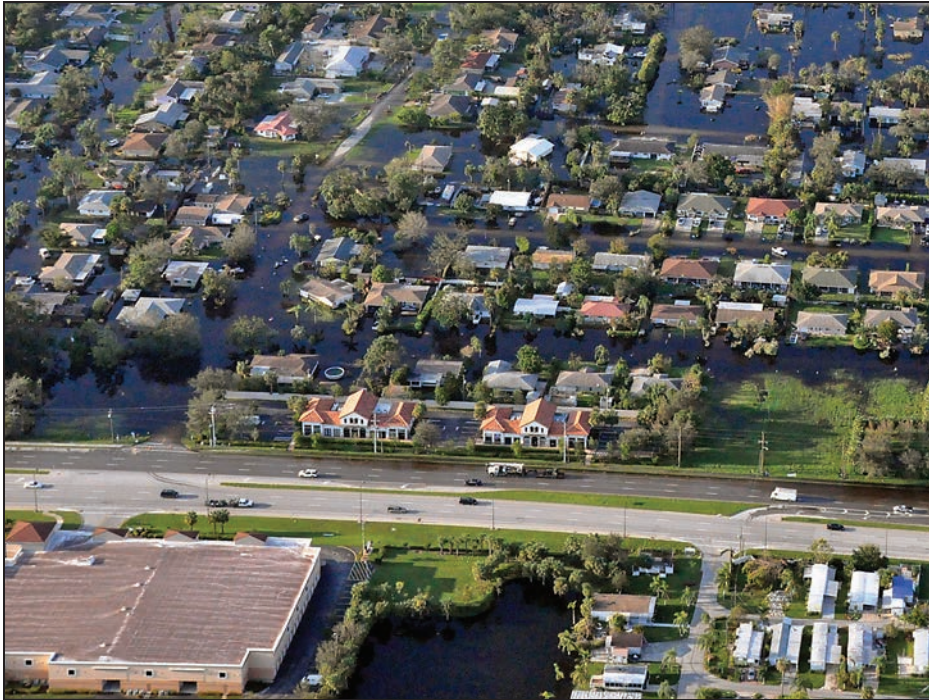
Figure 3-4:  
Long-duration flooding in  
the Bonita Springs area  
(Lee County, FL)

View looking north across Bonita Beach Road SE on September 15, 2017  
(photograph courtesy of Civil Air Patrol).

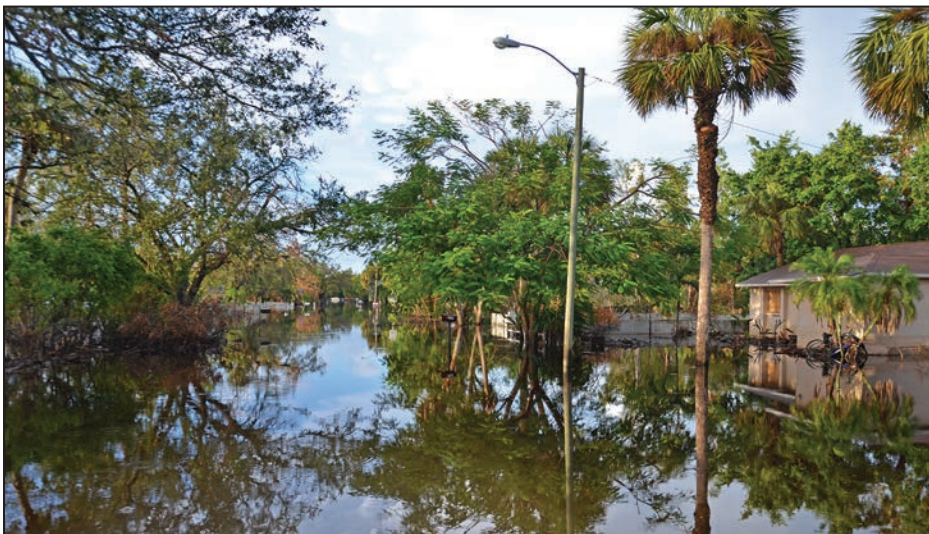
Part of Bonita Springs still flooded on September 23, 2017, nearly 2 weeks after  
Irma.

**Figure 3-5:**  
Elevated house with  
unreinforced masonry  
breakaway walls that  
performed as intended  
(Big Pine Key, FL)

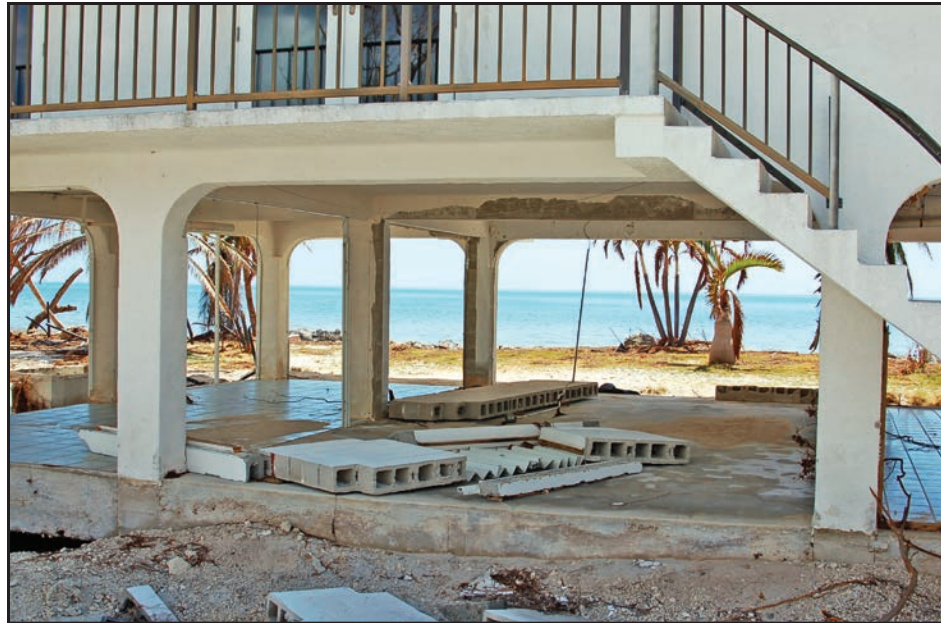
**Figure 3-6:**  
House constructed at grade  
where the masonry walls  
parallel to the shoreline  
were destroyed; this house  
was near the house shown  
in Figure 3-5  
(Big Pine Key, FL)

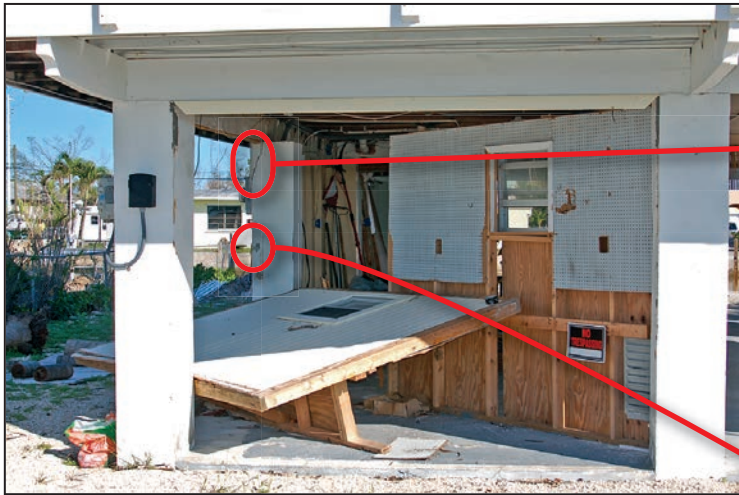
**Figure 3-8:**  
Example of partial failure of breakaway wall, with no associated damage to main structure observed (Cudjoe Key, FL)

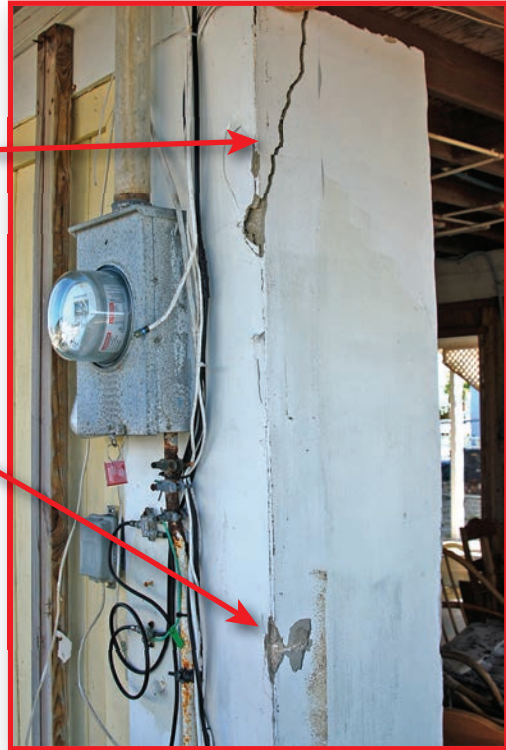
Performance of breakaway walls below elevated buildings varied. Some walls broke away cleanly without damaging the main structure (see Figure 3-7), while others did not. Of those that did not break away cleanly, some appeared to cause no damage to the structure (see Figure 3-8), while others appeared to cause damage to the columns to which they were attached (see Figure 3-9).

Figure 3-9: Example of a breakaway wall failure that likely contributed to damage to columns (Big Pine Key, FL)

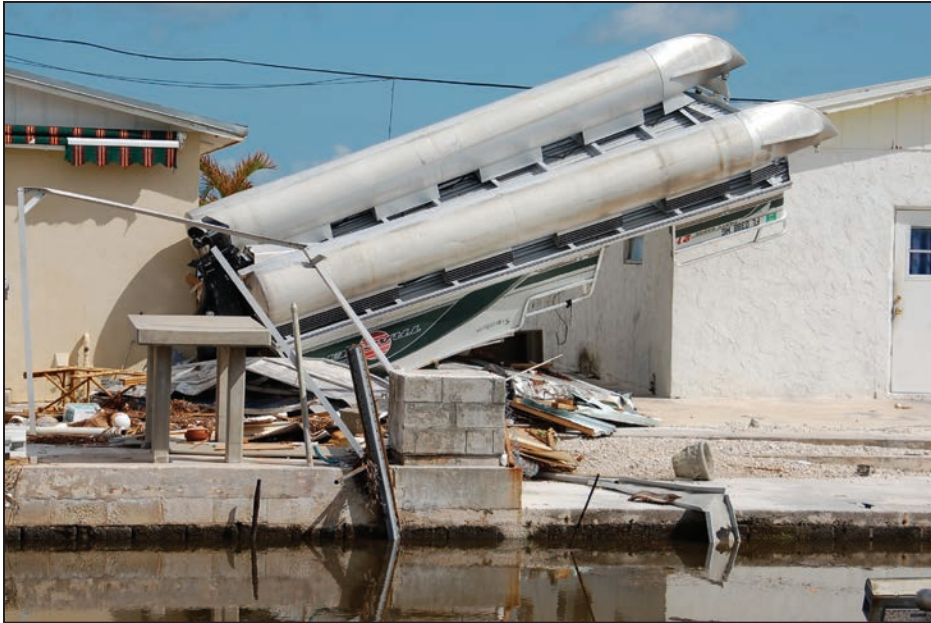
**Figure 3-11:**  
Boat and small debris that  
washed across a canal and  
onto houses  
(Big Pine Key, FL)

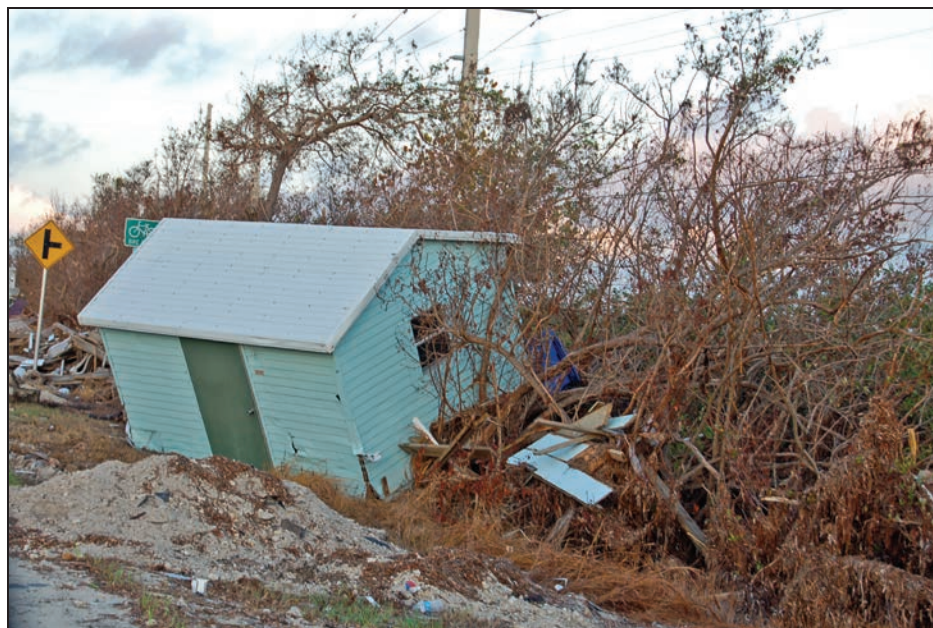
**Figure 3-13:**  
Shed that washed across  
Highway US 1  
(Grassy Key, FL)

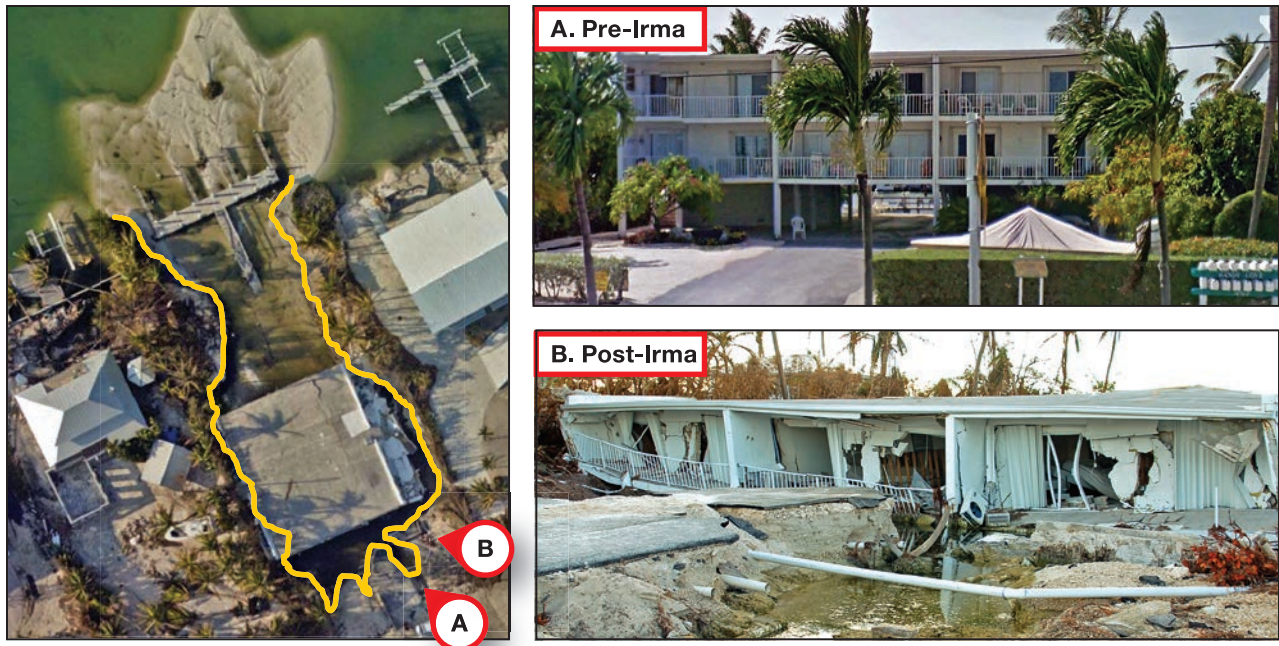
Figure 3-17: Collapsed building (Lower Matecumbe Key, FL)

The MAT observed one instance of building collapse in the Florida Keys (Figure 3-17). The building was a two-story multi-family structure elevated on an open concrete column foundation, with ground-level parking below (this building is 600 feet from the undermined building shown in Figure 3-14).

The yellow line in the aerial image was drawn by Village of Islamorada staff and indicates the boundary of the area scoured by Irma. The MAT did not determine whether scour contributed to the collapse.

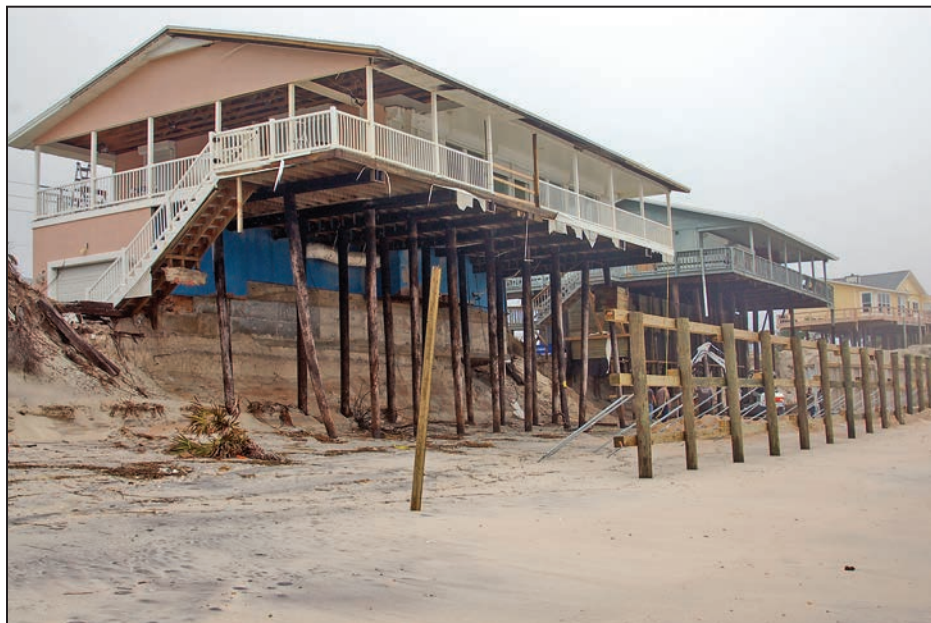
**Figure 3-19:**  
Undermined houses  
constructed on top of the  
dune (Vilano Beach, FL)

These houses survived the undermining, even though approximately 10 to 15 feet of dune height was lost beneath the houses. The pilings farther seaward are for a seawall under construction at the time of the MAT visit (February 2018).

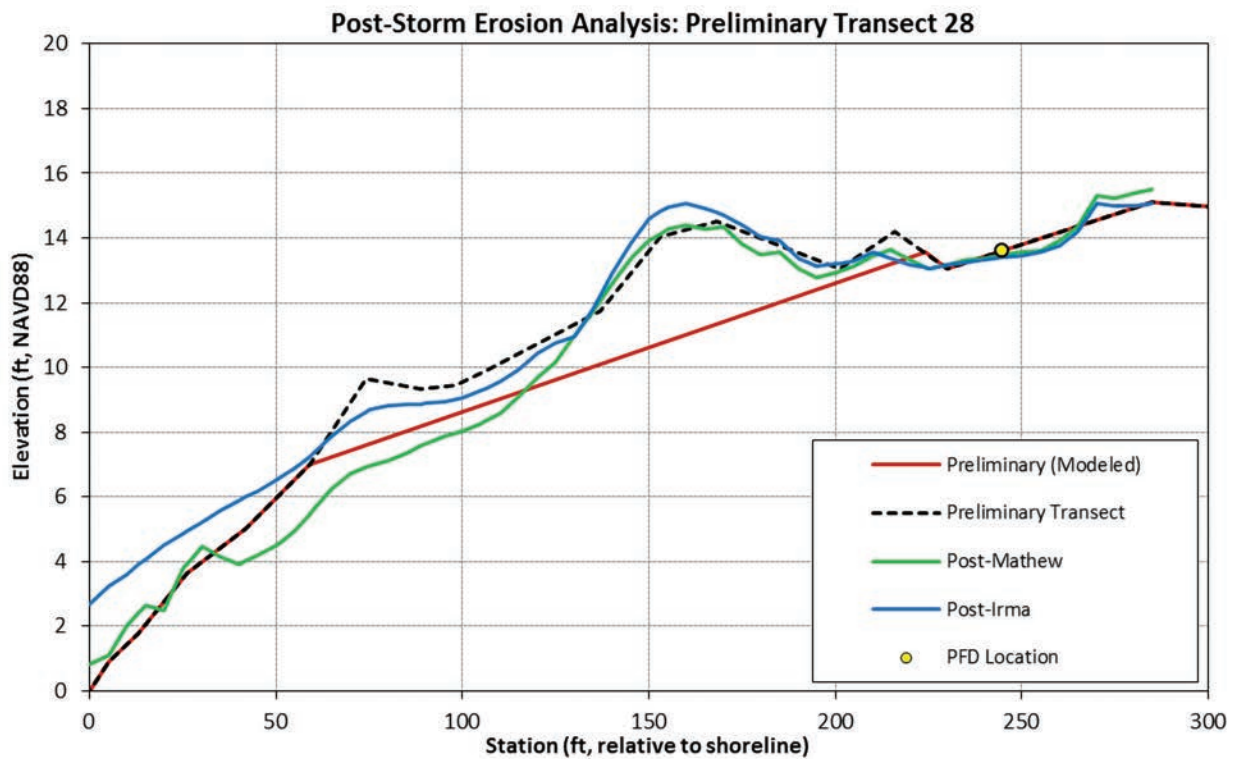
Figure 3-22: Beach and dune profiles at Transect 28

Figure 3-21 through Figure 3-26 illustrate dune erosion that occurred at selected FIS transect locations during Hurricane Matthew and Hurricane Irma.<sup>1</sup> The “preliminary transect” lines represent pre-Matthew ground elevations. The “preliminary modeled” lines represent the FIS estimation of dune erosion during a base flood. In some cases, Hurricane Matthew erosion was greater than Hurricane Irma erosion, while in others Hurricane Irma erosion was greater. In some cases, the modeled erosion understated actual erosion, while in others it overstated actual erosion. This information indicates high longshore variability in dune erosion may occur in any given storm. It also demonstrates that building foundations in high dune areas may sustain 5 to 10 feet or more of vertical erosion during a severe storm event.

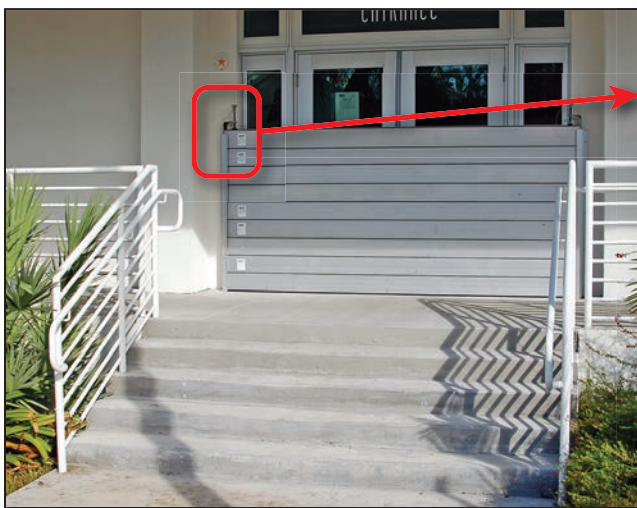
Figure 3-30: Flood plank system deployed at utility company building (Key West, FL)

Some dry floodproofing systems were not subject to flooding, but still sustained some minor water accumulation behind them due to rainwater between the floodproofing system and the building face (see Figure 3-30). In one case, significant flooding infiltrated a building as a result of building envelope failure that allowed large quantities of rainwater to enter and become trapped behind the floodproofing system.

Five door openings were covered by flood planks. Hurricane Irma floodwater did not reach the planks; however, wind-driven rain accumulated and entered the building behind one of the barriers deployed at a door without a canopy overhead (the amount of water entry was minor but still a nuisance). System components were lightweight and stored on site. It took two workers 2 hours to deploy. The system was deployed 2 days prior to Irma landfall.

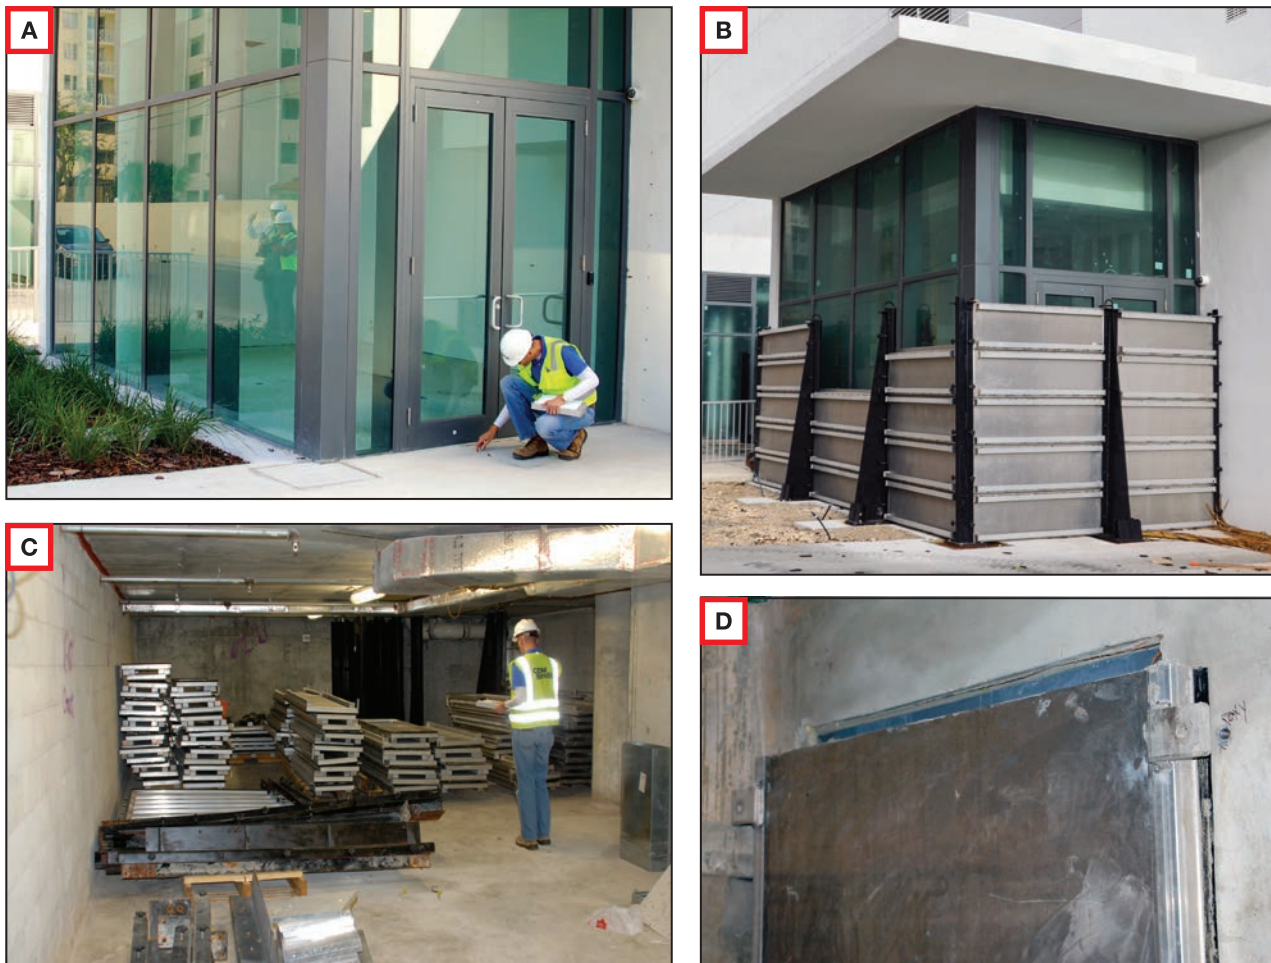
The doors without [A] and with [B] the floodproofing system deployed. The system took 10 workers with heavy equipment 2 full days to install prior to Hurricane Irma.

[D] shows a gap at the top of a doorway flood shield.

**Figure 3-31: A high-rise residential building under construction was successfully protected by a dry floodproofing method that used flood panels and doors; the floodproofing was installed by the building contractor (Miami, FL)**

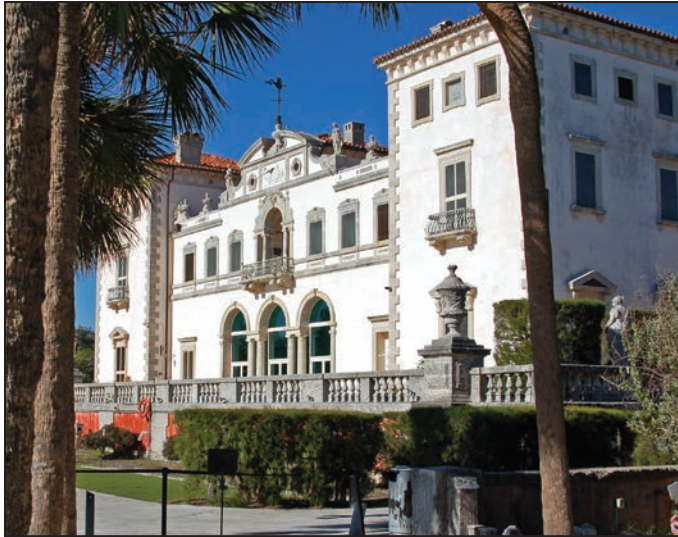
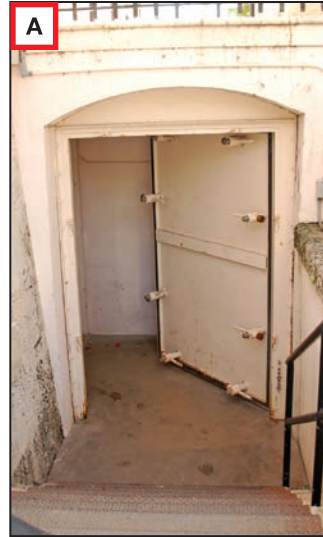
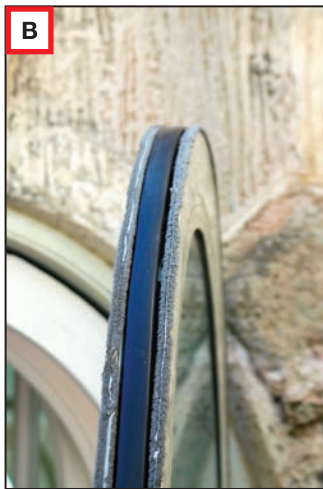
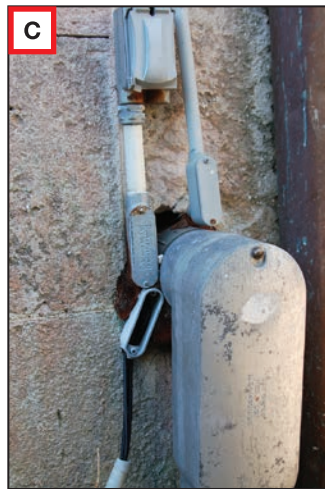
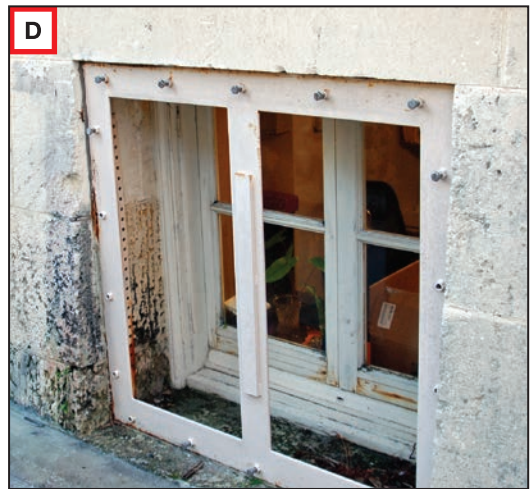
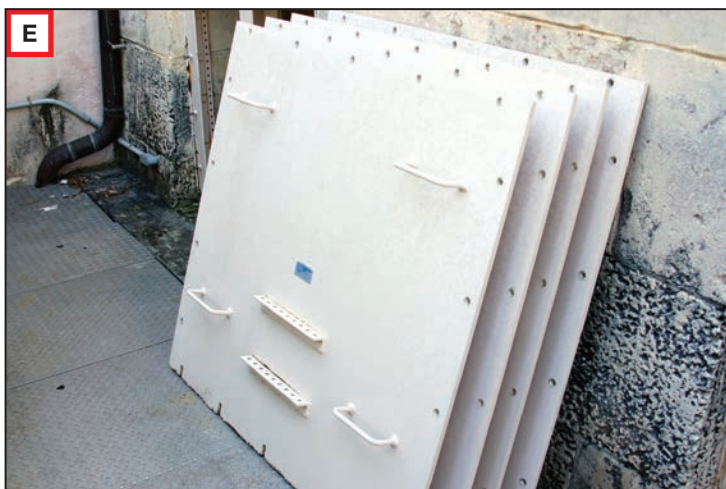
**[A]** Mechanical flood door at one building entrance.

**[B]** Air gasket on aquarium glass door (some air gaskets deflated).

**[C]** Penetration through wall that may have allowed water entry due to improper seal.

Figure 3-32: Floodproofing system components at a historic building (top); parts of the system failed and approximately 3 feet of flooding infiltrated part of the building (Miami, FL)

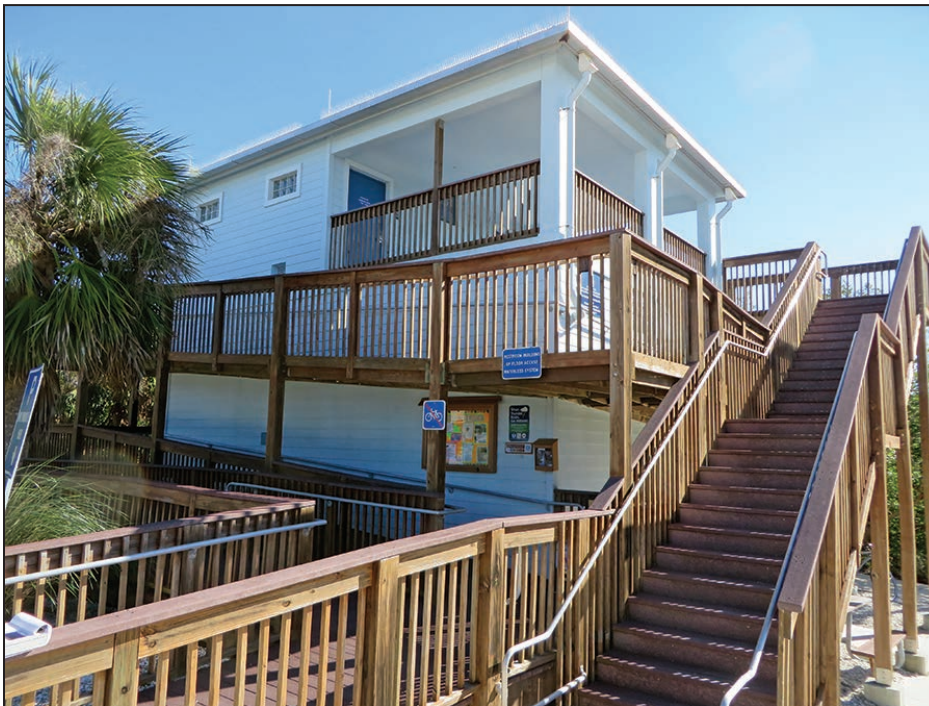
Figure 3-33:  
Elevated restrooms with  
ground-level enclosure.  
Bunche Beach Preserve  
restroom (Site 1; Lee  
County), where the degree  
of flooding in the enclosure,  
if any, would have been  
shallow.

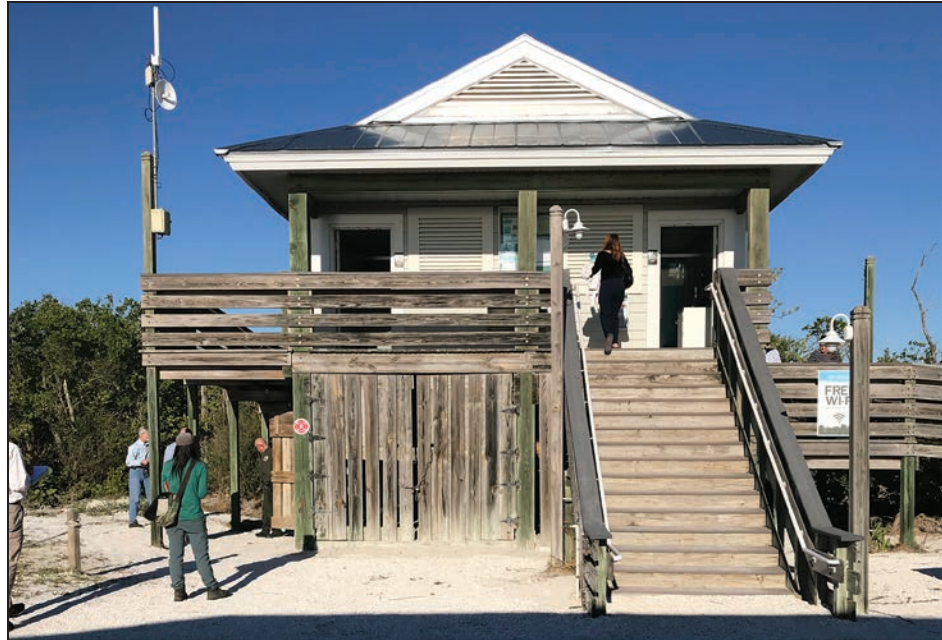
**Figure 3-34:**  
Elevated restrooms with  
ground-level enclosure.  
Lovers Key State Park  
restroom (Site 2; Lee County)  
enclosure sustained shallow  
flooding but no damage  
during Hurricane Irma.

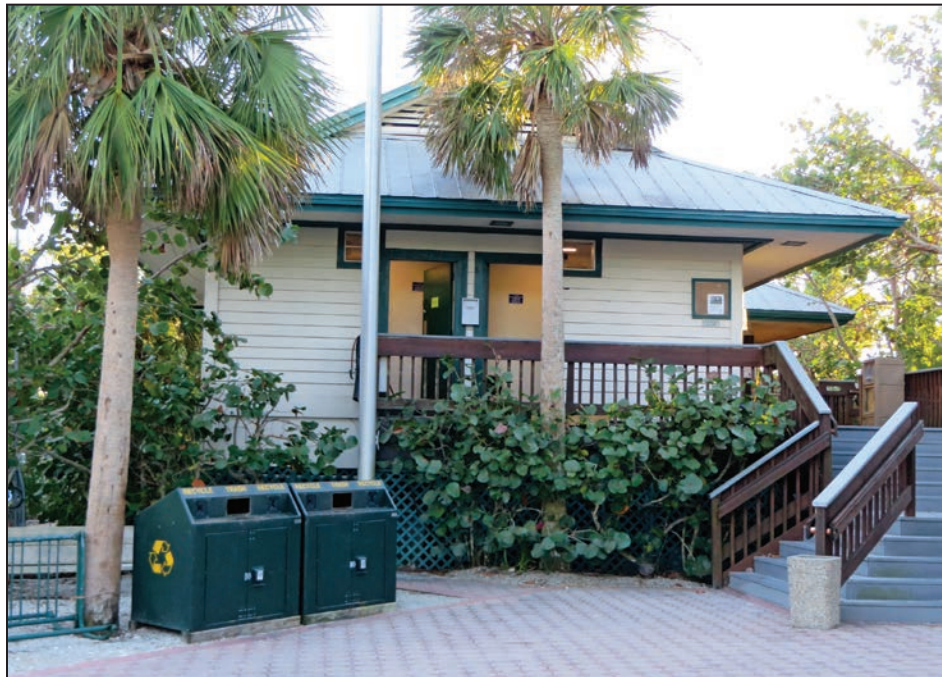
**Figure 3-35:**  
Elevated restroom  
at Barefoot Beach  
Preserve County Park  
(Site 3; Collier County)

| Site Identifier | Name/Location | MAT Observations |
|---|---|---|
| 3 | <b>Barefoot Beach Preserve<br/>County Park</b><br>(Collier County) | <ul style="list-style-type: none"> <li>• Zone VE<sup>(a)</sup></li> <li>• Intact and in use, December 2017</li> <li>• Timber pile foundation</li> <li>• Flooding was likely shallow and passed beneath building</li> <li>• There may have been wind damage to building</li> <li>• See Figure 3-35</li> </ul> |

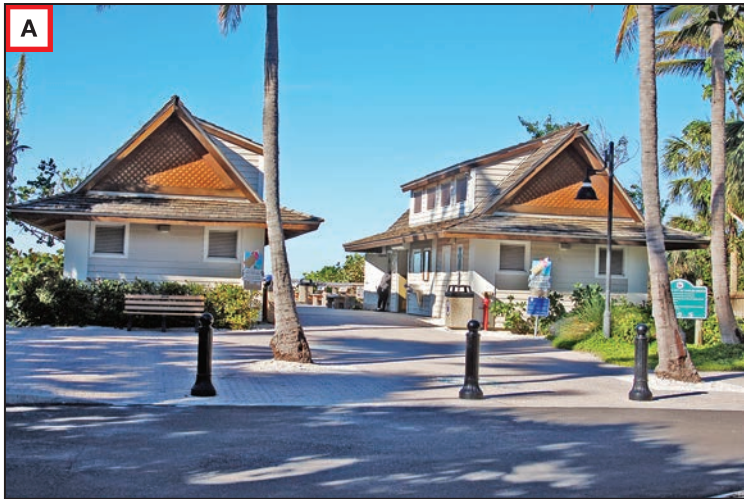
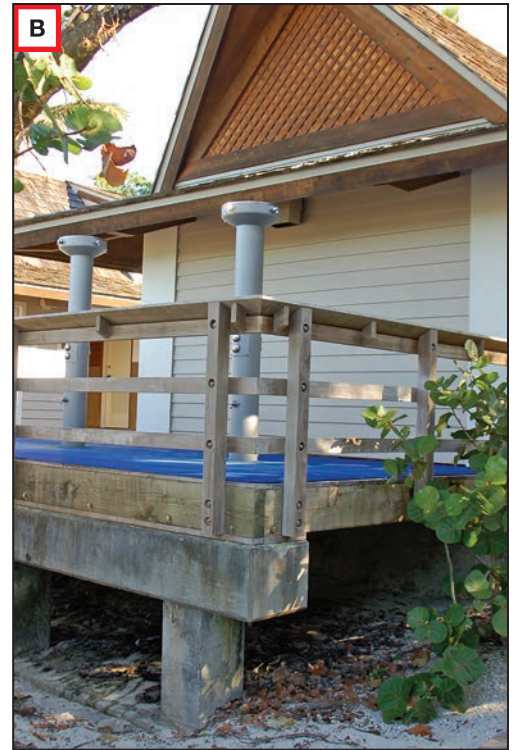
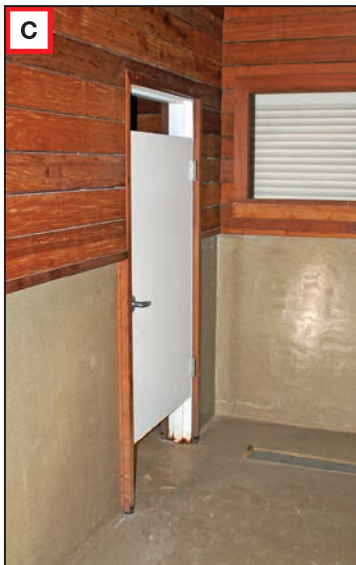
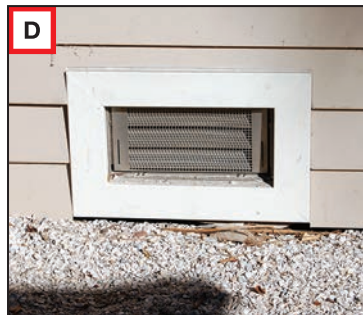
Figure 3-36: Elevated restrooms (Site 4; City of Naples Pier)

- [A]** Photo taken from land side
- [B]** Photo taken from beach
- [C]** Finished floor is below BFE but restroom walls are wet floodproofed to 1 foot above BFE
- [D]** Flood openings have been installed

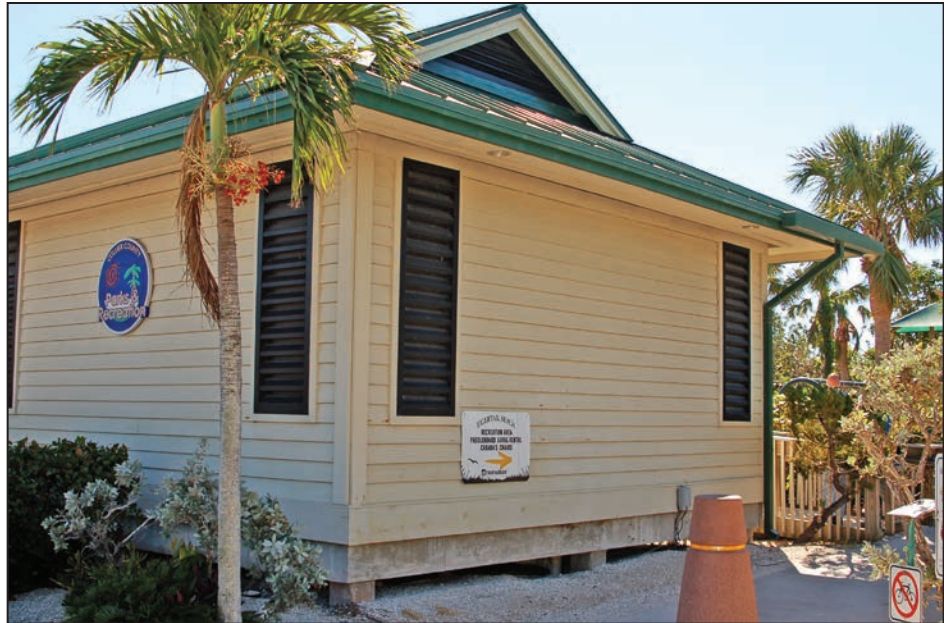
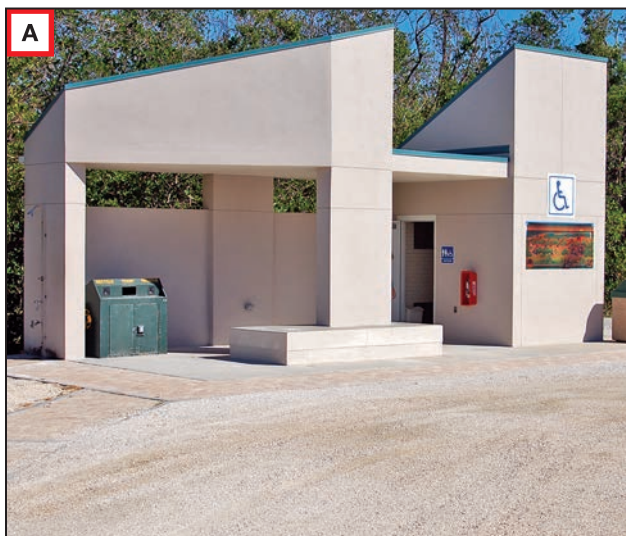
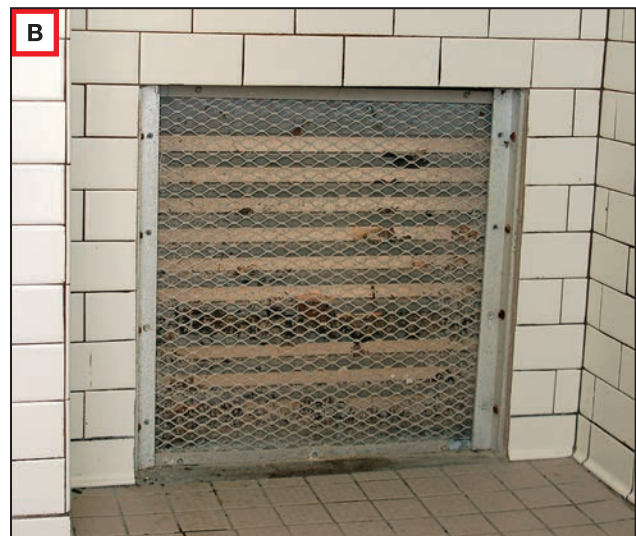
**Figure 3-38:** Grade-level restrooms at Marco Island (Site 6; Collier County)

- [A]** Restroom at Tigertail Beach, Marco Island. The estimated flood depth was 1 to 2 feet, and stormwater and surge from Hurricane Irma carried enough velocity to drive parking lot gravel around the restroom.
- [B]** Flood debris in a vent

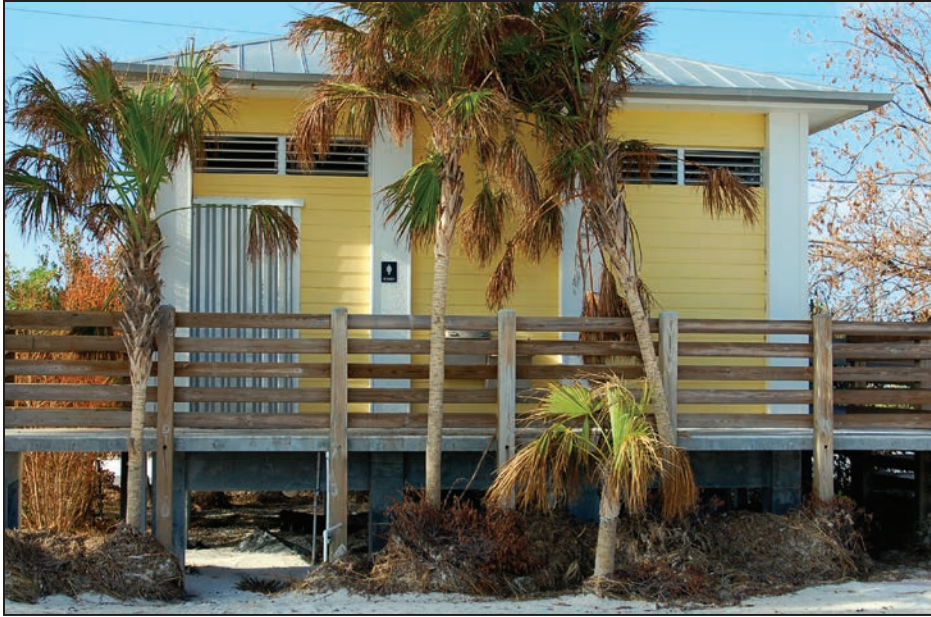
**Figure 3-39:**  
Elevated restrooms at  
Sombra Beach Park  
without ground-level  
enclosure and that  
sustained no flood damage  
during Hurricane Irma  
(Site 7; Marathon)

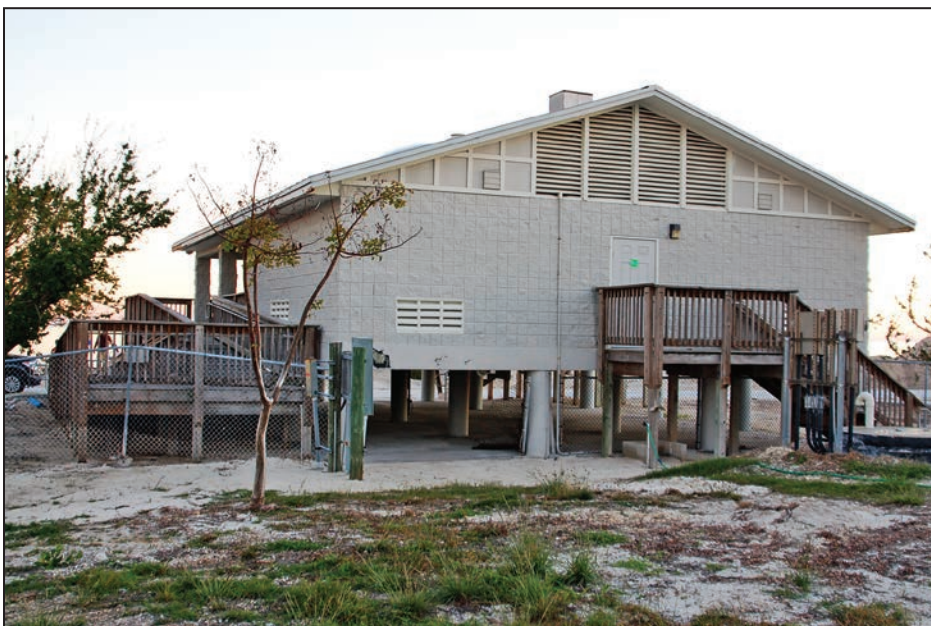
**Figure 3-40:**  
Elevated Long Key State Park  
restroom without ground-  
level enclosure and that  
sustained no flood damage  
during Hurricane Irma  
(Site 9; Monroe County)

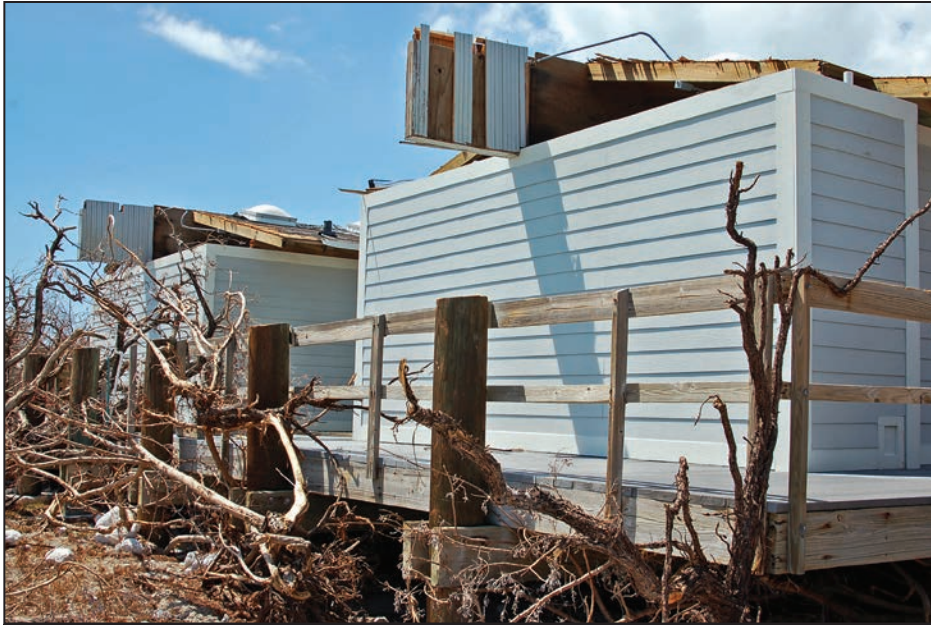
Figure 3-43:  
Elevated restroom at  
Bahia Honda State  
Park, Loggerhead  
(Site 13; Monroe County)

The elevated restroom sustained wind damage.

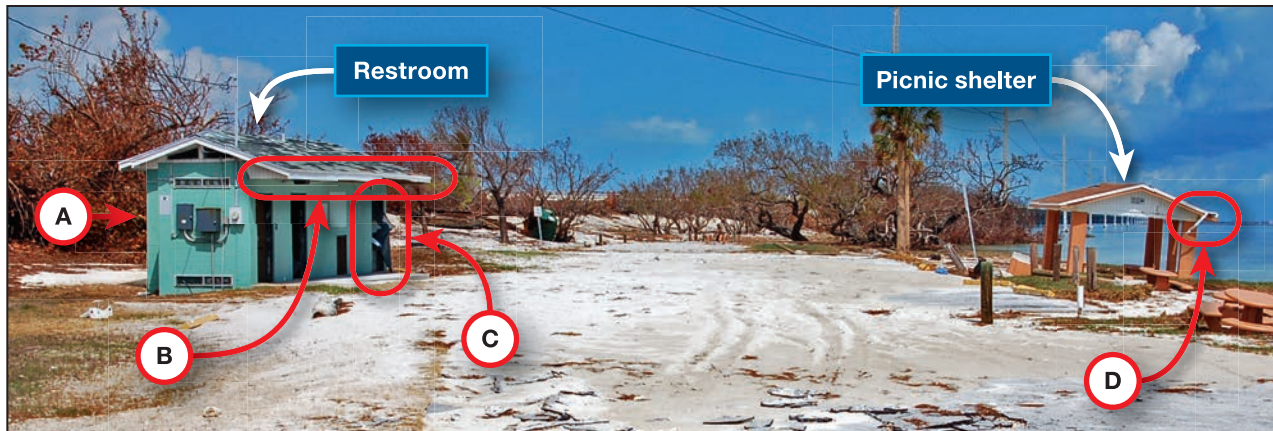
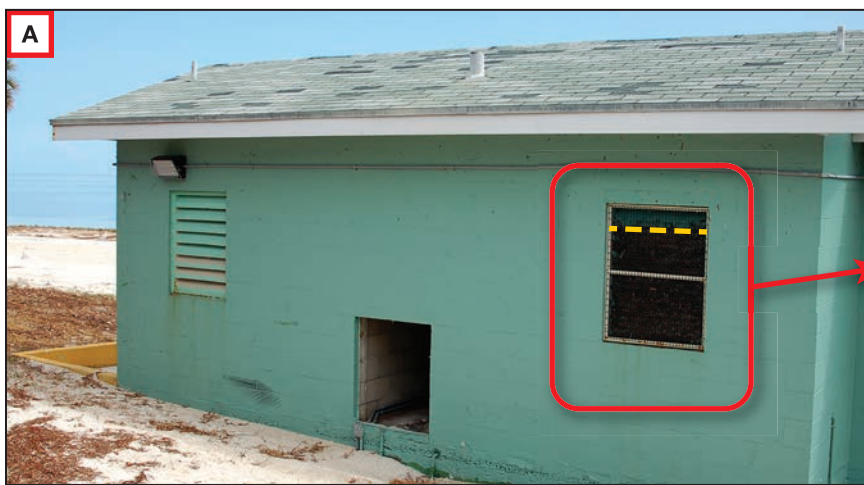
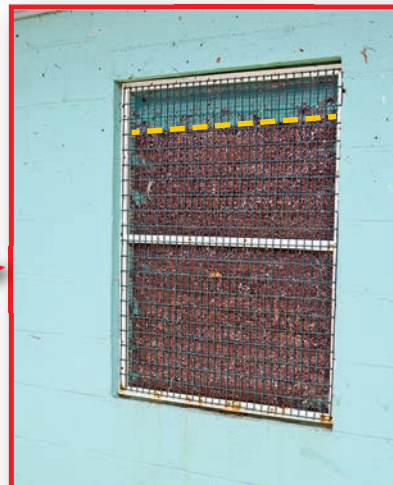
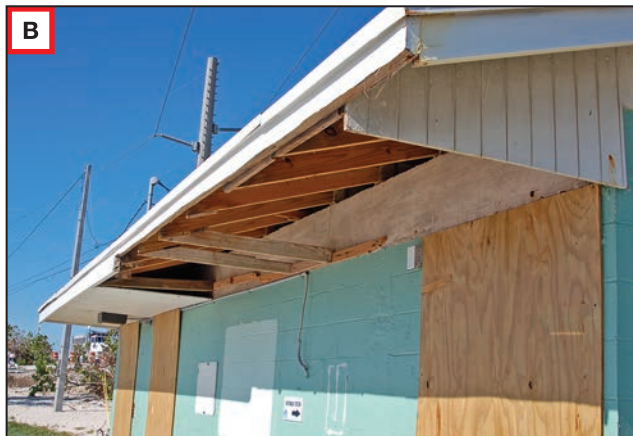
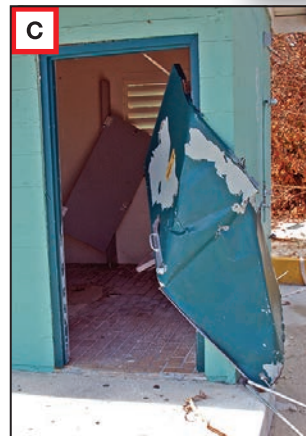
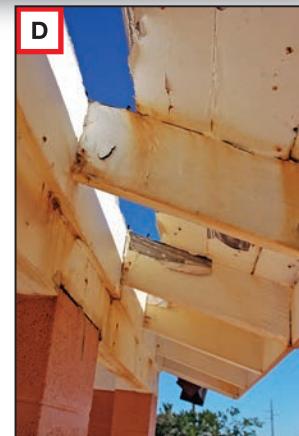
Figure 3-44: Grade-level Veterans Memorial Park restroom that was likely exposed to Zone V conditions (Site 14; Monroe County)

- [A]** Rear of restroom showing debris trapped inside vent—debris level was approximately 7 feet above grade and would have accounted for stillwater plus sloshing waves trapped inside restrooms
- [B]** Wave splash against seaward restroom wall likely damaged soffit
- [C]** Exterior door damaged by waves
- [D]** Wave crests were likely just below the shelter soffit and lifted the roof deck off

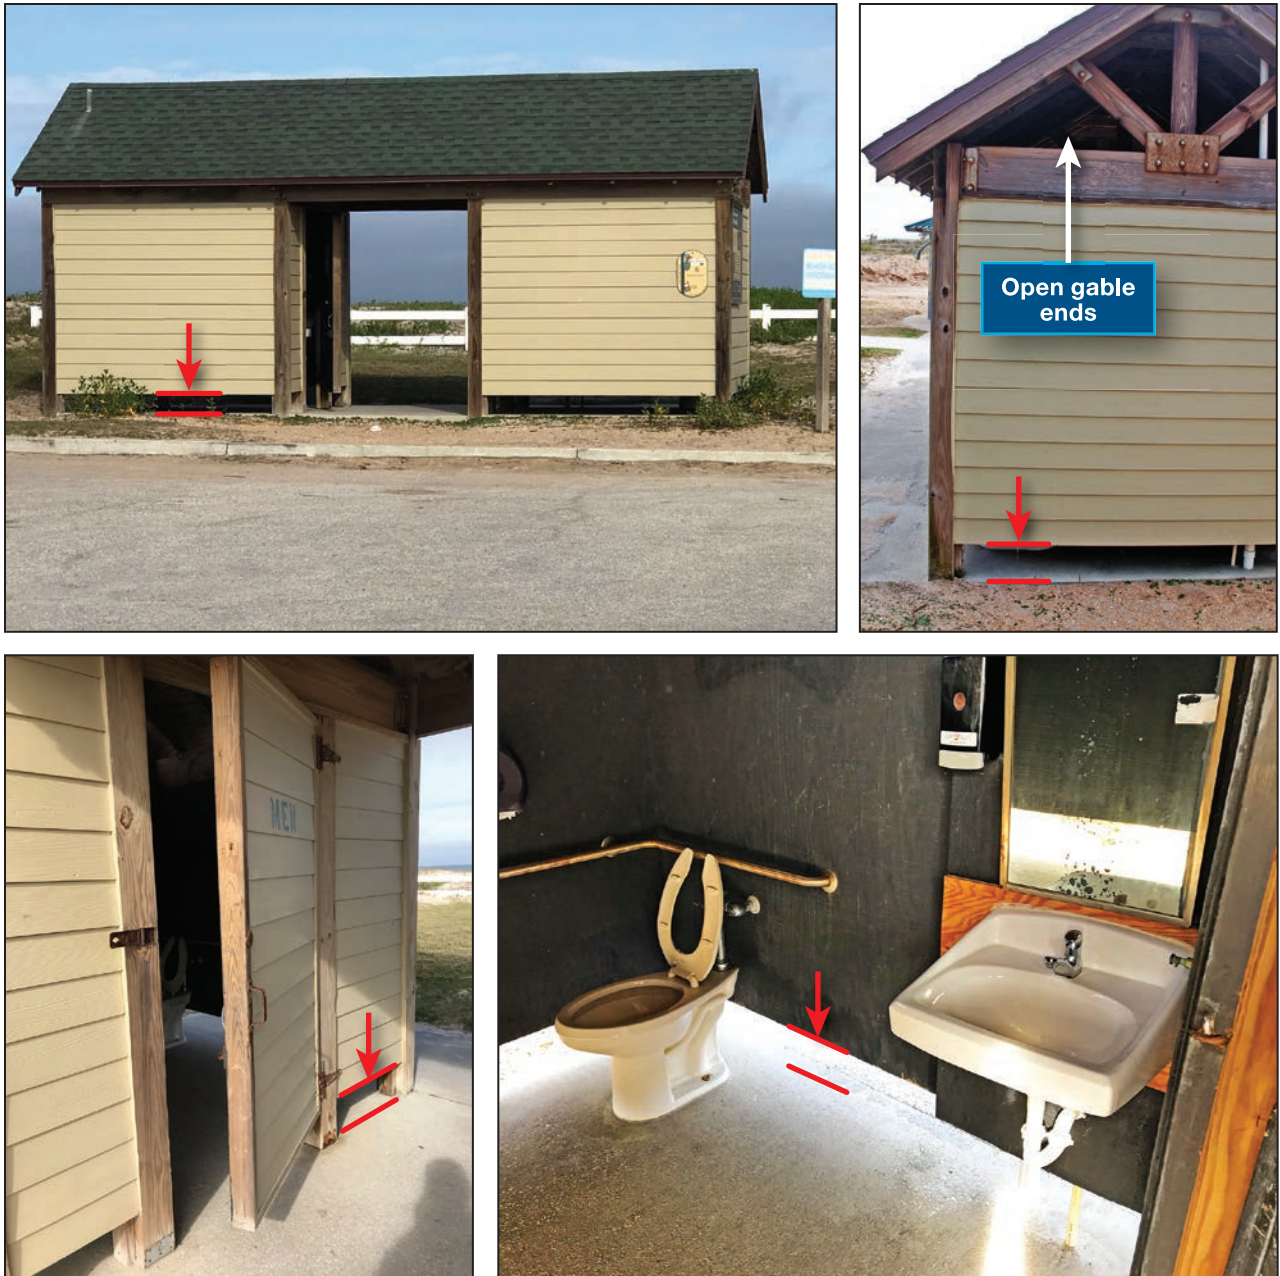
Figure 3-45: Grade-level Vilano Beach Surfside Park restrooms (Site 15; St. Johns County)

| Site Identifier | Name/Location | MAT Observations |
|---|---|---|
| 15 | <b>Surfside Park, Vilano Beach</b><br>(St. Johns County) | <ul style="list-style-type: none"> <li>• Zone VE<sup>(a)</sup></li> <li>• Intact and functional, February 2018</li> <li>• Wood frame, at-grade building (walls do not extend to slab)</li> <li>• See Figure 3-45</li> </ul> |

Exterior and interior photos of a restroom building at Surfside Park, St. Johns County. The wood frame outer walls do not extend to the floor slab (red arrows), and gable ends are open, allowing light and air to enter the restrooms. There is no electric service to the restrooms. The building likely sustained no flood damage during Irma.

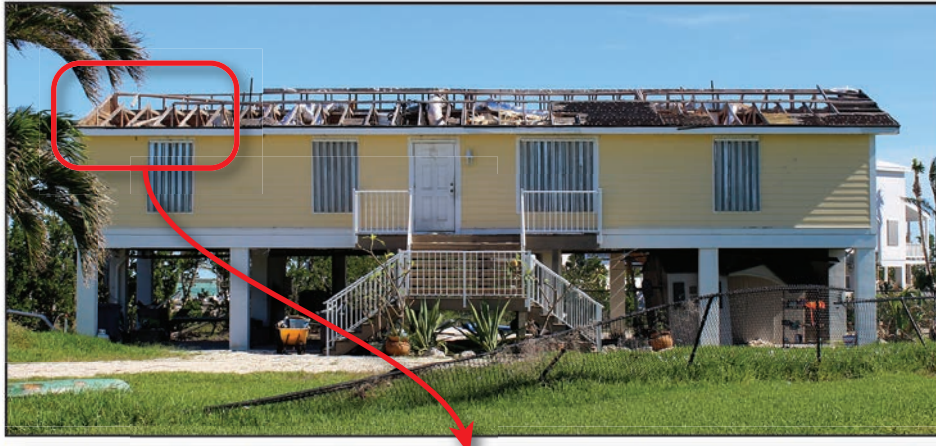
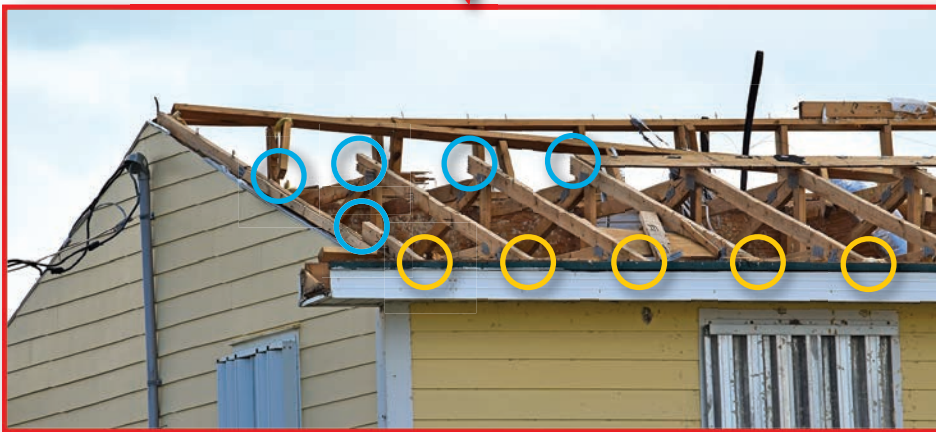
Figure 4-1:  
House with structural  
damage to roof system  
(EWS = 113 mph; EDWS =  
180 mph) (Sugarloaf Key)

Figure 4-1 shows an elevated, single-story, wood-framed house (built in 1988) that lost nearly all its roof sheathing, most likely due to withdrawal of the roof decking-to-framing fasteners. Numerous roof truss top chords located near the roof ridge were also damaged or missing, but roof framing adjacent to the front wall and the roof-to-front wall connections remained intact (see bottom photo in Figure 4-1). The roof truss bottom chords remained in place, providing lateral support that prevented wall collapse.

The close-up shows severed truss upper top chords (blue circles) and intact connection of lower top chord and top of wall (yellow circles).

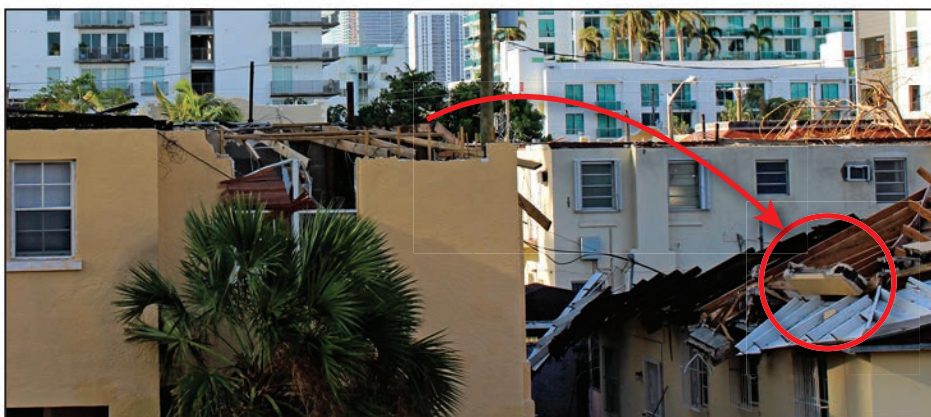
Figure 4-2:  
Residence where a roof-to-  
wall connection failed  
(EWS = 78 mph; EDWS =  
169 mph) (Miami)

Another example of roof damage on a pre-FBC dwelling (built in 1923) in Miami is shown in Figure 4-2, where large sections of roof were picked up by Irma's winds and dropped onto the neighboring house. As shown in the red circle, where connected, the conventional wood frame roof and bond beam separated from the masonry wall.

The failed connection resulted in large sections of roof being blown atop an adjacent structure. The red circle shows a portion of the bond beam attached to the displaced roof section.
