# Hurricane Irma in Florida

Building Performance Observations,  
Recommendations, and Technical Guidance

FEMA P-2023 / December 2018

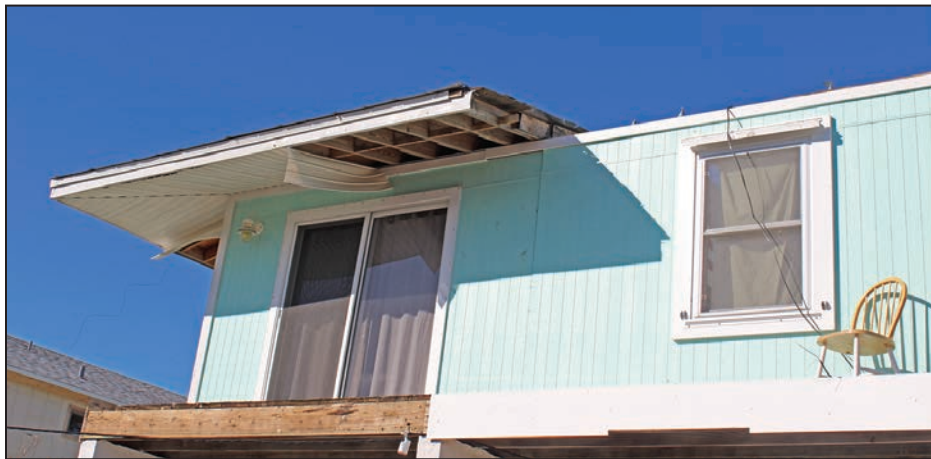
**Figure 4-3:**  
South end of east-facing wall; the south end of the roof remained in place (EWS = 113 mph; EDWS = 180 mph) (Cudjoe Key)

Figure 4-3 shows the south end of an elevated one-story, wood-framed residence (built in 1986) on Cudjoe Key where roof-to-wall connections failed to prevent large portions of the conventionally framed roof from lifting away. The rafters separated from the connectors, which are visible along the top of the wall everywhere the roof is missing. The MAT could not determine why the connection failed; the connectors may not have been adequate to resist uplift forces associated with Irma's winds on Cudjoe Key, or they may not have been installed according to the manufacturer's instructions. Pre-damage images show the north end of the house had a screened porch; all that remains of the porch is shown on Figure 4-4 and Figure 4-5, where the remaining post and header are visible along the right side of Figure 4-4 and left side of Figure 4-5. An exterior wall section adjacent to the screened porch also collapsed and is also shown in the images. One possible scenario is that the overhang portion of the screened porch began failing and created a breach in the envelope, allowing wind to enter the interior of the building and create high internal pressures.

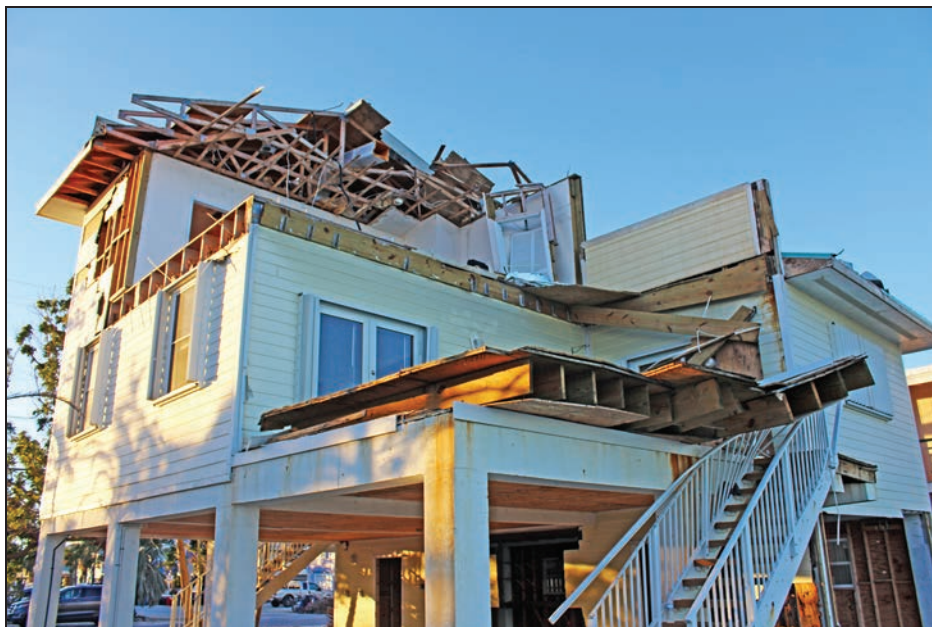
**Figure 4-6:**  
House with roof structure loss and collapse of the second floor exterior wall and adjacent deck (EWS = 113 mph; EDWS = 180 mph) (Ramrod Key)

Another example of wall failure was observed on Ramrod Key, as shown in Figure 4-6. The two-story, wood-framed residence (built in 1990) lost roof trusses above the east-facing (ocean-facing) second floor area; two exterior walls were lost from the room below the missing roof trusses, and the adjacent deck floor collapsed onto the porch floor below.

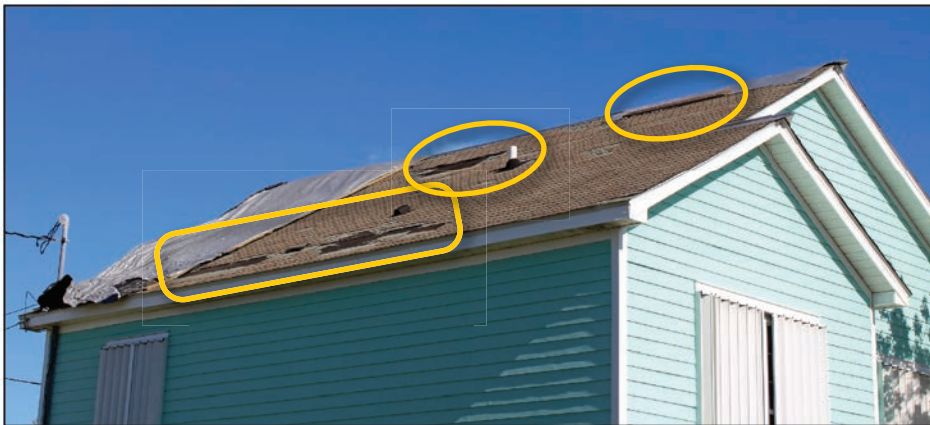
Figure 4-8:  
Asphalt shingle loss shown inside yellow ovals for house shown in Figure 4-7 (EWS = 111 mph; EDWS = 180 mph) (Big Coppitt Key)

The roof of the Big Coppitt Key house (built in 2005) shown in Figure 4-7 and Figure 4-8 was mostly hidden under a tarp, but the uncovered slope reveals shingle loss near the eaves and ridge. Figure 4-9 shows another post-FBC dwelling (built in 2007) with significant asphalt shingle loss that was observed in Marathon.

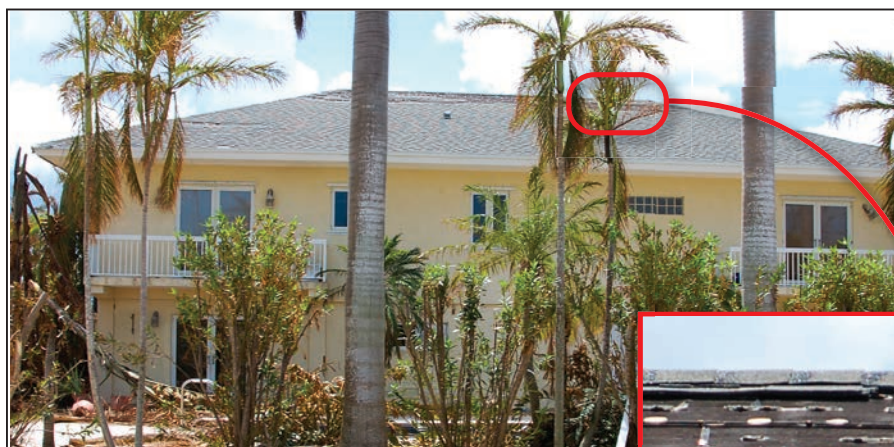
**Figure 4-10:**  
Residence that lost shingles  
near the ridge (EWS = 113 mph;  
EDWS = 180 mph)  
(Sugarloaf Key)

Asphalt shingle loss was limited on the Sugarloaf Key house (built in 1997) shown in Figure 4-10, but the pattern of loss near the ridge remains evident in the inset photo where shingle-to-roof deck nails remain in place. The Figure 4-10 inset photo indicates the shingles were likely installed incorrectly, because the shingle-to-roof deck nails were positioned too close to the top edge of the shingle. As shown in Figure 4-11, asphalt shingle nails in high-wind regions should be positioned close to the centerline of the shingle to secure the shingle underneath and decrease the moment arm of the uniform wind pressure acting on the shingle.

The red oval shows area of inset where remaining shingle-to-roof-deck nails can be seen inside yellow circles.

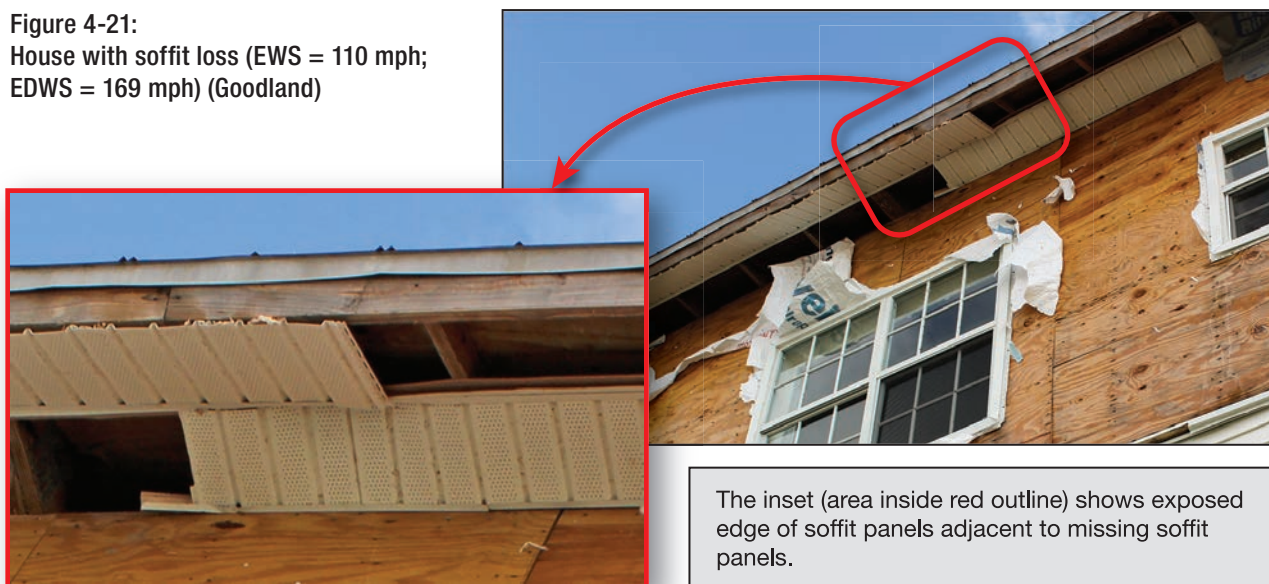
The MAT also observed post-FBC construction with vinyl soffit damage outside the Florida Keys, as demonstrated by a house in Goodland (Collier County) as shown in Figure 4-21. The dwelling (built in 2005) is part of a development described in detail in the text box “Vinyl Siding/Soffit Failure Example” in Section 4.2.3 and is another example of soffit failure associated with fascia cover loss. Although the missing fascia cover played a role by elevating wind pressures within the closed soffit system shown in Figure 4-21, the unconventional installation provided inadequate support for the soffit panels. The two parallel runs of soffit appear to be joined at the eave’s midpoint with back-to-back J-channels. With no nailing strip along the exterior wall, the inside edge of the soffit system could only be attached directly to framing at 24 inches on center.

**Figure 4-21:**  
House with soffit loss (EWS = 110 mph;  
EDWS = 169 mph) (Goodland)

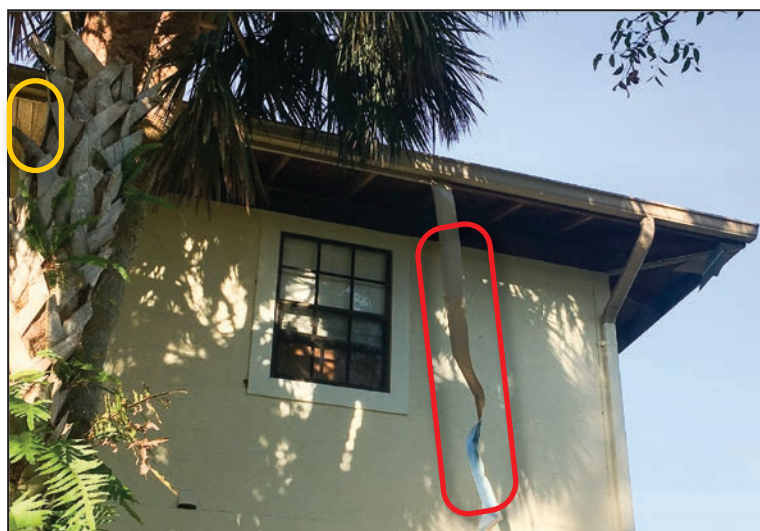
**Figure 4-24: Apartment building with metal soffit panel loss (EWS = 104 mph; EDWS = 166 mph) (Naples)**

In Naples, the MAT observed two apartment buildings with metal soffit panel loss patterns similar to the single-family Florida Keys dwellings shown above. On the left side of Figure 4-24, metal fascia covering can still be seen hanging from the eaves near the corner of the hip-roofed building (built in 1983). Soffit panels remain in place toward the center of the building, but are missing closer to the corner. The right side image of Figure 4-24 shows the adjacent side of the building where fascia covering is completely gone along with most of the metal soffit panels. On a nearby Naples apartment building (built in 1980), metal soffit panels were lost below the front porch gable end outlooker rafters. As shown in Figure 4-25, no damage is apparent along the adjacent fascia of the building.

Dangling fascia cover (red outline) is shown adjacent to missing metal soffit panels near the corner of a Naples apartment building (yellow outline indicates intact soffit panels).

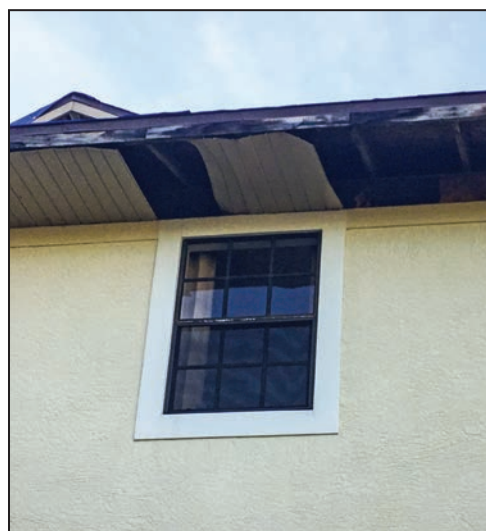
Missing metal soffit panels are shown below damaged fascia; located on the other side of the corner shown in left image.

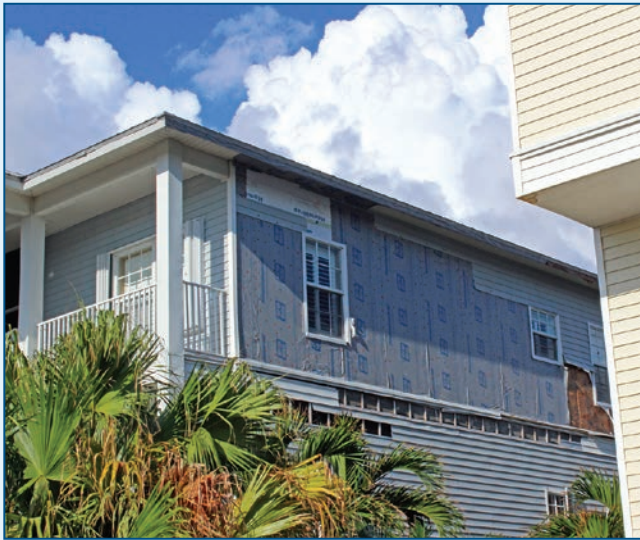
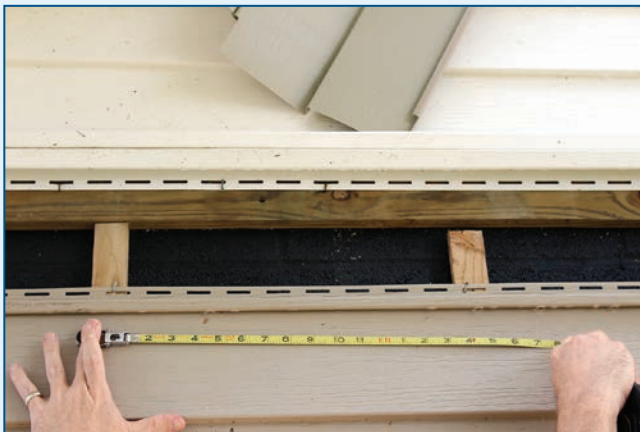
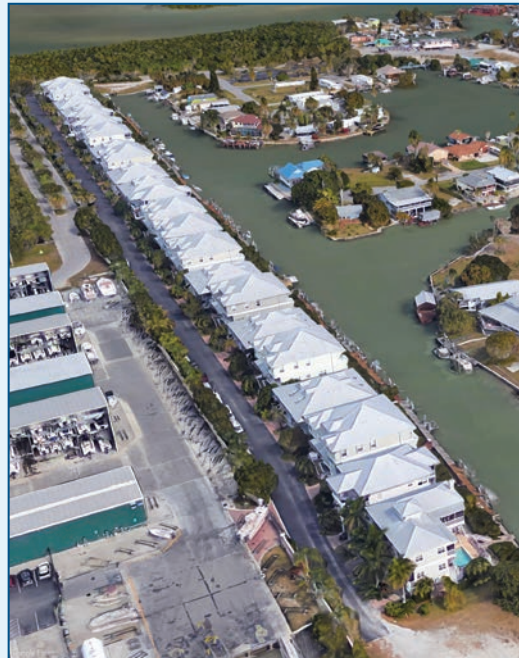
Maximum estimated 3-second gusts for Goodland during Irma were estimated to be 110 mph. The design wind speed for this site is approximately 169 mph, so vinyl siding and soffit assemblies rated for the site-specific conditions and installed per manufacturer's instructions should not have failed. According to Collier County Property Appraisal information, the houses were all built between 2005 and 2006, when the 2004 FBC was in effect statewide.

The top left photo shows typical siding damage in the area. The bottom left photo shows where siding was attached with staples to masonry wall furring strips at 16 inches on center. Additionally, there is no evidence of utility trim in the J-channel above, which would have been needed to secure the trimmed top course. Similarly, it does not appear that starter strips were used at the bottom of the first (lowest) course of siding, nor at the division between first and second floor siding sections. The photo on the right shows an aerial view of the neighborhood for perspective.

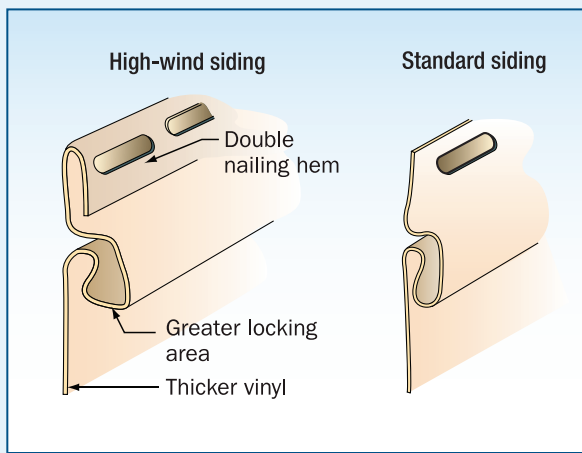
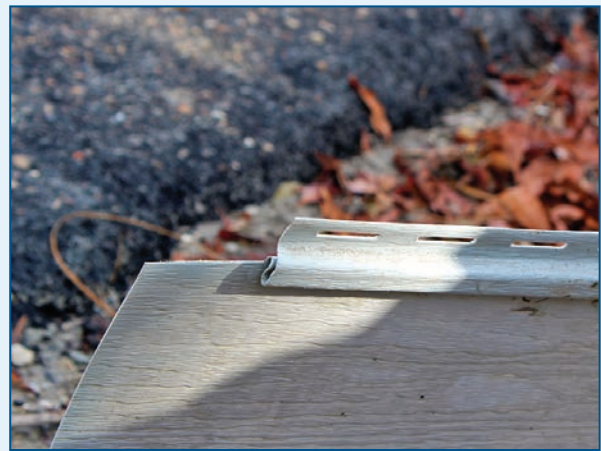
Figure 4-26:  
Vinyl siding lost along the  
back of a house (EWS =  
113 mph; EDWS = 180 mph)  
(Sugarloaf Key)

For a few other sites, such as the Sugarloaf Key house shown in Figure 4-26, the MAT was able to record product identification numbers that allowed them to compare product-specific wind ratings to the FBC requirements. The house (built in 2014) lost siding along its back; based on the product identification shown in the inset, the MAT determined that the product had a negative design wind pressure rating of  $-74$  psf (refer to Section 4.2.3.2). This vinyl siding product had a rolled-over nail hem, which is characteristic of higher-rated vinyl siding. Using the Risk Category II design wind speed of 180 mph, Exposure Category D, an effective wind area of 10 square feet for Zone 5 (corner zone), enclosed building classification, and an approximate mean roof height of 20 feet, the required design pressures (ASD) are  $+54$  psf and  $-72$  psf. Therefore, based on the required design pressure, the design pressure rating, and the estimated wind speeds at this site, the vinyl siding, if installed properly, should have resisted wind pressures sustained during Hurricane Irma. The State of Florida also requires building envelope products to be approved as described in the text box on the next page.

Much of the failed vinyl siding that the Irma MAT observed in Florida did not appear to be rated for high-wind regions. Technical Fact Sheet 5.3, “Siding Installation in High-Wind Regions,” in FEMA P-499, *Homebuilders Guide to Coastal Construction* (2010), includes guidance on vinyl siding installation. The left-side graphic below from Technical Fact Sheet 5.3 demonstrates the basic differences between vinyl siding rated for high-wind regions and standard vinyl siding. The right-side image is siding from one of the damaged houses in Goodland described in the previous text box. Note how the detached siding has a standard (single) hem and locking area depicted in left image (rather than the high-wind siding required by the FBC in this area).

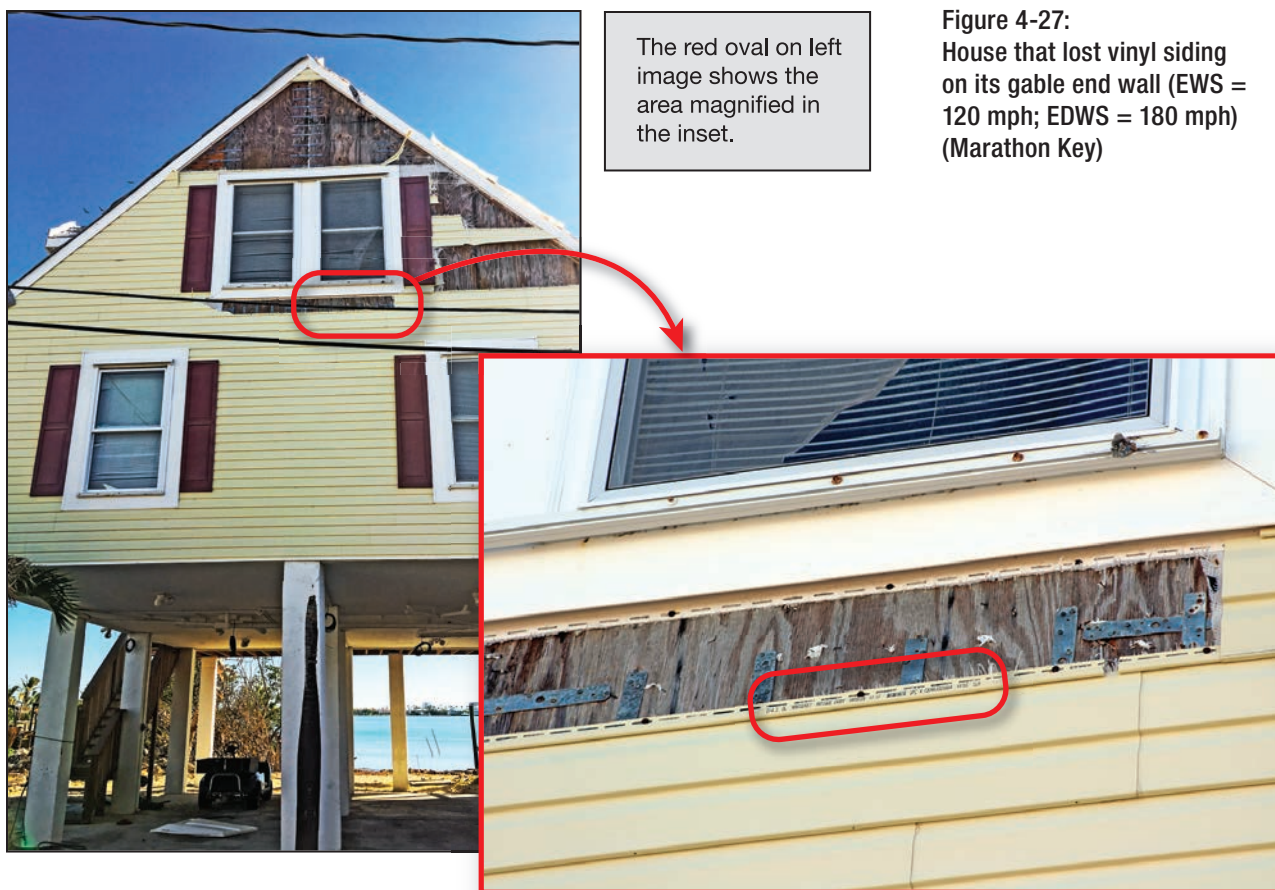
The Marathon Key house (built in 2009) shown in Figure 4-27 lost siding across a significant portion of one gable end wall; based on the product identification shown in the inset, the MAT determined that the product had a design wind pressure rating of  $-55$  psf (refer to Section 4.2.3.2). Using the Risk Category II design wind speed of 180 mph, Exposure Category D, an effective wind area of 10 square feet for Zone 5 (corner zone), enclosed building classification, and approximate mean roof height of 25 feet, the required design pressures are  $+56$  psf and  $-75$  psf. While the design pressure rating is about 27 percent less than the required design pressure, considering the estimated wind speeds at this site, the siding should have resisted wind pressures experienced during Hurricane Irma if it was properly installed. There is no evidence of utility trim under the window, which left the siding vulnerable at that location.

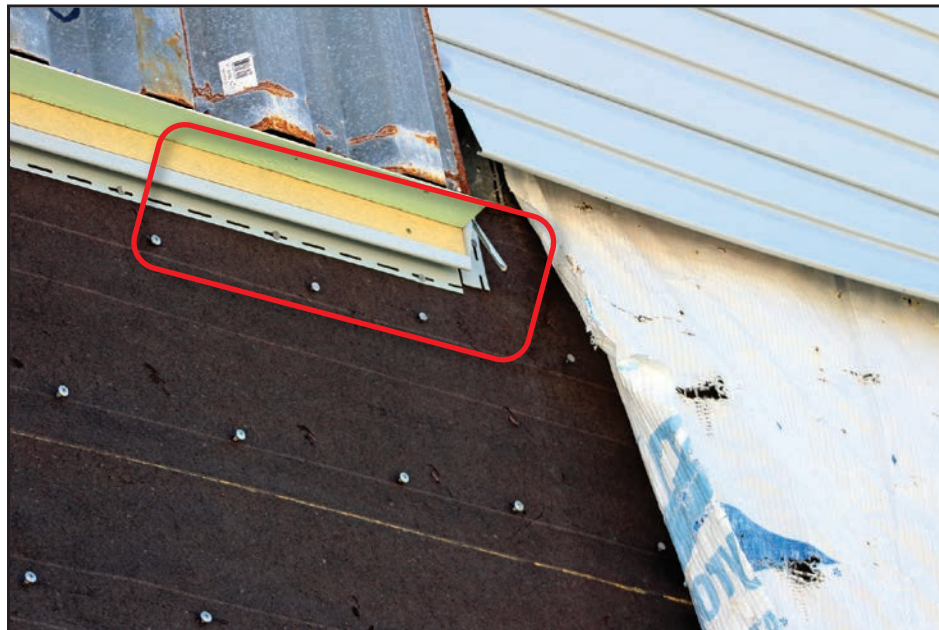
**Figure 4-29:** House appeared to lack utility trim under the windows, as shown in the red outline (EWS = 120 mph; EDWS = 180 mph) (Marathon Key)

The houses in Figure 4-29 (built in 2000), Figure 4-30 (built in 1977), and Figure 4-31 (built in 2000) show representative installation issues where vinyl siding failed. The house in Figure 4-29 was permitted to have its vinyl siding replaced in 2015, with work completed in 2016. The Little Torch Key house in Figure 4-31 was permitted to repair damage to its vinyl siding due to Hurricane Wilma in 2006, with the work completed the same year.

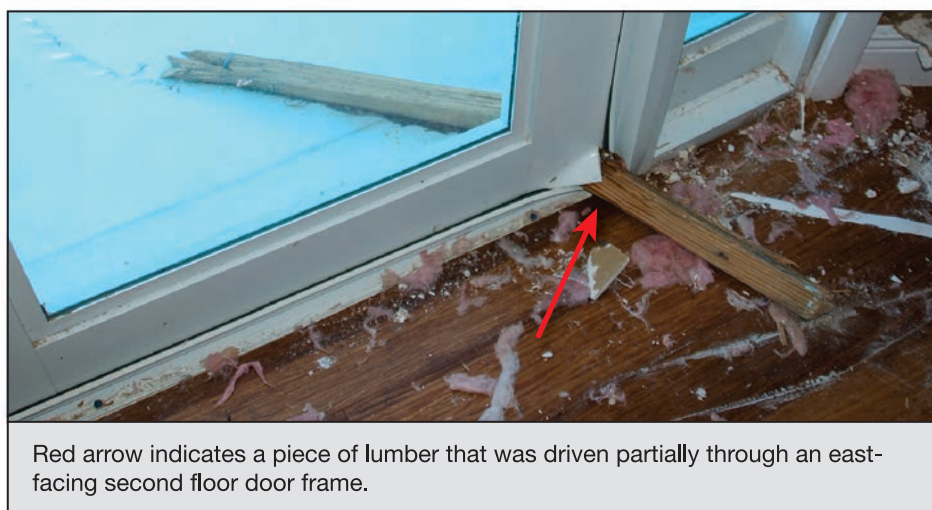
**Figure 4-34:**  
Wind-borne driven missile damaged second floor door at the same house as shown in Figure 4-33 (EWS = 114 mph; EDWS = 180 mph) (Little Torch Key)

The MAT visited the Little Torch Key house shown in Figure 4-33 and Figure 4-34 (built in 1985) to observe extensive wind-borne debris damage. The dwelling was struck repeatedly by construction materials blown from a nearby structure that was destroyed during Hurricane Irma. Figure 4-33 shows where the impact-resistant glazing did not prevent a wind-borne, 12-foot-long, 2x10 rafter from penetrating the interior of the house. This missile in particular is more massive than the D test missile (9-pound, 2x4 lumber) required by ASTM E1996. According to the homeowners, after penetrating the French door side light panel, the missile still had enough energy to reach and damage a television on the other side of the room. A second piece of wind-borne lumber penetrated the frame of an upper floor door unit on the same (east-facing) side of the house (see Figure 4-34).

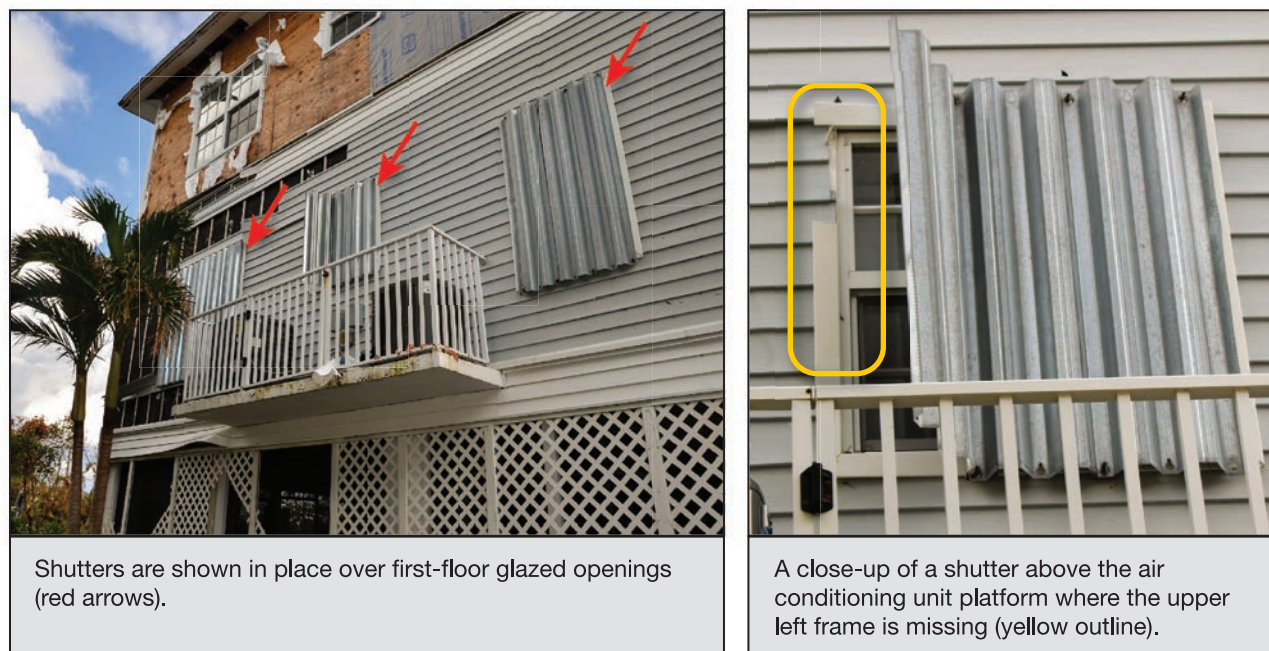
Another example of damage to impact-resistant covering systems is shown in Figure 4-36, where a portion of the system's frame supporting the left end of the corrugated metal shutter is missing (see yellow outline). Shutters were still in place on the elevated first floor of the Goodland residence (built in 2005), but the damaged frame (see right image of Figure 4-36) rendered the glazed opening beneath it vulnerable to impact, as the metal shutter peeled toward the right side support.

Figure 4-36: House with corrugated metal shutters (EWS = 110 mph; EDWS = 169 mph) (Goodland)

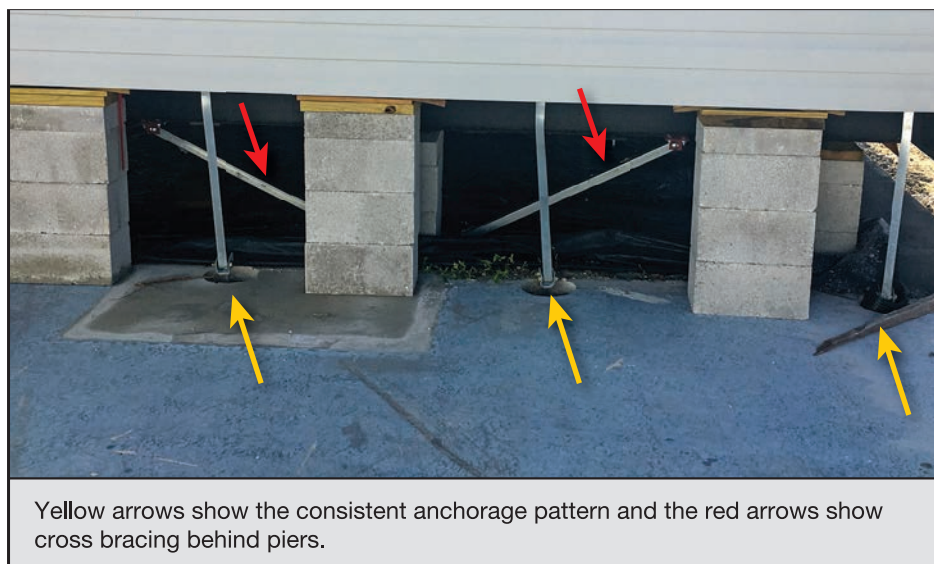
**Figure 4-40:**  
Consistent anchorage pattern observed on a new MH unit installation (EWS = 105 mph; EDWS = 164 mph) (Collier County)

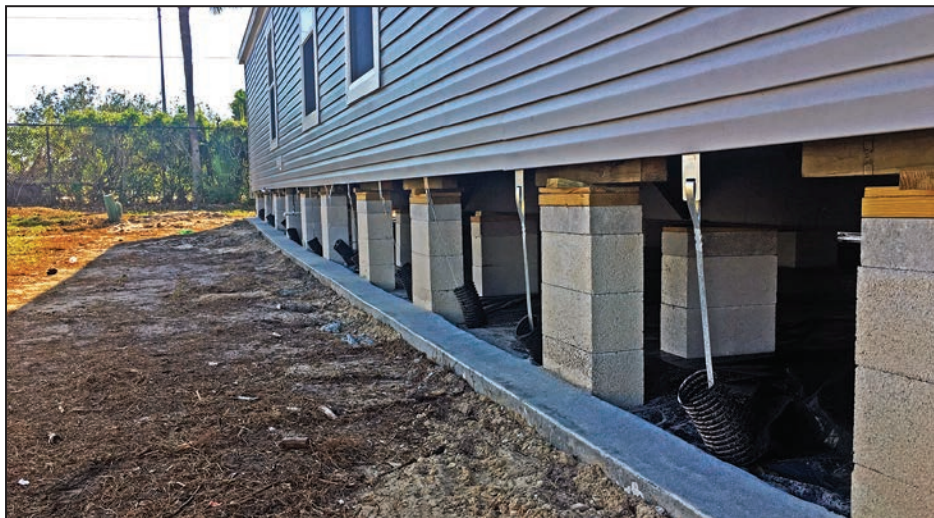
**Figure 4-41:**  
New MH unit installation with misaligned anchor strap installation (red outline) was otherwise anchored consistently with other post-Irma examples (EWS = 105 mph; EDWS = 164 mph) (Collier County)

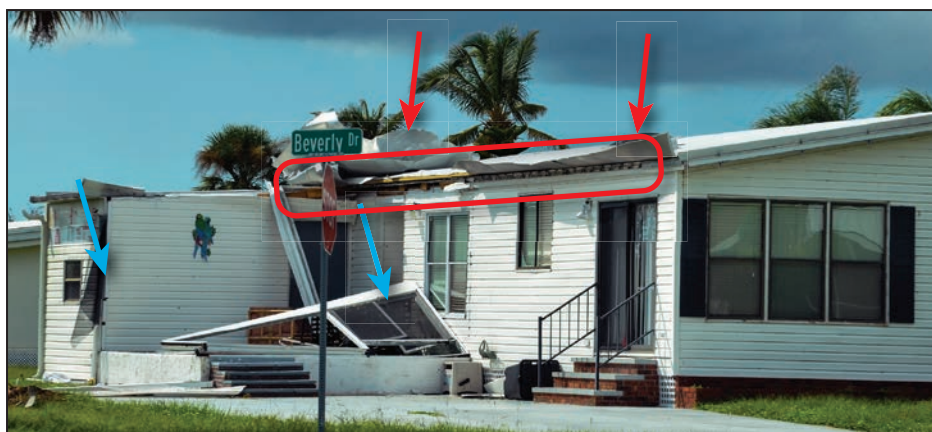
The screened porch (remnants shown with blue arrows) opened the top of an exterior wall (red outline) and peeled back the adjacent roof section (red arrows) when the porch was lost to high winds.

**Figure 4-45:**  
MH unit that was damaged when its screened porch was lost to high winds (EWS = 105 mph; EDWS = 166 mph) (Collier County)

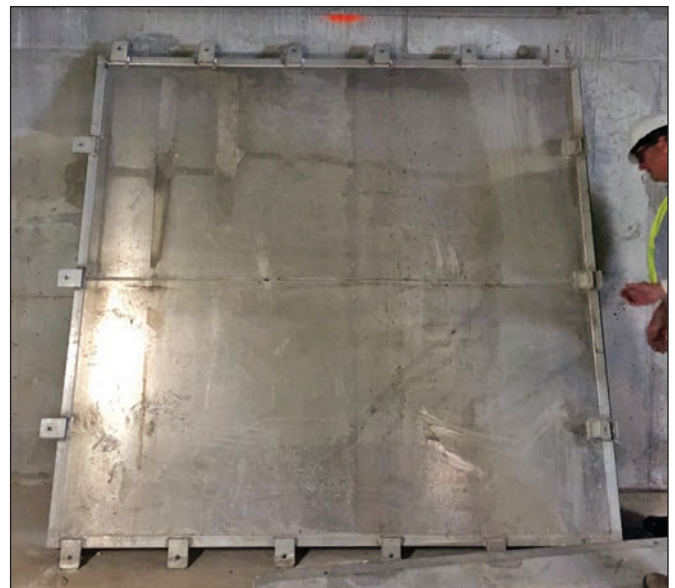
**Figure 1: Large (6 feet high x 6 feet wide) metal flood panel requiring special equipment for installation**

(Figure 1). If there are difficulties in installing large panels, consider approaches to improve the installation process. This may entail replacing the panel type with a passive floodproofing component or with a component that is easier to install.

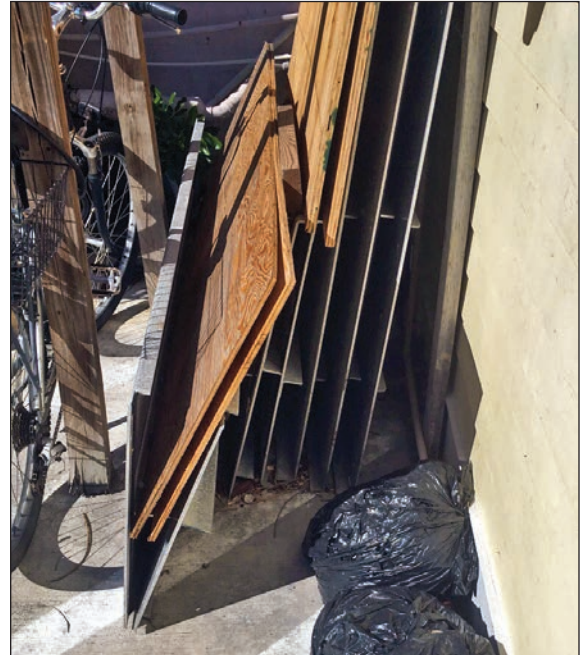
**Storage.** Determine an appropriate storage location for the dry floodproofing components, supplies, and equipment. Ensure the location is not open to the elements, as ultraviolet radiation and temperature extremes degrade rubber seals, gaskets, and component identification labels (Figure 2). Ensure this location is secure to prevent theft and vandalism, but is also accessible and labeled for the installer in case of deployment. On-site storage of floodproofing components is preferable. A separate location should be provided for spare parts.

**Figure 2: Flood panels (metal) and window shutters (plywood) were stored together outside a building. Panels and rubber gaskets were exposed to the elements; this storage practice is not recommended.**

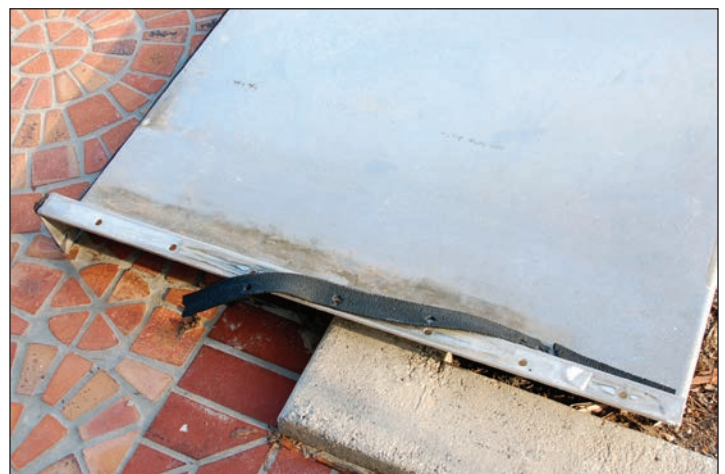
**Regular inspection.** Regularly inspect and maintain shields, doors, gates, pumps, equipment, gaskets, seals, brackets, panels, hardware, etc., and replace immediately if needed, to ensure system performance (Figure 3). Use the equipment list in the operations, maintenance, and testing plan to perform an annual accounting of all component and installation equipment.

**Figure 3: Torn gasket on metal flood panel after panel was removed. Gasket must be replaced before the next deployment.**

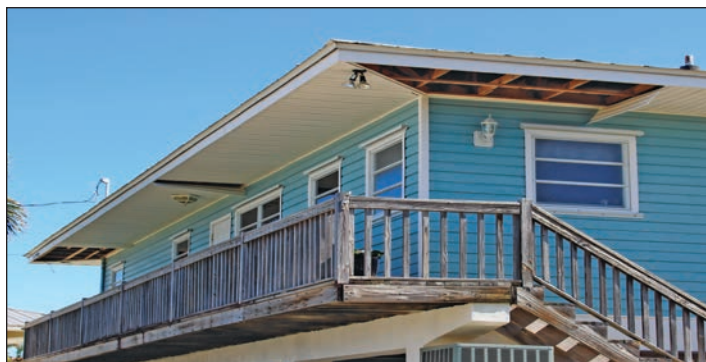
- Wind-damaged soffits allowed wind-driven rain to enter building envelopes, resulting in costly damage to building interiors.
- While some water was blown into attics through soffit vents, the amount of water intrusion increased dramatically when the soffit material was missing (Figure 1).
- Need for clarification of how to meet the 6th Edition (2017) FBCR soffit installation criteria.

Figure 1: Vinyl soffit damage on a home in Sugarloaf Key
