REDUCING THE FIRE HAZARD

IN ALUMINUM-WIRED HOMES

Jesse Aronstein, PH.D., P.E.

Latest update: July 6, 2007

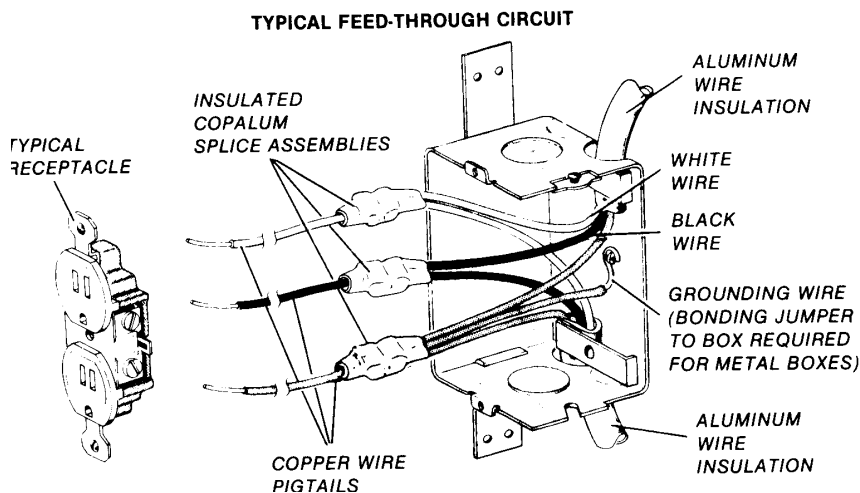
**FIGURE 3 - Illustration of copper wire pigtailed spliced to aluminum circuit wires using AMP* (Tyco) COPALUM connectors
(Source: U.S. Consumer Product Safety Commission)**

The AMP* "COPALUM" connector is applied using a special set of dies in a power-driven tool. After application of the connector, a heat-shrink insulator is applied. Solid copper wire "pigtailed" spliced to the aluminum wire this way may be connected to receptacles, switches, circuit breakers, lamps, appliances, and all other terminations in the normal manner. (Note: all aluminum branch circuit wire terminations in the home must be treated this way for a complete and permanent repair, as the overheating problem involves all types of aluminum-wired connections.)

Repair by pigtailing, using COPALUM connectors installed by a qualified electrician, is the only method considered by the U.S. consumer Product Safety Commission ("CPSC") to be a permanent repair. Their recommendation is based on extensive testing. The method is described in more detail, and sources for more information are provided in an article in Consumer Reports, January 1981.[7] While the application of COPALUM connectors is considered to be satisfactory without special preparation of the aluminum conductor, it is suggested that antioxidant compound and abrasion as per Section 1A (above) be used to provide an additional safety factor.

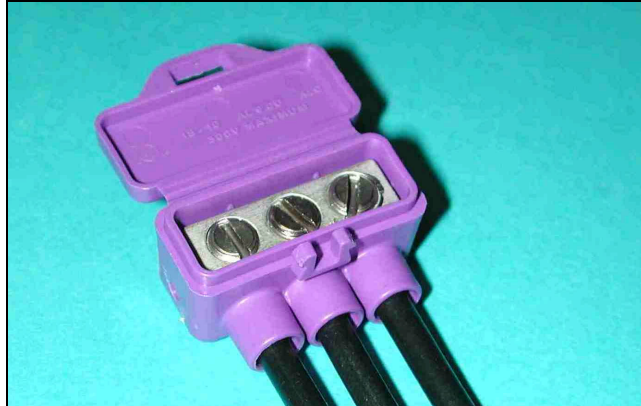
FIGURE 4 - King Innovation "AlumiConn" Connector

On the basis of the test results, the AlumiConn connector is predicted to have a high probability of failure-free long-term safe performance, PROVIDED THAT THE SETSCREWS ARE CAREFULLY TIGHTENED ACCORDING TO THE INSTRUCTIONS PROVIDED WITH THE PRODUCT (see notes below). If not adequately tightened by one of the two prescribed methods, there is a possibility that the connections will degrade due to wire stresses and/or motion when the completed connection is manipulated into the outlet (or junction) box.
