Investigation of Potential Benefits of
Revising Exception 1 under
FLORIDA BUILDING CODE,
ENERGY CONSERVATION,
Section 101.4.7.1.1
Duct Sealing upon Equipment Replacement

FSEC-CR-1979-14
June 2014

Authors
Janet McIlvaine
David Beal

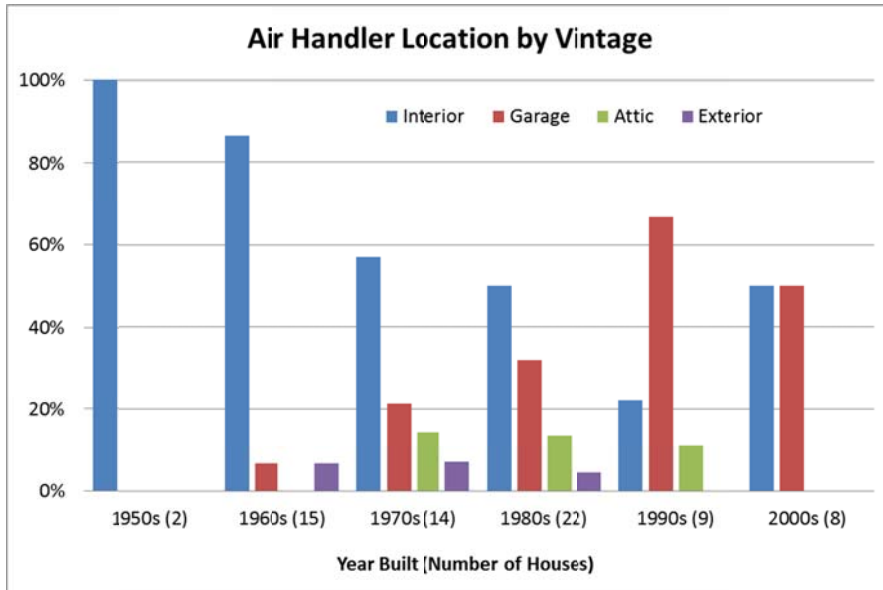
Figure 1. Pre-retrofit air handler location in field study of 70 central Florida renovations (McIlvaine et al. 2013). 40 homes had AHUs in the conditioned space, with greater prevalence in homes built before the 1990s.

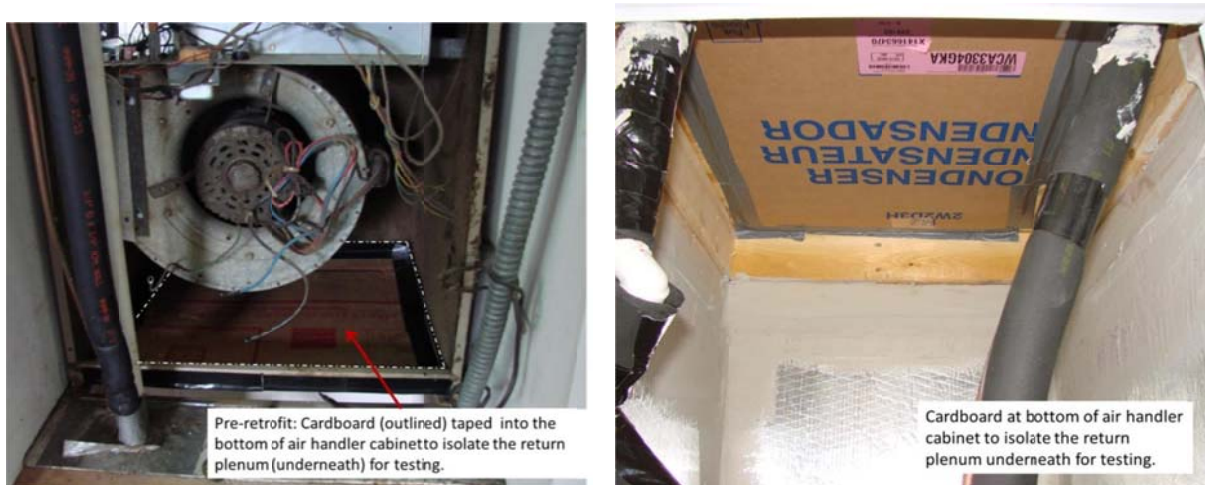
Figure 3 Pre-retrofit (left) and Post-retrofit (right) testing configuration to isolate the return plenum underneath the air handler support platform.

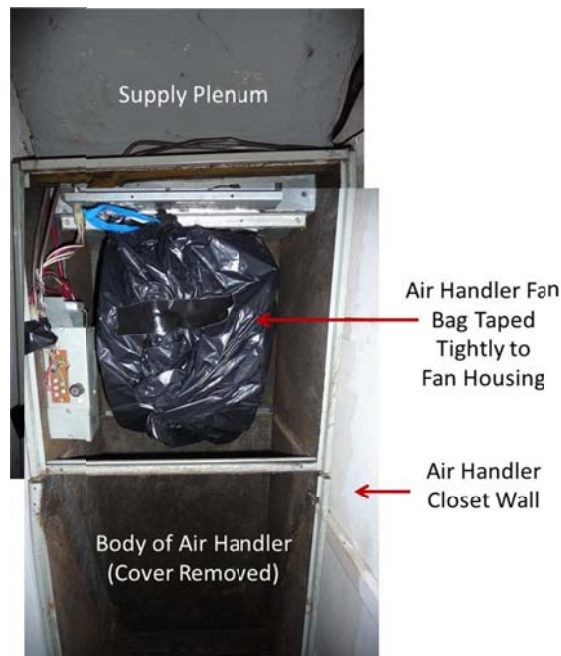
As found the air handler was gutted, coil removed for scrap and no front cover. However, since the entire air handler closet is the return plenum and the fan motor was still in-place, testing proceeded by bagging the fan with a garbage bag (Figure 8) and installing the duct blaster fan to the return grill behind the refrigerator. By closing the closet door the system was configured in typical operating condition; the lack of a front cover and coils in the air handler deemed not to interfere with the results as the air handler would be fully open to the closet when operating (at the return air intake on the air handler).

Figure 8. Return portion of air distribution system isolated from the supply by sealing around the air handler fan with a plastic bag taped at all edges.

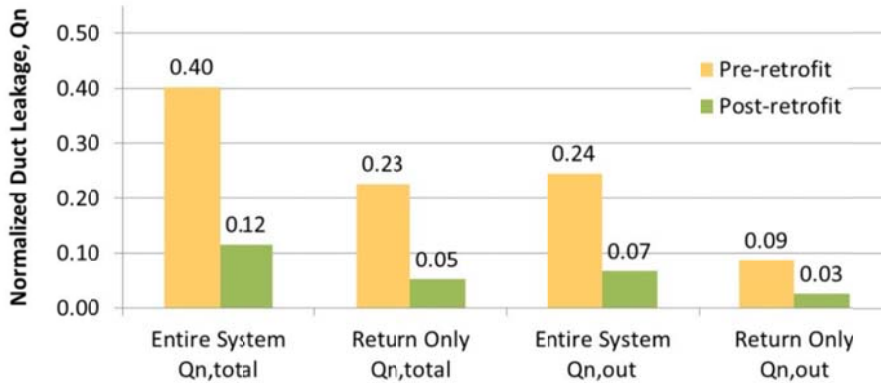
Qn,total		Qn,out	
	Entire System	Return Only	Entire System	Return Only
Pre-retrofit	0.40	0.23	0.24	0.09
Post-retrofit	0.12	0.05	0.07	0.03
Improvement	71%	77%	72%	71%

Figure 10 Pre- and post-retrofit normalized duct leakage test results for House 1962

In this house the contractor also addressed the obvious failures in the supply duct work, sealing the open supply in the kitchen, re-installing the supply boots found disturbed in the attic portion of the house, and sealing all supply boots with mastic on their inside surfaces. The improvement from these repairs is apparent in the leakage reduction for the entire system shown in Table 2 and Figure 10.

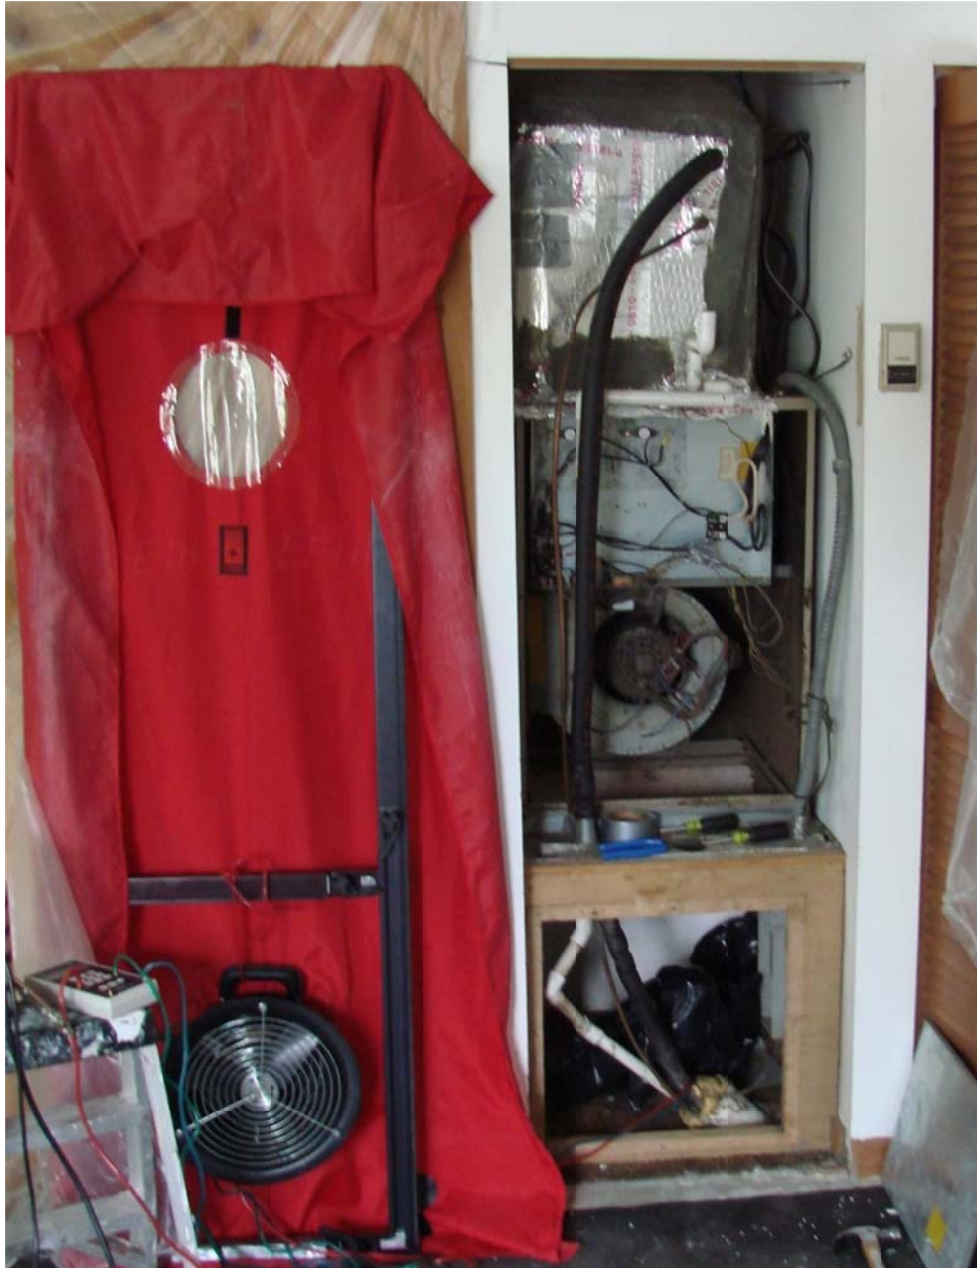
This 1364 ft², 3-bed/2-bath slab-on-grade frame house with attached garage was built in 1986 (Figure 11). Approximately 40% of the floor area is under a cathedral ceiling with an 11' height at the peak. The air handler was located on an open platform in a closet behind a louvered door (Figure 12). This installation provided very little access to the sides of the air handler. All supply duct work was in the attic.

Figure 12. Air handler mounted on an open frame platform

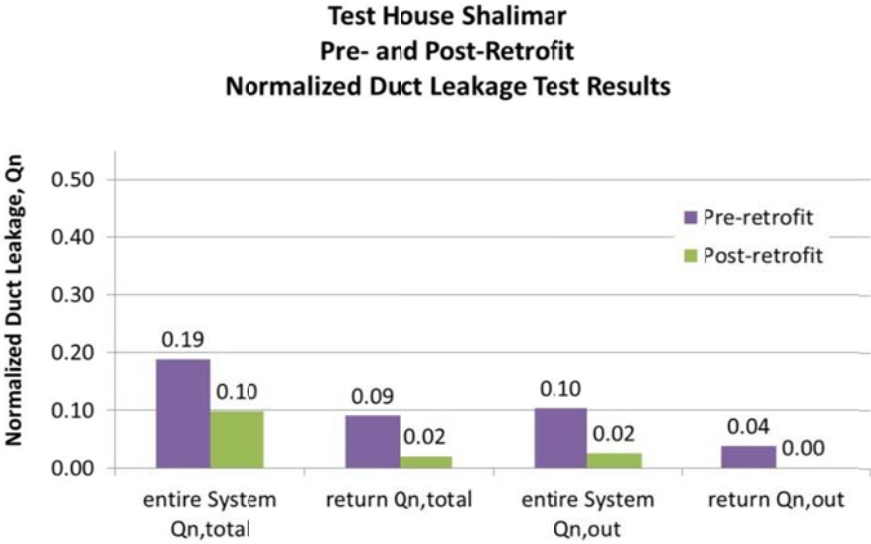
Qn, Total		Qn, out	
	Entire System	Return Only	Entire System	Return Only
Pre-retrofit	0.19	0.09	0.10	0.04
Post-retrofit	0.10	0.02	0.02	0.00
Improvement	48%	78%	76%	100%

Figure 16 Pre- and post-retrofit normalized duct leakage test results for House 194

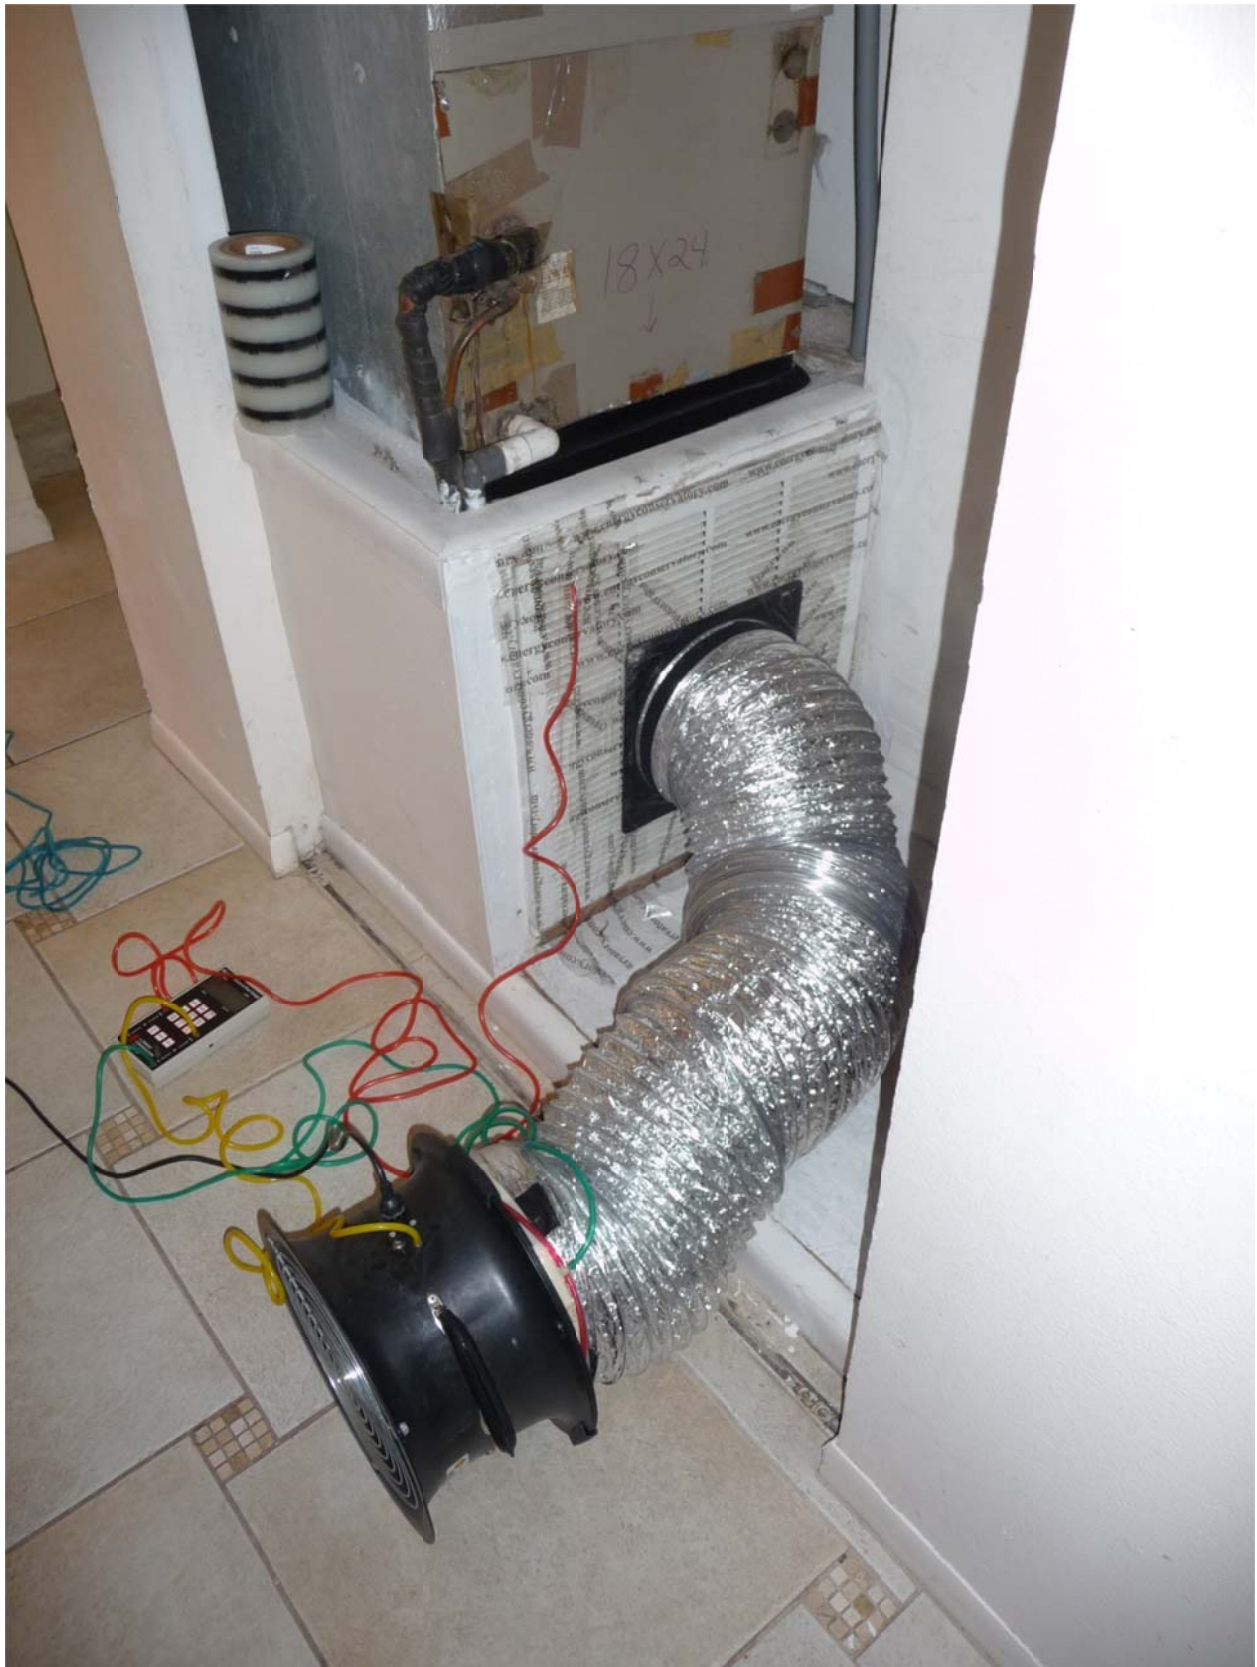
House 261 had a true return plenum with a filter-back grill installed. The duct blaster was installed to this grill (Figure 20). Isolating the return was accomplished by removing the up-flow air handler fan and sealing the resulting hole with cardboard (Figure 21). Further isolation was accomplished by taping the air handler seams closed.

Figure 20 Pre-retrofit duct testing in progress

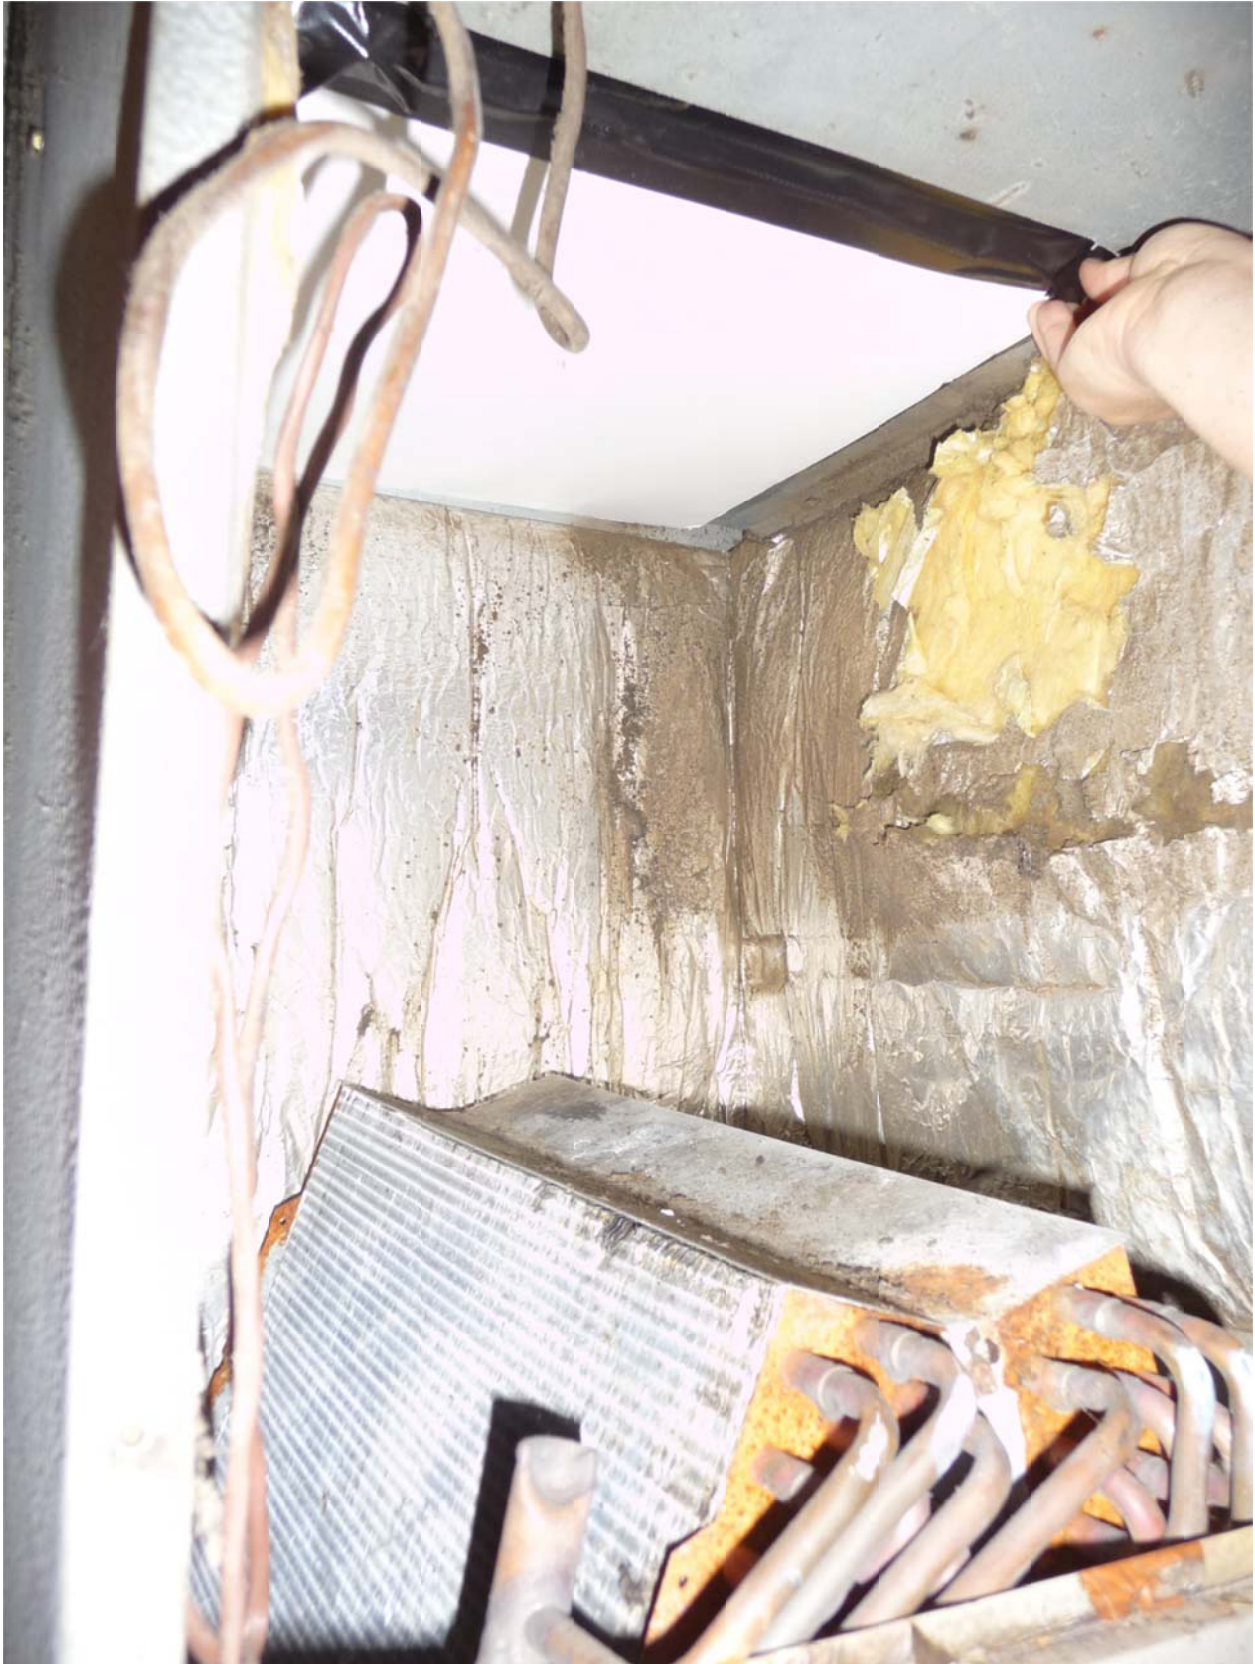
Figure 21 Blocking the supply side of the air distribution system for testing.

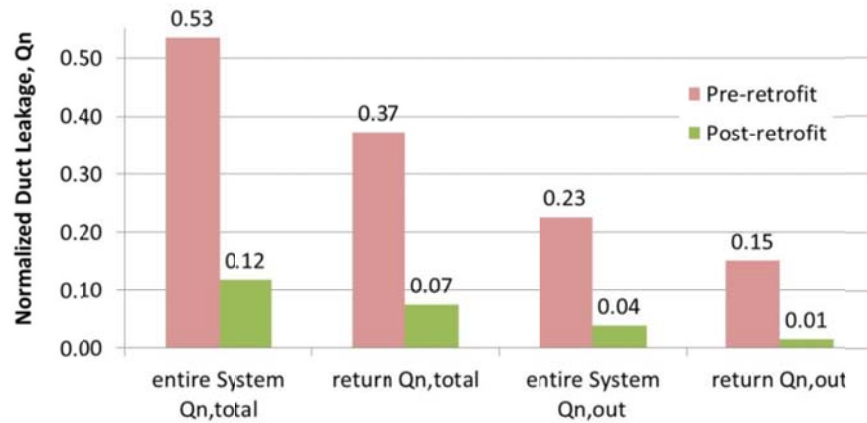
Qn, Total		Qn, out	
	Entire System	Return Only	Entire System	Return Only
Pre-retrofit	0.53	0.37	0.23	0.15
Post-retrofit	0.12	0.07	0.04	0.01
Improvement	78%	80%	83%	90%

Figure 24. Pre- and post-retrofit normalized duct leakage results for House 261

The success of the retrofit's sealing efforts is illustrated by the result tabulated below (Table 4) and shown in Figure 24.

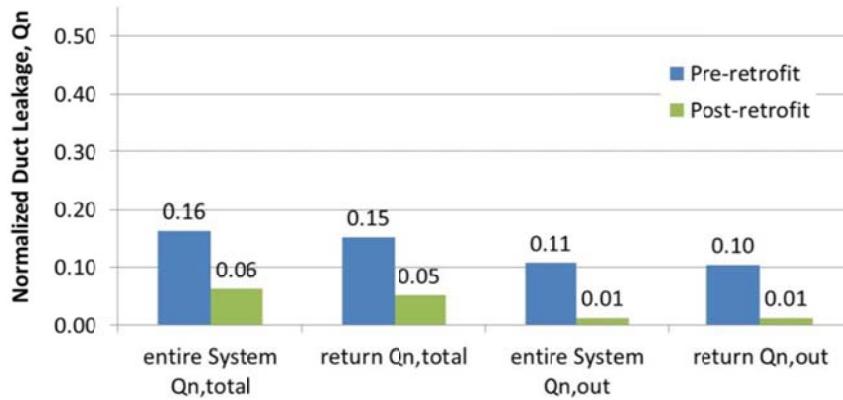
The efforts to seal both the supply and return systems resulted in an extremely tight duct system. The system was so tight that it was difficult to resolve any difference between the entire system readings and the return only test results, as seen below in Table 5 and Figure 29.

Qn, Total		Qn, out	
	Entire System	Return Only	Entire System	Return Only
Pre-retrofit	0.16	0.15	0.11	0.10
Post-retrofit	0.06	0.05	0.01	0.01
Improvement	62%	66%	89%	88%

Figure 29. Pre- and post-retrofit normalized duct leakage test results for House 223

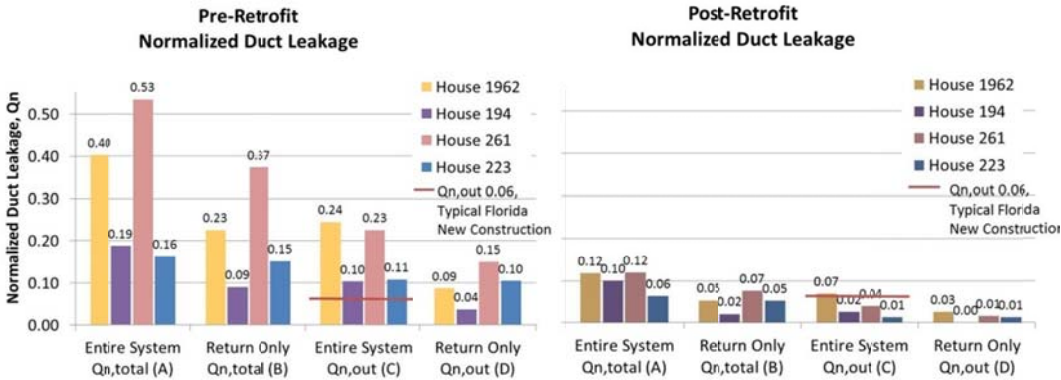
Figure 30. Pre-retrofit (left) and post-retrofit (right) duct testing results.

Pre- and Post-retrofit CFM25,out (duct leakage to the outside) for the entire system (Figure 30, left and right, C) ranges from 0.10 to 0.24 and 0.01 to 0.07 respectively. These are within the range anticipated based on previous field studies (Tables 7 and 8).

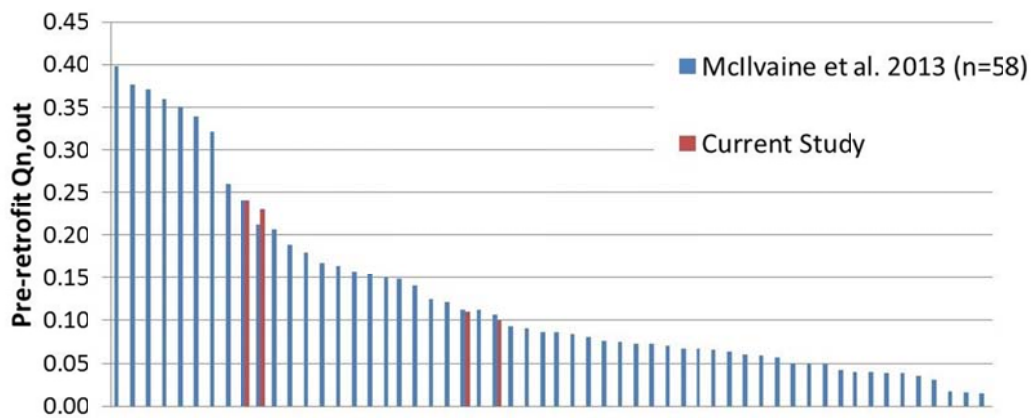
Figure 31. Pre-retrofit Qn,out (red) in relation to those found a previous field study of existing homes in central Florida (blue).

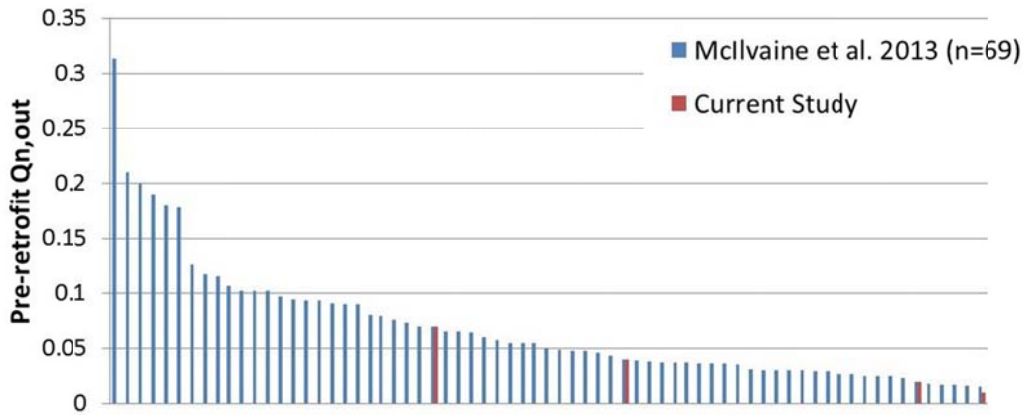
Reduction in the Entire System ranged from 48% to 78% for Qn,total and 72% to 89% for Qn,out. These results are outstanding and reflect commendable work of the HVAC contractors involved. Houses 223, 261, and 194 achieved post-retrofit Qn,out results satisfy the duct air tightness criteria for high performance housing set by the ENERGY STAR for New Homes program (ENERGY STAR 2012). It is also a positive reflection on the affordable housing entities that wrote the scopes of work for these four houses. Although these housing partners were FSEC partners on previous projects, researchers did not provide any guidance or input on the design or execution of these system change-outs. The pre-retrofit Qn,out in this small sample ranged from 0.10 to 0.24; the maximum being more than double the minimum. Although the sample is small, it's safe to say that these pre-retrofit test results are not uncommon in the existing Florida housing stock. For Qn,out, they all fall well within the pre-retrofit range evidenced in an earlier, larger field study (Figure 31). At post-retrofit, the results fell in the bottom half of the earlier study's range with Houses 223 and 194 in line with the lowest leakages measured (Figure 32).

Figure 32. Post-retrofit $Q_{n,out}$ (red) in relation to those found a previous field study of existing homes in central Florida (blue).
