Final Report for Project Entitled:

**Full Scale Wind Load Testing of Aluminum Screen Enclosures
PO Number A95F33**

Florida Building Commission
State of Florida Department of Business and Professional Regulation

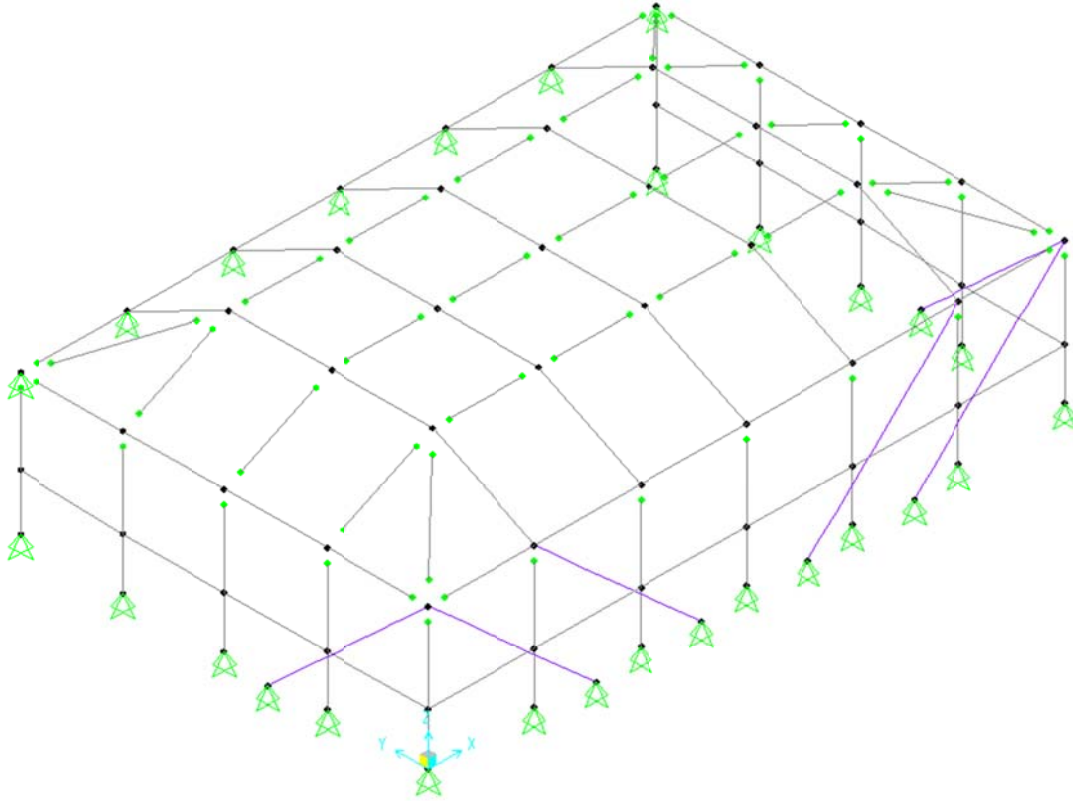
In order to assist the experimental set up, finite element analysis was conducted for both specimens using SAP2000 (CSI 2009). Figure 1 shows the developed finite element model. All boundaries have fixed translations and freed rotations. Moment end-releases are shown with green dots in the figure. In reality these connections would have some moment resistance, but they were modeled as hinges due to the unavailability of their moment resistance.

Figure 1. Finite element model of the Generic screen enclosure specimen (AAF specimen does not have side cables, but it has additional roof bracings)

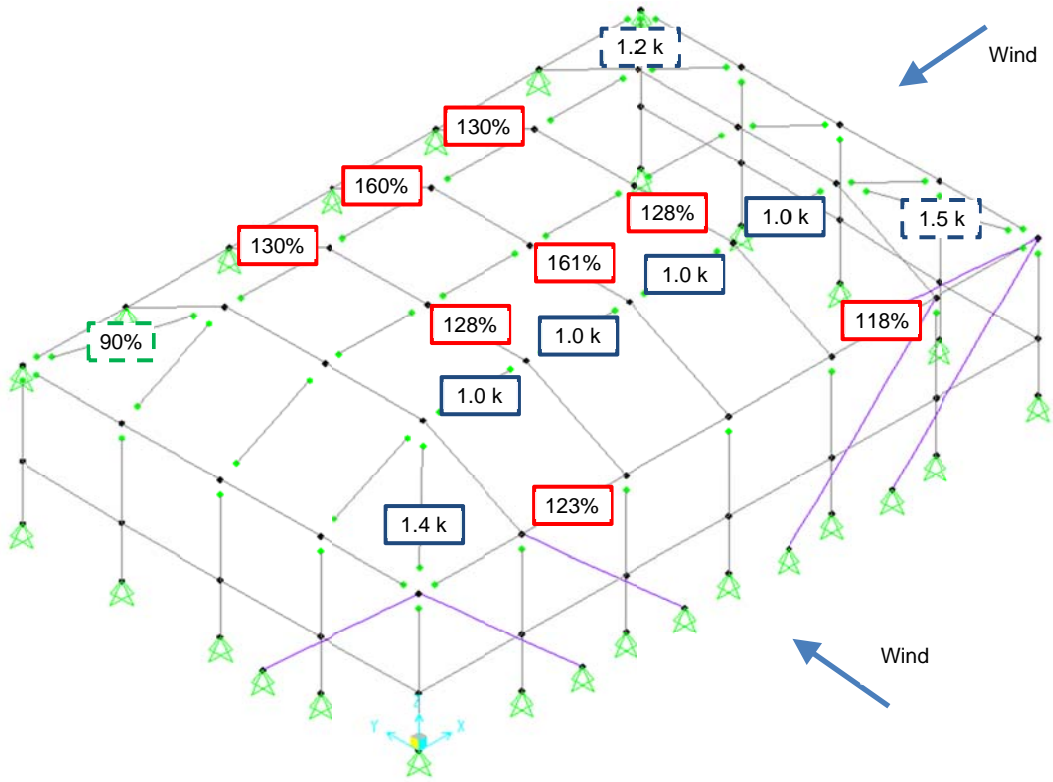
In the figure, dotted lines represent the first load case whereas the solid lines represent the second load case. Red box means high actual to allowable stress ratio: moment (% is shown), green box means high actual to allowable stress ratio: column (% is shown), and blue box means high tension (kips is shown).

Figure 2. Members with high actual to allowable stress ratios and high tensile forces: Generic specimen

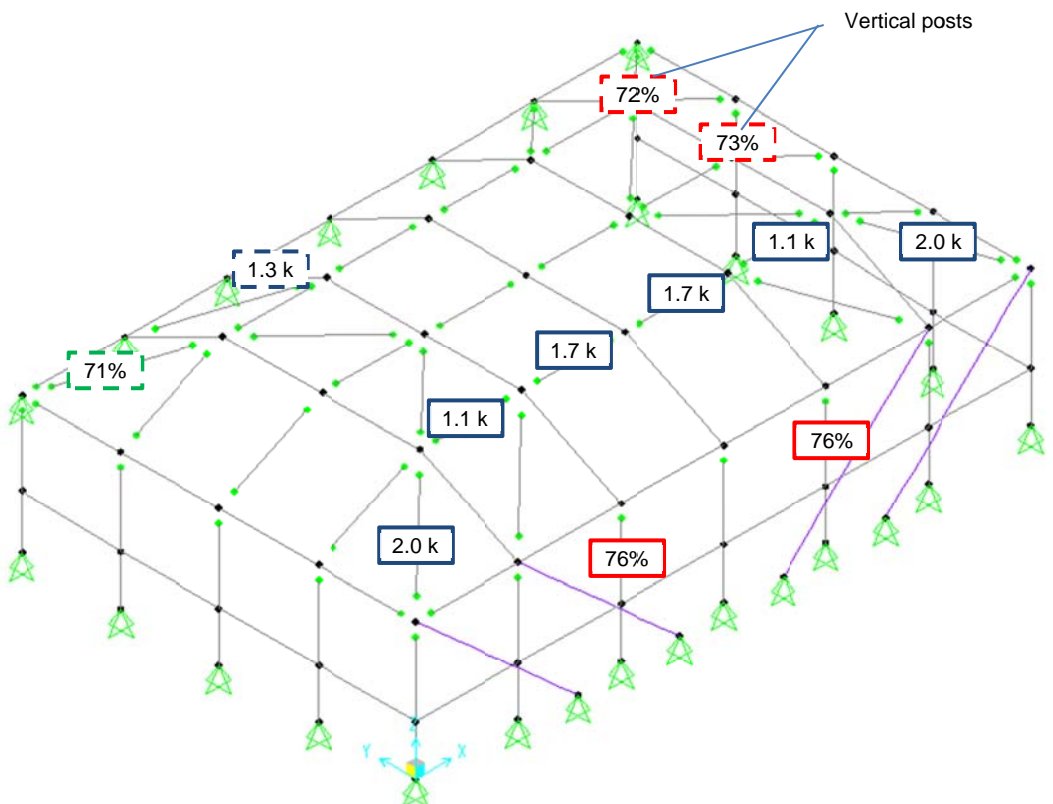
Figure 3. Members with high actual to allowable stress ratios and high tensile forces: AAF specimen

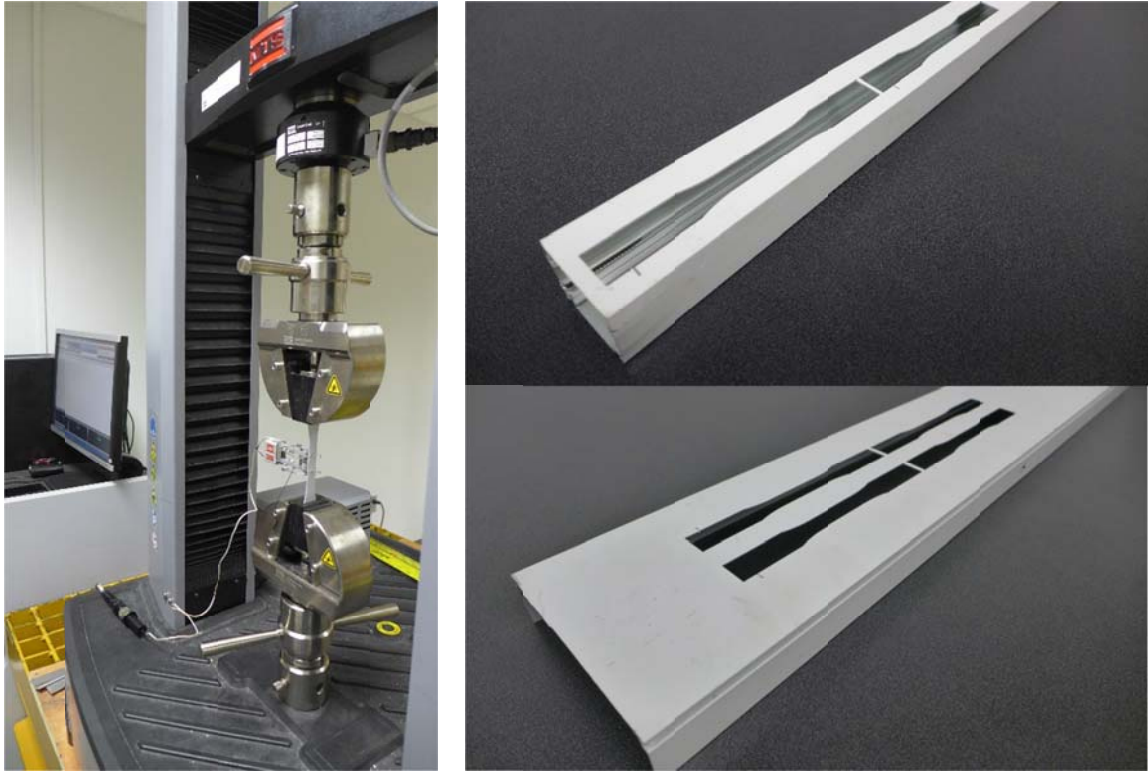
Material properties were obtained after testing the 12 coupons. The average elastic modulus was 9,300 ksi, which was used in the analysis instead of the published value. The yield stress and the ultimate stress were also lower than the published values. The mean and the standard deviation of the yield stress were 32.3 ksi and 1.2 ksi, resulting in a statistically calculated minimum of 27.8 ksi (vs. 35 ksi specified minimum). The mean and the standard deviation of the ultimate stress were 37.5 ksi and 0.9 ksi, resulting in a statistically calculated minimum of 34.0 ksi (vs. 38 ksi specified minimum).

Figure 29. Material testing machine (left) and 2X2 and 2X6 SMB after harvesting testing coupons (right)

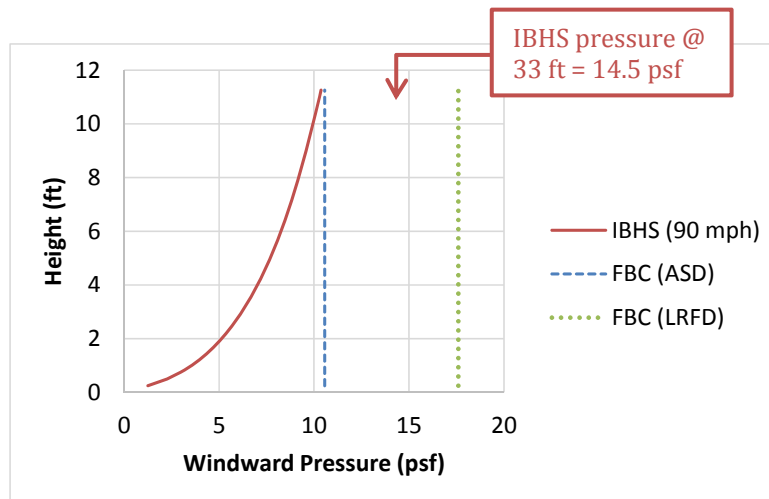
Figure 33 compares the design loading and the actual loading for the windward wall. At the reference height of 33 ft, actual loading is greater than the ASD loading but smaller than the LRFD loading. However, below 11 ft where the screen enclosure is located, the design loading is always greater than the actual loading. The trend is similar to the leeward wall, but the design loading is lower than the windward case. To compare the total loading approximately, base shear and base moment were also computed assuming freestanding walls. Figure 34 summarizes the comparison.

Figure 33. Comparison of the design loading and the actual loading

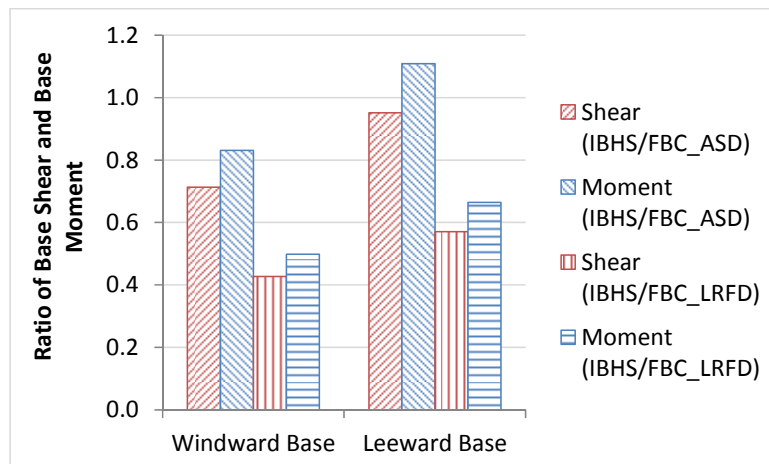
Figure 34. Ratio of the actual to design base shear and base moment

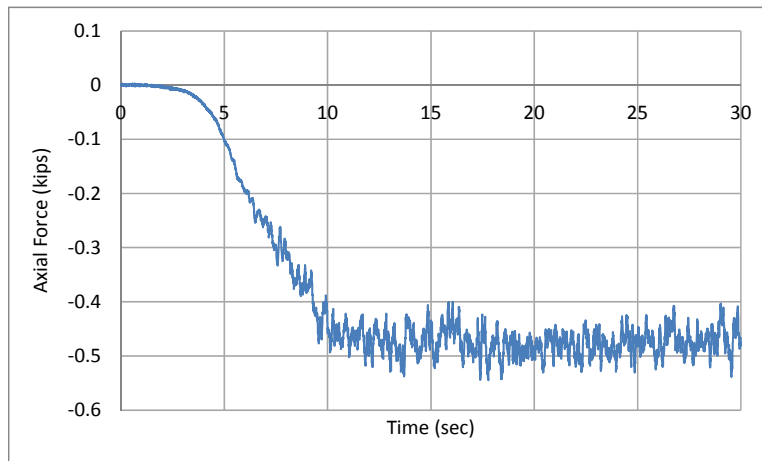
Unlike the pull tests presented earlier, data from wind tests fluctuate due to the fluctuations of the wind. Figure 35 shows sample time-series from Run 28, for the sensor A-6 of the Generic specimen. The original time series was 300 seconds but only the first 30 seconds is shown here. The change in force was measured with respect to the initial condition, after the gravity and the cable tensions were applied. This particular member was subjected to the compression when the wind loading was applied. The force fluctuated because of the fluctuations of the wind. In order to compare this type of data with the static finite element analysis, the mean and the maximum of the time-series were used. In the example shown in Figure 35, the mean = -0.466 kips and the maximum (compressive force) = -0.579 kips.

Figure 35. Sample time-series from the experiment: Generic specimen, Run 28, sensor A-6

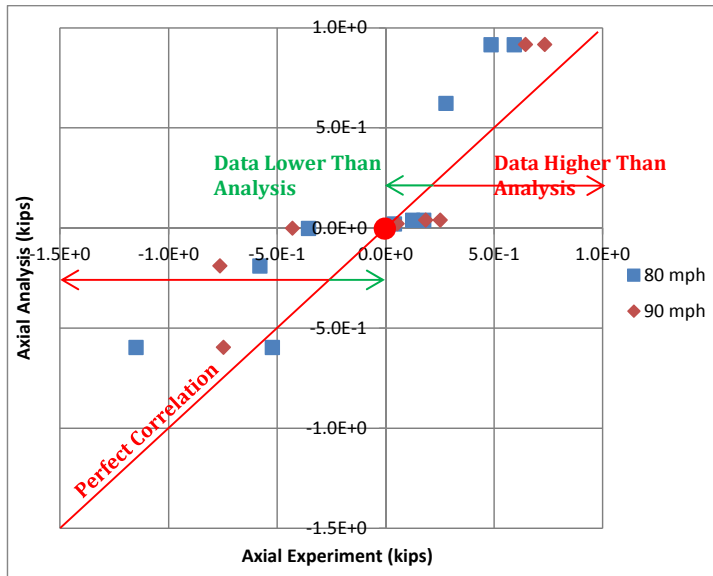
Experimental data from the Generic specimen is first compared to the analysis result. Maximum measurement from each sensor was compared to the corresponding analysis result as shown in Figure 36. Similar figures for other wind angles and moments can be found in the Appendix (section 11.3). For the square markers, experimental data from 80 mph test were used. For the diamond markers, experimental data from 90 mph test were used. For both markers, analysis results using FBC ASD loading were used. All sensor data were used for 80 mph case, but sensors 7, 13, 15, and 17 failed during the 90 mph test. In this figure, we can see that tensile forces from the experiment are smaller than those from the analysis, except for tensile forces of small magnitude. Therefore, if the structure can sustain the high tensile forces shown earlier in Figure 2, no additional members raise any concern. On the other hand, compressive forces from the experiment are larger than those from the analysis for some members. What this implies is that the current design loading with conventional finite element analysis may not catch potential failure of these members. These sensor locations are marked for further investigation.

Figure 36. Comparison of the data from the experiment and results from the analysis: Generic specimen, 0 degree wind angle, axial forces

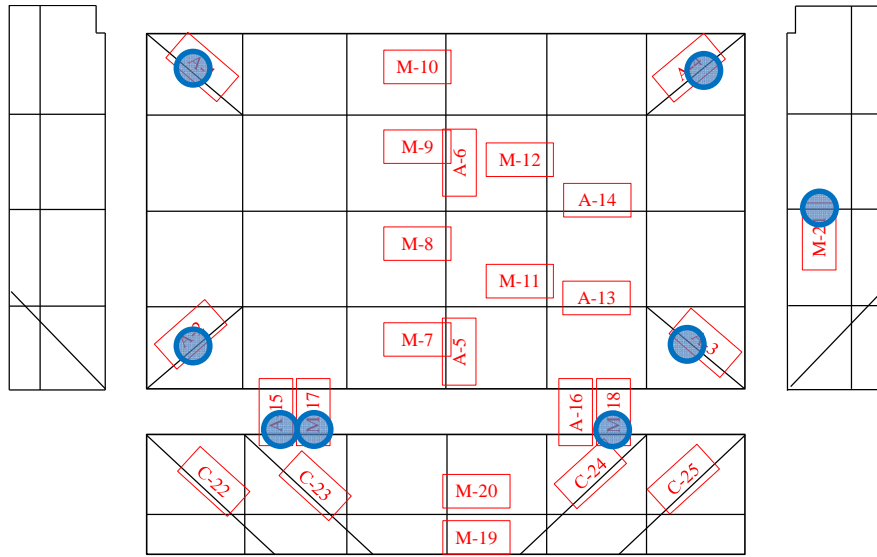
Figure 37 graphically shows the marked sensor locations. Corner bracings, the center post on the windward wall (for 90 degrees wind angle), and members next to the cables showed high experimental measurement. These locations experience higher localized forces than what's predicted by the finite element analysis. For these members, actual to allowable stress ratios were computed for members in compression or bending, using both the maximum measurement and average measurement. For the members in tension, tensile forces were obtained. The results are summarized in Figure 38. All sensors used the data from 90 mph tests except the sensors failed at that speed, for which the data from 80 mph tests were used. The only member that exceeded the allowable stress is the corner bracing with the sensor A-1. The member did not buckle probably because the actual connections at the ends provide shorter length for buckling, compared to the length used for the allowable stress calculation.

When we compare high moment locations (M-17, M-18) with the location that lost the screen attachment (see Figure 24), we can hypothesize that high moment contributed to the failure of the screen attachment. We can also hypothesize that overall higher moments in the Generic specimen led to greater loss of screen attachments compared to the AAF specimen. With the available data, it is not possible to prove or disprove these points, but these can be further investigated in the future study.

Figure 37. Sensor locations that showed notable forces and moments: Generic specimen

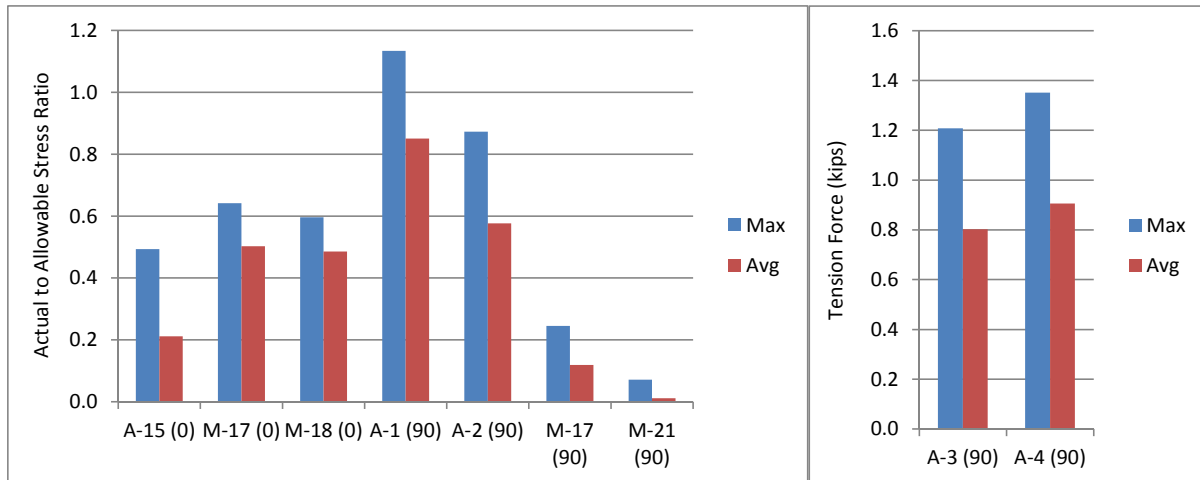
Figure 38. Actual to allowable stress ratio (left) and tension (right) of selected members: Generic specimen

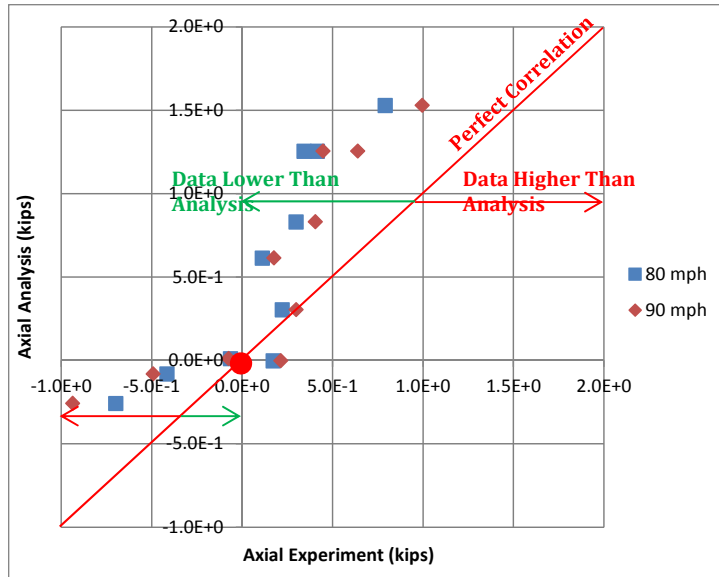
Similar data analysis was conducted for the AAF specimen as shown in Figure 39. Additional figures can be found in the Appendix (section 11.3). All sensors were used except the sensors 3, 12, and 19 due to the poor quality of data. Sensors with notable forces and moments were marked, which are summarized graphically in Figure 40. Similar to the Generic specimen, the posts on the windward wall (for 90 degrees wind angle) and the roof corners showed high forces and moments. The center roof beam also showed high forces and moments.

Figure 39. Comparison of the data from the experiment and results from the analysis: AAF specimen, 0 degree wind angle, axial forces

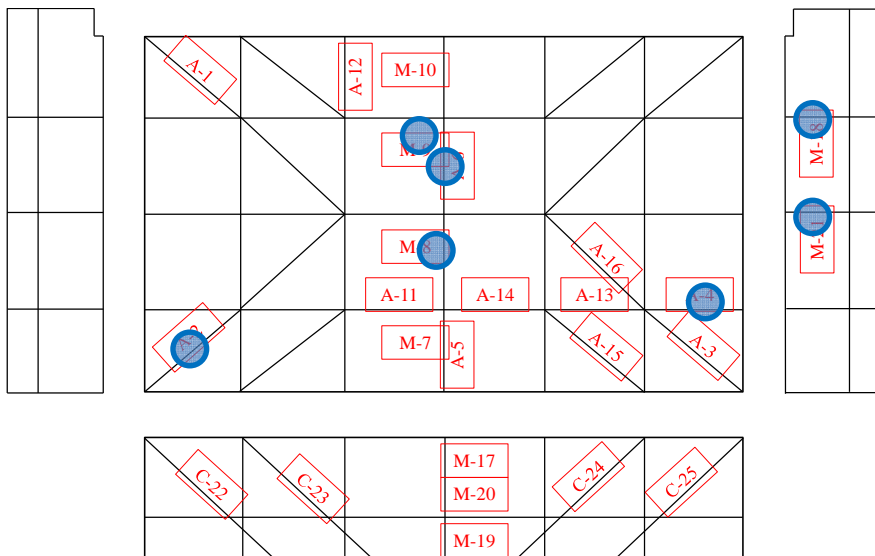
Figure 40. Sensor locations that showed notable forces and moments: AAF specimen

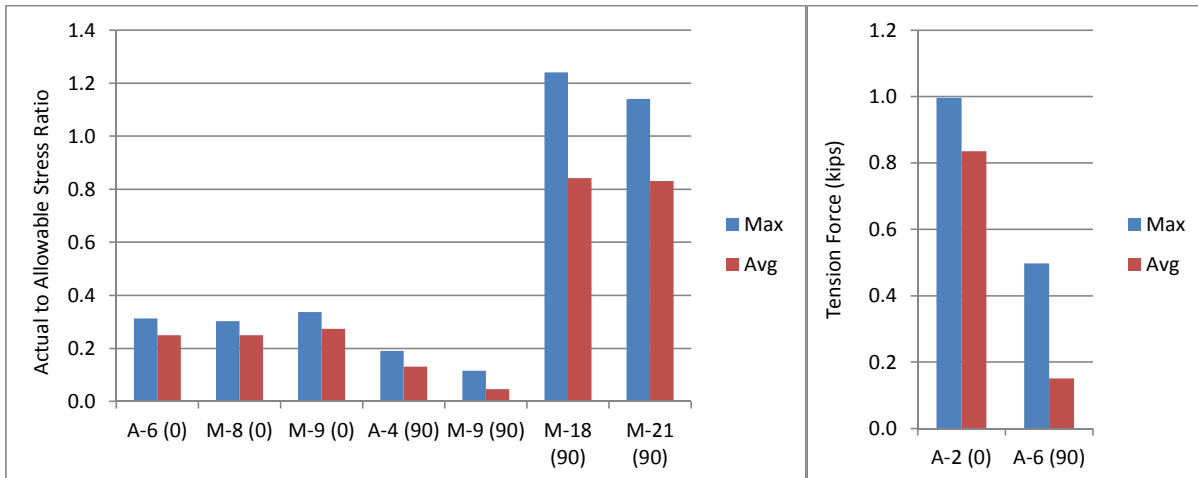
Figure 41 shows further analysis of these notable locations. All sensors used the data from 90 mph tests. M-18 shows the moment of the vertical post that failed during the 100 mph test. Even at 90 mph, the maximum actual to allowable stress ratio exceeded 1.0. Other sensors also showed large values, but not to the extent to fail the members.

Figure 41. Actual to allowable stress ratio (left) and tension (right) of selected members: AAF specimen
