Final Report:

Evaluation of Wind Resistance of Vinyl Siding and Soffit Systems, and Performance during the 2017 Hurricane Irma

Project #: P0103255

Report No. 01-19 6 June 2019

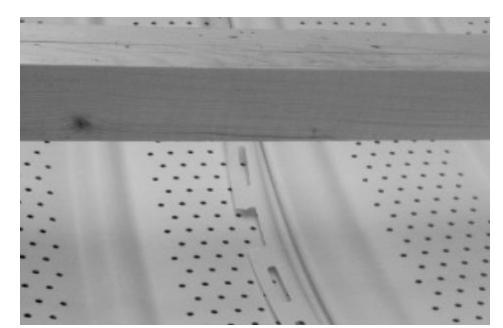
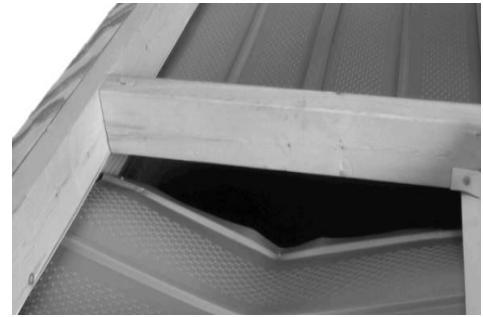
Figure 3. Failure Modes (Masters and Kiesling 2011)

- Dominant failure mode
- Nail pullover of the J-channel can cause the panels to disengage
- The sequence of nail pullover and panel unlocking could not easily be distinguished visually

Non-dominant failure mode

Permanent Set

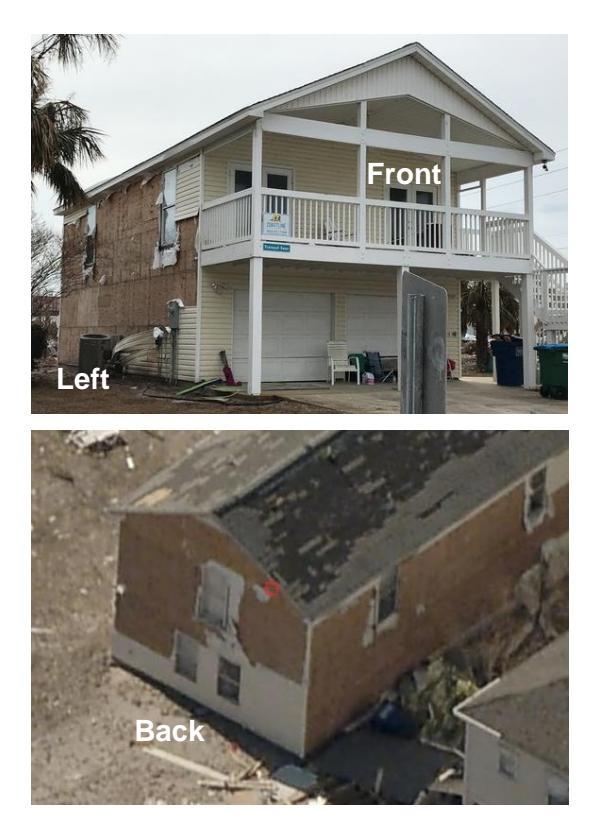
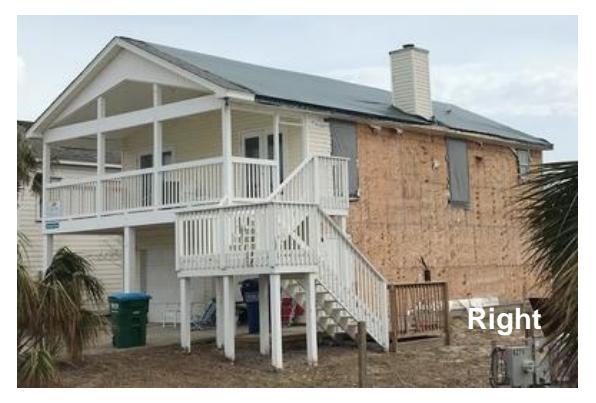
Wall Surface Damage Ratios:

Front (1st story): 0% Front (2nd story): 0% Left (1st story): 80% Left (2nd story): 90% Back (1st story): 20% Back (2nd story): 95% Right (1st story): 90%

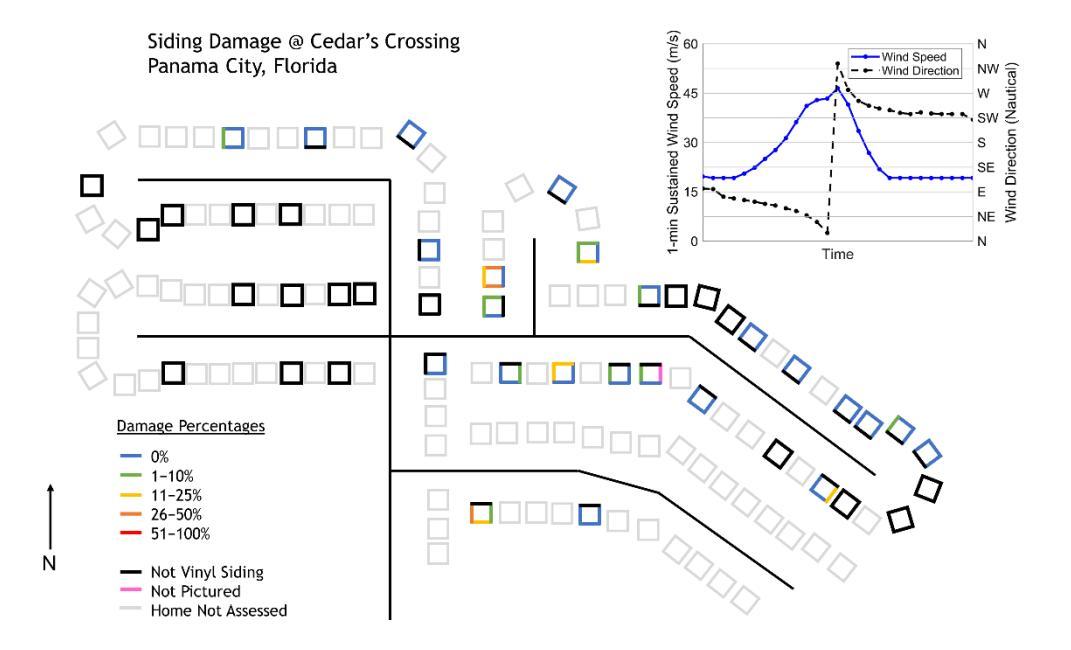
Figure 16. Summary of damage to vinyl siding in the Cedar's Crossing neighborhood. The estimated wind speed and direction time history at this location is provided in the inset. The peak 1-minute sustained wind speed at this location was approximately 45 m/s out of the NE to NW.

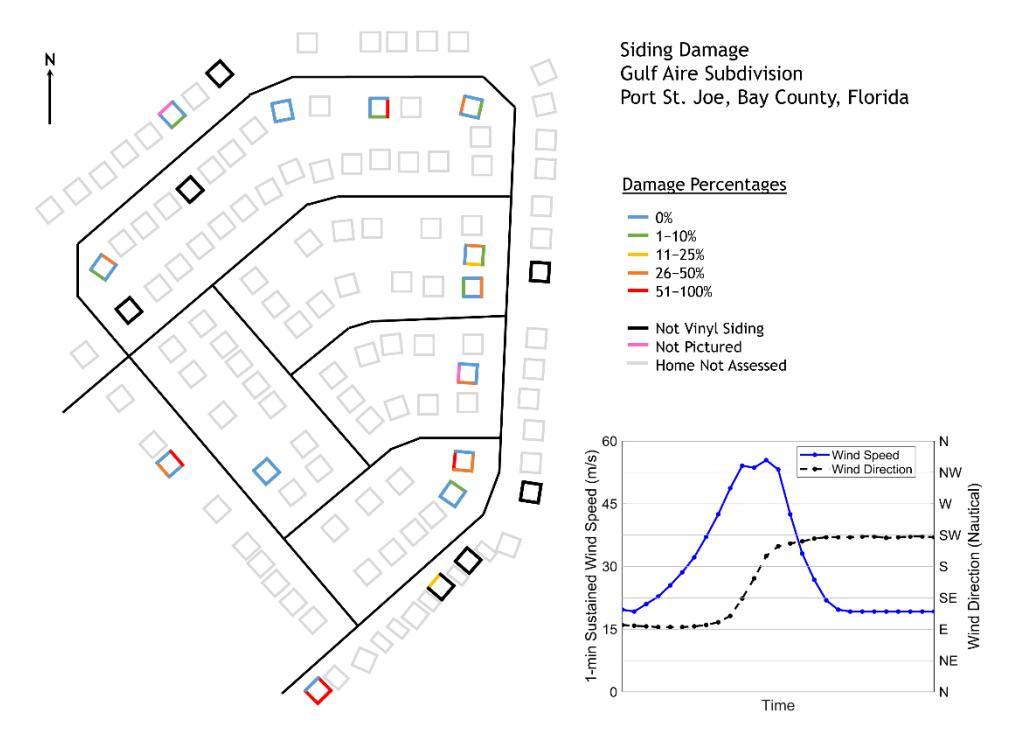
Figure 17. Vinyl siding damage classified in Gulf Aire neighborhood. The estimated wind speed and direction time history for the neighborhood is shown in the inset. The estimated peak 1-minute sustained wind speed was 56 m/s, coming out of the SE to SW.

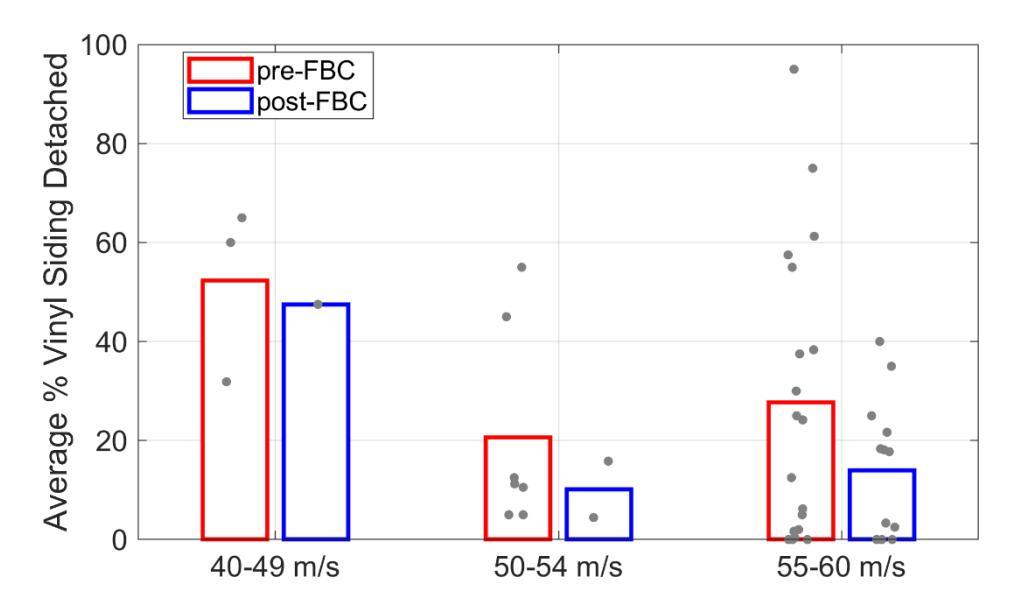
Overall performance of vinyl siding performance was mixed in both Hurricanes Irma and Michael. Figure 18 and Figure 19 provide the percentage of vinyl siding on each home that was damaged, stratified by wind speed. The extent of damage to post-FBC homes observed in Hurricane Irma is concerning given the below design level wind speeds. Failure rates were higher in the Florida Keys for post-FBC homes than in the Gulf Aire neighborhood for pre-FBC homes following Hurricane Michael, despite the design wind speed being exceeded there. The contrast in damage suggests there are other underlying factors beyond the vinyl siding material itself that may be contributing to enhanced probabilities of failures, one potentially being the elevation of homes above the flood plain in the Florida Keys. For example, based on discussions with local building officials in Monroe County, it is unclear whether modular homes (which comprised a significant proportion of the homes in our Irma vinyl siding dataset) take into account the enhanced wind loads that occur on elevated homes as compared to those installed at ground level. Modular homes may be being designed for the correct design wind speed, but not taking into account wind loads which may be as much as 12% higher (per ASCE 7-10 velocity exposure factor) when elevated above the flood plain. Further exploration is needed in this area.

Figure 18. Sample performance of pre- and post-FBC vinyl siding in Hurricane Irma stratified by estimated 1-minute sustained wind speeds. Boxes designate the average % vinyl siding detached over all homes within each bin and code classification. Each grey dot represents an individual home.

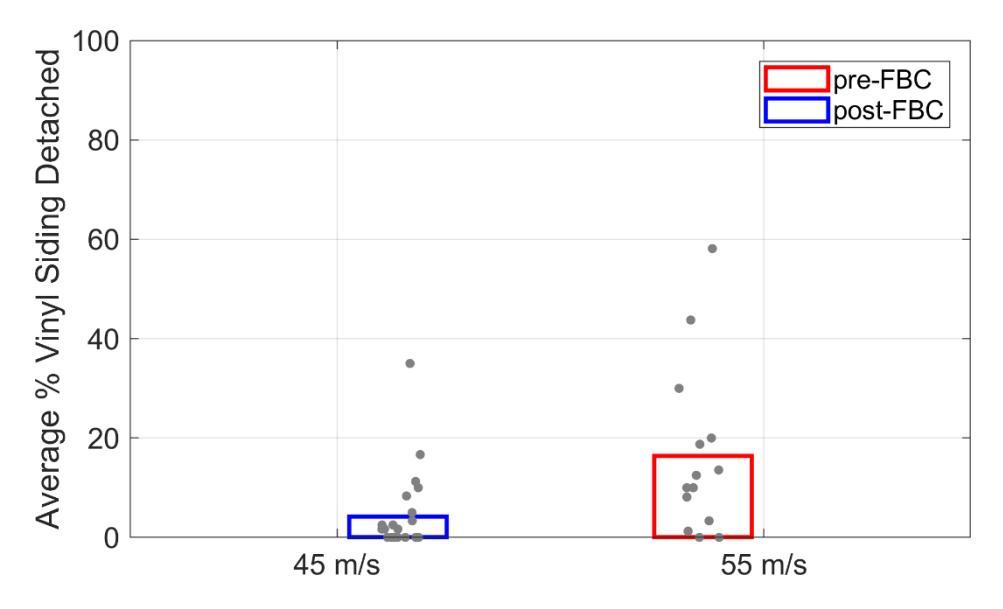
In Cedar's Crossing, vinyl siding was only present on post-FBC homes, making it a good case study for performance. Average siding loss was less than 40% for all homes, and averaged approximately 5%. Nonetheless, significant sections of vinyl siding were lost for multiple wall surfaces at wind loads 30% below design. Failures for individual wall surfaces is discussed more fully in later sections of this report.

Figure 19. Sample performance of pre- and post-FBC vinyl siding in Hurricane Michael stratified by estimated 1-minute sustained wind speeds (45 m/s = Cedar's Crossing, 55 m/s = Gulf Aire). Boxes designate the average % vinyl siding detached over all homes within each bin and code classification. Each grey dot represents an individual home.

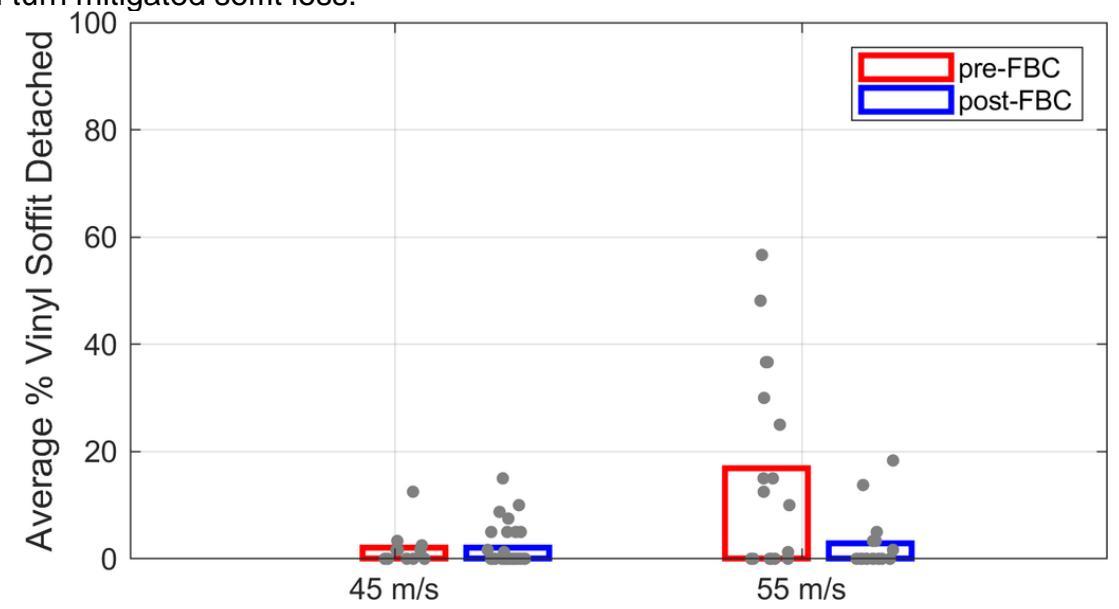
Figure 22 and Figure 23 illustrate the performance of vinyl soffits and fascia systems in pre- and post-FBC homes in the Cedar's Crossing neighborhood and in the Gulf Aire / Beacon Hill neighborhoods. Vinyl soffit damage was more pronounced in pre-FBC homes in Gulf Aire as compared to the post-FBC homes in Gulf Aire and Beacon Hill that experienced approximately the same wind speeds. In Cedar's Crossing, vinyl soffit damage was similar in both pre- and post-FBC homes, while fascia damage was actually higher on average in post-FBC homes.

Figure 22. Sample performance of pre- and post-FBC vinyl soffit in Hurricane Michael stratified by estimated 1-minute sustained wind speeds (45 m/s = Cedar's Crossing, 55 m/s = Gulf Aire). Boxes designate the average % vinyl siding detached over all homes within each wind speed and code classification. Each grey dot represents an individual home.

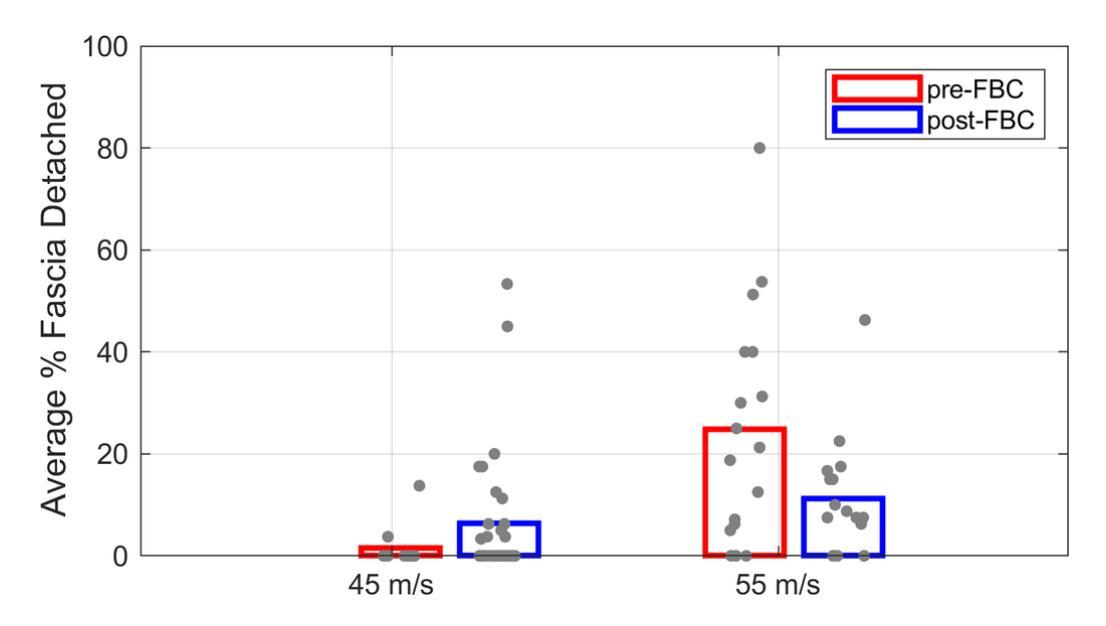
Figure 23. Sample performance of pre- and post-FBC fascia in Hurricane Michael stratified by estimated 1-minute sustained wind speeds (45 m/s = Cedar's Crossing, 55 m/s = Gulf Aire). Boxes designate the average % vinyl siding detached over all homes within each wind speed and code classification. Each grey dot represents an individual home.

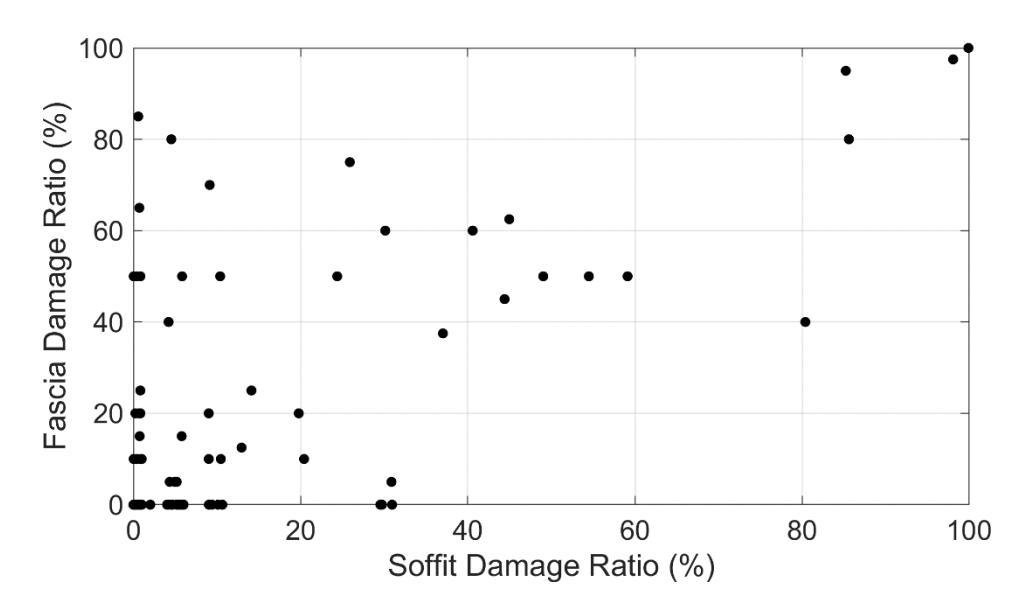
Figure 24 demonstrates the positive correlation between soffit damage and fascia damage on a given wall surface. Soffit damage did occur without corresponding fascia damage, with this failure typically occurring when the soffit separated from the starter strip at the exterior wall. Fascia damage was more common however, often corresponding to soffit failures on the same wall. The correlation coefficient between soffit and fascia failures was 0.67, indicating a moderate positive correlation between the two failures. On average, when soffit failure occurred, 21% of the failures corresponded to fascia failures

at the same locations. Anecdotally, the presence of gutters prevented fascia loss, which in turn mitigated soffit loss.

Figure 24. Relationship between soffit damage ratio and fascia damage ratio for each wall surface. Each marker represents a single wall surface for which both soffit and fascia performance could be assessed.

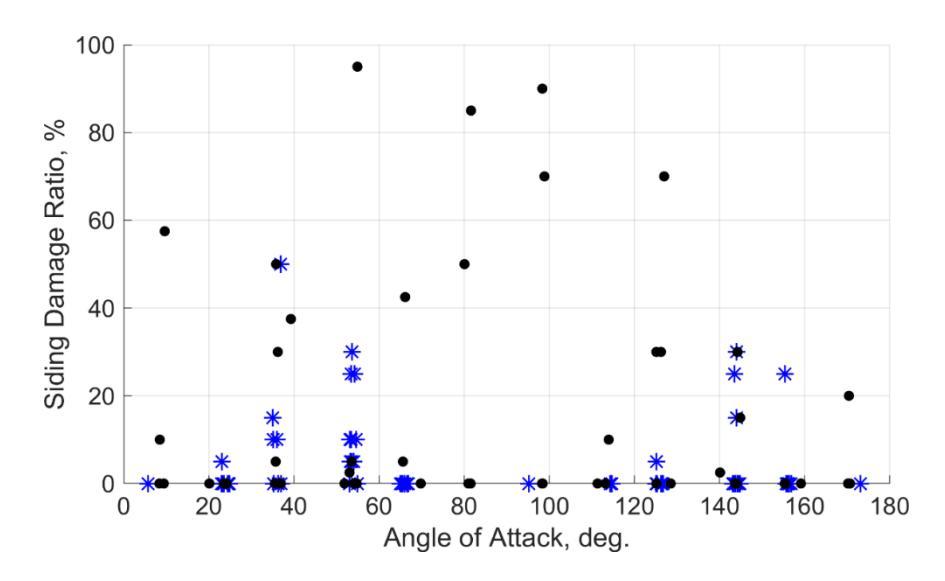
Cedar's Crossing and Gulf Aire neighborhoods impacted by Hurricane Michael. A distinct bi-modal relationship is evident in the Cedar's Crossing neighborhood, but the trend is much nosier, if present at all, in the Gulf Aire homes. Evaluated within the context of the entire wind speed time history for Cedar's Crossing, where the highest winds shifted from NE to NW, the data suggests that vinyl siding failure is most likely to occur in the separation regions associated with cornering flows. More data is needed in neighborhoods with similar homes in order to confirm the trend more strongly.

Figure 27. Relationship between siding damage ratio and wind angle of attack for vinyl siding in Cedar's Crossing (blue asterisks) and Gulf Aire (black dots). Each marker represents a single wall elevation in the dataset.

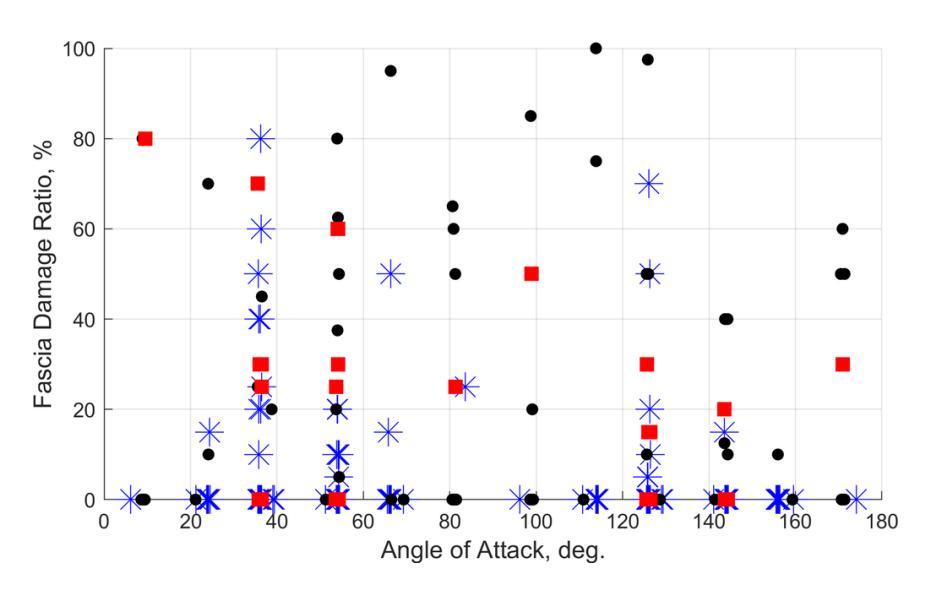
Figure 28 and Figure 29 provide the relationship between soffit and fascia damage and the wind angle of attack relative to each wall surface, with added data from the Beacon Hill neighborhood (which had vinyl soffit but no vinyl siding). The same trend between cornering winds and failures may be present in the Cedar's Crossing neighborhoods, where soffit and fascia failures appear to be more common under cornering flows, but overall the trends are noisy and inconclusive, particularly for fascia damage.

Figure 28. Relationship between soffit damage ratio and wind angle of attack for vinyl soffit in Cedar's Crossing (blue asterisks), Gulf Aire (black dots), and Beacon Hill (red squares). Each marker represents a single wall elevation in the dataset.
