Investigation of Potential Benefits of
Revising Exception 1 under
FLORIDA BUILDING CODE,
ENERGY CONSERVATION,
Section 101.4.7.1.1
Duct Sealing upon Equipment Replacement

FSEC-CR-1979-14
June 15, 2014
Revised June 30, 2014

Authors
Janet McIlvaine
David Beal

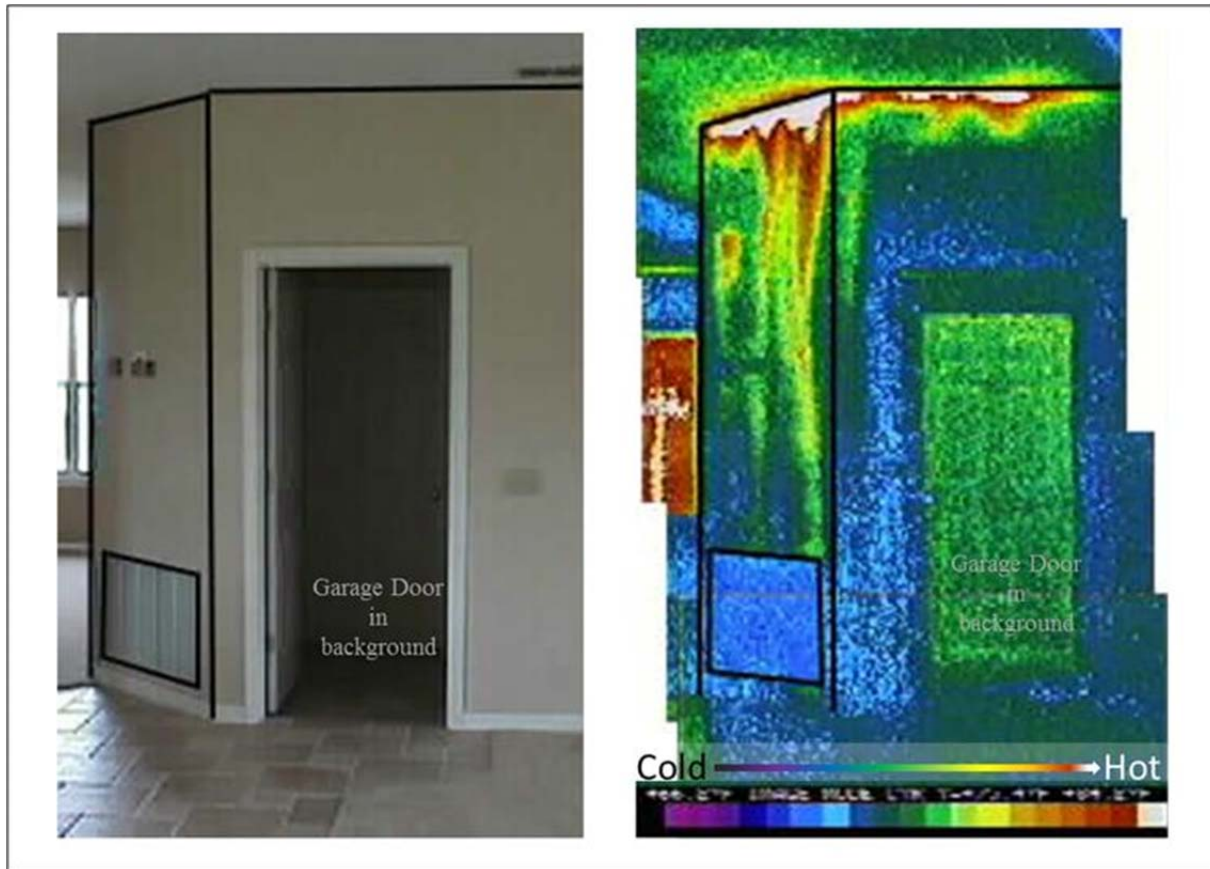
Air handler closets typically house a central return plenum, and are usually formed by the walls of the closet. If these walls are unfinished, open wall cavities it results in a return plenum that pulls air from those wall cavities and the attic above as shown in the infrared image in Figure 2 (Parker et al. 1998). The infrared image shows the wall between the utility room and the main body of the house. The return air path is unintentionally connected to the wall cavity, and consequently the attic, as evidenced by the signature of hot air being pulled down the wall during air handler operation.

Figure 2. Left: A return plenum formed by unfinished framing under an air handler support platform is on the other side of this wall mounted return air grille in a utility room. Right: Infrared image showing hot attic air (see color scale at bottom of image) being pulled down the interior wall cavity during air handler run time (Parker, et al. 1998.).

By modifying Exception 1 to exclude only accessible *ducted* pathways in conditioned space, not accessible building cavities, from the sealing requirement, this leakage path could be significantly diminished in 1,000's of existing homes at the time of air handler change-out. The benefits would include enhanced HVAC system performance, building durability, comfort, and energy efficiency. These benefits would be rendered by the improvement of duct system air tightness and reduction of uncontrolled air flow from mechanically induced infiltration (Cummings and Withers 1998; Cummings et al. 2012). The Florida Building Code Commission has acknowledged the wisdom of sealed return plenums by requiring them in all new Florida homes under the Florida Building Code, Residential, Chapter 16, Table M1601.4 (Florida Building Code 2010: Mechanical 2011) (See Appendix B).

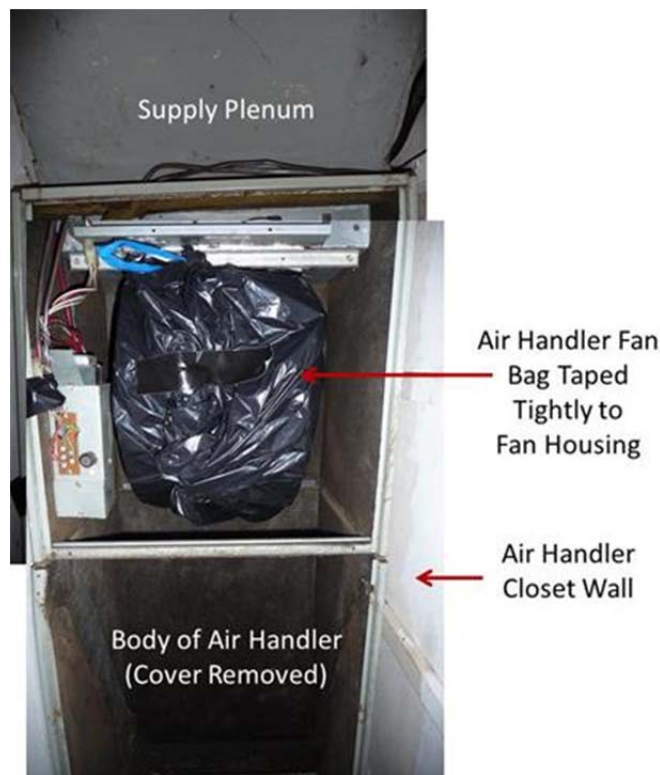
As found the air handler was gutted, with the coil removed for scrap and no front cover. However, since the entire air handler closet is the return plenum and the fan motor was still in place, testing proceeded by bagging the fan with a garbage bag (Figure 8) and installing the duct blaster fan to the return grill behind the refrigerator. By closing the closet door the system was configured in typical operating condition; the lack of a front cover and coils in the air handler deemed not to interfere with the results as the air handler would be fully open to the closet when operating (at the return air intake on the air handler).

Figure 8. Return portion of air distribution system isolated from the supply by sealing around the air handler fan with a plastic bag taped at all edges.

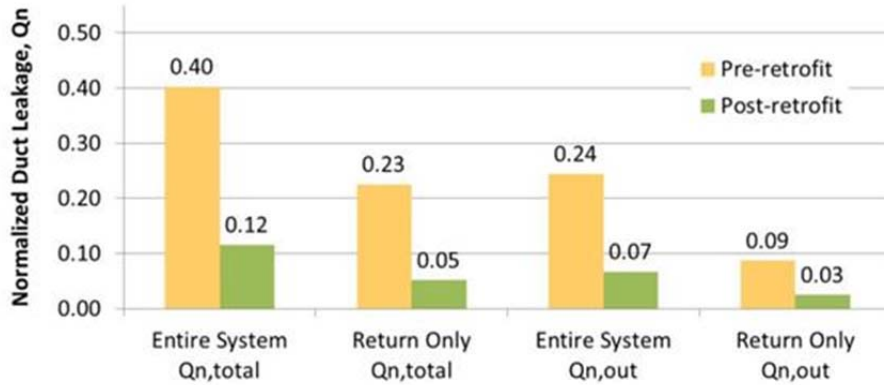
In this house the contractor also addressed the obvious failures in the supply duct work, sealing the open supply in the kitchen, re-installing the supply boots found disturbed in the attic portion of the house, and sealing all supply boots with mastic on their inside surfaces. The improvement from these repairs is apparent in the leakage reduction for the entire system shown in Table 2 and Figure 10.

Qn,total		Qn,out	
	Entire System	Return Only	Entire System	Return Only
Pre-retrofit	0.40	0.23	0.24	0.09
Post-retrofit	0.12	0.05	0.07	0.03
Improvement	71%	77%	72%	71%

Figure 10 Pre- and post-retrofit normalized duct leakage test results for House 1962

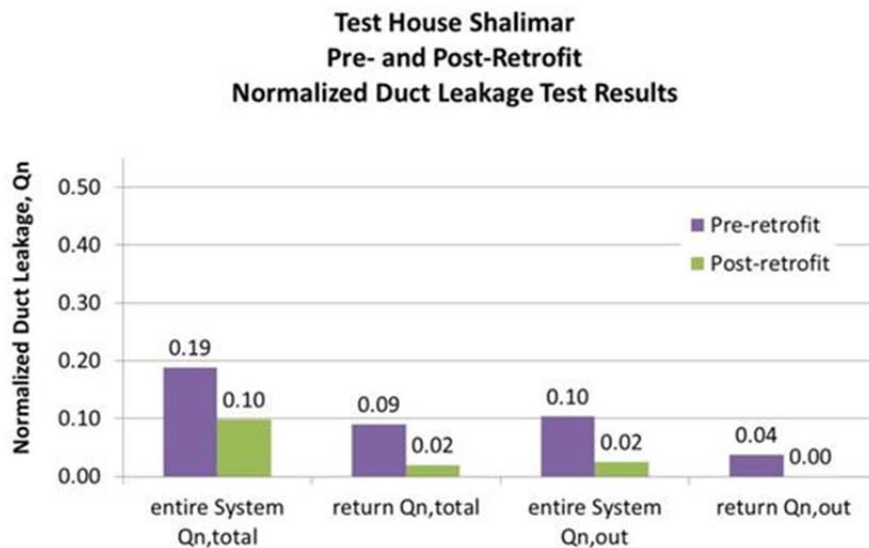
Qn, Total		Qn, out	
	Entire System	Return Only	Entire System	Return Only
Pre-retrofit	0.19	0.09	0.10	0.04
Post-retrofit	0.10	0.02	0.02	0.00
Improvement	48%	78%	76%	100%

Figure 16 Pre- and post-retrofit normalized duct leakage test results for House 194

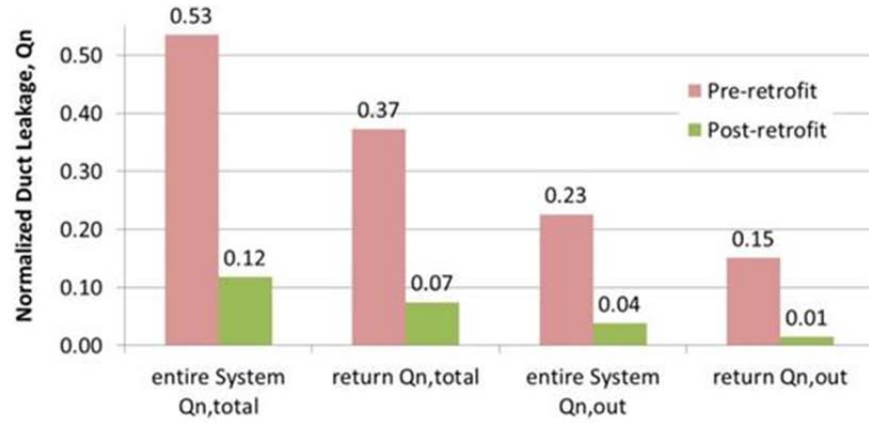
The success of the retrofit's sealing efforts is illustrated by the result tabulated below (Table 4) and shown in Figure 24.

Qn, Total		Qn, out	
	Entire System	Return Only	Entire System	Return Only
Pre-retrofit	0.53	0.37	0.23	0.15
Post-retrofit	0.12	0.07	0.04	0.01
Improvement	78%	80%	83%	90%

Figure 24. Pre- and post-retrofit normalized duct leakage results for House 261

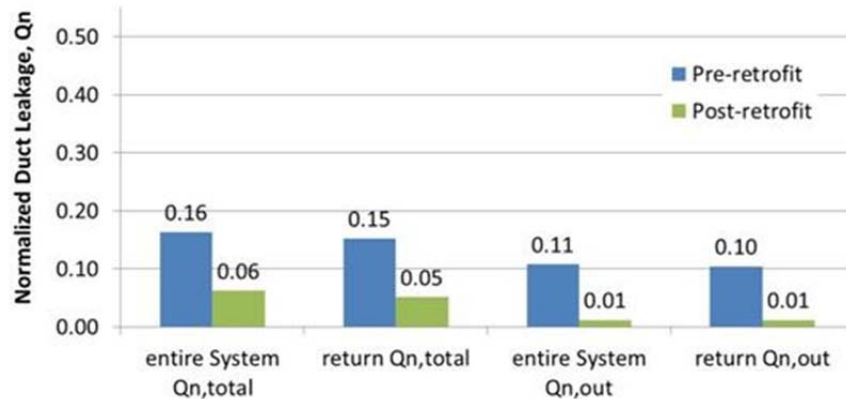
The efforts to seal both the supply and return systems resulted in an extremely tight duct system. The system was so tight that it was difficult to resolve any difference between the entire system readings and the return only test results, as seen below in Table 5 and Figure 29.

Qn, Total		Qn, out	
	Entire System	Return Only	Entire System	Return Only
Pre-retrofit	0.16	0.15	0.11	0.10
Post-retrofit	0.06	0.05	0.01	0.01
Improvement	62%	66%	89%	88%

Figure 29. Pre- and post-retrofit normalized duct leakage test results for House 223

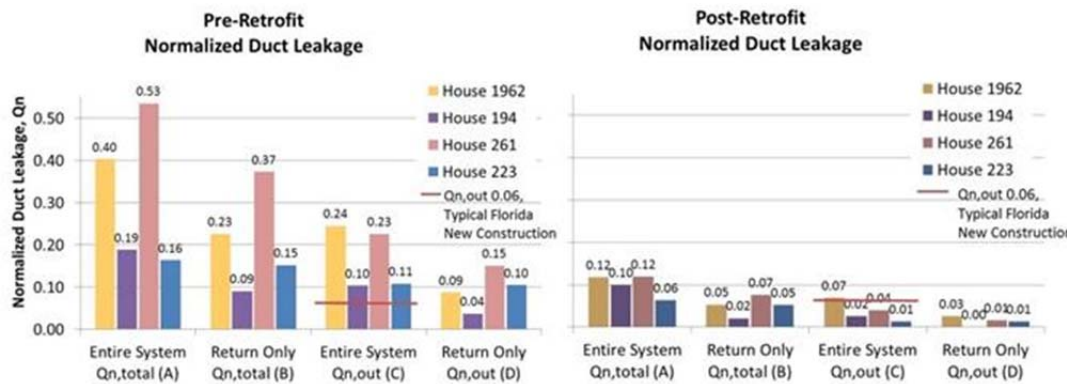
Figure 30. Pre-retrofit (left) and post-retrofit (right) duct testing results.

Pre- and Post-retrofit CFM25,out (duct leakage to the outside) for the entire system (Figure 30, left and right, C) ranges from 0.10 to 0.24 and 0.01 to 0.07 respectively. These are within the range anticipated based on previous field studies (Tables 7 and 8).

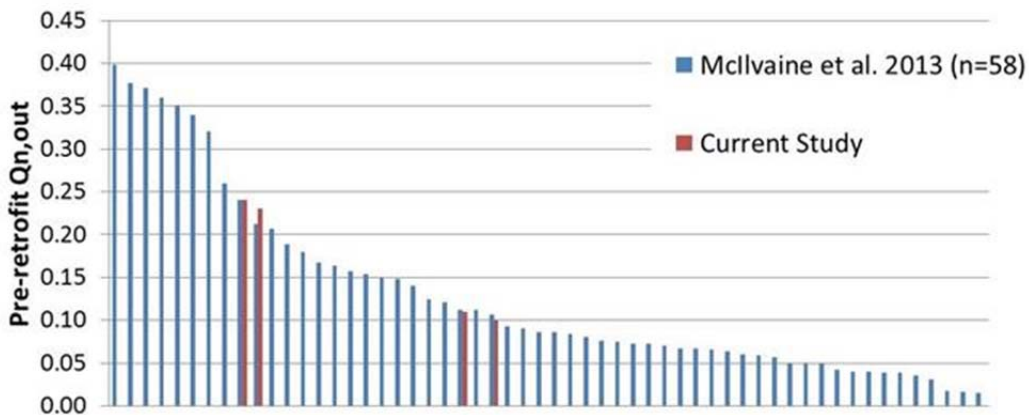
Figure 31. Pre-retrofit Qn,out (red) in relation to those found a previous field study of existing homes in central Florida (blue).

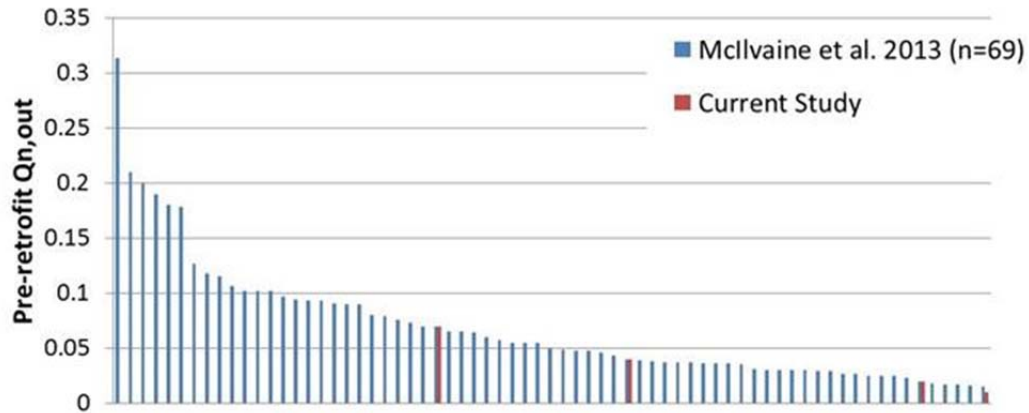
Air leakage reductions in the entire system (supply-side, return-side, and air handler) ranged from 48% to 78% for Qn,total and 72% to 89% for Qn,out. These results are outstanding and reflect commendable work of the HVAC contractors involved. Houses 223, 261, and 194 achieved post-retrofit Qn, out results that satisfy the duct air tightness criteria for high performance housing set by the ENERGY STAR for New Homes program (ENERGY STAR 2012). It is also a positive reflection on the affordable housing entities that wrote the scopes of work for these four houses. Although these housing partners were FSEC partners on previous projects, researchers did not provide any guidance or input to the participating HVAC contractors on the design or execution of these system change-outs. The pre-retrofit Qn,out in this small sample ranged from 0.10 to 0.24; the maximum being more than double the minimum. Although the sample is small, it's safe to say that these pre-retrofit test results are not uncommon in the existing Florida housing stock. For Qn,out, they all fall well within the pre-retrofit range evidenced in an earlier, larger field study (Figure 31). At post-retrofit, the results fell in the bottom half of the earlier study's range with Houses 223 and 194 in line with the lowest leakages measured (Figure 32).

Figure 32. Post-retrofit Qn,out (red) in relation to those found a previous field study of existing homes in central Florida (blue).
