Final Report for Project Entitled:
Full Scale Wind Load Testing of Aluminum Screen Enclosures
PO Number A95F33

Performance Period: 1/6/2014 – 6/30/2014

Presented to the
Florida Building Commission
State of Florida Department of Business and Professional Regulation

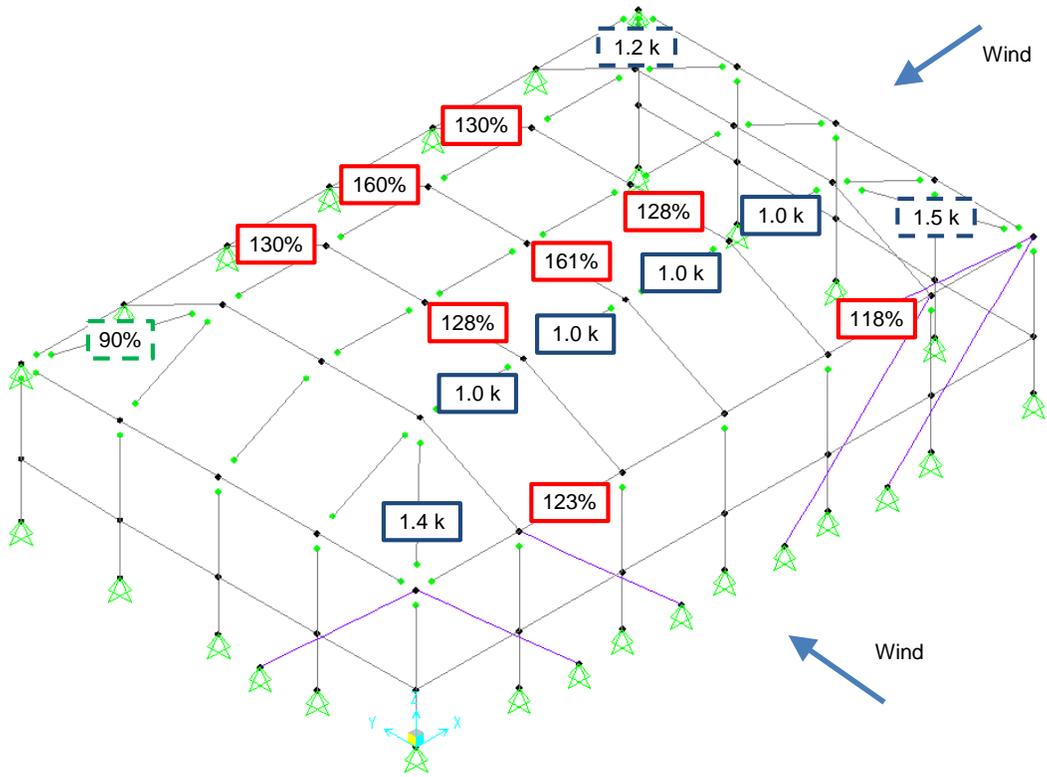
In the figure, dotted lines represent the first load case whereas the solid lines represent the second load case. Red box means high actual to allowable stress ratio: moment (% is shown), green box means high actual to allowable stress ratio: column (% is shown), and blue box means high tension (kips is shown).

Figure 2. Members with high actual to allowable stress ratios and high tensile forces: Generic specimen

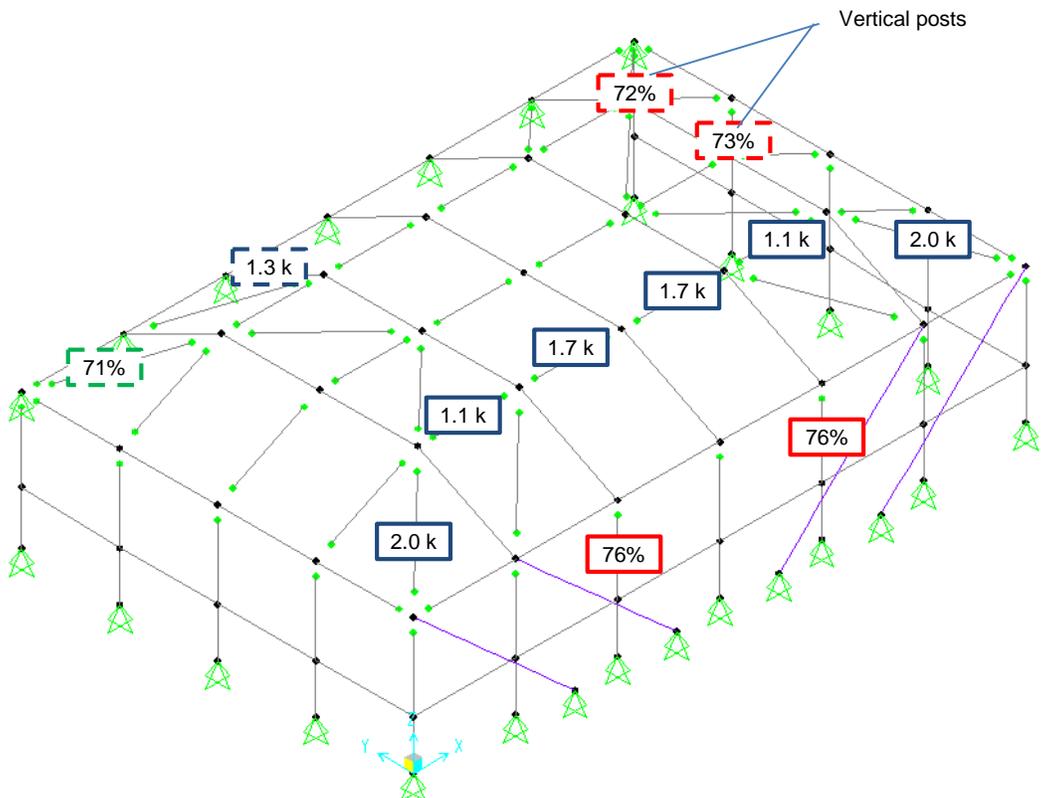
Figure 3. Members with high actual to allowable stress ratios and high tensile forces: AAF specimen

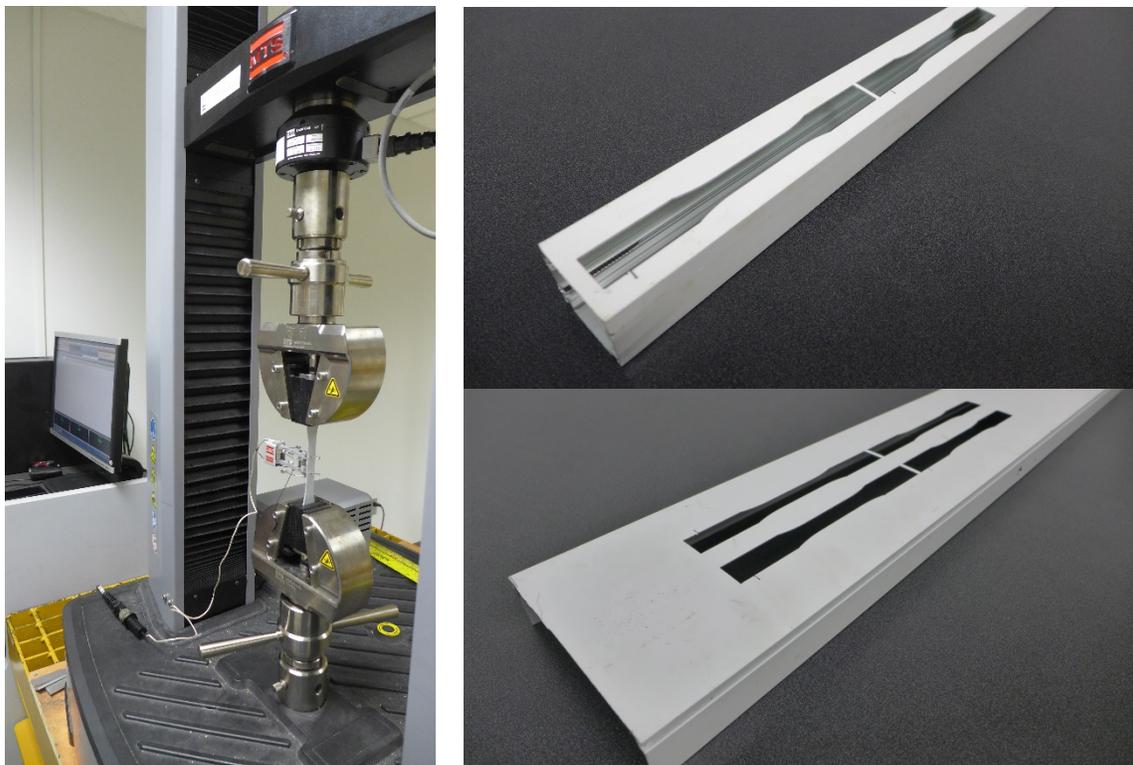
Material properties were obtained after testing the 12 coupons. The average elastic modulus was 9,300 ksi, which was used in the analysis instead of the published value. The yield stress and the ultimate stress were also lower than the published values. The mean and the standard deviation of the yield stress were 32.3 ksi and 1.2 ksi, resulting in a statistically calculated minimum of 27.8 ksi (vs. 35 ksi specified minimum). The mean and the standard deviation of the ultimate stress were 37.5 ksi and 0.9 ksi, resulting in a statistically calculated minimum of 34.0 ksi (vs. 38 ksi specified minimum).

Figure 29. Material testing machine (left) and 2X2 and 2X6 SMB after harvesting testing coupons (right)

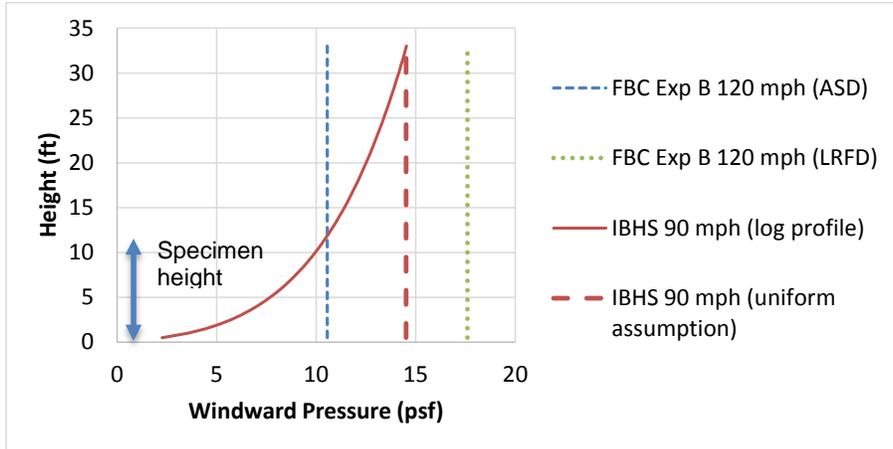
ASCE 7 and the Florida Building Code use constant pressure below the height of 15 ft. On the other hand, the wind profile of the IBHS facility can be described with a log wind profile with $z_0 = 0.01$ (Morrison et al. 2012). Assuming the drag coefficient of 0.7 (Reinhold et al. 1999), which includes the gust effect, drag, and screen reduction factor, estimated pressure with the log profile assumption is also shown in Figure 33. At the reference height of 33 ft, estimated actual loading is greater than the ASD loading but smaller than the LRFD loading. However, below 11 ft where the screen enclosure is located, the design loading is always greater than the actual loading.

Figure 33. Comparison of the design loading and the actual loading

As shown in Figure 33 and , the actual loading applied in the experiment is lower than the design loading used in the analysis. Therefore, data (force or moment) from certain sensor should also be lower than the corresponding result from the analysis. If the experimental data is higher than the analysis result, possible causes include localized effect of the wind gust, and discrepancy between the finite element model and the physical specimen. In this project, we investigated those data points in detail (i.e., experiment > analysis) focusing on implications on the current design code, but we did not investigate the exact cause. Further research is necessary to identify the cause.

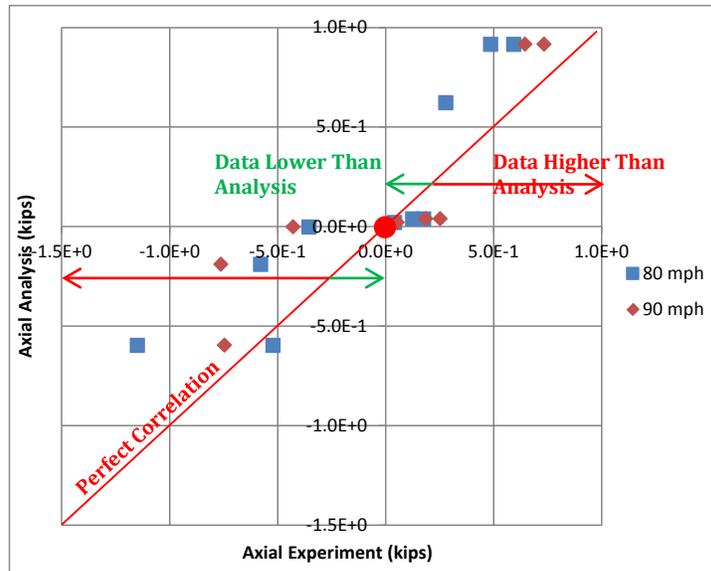
35. Similar figures for other wind angles and moments can be found in the Appendix (section 11.3). For the square markers, experimental data from 80 mph test were used. For the diamond markers, experimental data from 90 mph test were used. For both markers, analysis results using FBC ASD loading were used. All sensor data were used for 80 mph case, but sensors 7, 13, 15, and 17 failed during the 90 mph test. In this figure, we can see that tensile forces from the experiment are smaller than those from the analysis, except for tensile forces of small magnitude. Therefore, if the structure can sustain the high tensile forces shown earlier in Figure 2, no additional members raise any concern. On the other hand, compressive forces from the experiment are larger than those from the analysis for some members. What this implies is that the current design loading with conventional finite element analysis may not catch potential failure of these members. These sensor locations are marked for further investigation.

Figure 35. Comparison of the data from the experiment and results from the analysis: Generic specimen, 0 degree wind angle, axial forces

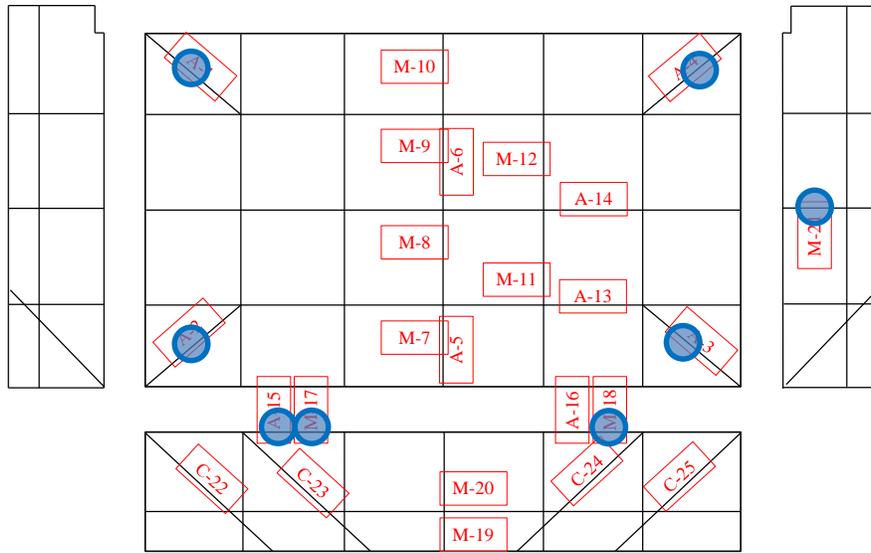
Figure 36 graphically shows the marked sensor locations. Corner bracings, the center post on the windward wall (for 90 degrees wind angle), and members next to the cables showed high experimental measurement. These locations experience higher localized forces than what's predicted by the finite element analysis. For these members, actual to allowable stress ratios were computed for members in compression or bending, using both the maximum measurement and average measurement. For the members in tension, tensile forces were obtained. The results are summarized in Figure 37. All sensors used the data from 90 mph tests except the sensors failed at that speed, for which the data from 80 mph tests were used. The only member that exceeded the allowable stress is the corner bracing with the sensor A-1. The member did not buckle probably because the actual connections at the ends provide shorter length for buckling, compared to the length used for the allowable stress calculation.

When we compare high moment locations (M-17, M-18) with the location that lost the screen attachment (see Figure 24), we can hypothesize that high moment contributed to the failure of the screen attachment. We can also hypothesize that overall higher moments in the Generic specimen led to greater loss of screen attachments compared to the AAF specimen. With the available data, it is not possible to prove or disprove these points, but these can be further investigated in the future study.

Figure 36. Sensor locations that showed notable forces and moments: Generic specimen

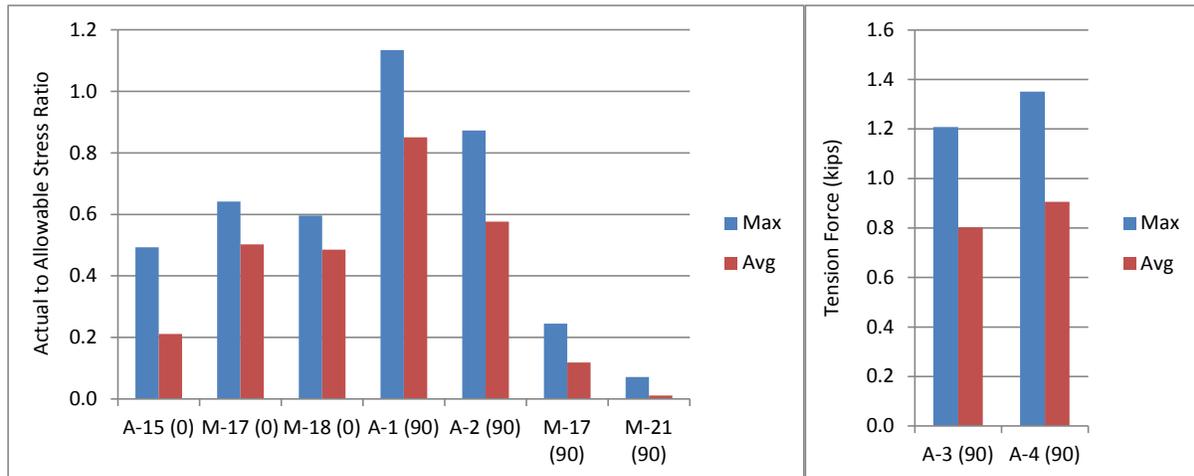
Figure 37. Actual to allowable stress ratio (left) and tension (right) of selected members: Generic specimen

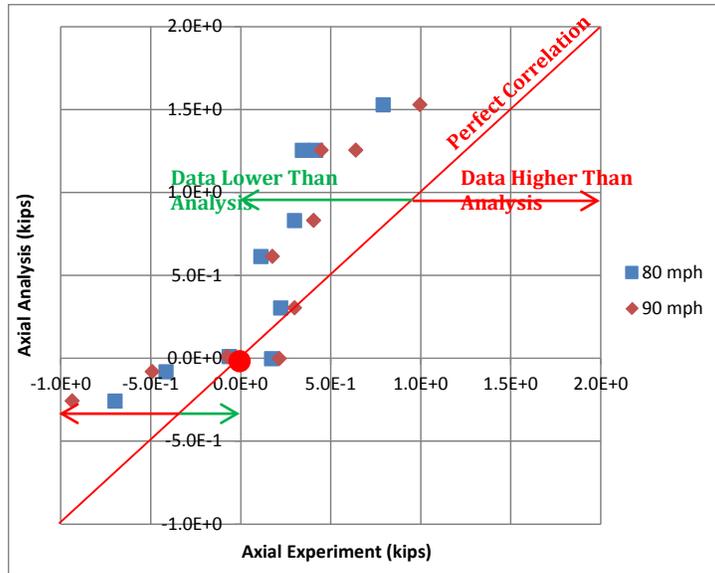
Similar data analysis was conducted for the AAF specimen as shown in Figure 38. Additional figures can be found in the Appendix (section 11.3). All sensors were used except the sensors 3, 12, and 19 due to the poor quality of data. Sensors with notable forces and moments were marked, which are summarized graphically in Figure 39. Similar to the Generic specimen, the posts on the windward wall (for 90 degrees wind angle) and the roof corners showed high forces and moments. The center roof beam also showed high forces and moments.

Figure 38. Comparison of the data from the experiment and results from the analysis: AAF specimen, 0 degree wind angle, axial forces

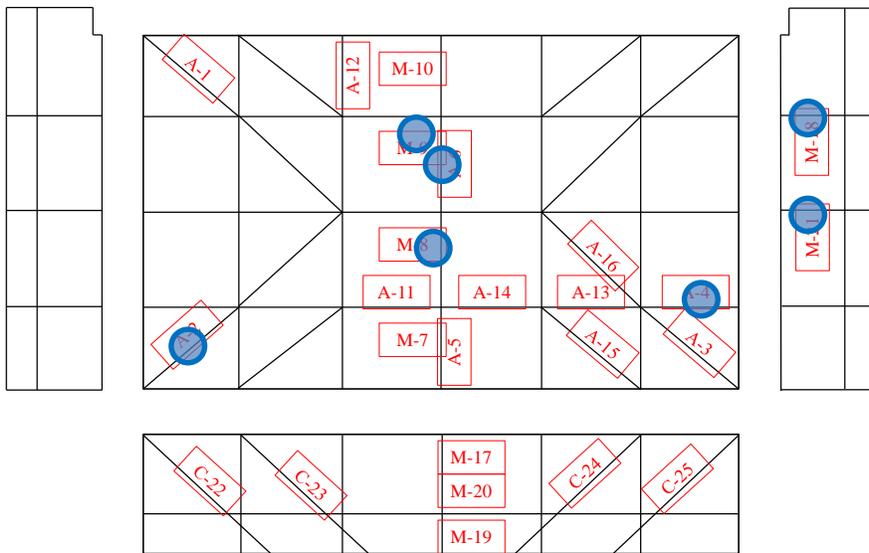
Figure 39. Sensor locations that showed notable forces and moments: AAF specimen

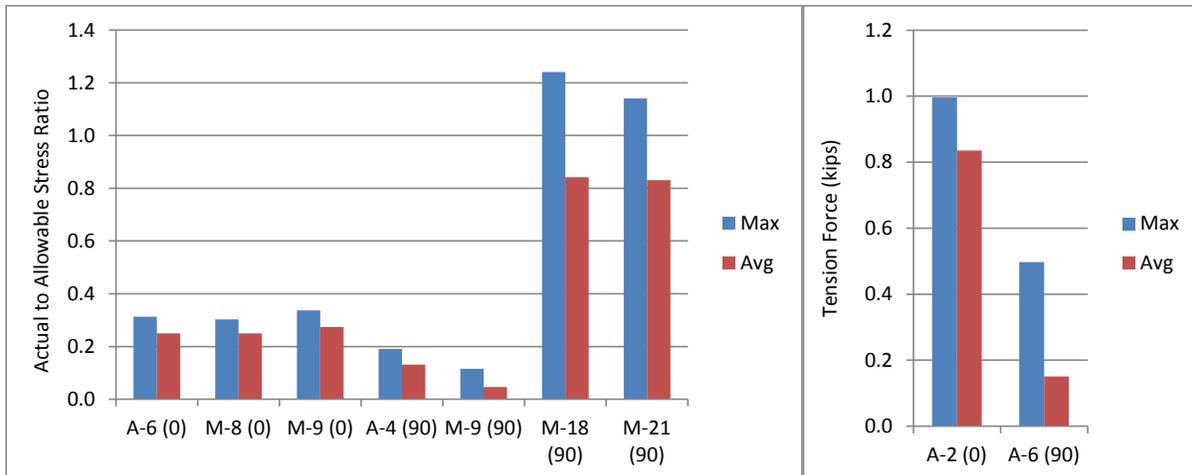
Figure 40 shows further analysis of these notable locations. All sensors used the data from 90 mph tests. M-18 shows the moment of the vertical post that failed during the 100 mph test. Even at 90 mph, the maximum actual to allowable stress ratio exceeded 1.0. Other sensors also showed large values, but not to the extent to fail the members.

Figure 40. Actual to allowable stress ratio (left) and tension (right) of selected members: AAF specimen
