Final Report:

Survey and Investigation of Buildings Damaged by Category-III, IV & V Hurricanes in FY 2018-2019 – Hurricane Michael

Project #: P0091032

Report No. 01-19

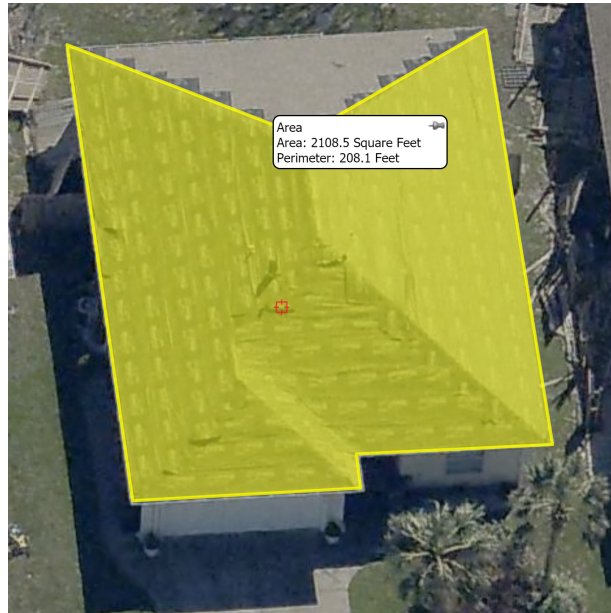
Figure 8. Example of estimated area of roof cover damage

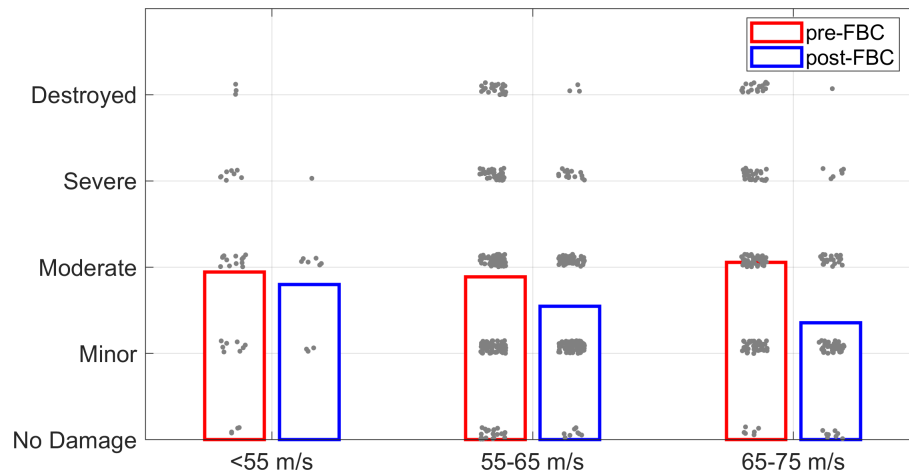
The following figures (Figure 17, Figure 18, and Figure 19) provide an overview of pre- and post-FBC wind performance stratified by peak gust wind speed for all buildings combined, single-family residences, and non-single-family residences respectively. Regardless of building type and peak wind speed, post-FBC buildings perform better or, in one case (single-family residences that experienced < 55 m/s gust wind speeds), nominally the same as pre-FBC buildings. However, an interesting trend demonstrated in the data is the non-progressive nature of the wind speed to damage relationship. Generally, it is expected that wind damage increases with wind speed, all else being equal. In this case, design wind speeds for the majority of the study region are nearly the same, negating that possible factor. It is unexpected then to see the average wind damage rating actually decrease for homes that experienced the highest wind speeds, relative to those that experienced the lowest or middle tier wind speed range. Further research into this trend is warranted, potentially with detailed review of permit records where available. It is possible that newer homes in the coastal areas that experienced higher wind speeds were more likely to invest in code-plus construction. The famous Sand Palace home is one example (Pino 2019), as well as the Habitat for Humanity

Figure 17. Distribution of wind damage ratings for all buildings, stratified by peak gust wind speed. Within each wind speed bin, the left bar is pre-FBC and the right bar is post-FBC, and indicates average damage rating. Grey circle markers represent the wind damage rating of each individual building in the dataset.

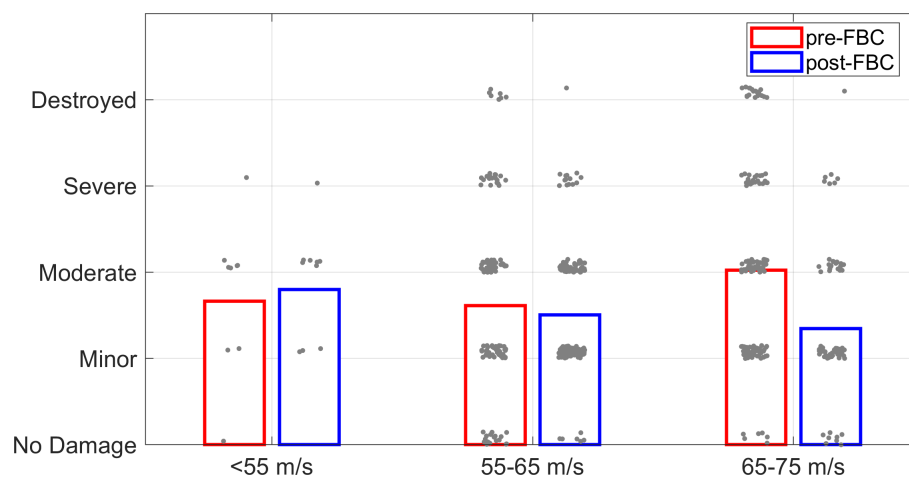
Figure 18. Distribution of wind damage ratings for single-family residences, stratified by peak gust wind speed. Within each wind speed bin, the left bar is pre-FBC and the right bar is post-FBC, and indicates average damage rating. Grey circle markers represent the wind damage rating of each individual building in the dataset.

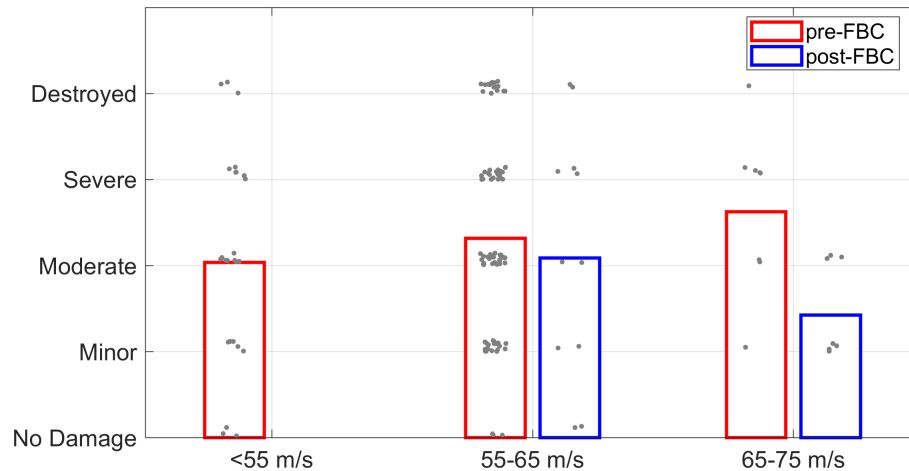
Figure 19. Distribution of wind damage ratings for non-single-family residences, stratified by peak gust wind speed. Within each wind speed bin, the left bar is pre-FBC and the right bar is post-FBC, and indicates average damage rating. Grey circle markers represent the wind damage rating of each individual building in the dataset.

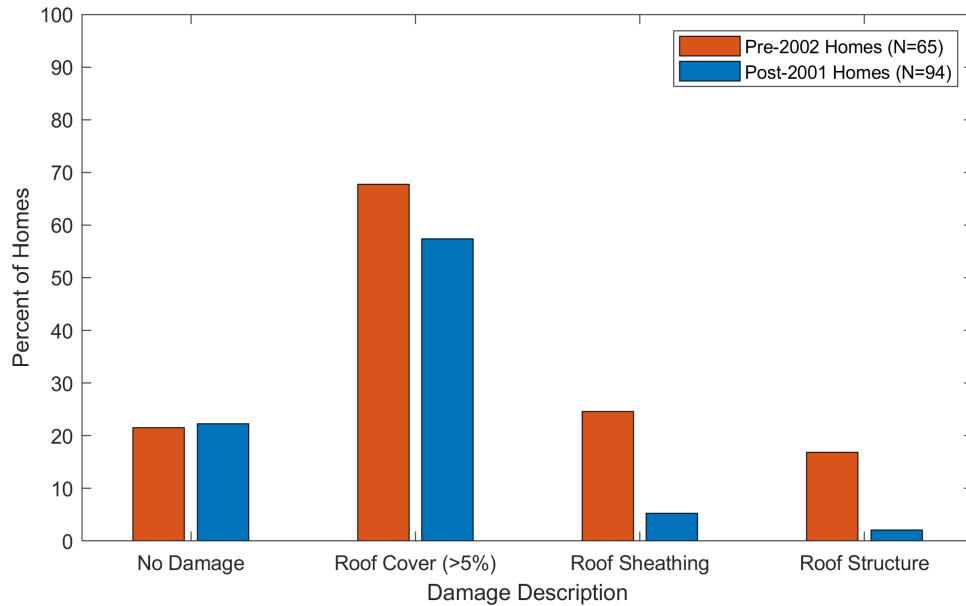
The following summarizes the performance of the pre- and post-FBC homes in the dataset of 171 homes for which the full DEQC protocol has been completed. Figure 20 and Figure 21 provide the relative distribution of roof and wall failures in pre- and post-FBC buildings. Roof cover damage occurred to the majority of pre- and post-FBC homes. If no secondary water barrier was present, this data also indicates that interior damage due to rainwater ingress was likely a significant driver of economic losses, as has been the case in past hurricane events. The research team did not directly observe any secondary water barriers in the inland study regions, so we do not expect that was commonly installed.

Figure 20. Percent of pre- and post-FBC homes experiencing no or very minor roof damage, roof cover damage, roof sheathing damage, or roof structure damage.

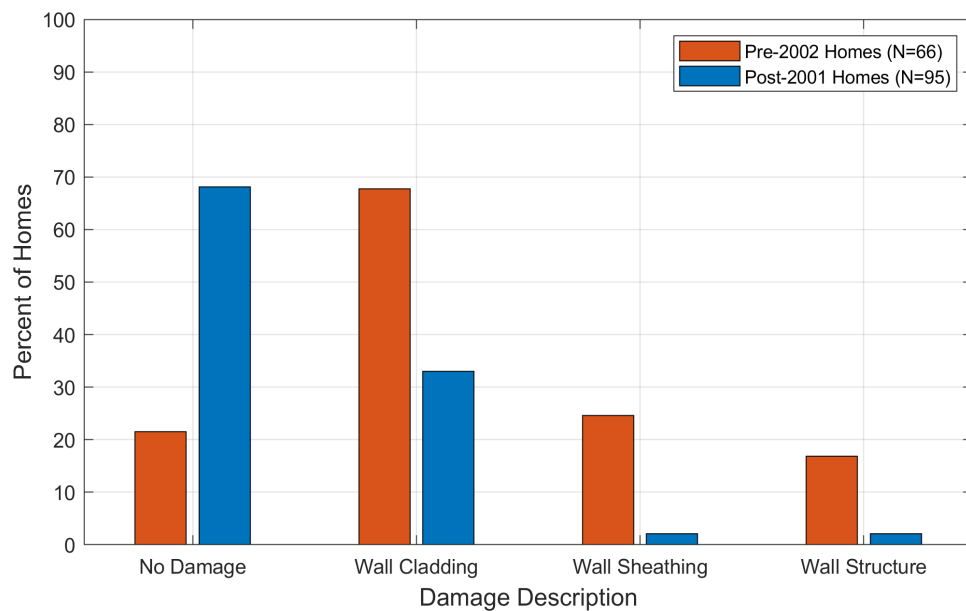
Figure 21. Percent of pre- and post-FBC homes experiencing no wall damage, wall cladding damage, wall sheathing damage, or wall structure damage.

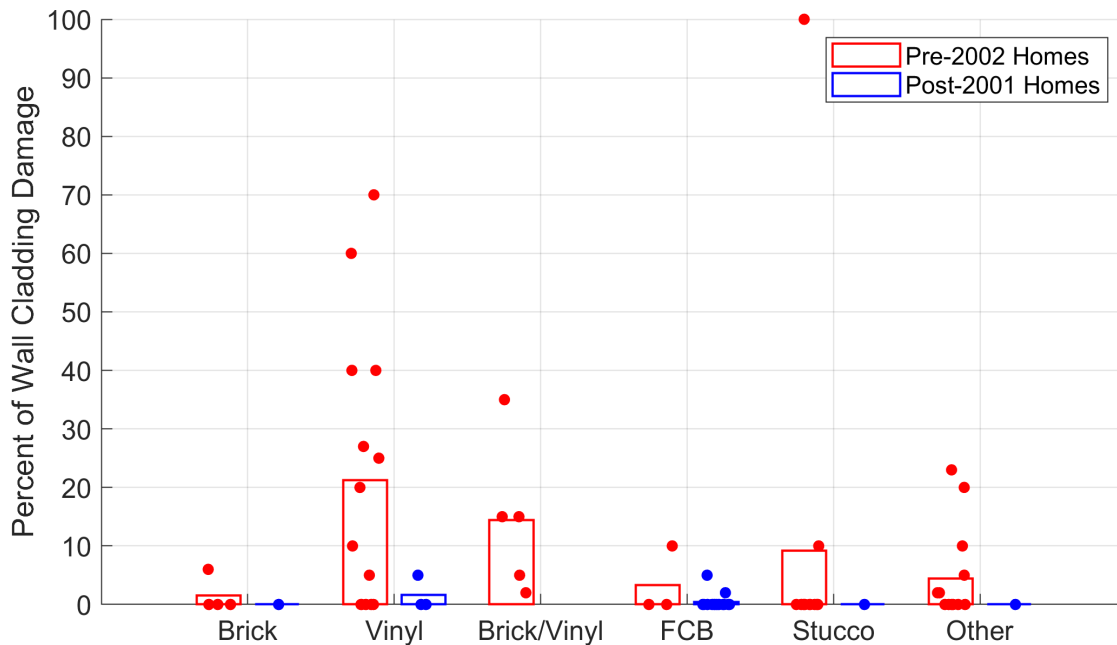
Figure 24. Wall cladding damage percentage by material type for homes experiencing peak gusts of approximately 68 m/s (Gulf Aire and Beacon Hill neighborhoods). Bars depict the mean percentage. FCB = fiber cement board.

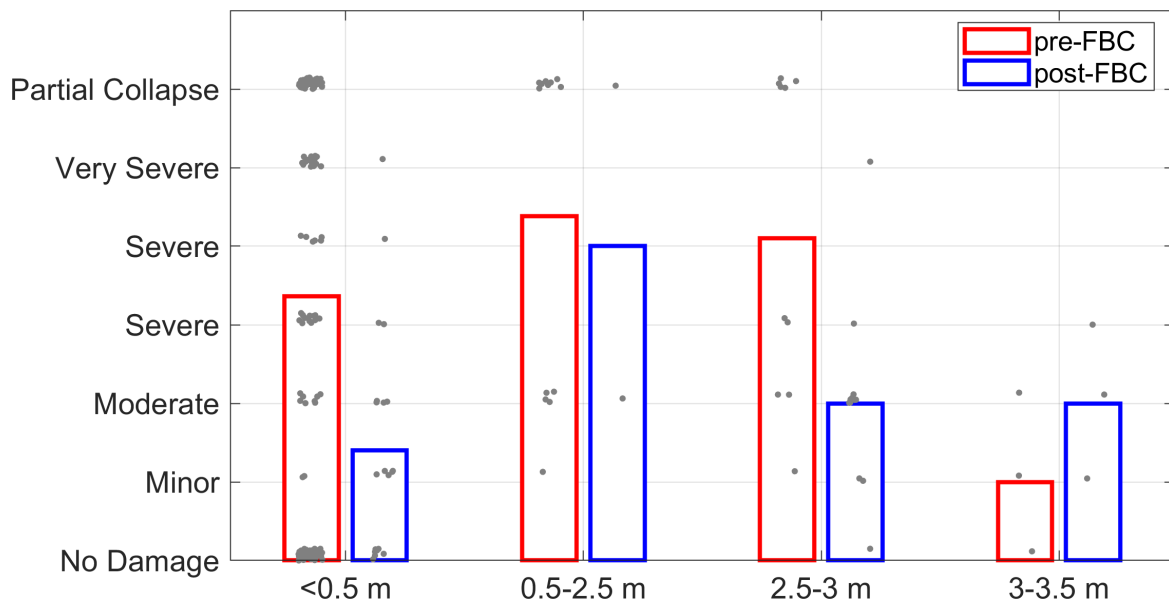
Figure 27 plots the distribution of surge damage by first floor elevation. The surge damage is not conditioned on the surge inundation in this plot. Overall, post-FBC buildings still performed better even for nominally equivalent first floor elevations. The exception was the highest first floor elevation bin (3-3.5 m), but the number of data points there is small (N = 6). Permit data should be explored to more precisely examine the details of the structural load paths in these homes as customized construction (i.e., code plus construction), is potentially more likely in such coastal areas and year built may not be as accurate of a delineator between design and construction quality.

Figure 27. Surge damage ratings by first floor elevation (m) for pre- and post-FBC buildings. Note that surge inundation varied significantly between the buildings represented here.

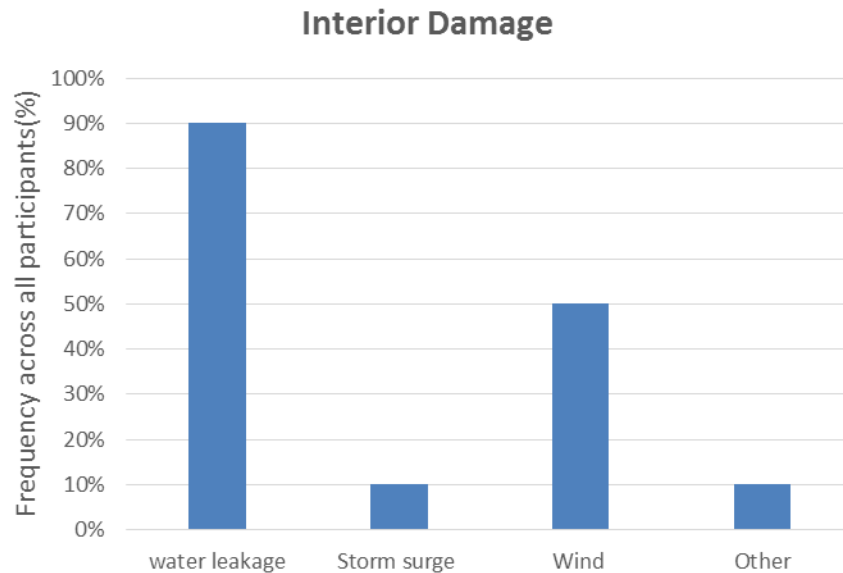
Figure 35. Frequency of reported interior damage across all participants

Most of the participants faced the water leakage damage (90%). They reported that they had storm surge damage (10%), wind damage (50%) following with other interior damage (10%). The highest estimated costs is for water leakage repair (n=9,M=\$32,000), for storm surge (N=1 , M=\$32000) and for Wind (N=1 ,M=\$32000)

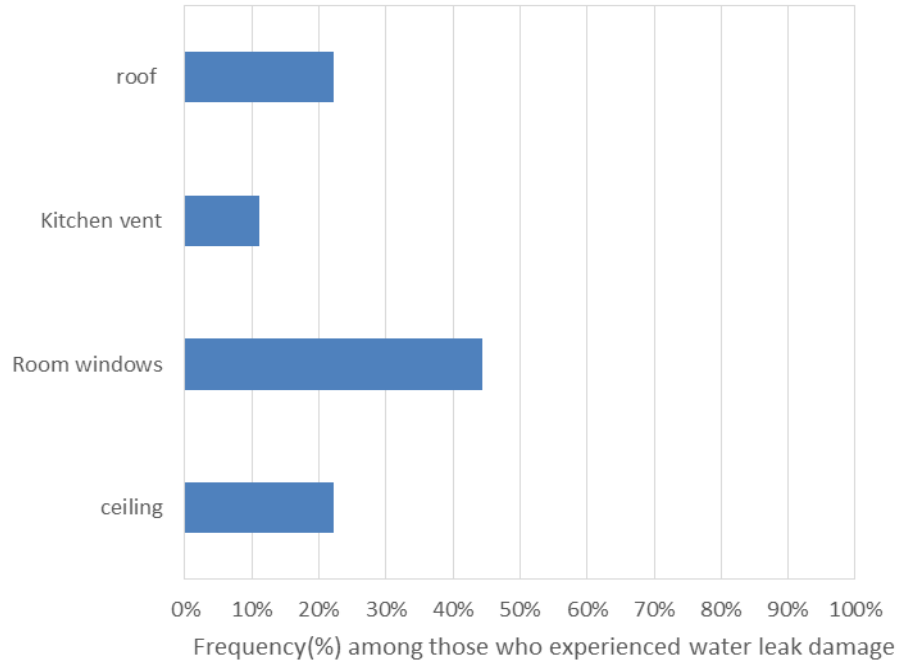
Figure 37. Where the water came in as a result of Hurricane Michael for those reporting water leak damage.

The participants reported that the water leakage occurred in the various areas of the room. Most of the participants had the damage to their roof, windows and damage to their belongings. They thought that the water leakage occurred due to the wind, rain, debris etc.

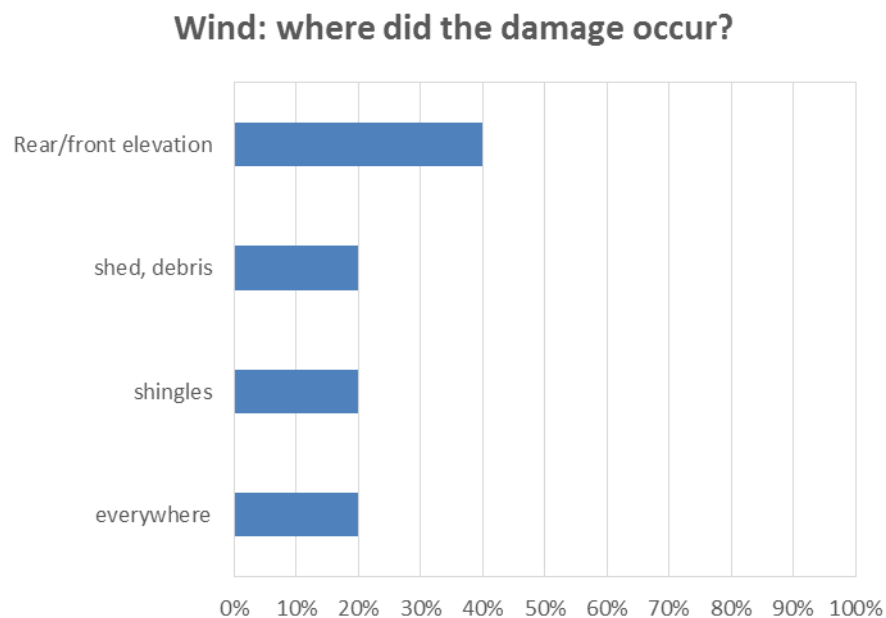
Figure 41. Location in the home where the wind damage occurred

About (71.2%) participants had faced the damage due to the wind. The location of the wind damage, extent of the damage, damage to the belongings and the reasons for the wind damage were responded by the participants which is shown in the following table 11 and table 12.

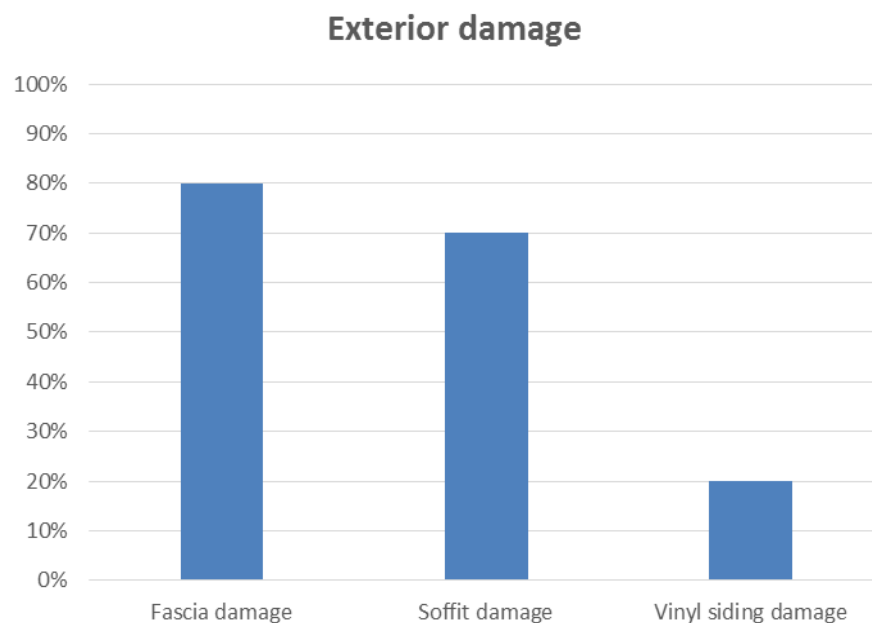
Figure 43. Frequency of reported exterior damage across all participants

The participants reported that they had the fascia damage (80%), soffit damage (70%) and the vinyl siding damage (20%).
