# Final Report

## Evaluation of Concrete Pile Foundations During Hurricane Michael

Raphael Crowley, Ph.D., P.E.  
Principal Investigator  
Associate Professor (Coastal and Port Engineering)

Taylor Engineering Research Institute  
School of Engineering  
University of North Florida  
1 UNF Drive  
Building 4, Room 1501  
Jacksonville, FL 32224

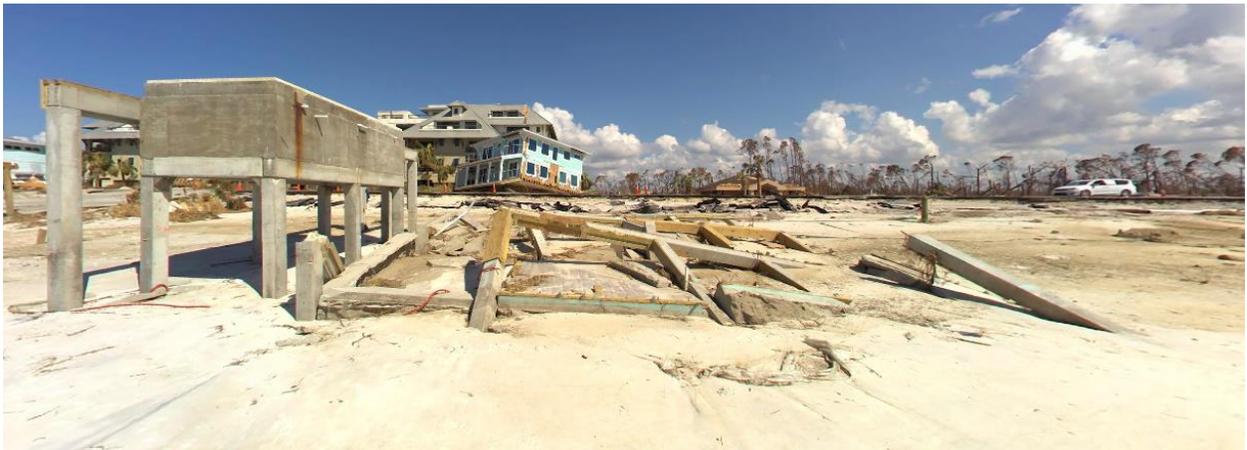
Figure 2-6. Opposite angle for 1207 FL-30/US-98; data were available from the beach side at this location

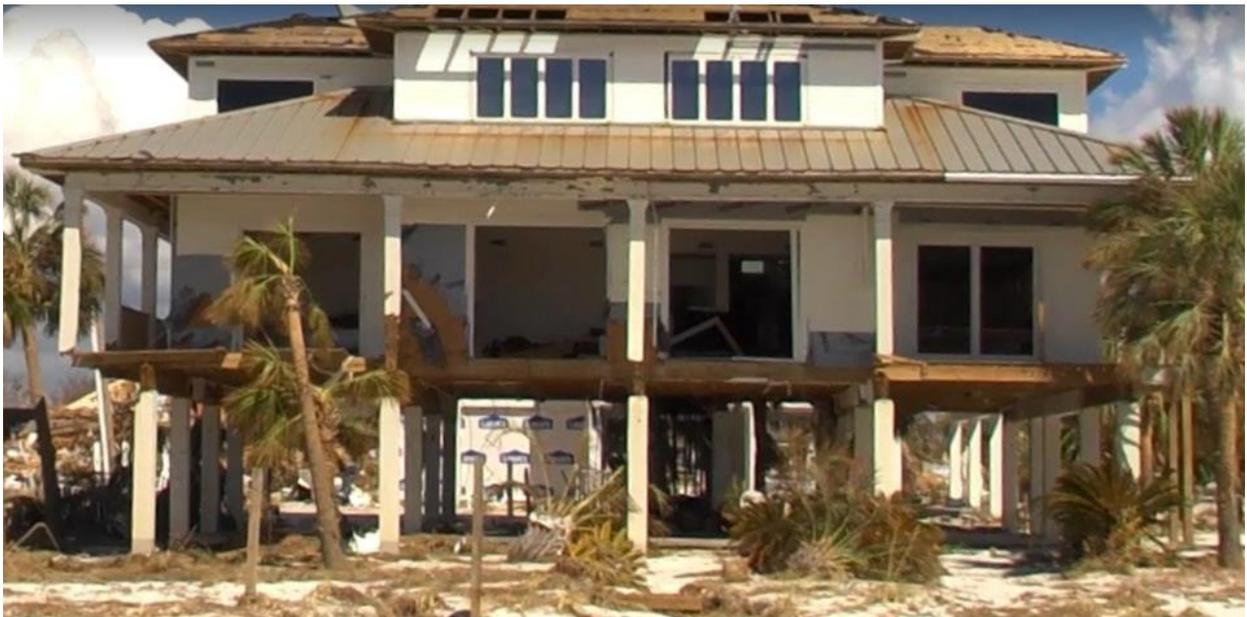
Figure 2-11. Evidence of a structure with concrete foundations that did not fail located at 108 S 27<sup>th</sup> Street

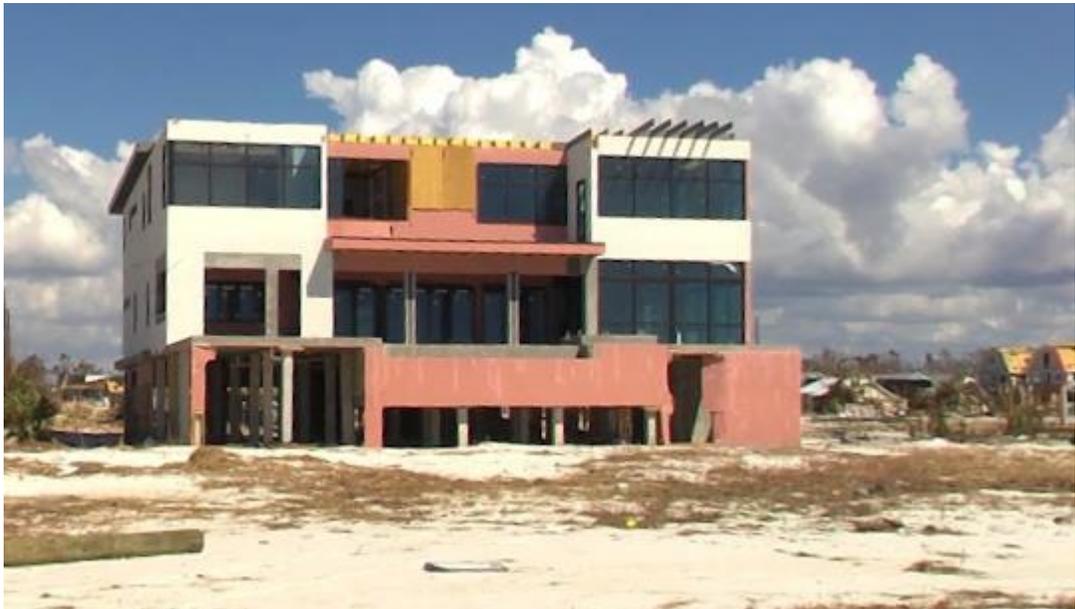
Figure 2-13. Evidence of a structure with little apparent concrete foundation structural damage located at 112 S 30<sup>th</sup> Street

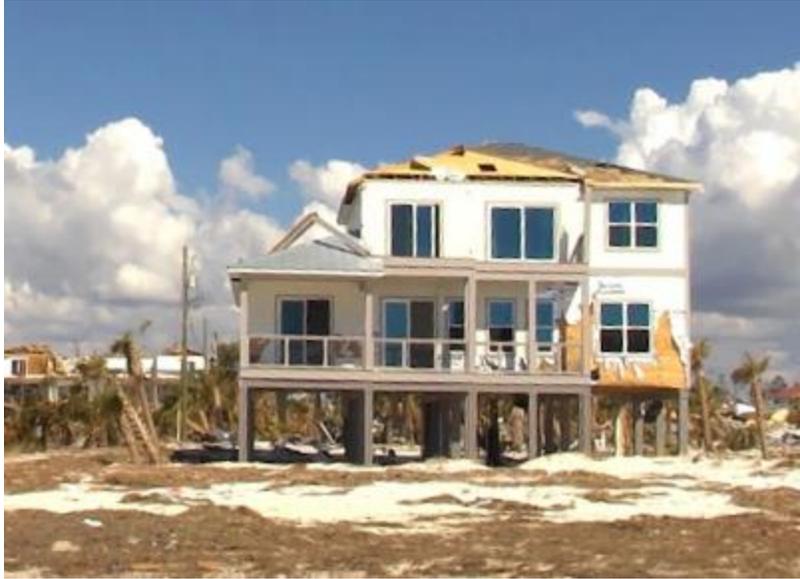
Figure 2-14. Evidence of a structure with little apparent concrete foundation structural damage located at 112 S 31<sup>st</sup> Street

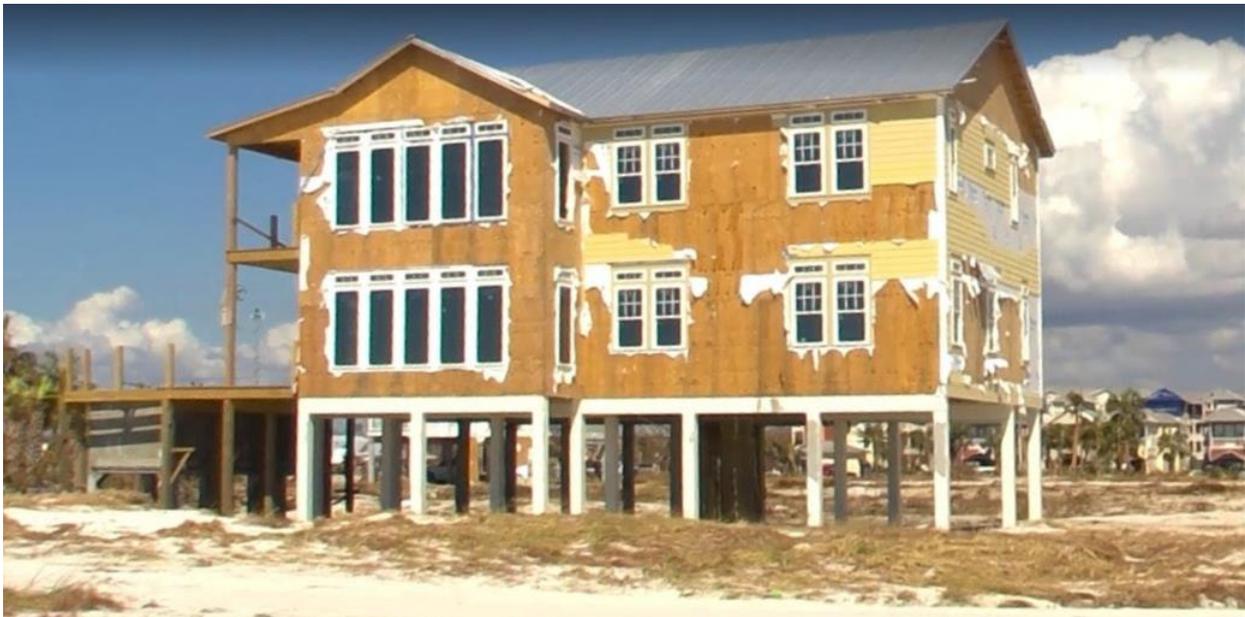
Figure 2-15. Evidence of a structure with little apparent concrete foundation structural damage located at 114 S 33<sup>rd</sup> Street

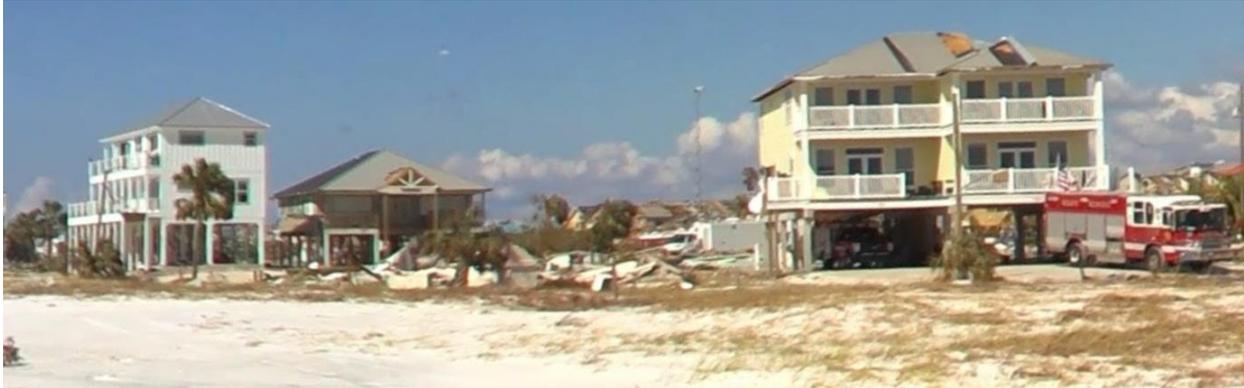
Figure 2-16. Evidence of two structures with apparent concrete foundations and little observable damage located at 114 S 35 Street (right structure) and 117 S 36<sup>th</sup> Street (left structure)

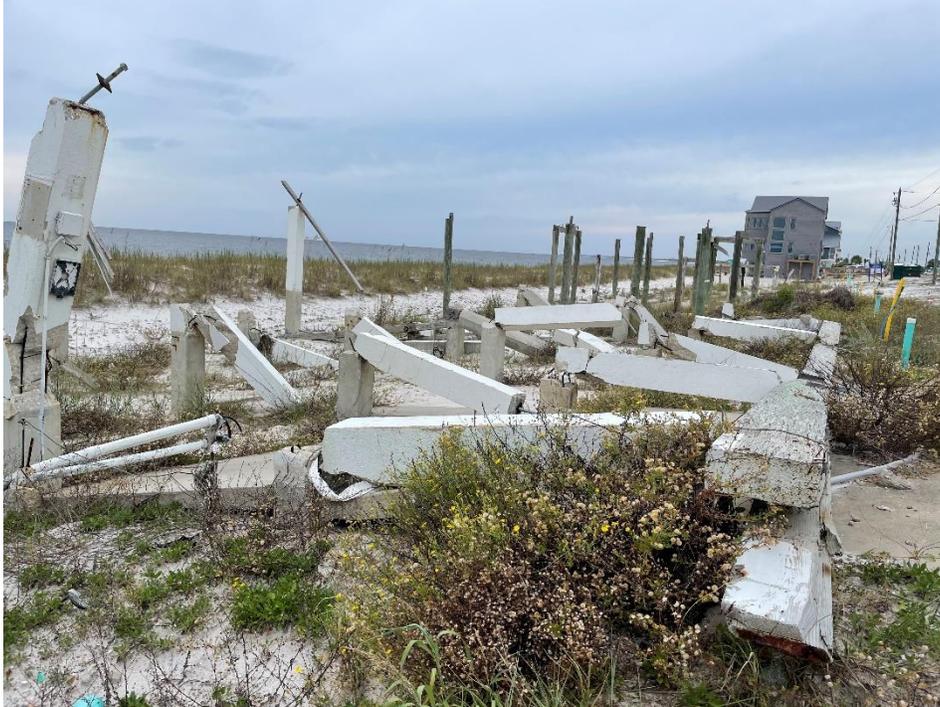
Figure 2-17. Site visit data from 1101 FL-30/US-98 showing overview of remaining debris

While either the 1101 FL-30/US-98 or the 112 S 31<sup>st</sup> St. properties could be used for subsequent analysis, investigators reasoned that the purpose of this project was to investigate “failure.” As such, subsequent investigation focused on the property located at 1101 FL-30/US-98. As shown in Fig. 2-17 through Fig. 2-24, the piles at 1101 FL-30/US-98 appeared to fail via insufficient bending moment capacities. Furthermore, analysis of the paint along the pile-lengths appeared to show that the location of these moment failures was very close to a grade-level slab that had been installed around the piles. This is particularly evident in Fig. 2-18 through Fig. 2-22 where, as shown, breakage appears to have occurred very close to the paint-line. Using Google (2022) historical image data, previous images of the structure at 1101 FL-30/US-98 were obtained (see Fig. 2-28 through Fig. 2-31). As shown in the historical images, the piles are clearly painted white above grade-level and a slab was clearly installed around the piles.

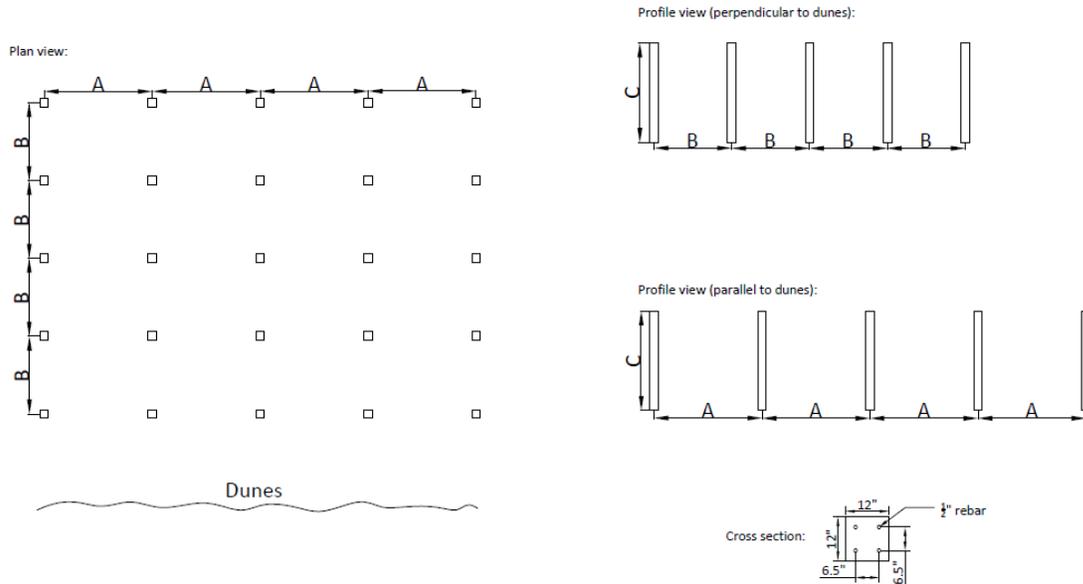
Figure 2-25. Sketch of pile layout at 1101 FL-30/US-98

B (spacing perpendicular to dunes) = 108"

C (column height) = 138"

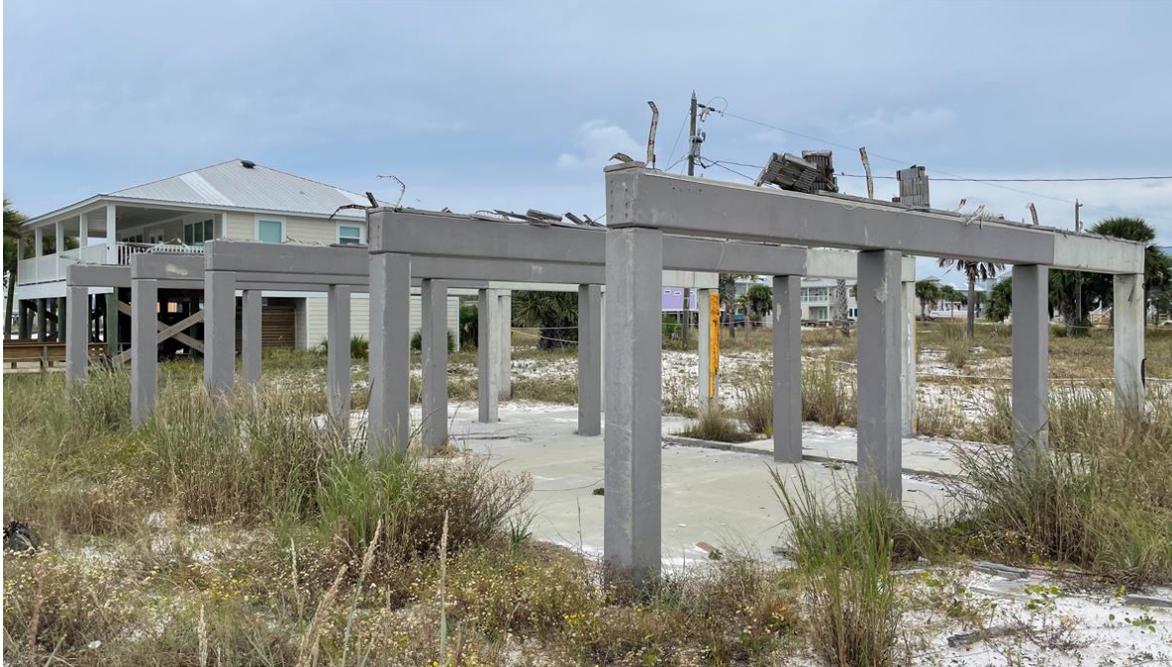
Since Hurricane Michael, the superstructure at 112 S 31<sup>st</sup> St. has been razed, but the concrete pile foundations remain (Fig. 2-26).

Figure 2-26. Remaining concrete pile foundations at 112 S 31<sup>st</sup> St.

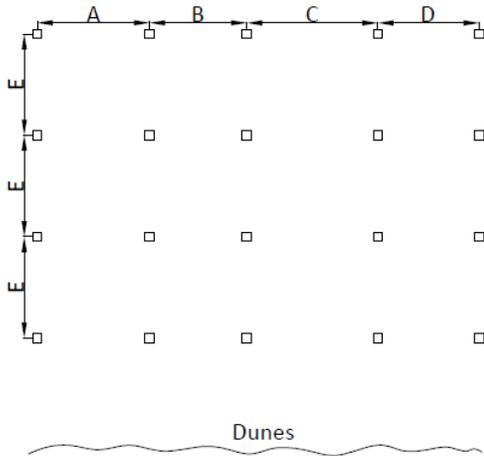
- A (parallel to dunes) = 144"
- B (parallel to dunes) = 125"
- C (parallel to dunes) = 168"
- D (parallel to dunes) = 130"
- E (perpendicular to dunes) = 130"
- F (column height) = 107"
- G (beam height) = 15.5"

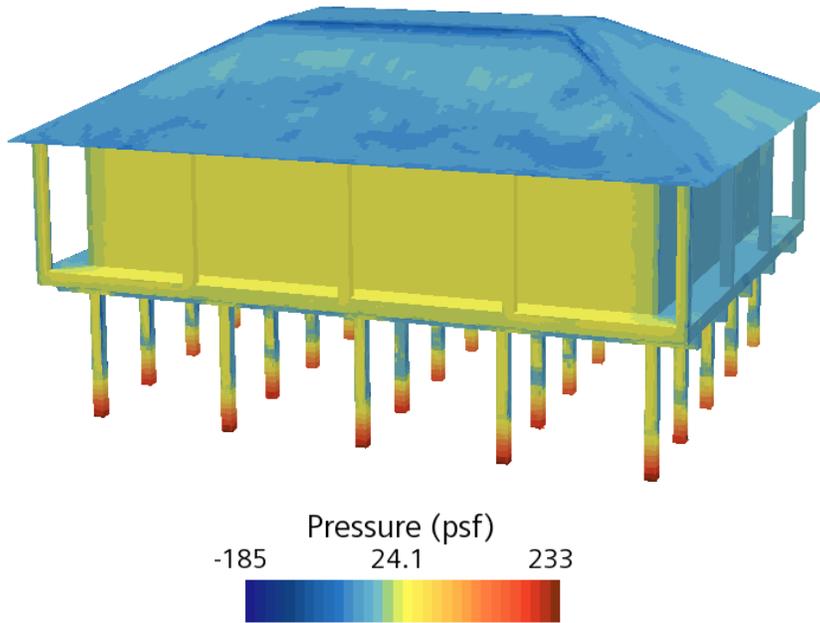
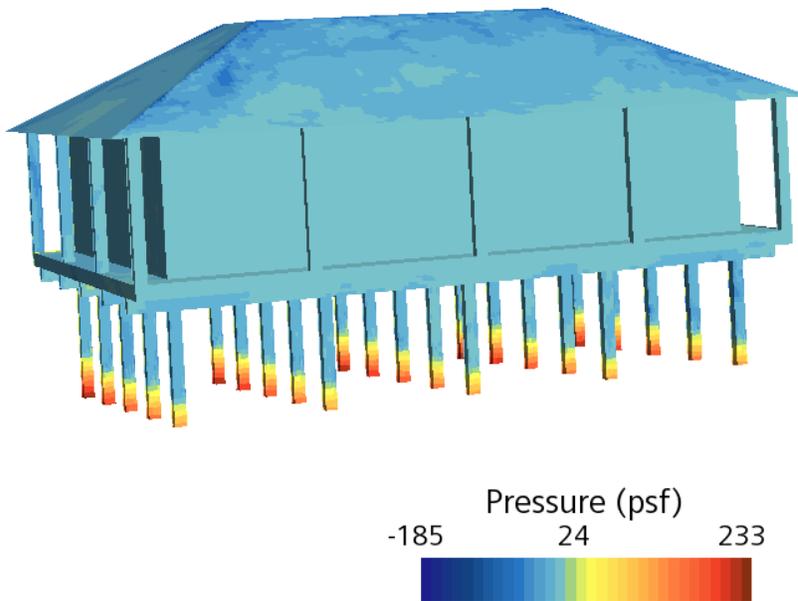
Figure 3-19. CFD pressure map on windward side of the structure

As shown in Fig. 3-18, the total force in the x-direction computed using CFD was approximately 25 k. This force is almost entirely due to the force on the walls as illustrated below in Fig. 3-19 and Fig. 3-20. Wall pressures compared well to wall pressures computed using first-level analysis. Furthermore, results indicated that ASCE7 computes a conservative value for the force on the structure. Recall that total pressure in ASCE7 is computed by adding the external pressures to the internal pressures. Since it is not possible to model internal pressures in CFD, the correct basis of comparison between the two methods is to compare the external pressure only. On the windward side of the structure, neglecting internal pressure, ASCE7 returns external pressures that range between 32 psf and 34 psf. On the windward structure face, CFD returns external pressures between approximately 25 psf and 36 psf. On the leeward side of the structure, ASCE7 returns a pressure of -20 psf compared to pressures ranging from -15 psf to -10 psf from CFD. Again, it is important to note that these results were obtained using a 175-mph wind speed compared to a 140-mph basic wind speed from ASCE7. Overall, then, for wall pressure, one may conclude that ASCE7 performs well/conservatively when compared to results from CFD.

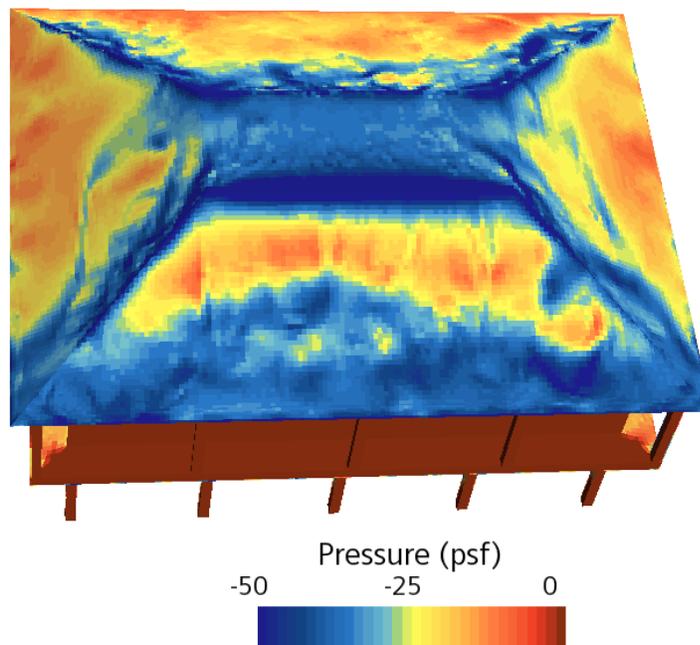
Figure 3-21. Close-up pressure map on structure roof (wind speed was from top-to-bottom)

A close-up of the structure's roof (Fig. 3-21) shows that CFD predicted the wind forcing on the structure to consist of an uplift force that acted in the net negative direction away from the structure. This contrasts with results from ASCE7 in the sense that ASCE7 predicted that the roof forcing would add to the lateral force on the overall structure (i.e., act in the positive x-direction). As such, the data suggest that ASCE7 performs well/conservatively for this structure when compared to results from CFD in the context of lateral loading on the structure.

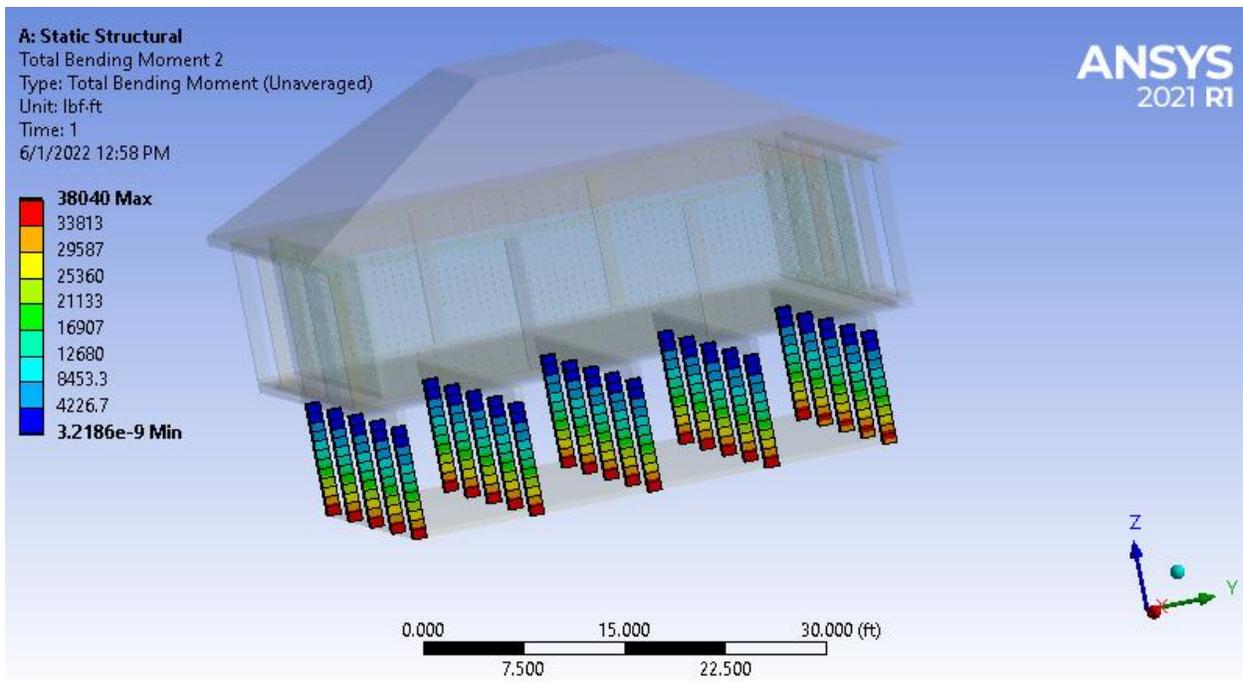
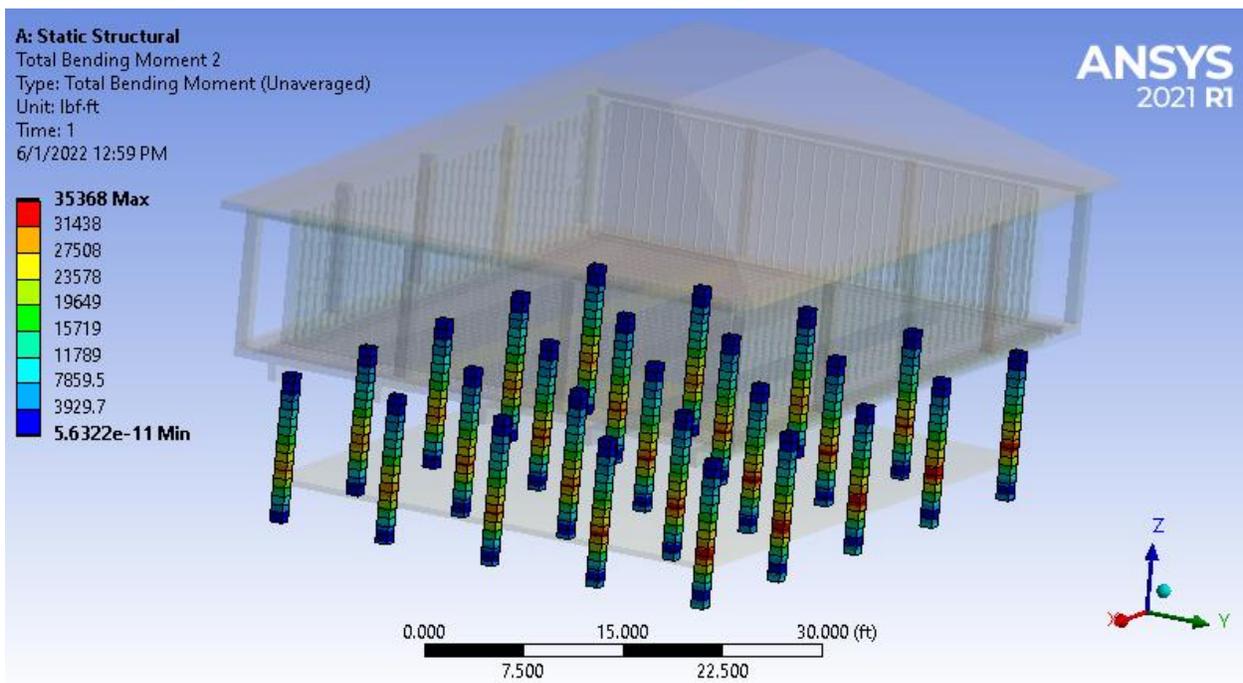
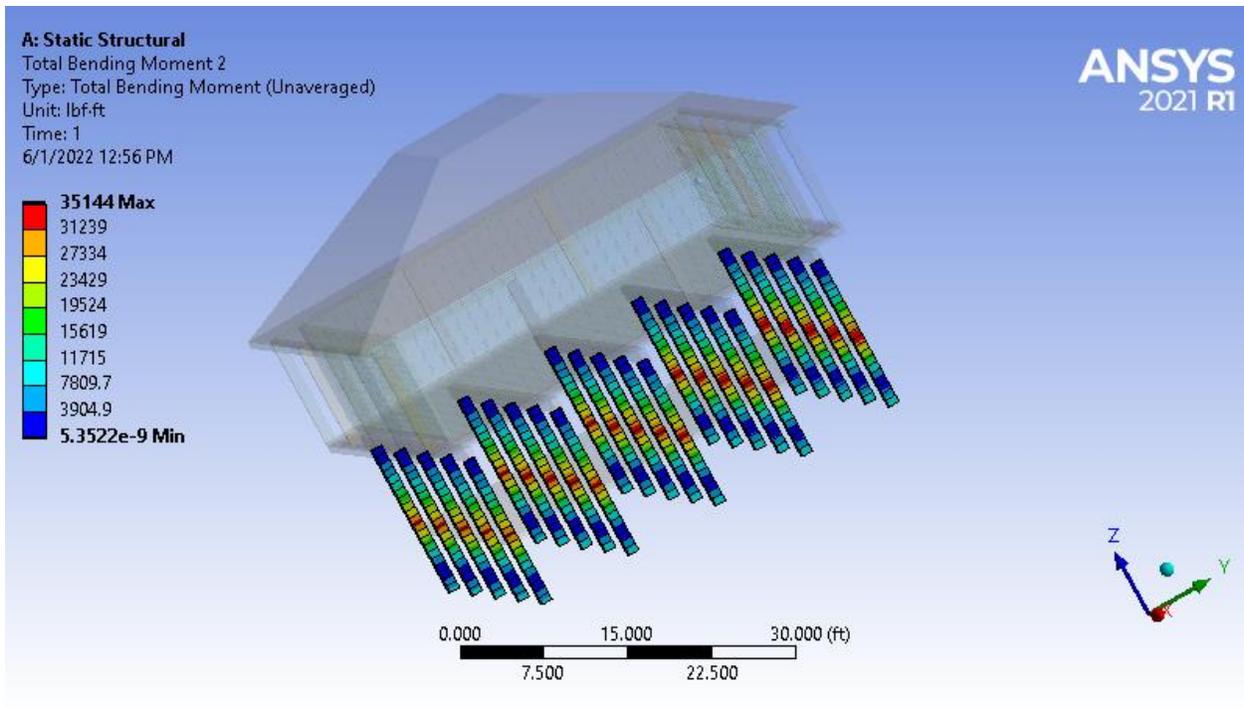
Figure 4-3. Results from model FEA1

Results from FEA modeling showing internal moment contours are presented below from Fig. 4-3 through Fig. 4-13. These results were compared with moment capacity computed in Section 3.1 (i.e., 78 k-ft). As shown in these figures, failure is dependent upon three variables – initial water level, scour depth, and whether the grade-level slab was connected to the piles. If the initial water level was presumed to be +15.6 ft NAVD, then the structure does not fail if the grade-level slab was connected to the piles (Fig. 4-3 through Fig. 4-5). On the other hand, when the same slab geometry was used and the water level was increased to the highest value reported by FEMA’s MAT report (i.e., 21.2 ft NAVD), then the piles always fail due to insufficient moment capacities regardless of scour depth (Fig. 4-6 through Fig. 4-8). Particularly interesting about Fig. 4-3 through Fig. 4-5 is that the *magnitude* of the maximum moment did not change significantly for a given loading scenario regardless of scour depth. Rather, the *location* of the maximum moment changed relative to its position from the gradeline. In all cases from Fig. 4-3 through Fig. 4-8, the piles’ maximum moment was experienced just above the grade-level slab, regardless of scour depth. In effect then, the grade-level slab provided a point of fixity for the piles.

Results from Task 3 imply that the reason the structure at FL-30/US-98 failed was because the water elevations were too high relative to the pile elevations. As shown in Fig. 4-3 through Fig. 4-5, if the initial water elevation was +15.6 ft NAVD, the structure would not have failed even if up to 6 ft of scour developed around the structure. On the other hand, Fig. 4-11 through Fig. 4-13 show that failure was likely at an initial water elevation of +18.4 ft NAVD; and Fig. 4-6 through Fig. 4-8 show that failure was almost guaranteed with an initial water elevation of +21.2 ft NAVD. If the structural elevation had been raised another 5 ft to 6 ft, the structure would have responded more like Fig. 4-5 in the sense that the water would have mostly passed below the structure’s first floor, and the structure likely would have survived assuming the 6-ft of scour was an overestimation and actual scour was closer to 3-ft. This may have been why the foundation at 112 S 31<sup>st</sup> St. survived the storm while the structure at 1101 FL-30/US-98 failed. Water level elevations from the FEMA MAT report are presented below in Fig. 4-1:

Scour appears to have played some role in structural response, but its effect is relatively minor when compared to the effect of water impacting the first floor of the structure. Results in Chapter 3 show that if most of the water passes below the structure’s first floor (i.e., Fig. 4-3 through Fig. 4-5), then the structure still withstands the storm. If on the other hand, the structure’s first floor elevation is too low relative to the initial water level, then the structure will still likely fail (Fig. 4-6 through Fig. 4-8 for example). Results in Fig. 4-11 through 4-13 combined with results from Fig. 4-21 imply that there is some “sweet spot” where scour would play a critical role in the sense that for a certain water elevation, failure might not occur under a 3-ft of scour (for example) but might occur under 6-ft of scour (again, for example). Thus, mitigating scour via some form of ground improvement below the structure’s grade-level slab and around the structure may have helped to mitigate failure for certain storms. But, for this storm (i.e., Hurricane Michael), results imply that even scour mitigation probably would not have prevented failure at 1101 FL-30/US-98. The relatively minor effect of scour when compared to initial water level elevation is illustrated below in Fig. 5-3 which shows results from an ANSYS model at 1101 FL-30/US-98 with 3-ft of scour, the attached grade-level slab, and an initial water elevation of +18.9 ft NAVD (i.e., only 6-inches higher than the scenario presented in Fig. 4-12).

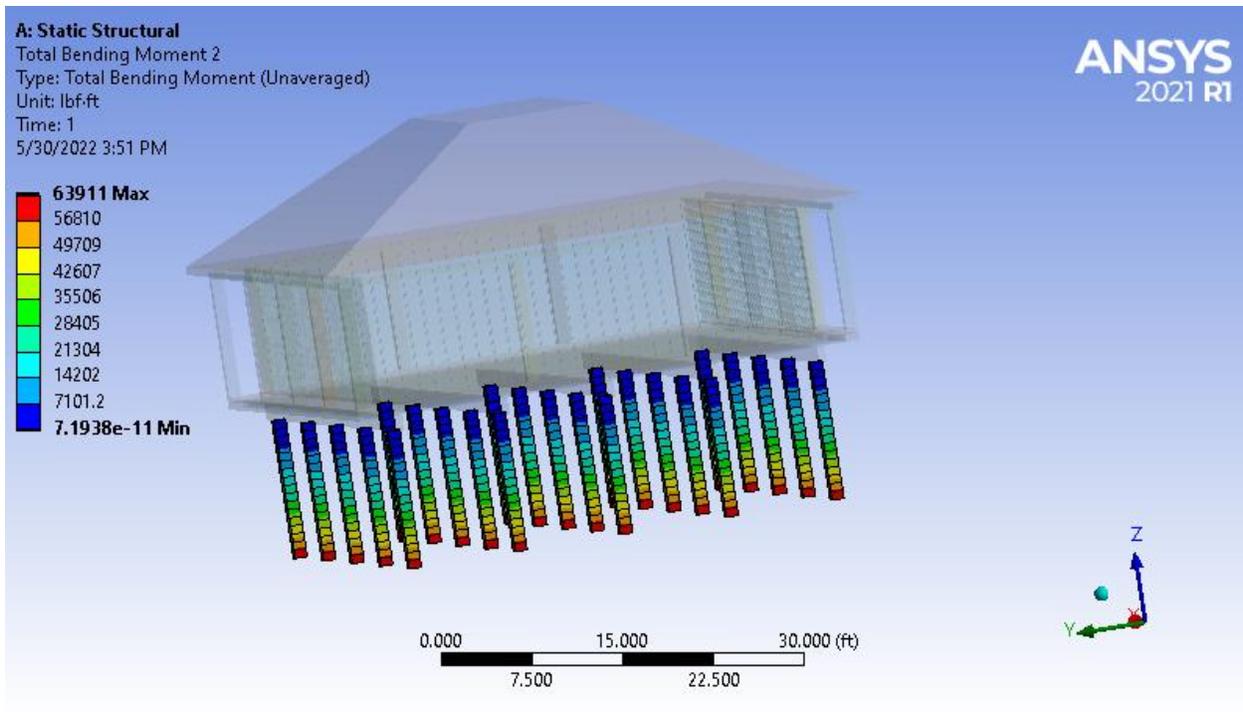
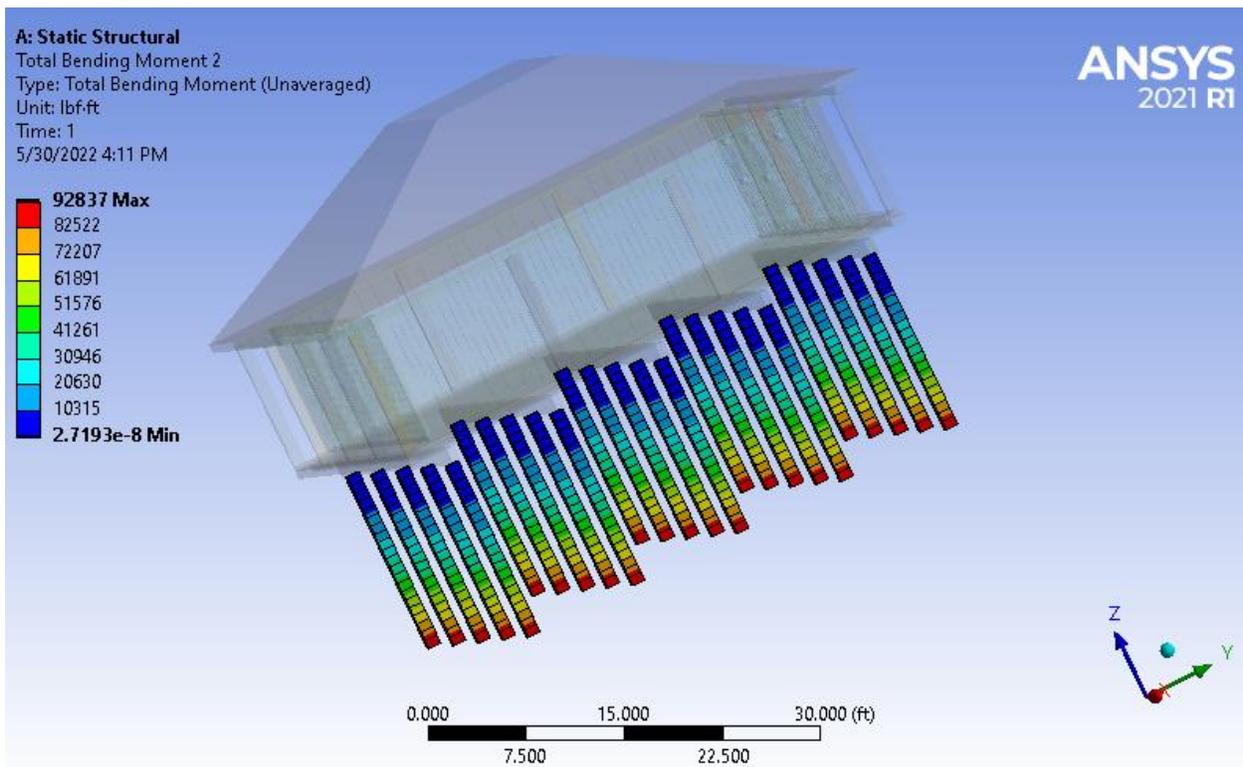
Figure 4-9. Results from model FEA202

However, when the grade-level slab was removed, scour played a larger role in terms of the maximum moment magnitude. Note in Fig. 4-9 and Fig. 4-10, results show that with an initial water-elevation of +15.6 ft NAVD and the grade-level slab “broken away,” the structure survived 6 ft of scour but not 9 ft of scour. Likewise, results in Fig. 4-3 imply that the structure would have survived with no scour. But it is important to reiterate that under an initial water-elevation of +15.6 ft NAVD, the structure *also* survived the scenario when the grade-level slab was connected. When the midpoint water level was examined (i.e., Fig. 4-11 through Fig. 4-13), the structure failed under the zero-scour condition and was very close to failure under both the 3-ft and 6-ft scour conditions.

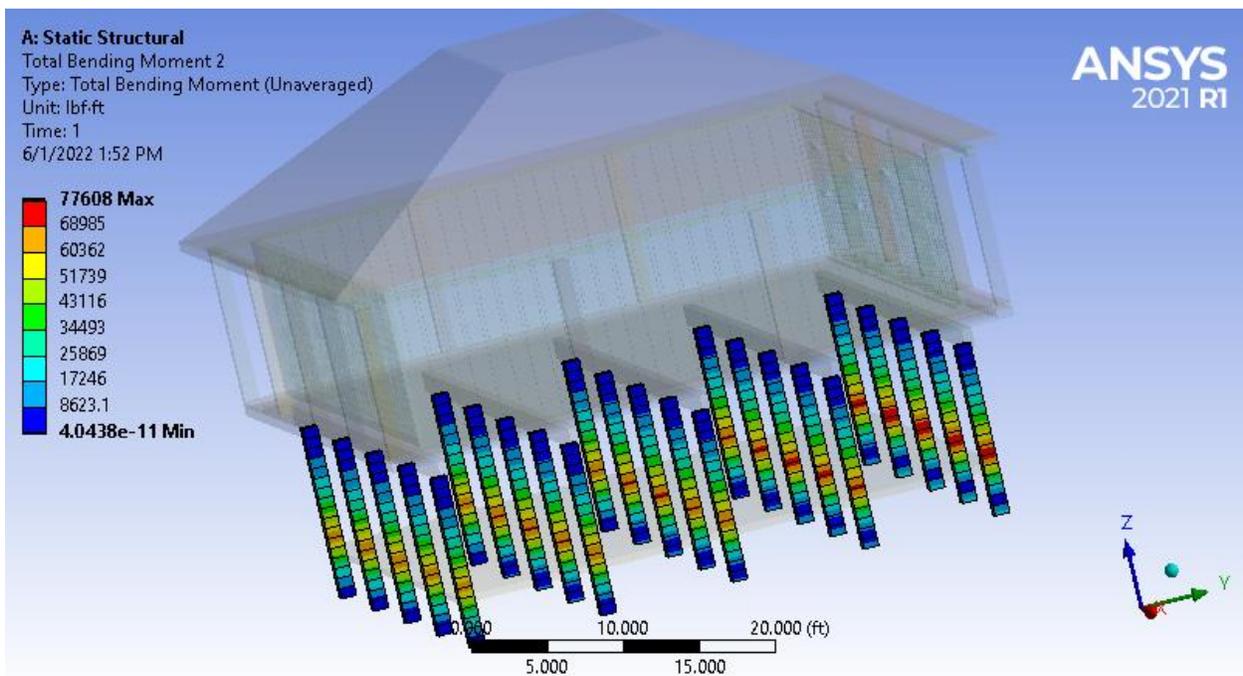
Figure 4-12. Results from model FEA302

While results in Fig. 4-12 show that the structure was very close to failure with an initial water level of +18.4 ft NAVD, results in Fig. 5-3 show that increasing the initial water-elevation by only 6-inches is enough to cause the structure to fail. Or, conversely, reiterating the conclusions from Fig. 4-21, results show that a 1-ft increase in scour only leads to an 11% increase in overturning moment.

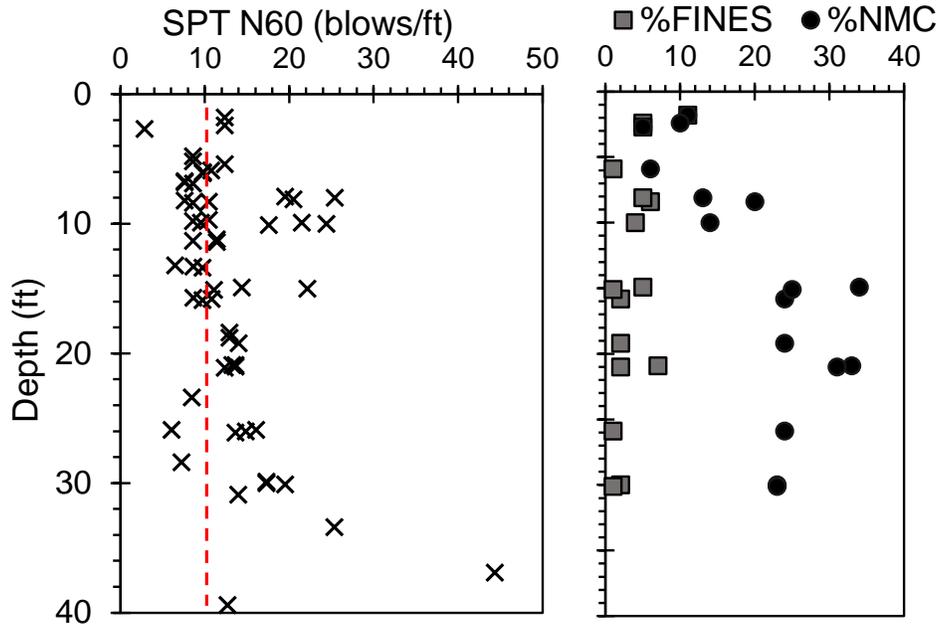
Figure 4-15. Subsurface testing data obtained from Rosemary beach site

physical and strength properties, which are used as input for the analytical solutions in GEO5. The calculated N<sub>60</sub> values for the 6 SPTs, presented as a profile with depth, is shown along with the laboratory testing results, in Fig. 4-15. Based on the subsurface testing presented, the subsurface conditions at the 1101 FL-30/US-98 site were assumed to be a medium dense clean sand with a conservative N<sub>60</sub> value of 10 blows/ft for the entire testing and modeling subsurface space.

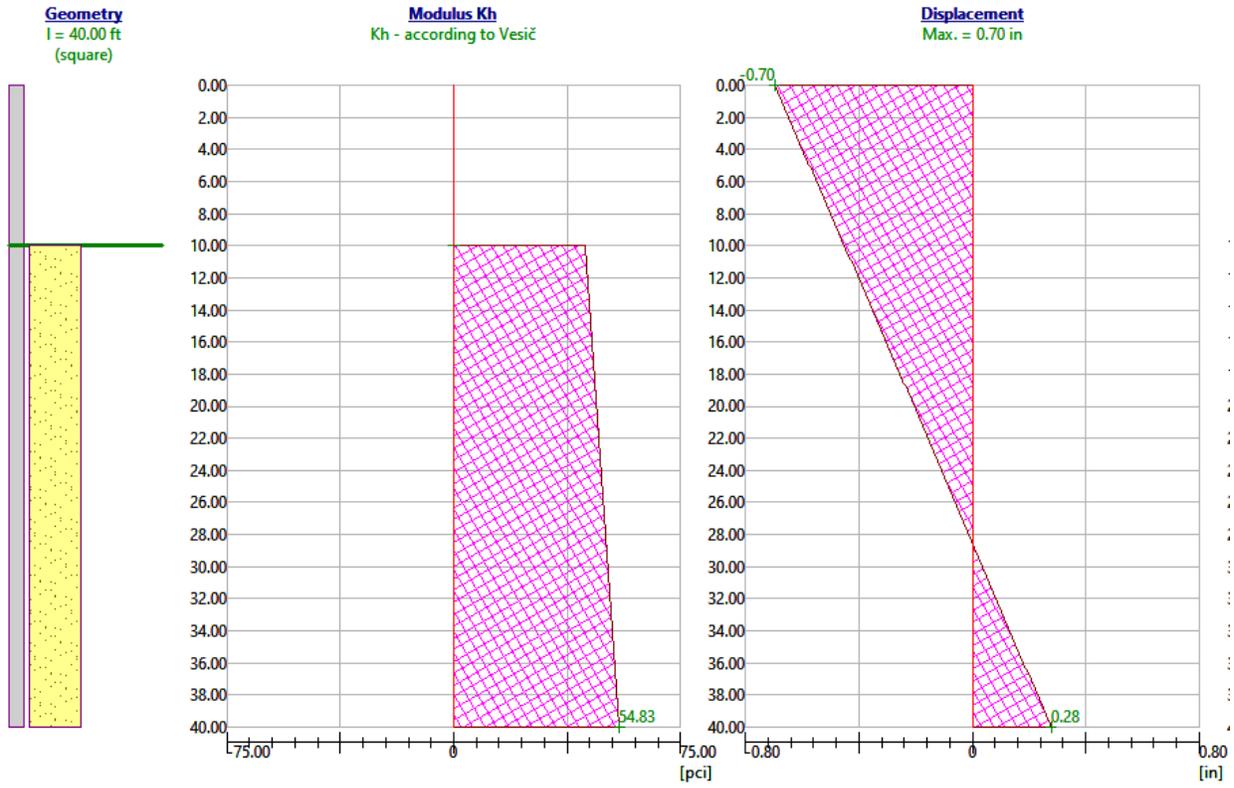
Figure 4-17. GEO5 analysis output showing max lateral displacement from RIGID pile as indicated by linear displacement profile.

The initial scope of GEO5 pile analysis was to determine if any potential lateral displacement of the pile occurred during Hurricane Michael. For this analysis, the RIGID pile was first applied to directly measure the soil response. Three separate loading scenarios were applied in this step: 100 k (4 kip/pile), 300 k (12 k/pile) and 400 k (16 kip/pile), all based to cover the minimum, expected, and high values of loading due to Hurricane Michael. In all loading scenarios, a truly rigid response was observed as shown from the linear displacement profile (e.g., Fig. 4-17).

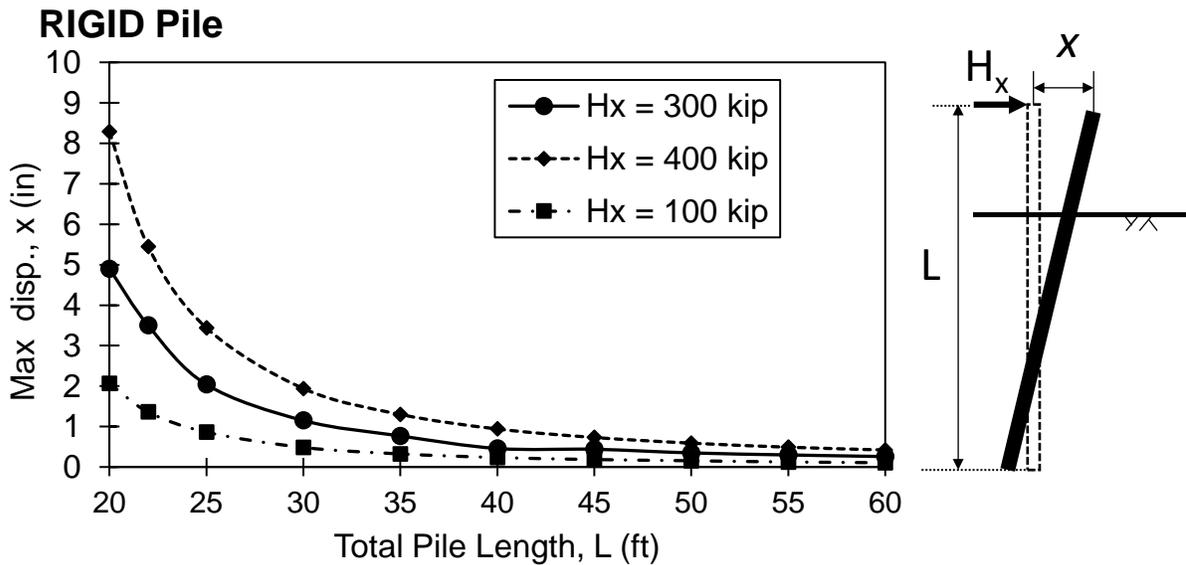
Figure 4-18. Recorded maximum horizontal pile displacement for varying horizontal loading and total pile length.

As anticipated, lateral displacement of the pile, when modeled as a rigid member, is a function of the total length of the construction pile. Analysis shows there is a convergence of recorded displacement for the full range of anticipated storm loading once the pile reached a total length of 35 ft. Note: displacements values are shown in inches while the total pile lengths are provided in ft. Therefore, at a pile length of 35 ft. The anticipated distortion of the pile (i.e., the displacement per length) is between  $1/280$  to  $1/850$ . The minimal observed displacement with a rigid pile suggests that the soil bearing capacity was not a major contributing factor to the failure of the pile.

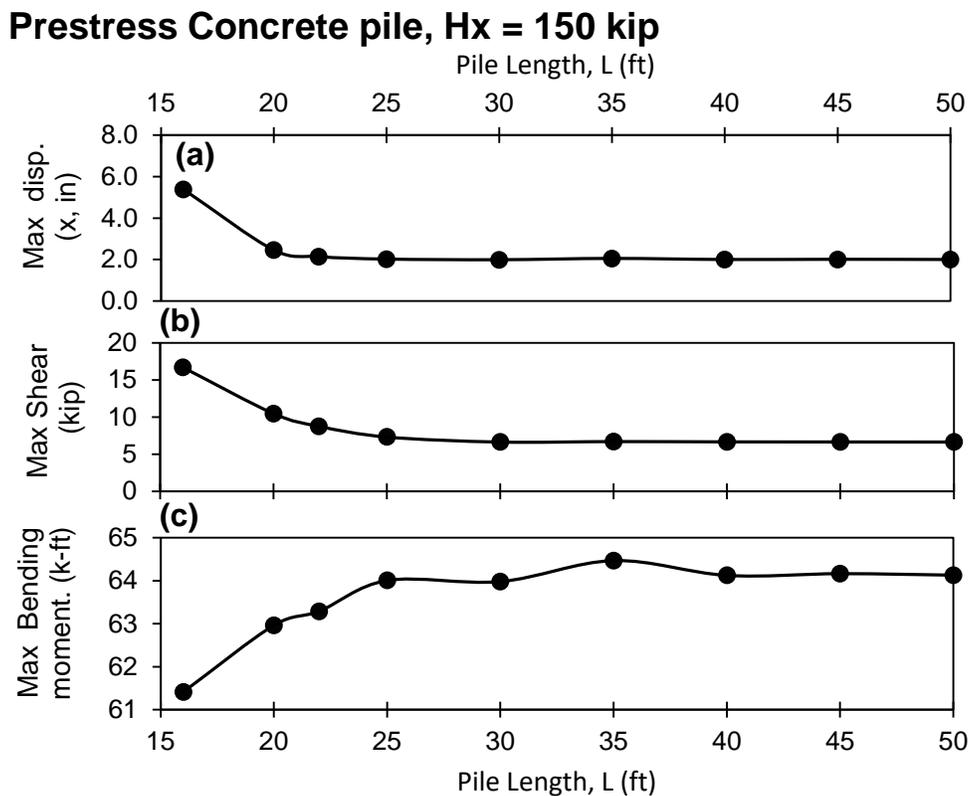
Figure 4-19. Analysis results for the prestressed concrete pile with Hx =150 kip showing (a) maximum horizontal displacement, (b) maximum internal shear, and (c) maximum bending moment within the pile, as a function of modeled pile length.

was satisfactory in shear resistance but failed in bending for all three loading conditions. Although the observed failure in the piles located at 1101 FL-30/US-98 did not match the maximum bending from the GEO5 analysis, the occurrence of scour and the addition of the point of fixity from the superstructure was not analyzed in depth for this task.

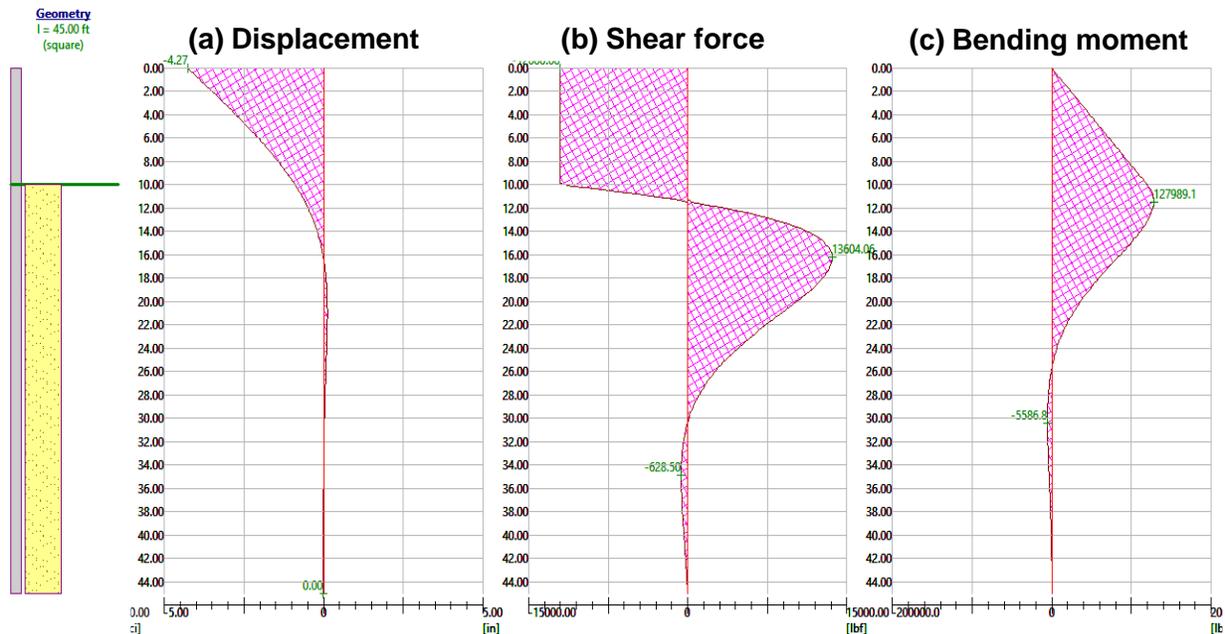
Figure 4-20. Example of results from GEO5 for prestressed pile with  $L=45$  and  $H_x = 300$  kip

It was observed that, regardless of the loading and the pile length, the maximum bending moment occurred at approximately 0.5 ft below the grade-level. As noted previously, the piles at the 1101 FL-30/US-98 appear to have all failed in bending at a location at or above the grade-level slab. As previously mentioned, the GEO5 pile analysis presented thus far differs from the “real-world” condition by not including any additional reaction forces (and subsequent addition to the pile stiffness) from the grade-level slab nor the superstructure. Moreover, several feet of scour were known to have occurred during the storm event. Although the contributions of the grade-level slab and the superstructure are not able to be modeled using the GEO5 software, the scour could be modeled by incrementally lowering the grade line in the model domain.

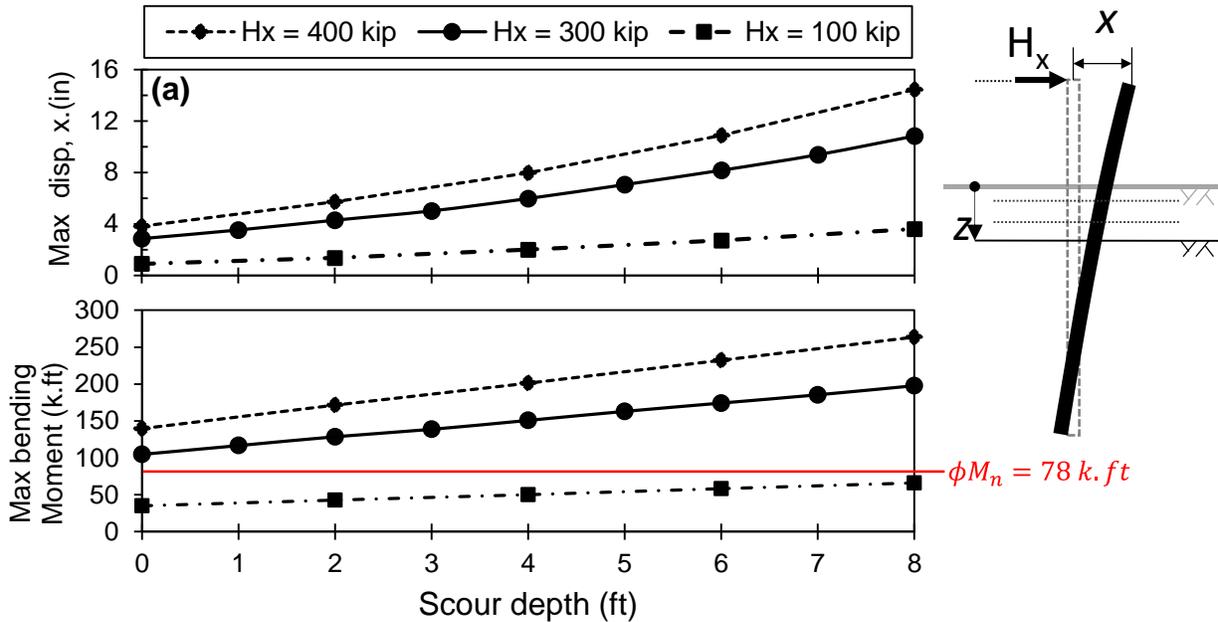
Figure 4-21. Analysis results for the prestressed concrete pile with assumed pile length of 35 ft, showing (a) maximum horizontal displacement and (b) maximum bending moment within the pile, as a function of scour depth.

As shown in Figure 4-21, both the displacement and max bending moment increases for all three loading scenarios, as scour depth increases. If the maximum bending moment trend is normalized, it is observed that 1 ft of scour will increase the maximum moment by 11%.

- For a 35-ft pile with an initial exposed pile of 10 ft, every foot of scour will increase the calculated maximum moment bending by 11%, regardless of loading conditions. Although not necessarily accurate for the structure in this study, this type of analysis can provide an estimation of critical conditions which will produce bending moments exceeding the piles capacity.

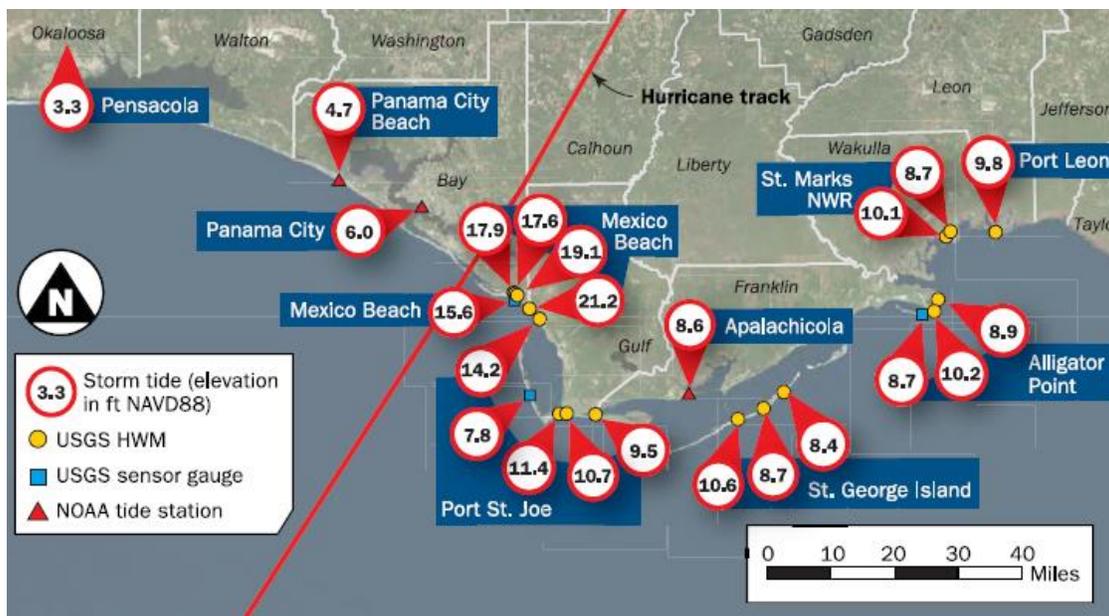
Figure 5-1. Water level elevations from FEMA MAT report

Note that in Fig. 5-1, the +21.2 ft NAVD approximate water-elevation appeared to be relatively localized. If the water elevation at 112 S 31<sup>st</sup> St. had been just slightly lower, there may have been sufficient space between the water and the structure to prevent failure – see Fig. 5-2 below, for example:
