# Final Report

## Evaluation of Concrete Pile Foundations During Hurricane Michael

Raphael Crowley, Ph.D., P.E.  
Principal Investigator  
Associate Professor (Coastal and Port Engineering)

Taylor Engineering Research Institute  
School of Engineering  
University of North Florida  
1 UNF Drive  
Building 4, Room 1501  
Jacksonville, FL 32224

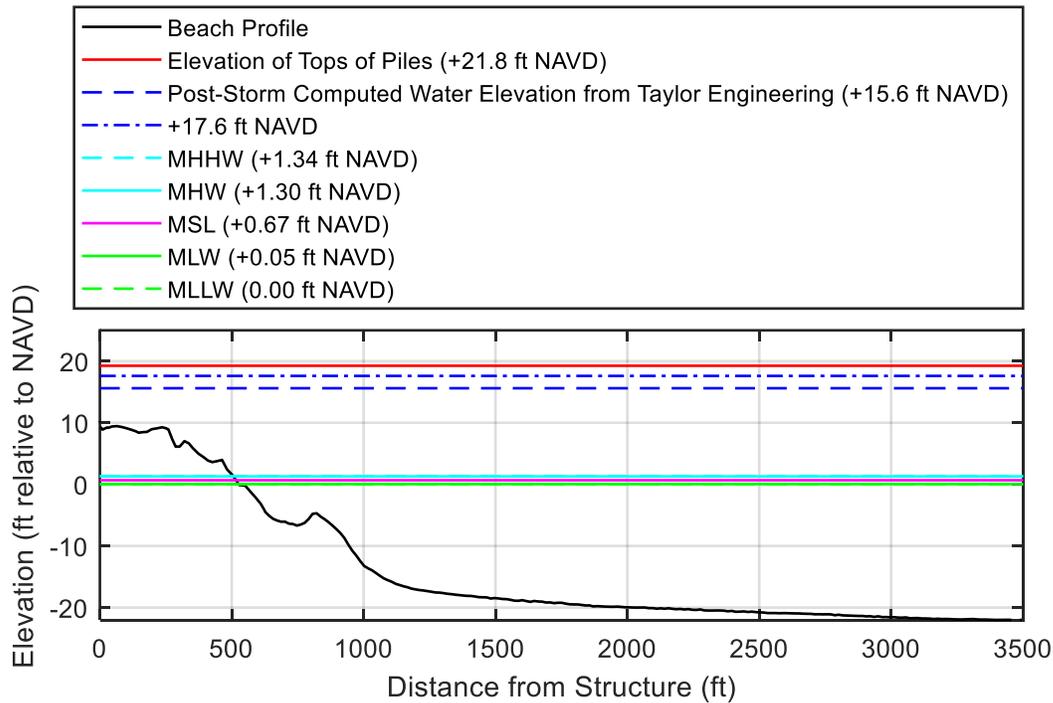
Figure 5-2. Beach profile near 112 S 31<sup>st</sup> St., Mexico Beach showing a presumed worst-case water level of +17.6-ft NAVD

Note that in Fig. 5-1, the +21.2 ft NAVD approximate water-elevation appeared to be relatively localized. If the water elevation at 112 S 31<sup>st</sup> St. had been just slightly lower, there may have been sufficient space between the water and the structure to prevent failure – see Fig. 5-2 below, for example:

When analyzing these scenarios, it is important to reiterate that even the best-case +15.6 ft NAVD initial water-elevation is still greater than a 500-year storm return period, and a 500-year return period is much greater than the 100-year return period specified by the Florida Building Code or its reference to ASCE24, Chapter 4.

Alternatively, if one did not wish to build the structure higher, one could instead use more longitudinal reinforcement in the piles. For example, if one increased the number of prestressing strands in the piles from 4 strands to 6 strands, each pile’s design moment capacity would increase from 78 k-ft to 89 k-ft (i.e., increase  $A_{ps}$  in Section 3.1). This would mitigate failure under the +18.4 ft NAVD elevation scenario, although the structure may have still failed under the +21.2 ft NAVD elevation scenario.
