Testing 21053 4831 SW 168 Ave Southwest

F+E | LC#18-0524.01 - ASTM E1105 Field Water Infiltration Test

Description Test Report Number S001-T001

Specimen Name	S001-T001
Product Description	Series "Barcelona" Model "TSL30I" Triple Horizontal Window
Product Manufacturer	Soft-Lite Windows
Configuration	X/O/X
Overall Dimensions	73" L x 49" H
Location Within Building	1st Floor East Elevation , Living Room
Approximate Age of Specimen	New
General Physical Conditions	Good

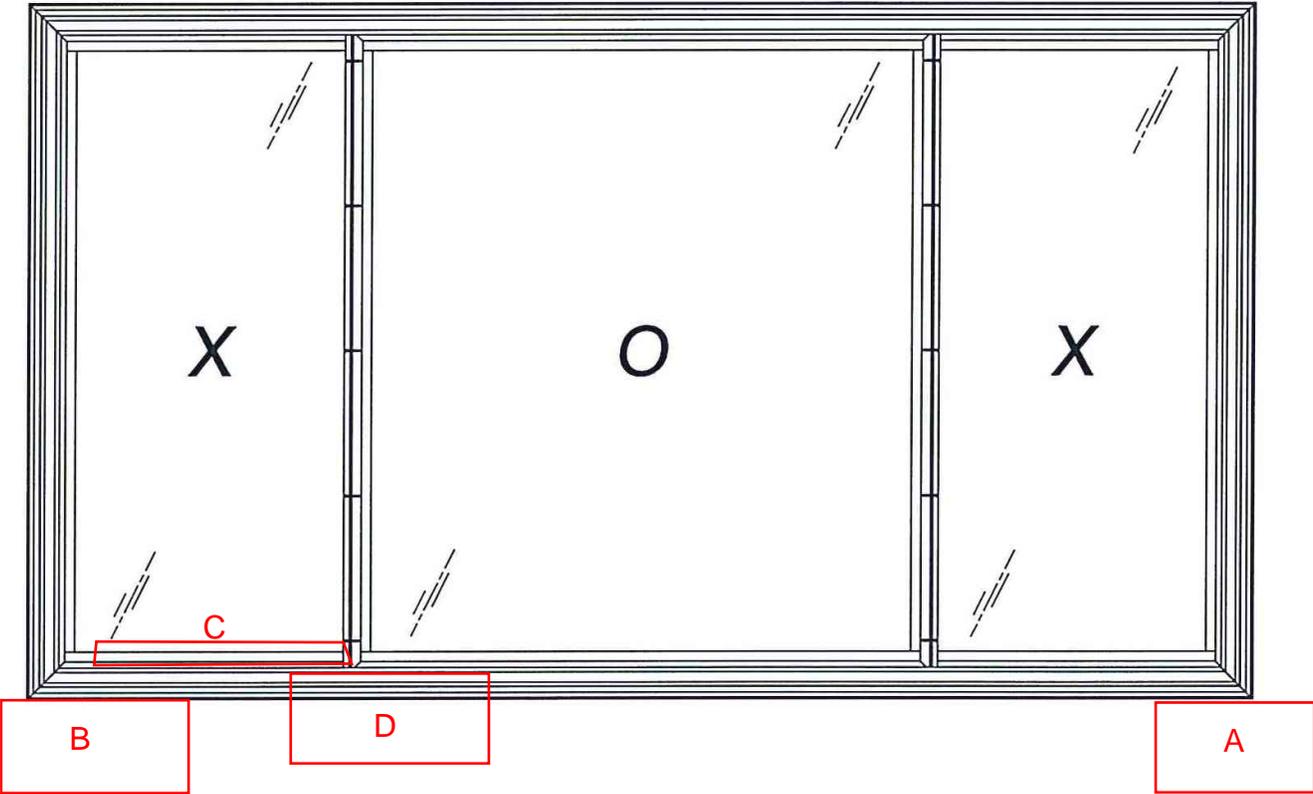
Test Specimen Drawing (Attachment 2)

Item	Description
A	During test T001A, water infiltration was observed entering under the frame sill bottom right corner approximately one (1) minute into test.
B	During test T001B, water infiltration was observed entering under the frame sill bottom right and left corners approximately three (3) minutes into test
C	During test T001C, water infiltration was observed entering through the glazing pocket of the left operable vent approximately one (1) minute into test.
D	During test T001C, water infiltration was observed overflowing the frame sill at the bottom left corner approximately two (2) minutes into test.
