**From:** Soto, Rolando <ROSOTO@broward.org>  
**Sent:** Thursday, April 20, 2023 2:55 PM  
**To:** Madani, Mo  
**Cc:** Parks, Bryan; mbeck@coconutcreek.net; Ryan Banyas - Coconut Creek FCO  
**Subject:** Toilet exhaust fan fires.  
**Attachments:** Bathroom fan code amendment.docx; FW: Ventilation Bathroom Fan Fires; Eutectic-TCO-Report-6b6-cleared-cleaned-January-2018-version (1).pdf; google search.docx

Bathroom fan code amendment.

# CPSC Staff Assessment on Eutectic-Type Thermal-Cutoff Fuse Failures in Shaded-Pole Motors Used in Exhaust Fans

December 2017

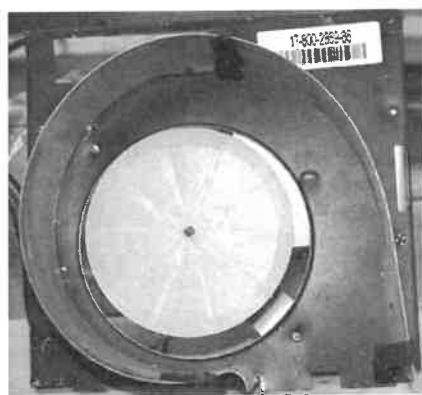
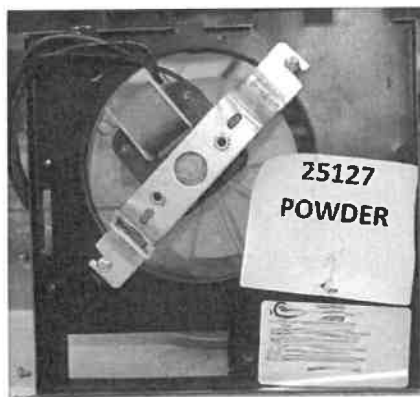
Figure 1. Fan assembly for “box” type housing

The majority of the incidents (75 percent, 318/423) involved bathroom/restroom exhaust fans. Where photographs were available, the fans appear to have similar construction. The exhaust fans contain an external housing, a motor, an impeller, and a grill cover. The exhaust fans may incorporate a light option, but the incidents did not report the lighting assembly as the cause of the incident or fire. The “box” type exhaust fans contain a box housing that is mounted to the building structure. A fan assembly is mounted in the box housing. The fan assembly typically contains a mounting frame, fan motor, impeller, and power cord as shown in Figure 1. The box housing contains the electrical connections for the fan and light option and connection for the ducting.

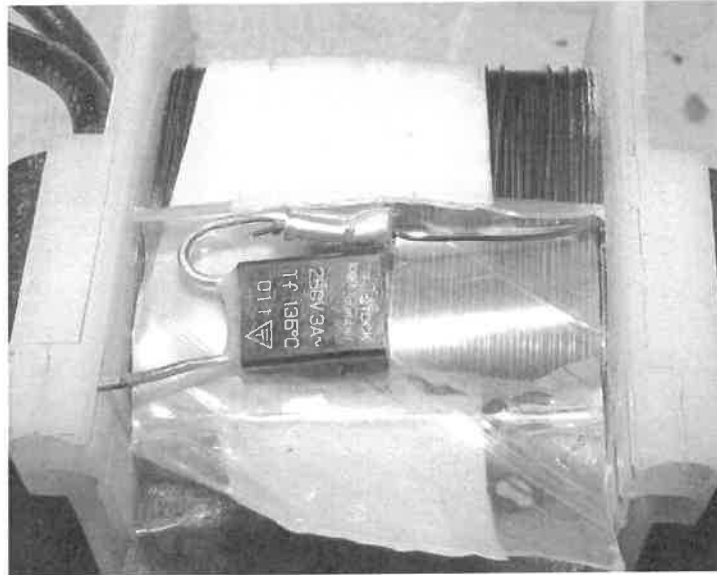
Figure 6. Radial eutectic-type thermal fuse in the sample fans

All the fan samples contained radial eutectic-type thermal fuses. The fuses are marked with a functioning temperature of 136°C and rated for 250V 3A, as shown in Figure 6.

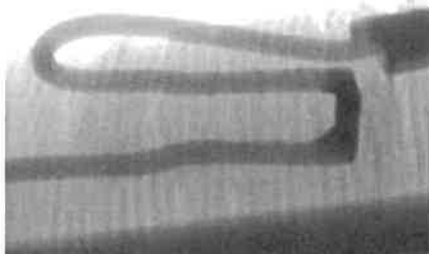
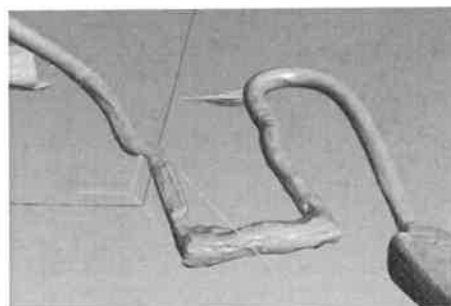
Figure 7. Smooth and uniform solder linkage (Sub 44)

All 100 TCOs in the fans were x-rayed and 3-D imaged by computed tomography (CT). CT imaging can reveal detailed images of the internal TCO without destructive analysis. The CT scan allows cross-sectional details of the thermal linkage that cannot be seen in conventional radiographs by X-rays. The thermal linkage connects the two wire leads, as shown in the radiograph and CT images in Figure 7. In the examined thermal linkages in the fan samples, the thermal linkages varied with the shape of the linkage, such that some of the linkages were not uniform, as shown in Figure 8. It is unknown if the variations were caused from manufacturing or usage before collection.

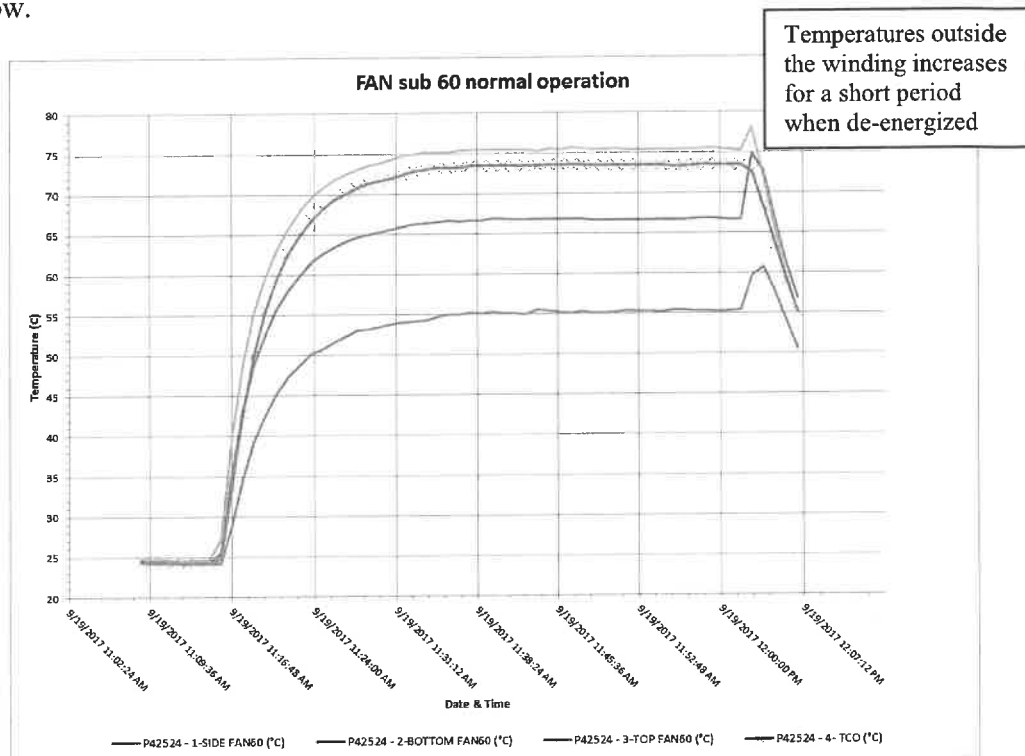
Figure 11. Temperature measurements on the winding and within the TCO (Fan 60)

The testing showed that the TCO's internal temperature for this freely spinning motor with impeller is about 73°C. The thermocouple at the top of the winding measured slightly higher, at 76°C, than the TCO temperature as shown in Figure 11. When the fan was de-energized, the thermocouples located on the winding wrap measured an increase in the winding temperature because of the lack of airflow over the thermocouples when the

impeller stopped spinning. The temperature within the TCO did not measure the same increase in temperature when the fan was de-energized. This is most likely caused by the TCO being located below the wrap, which caused the TCO not to be affected by the airflow.

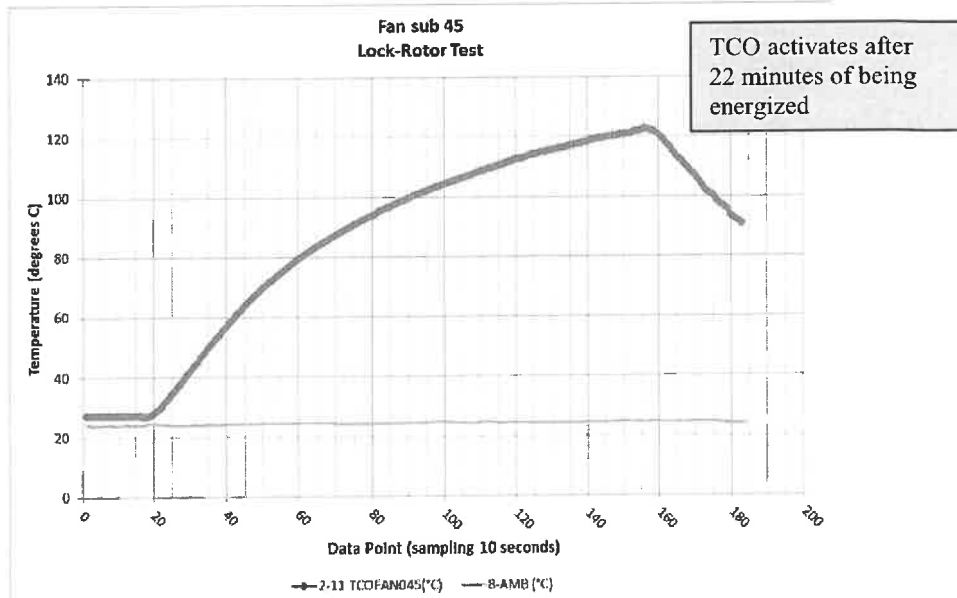
Figure 13. Sub 45 temperature measurement outside the winding

Fan sub 45 rotor did not turn freely in the condition in which it was received because of what appears to be dust and grime build-up at the bearings. When the sample was energized, the impeller/rotor did not spin; thus, it was in “locked-rotor” condition. Figure 12 shows sub 45 before any testing.

The fan was tested in its as-received condition, *i.e.*, locked-rotor condition. A single thermocouple was placed on the side of the winding, on the outside of the wrap, adjacent to the TCO location. After being energized, the TCO activated after 22 minutes, as shown by the temperature traces in Figure 13. For the location of this thermocouple, the temperature shows a maximum of 120°C, but this location is about 20°C cooler than the actual TCO or at the top of the winding. The actual TCO functioning temperature ( $T_f$ ) was calculated to be about 140°C ( $120^\circ\text{C} + 20^\circ\text{C}$ ), which corresponds closely to the  $T_f$  of 136°C. This testing in lock-rotor condition also verified that the side thermocouple measurements on the paper wrap were about 20°C lower than the actual TCO or the top of the windings. Figure 14 shows the radiographs of the TCO’s fusible link after lock-rotor testing, which shows the thermal linkage melted or open.

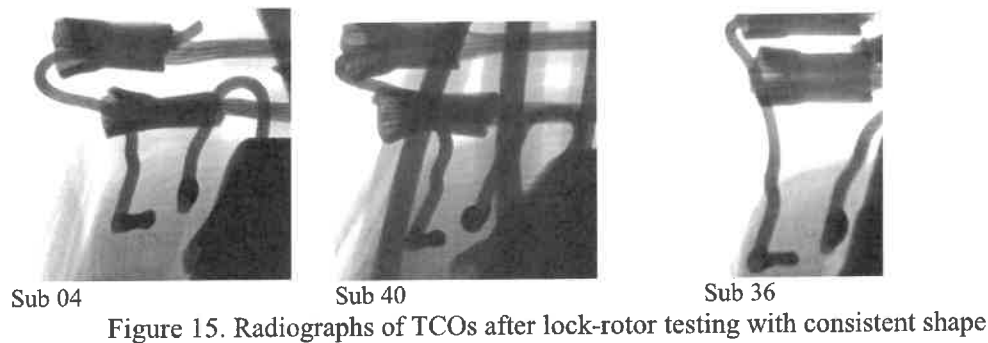
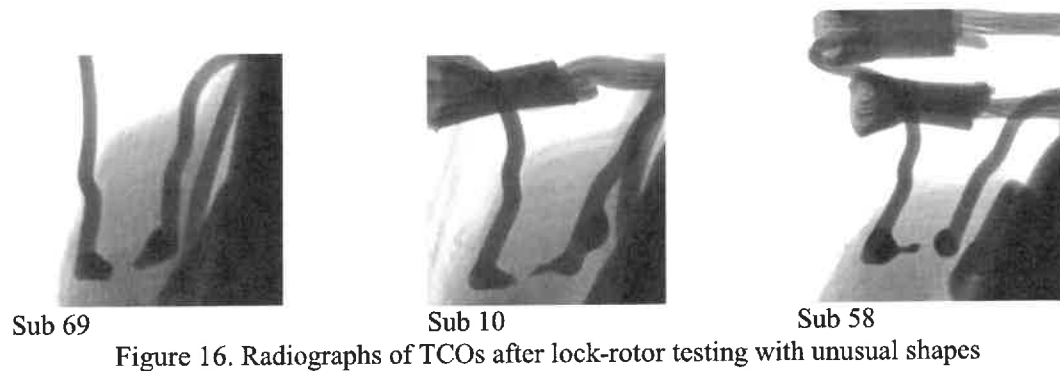
In other testing, where the TCO opened during lock-rotor conditions around the same elapsed time of 20 minutes, the thermal linkage had the same characteristic of only one end of the thermal linkage melting, as shown in Figure 15. This appeared to be caused by the TCO wire lead that is connected to the winding having a higher temperature than the wire lead connected to the power conductor. The wire lead would conduct the thermal energy from the winding during locked-rotor operation, thus causing one TCO wire lead to heat faster than the other TCO wire lead. Staff observed that for cases when the elapsed

time was longer during the lock-rotor condition for the TCO to trip, and the temperature was higher than average, the thermal linkage would have inconsistent melting patterns, as shown in Figure 16. Staff expected that the delayed opening would result in a uniform temperature gradient within the TCO, thus causing the fusible linkage to melt completely or uniformly. But this was not the case, because the thermal linkage had irregularities, which suggests that other factors may be affecting the melting characteristics of the linkage.

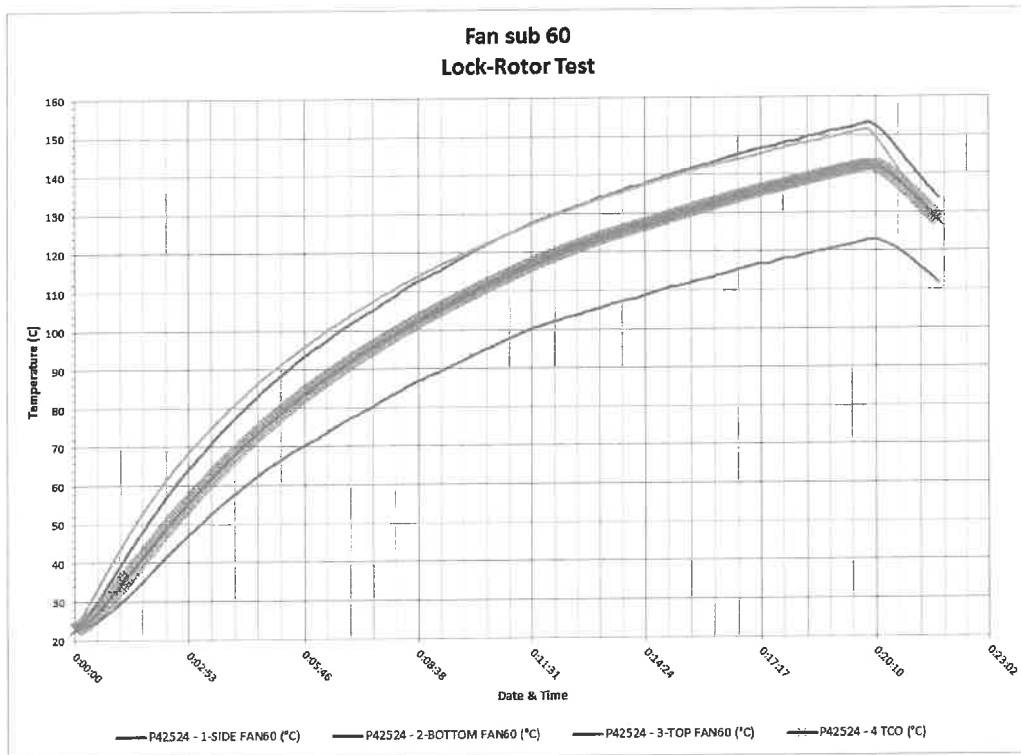
Figure 17. Temperature on the winding and within the TCO during a lock-rotor test

The same fan sub 60 that was instrumented with a thermocouple inside a TCO was used to measure the temperatures during lock-rotor conditions. Similar to the normal operation test, fan sub 60 had the three thermocouples on the paper wrap exterior of the winding and thermocoupled TCO. The lock-rotor condition was operated for 20 minutes to simulate the TCO tripping after 20 minutes in lock-rotor testing, as seen in Sub 45. After 9 minutes 12 seconds, the TCO temperature reached 105°C, as shown in Figure 17. At 15 minutes, the TCO temperatures reached 130°C. Shortly before 20 minutes, the TCO temperature reached 140°C. The TCO temperature measured approximately 142°C at 20 minutes or the manual trip time. The measurements in this test closely correspond to the sub 45 locked-rotor test. As mentioned previously, the TCO in sub 45 tripped at a measured temperature on the side of the winding around 120°C, and the temperature measured on the side of the winding in the test after 20 minutes of operation was about 123°C.

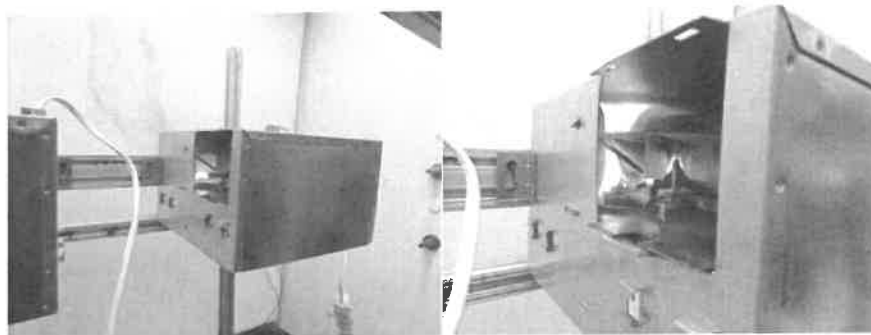
Figure 19. Bypassed TCO lock-rotor test

For the third test period, the fan was energized in the lock-rotor condition, and after about 30 minutes, the temperature increased rapidly, which resulted in smoke and flames. The thermocouple temperature traces are shown in Figure 18. The motor winding ignited, which then ignited the plastic impeller, as shown in Figure 19. The plastic impeller resulted in dripping, flaming plastic. The total lock-rotor test time was about 4.5 hours (period 1 + period 2 + period 3).

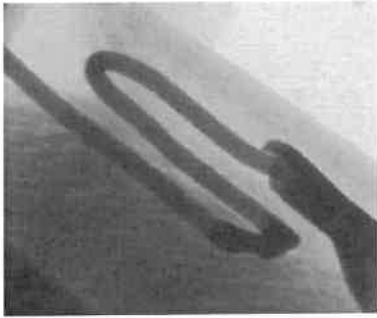
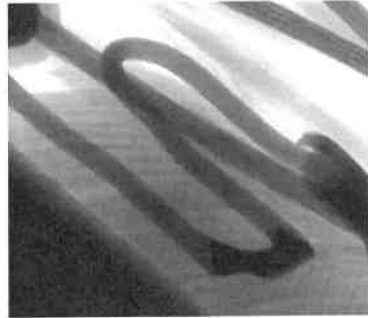
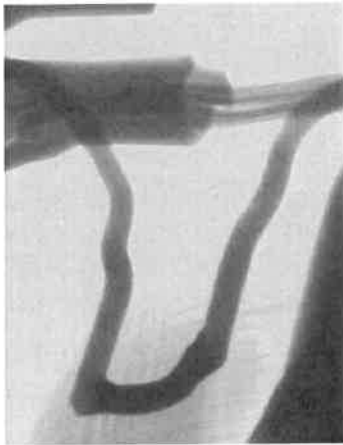
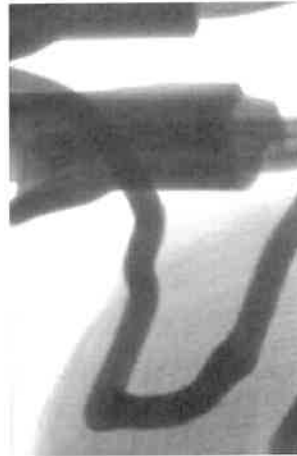
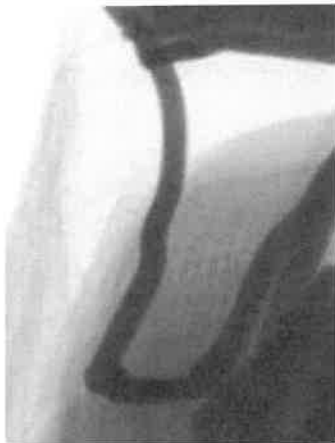
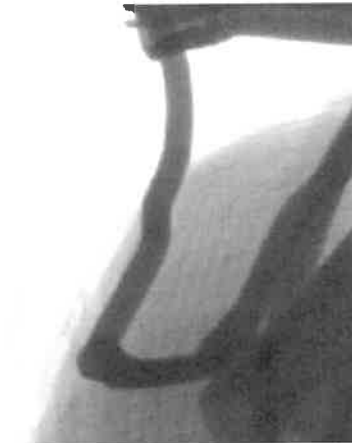
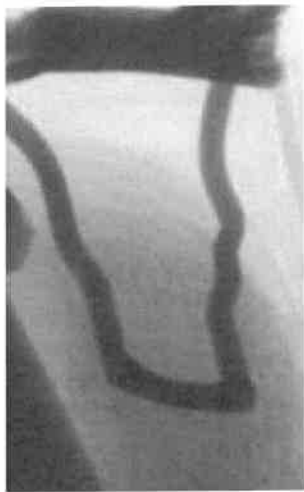
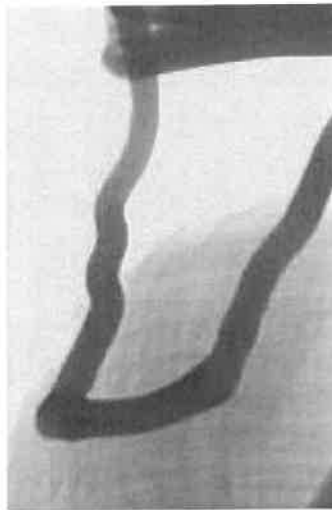
Figure 22 Thermal linkages before and after conditioning

For test group 3, all of the TCOs were x-rayed before and after conditioning. The thermal linkages did not appear visually to have changed after conditioning at 105°C for up to 305 hours. Figure 22 shows radiographs of the thermal linkages before and after conditioning for various lengths of time.

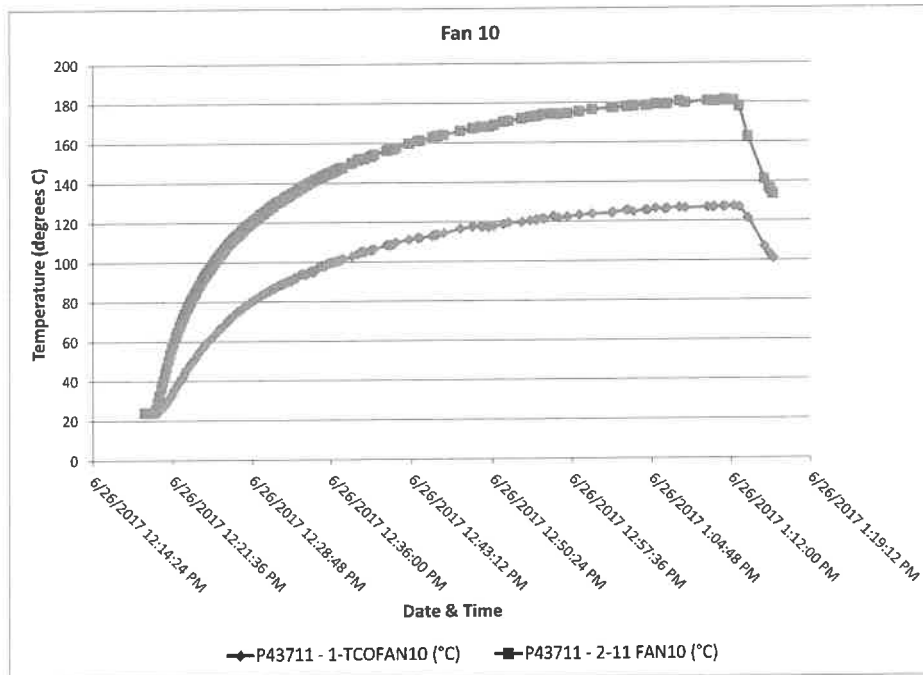
Figure 23. Temperature traces for Sub 10 Test Group 3 - Lock-Rotor Test

Staff conditioned the fan (sub 10) for 64 hours 30 minutes. During the locked-rotor testing, the TCO activated. The TCO activated approximately 52 minutes after the rotor was locked. The activation time was about 30 minutes longer than seen during typical lock-rotor testing, which activated around 20 minutes within the testing. Figure 23 shows the temperature traces for the thermocouples during the lock-rotor test.

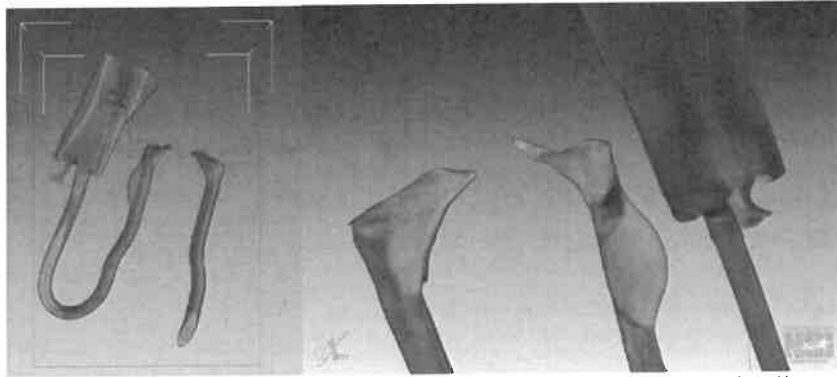
Figure 24. CT scan of the fusible link after lock-rotor testing (sub 10)

Figure 24 shows the CT scan of the fusible link after the lock-rotor test. As seen in prior testing when the trip time is longer than average, the fusible link melts at the center of the link. The figure does show a partial wetting of the electrodes occurred, which allowed the solder link to bead.

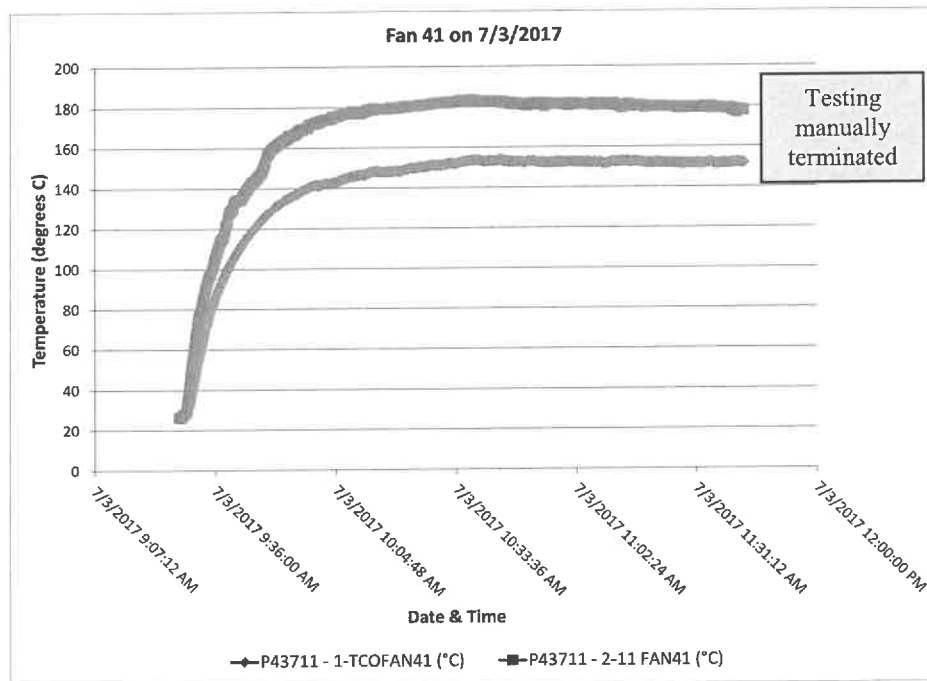
Figure 25. Temperature traces for Sub 41 Test Group 3 - Lock-rotor Test

Staff conditioned the fan (sub 41) for 232 hours 30 minutes. During the lock-rotor testing, the TCO did not activate. After about an hour, the temperature appeared to have leveled to a constant temperature or steady state. Staff terminated the lock-rotor testing after approximately 2 hours 30 minutes. Figure 25 shows the temperature traces for the thermocouples during the lock-rotor test on July 3, 2017.

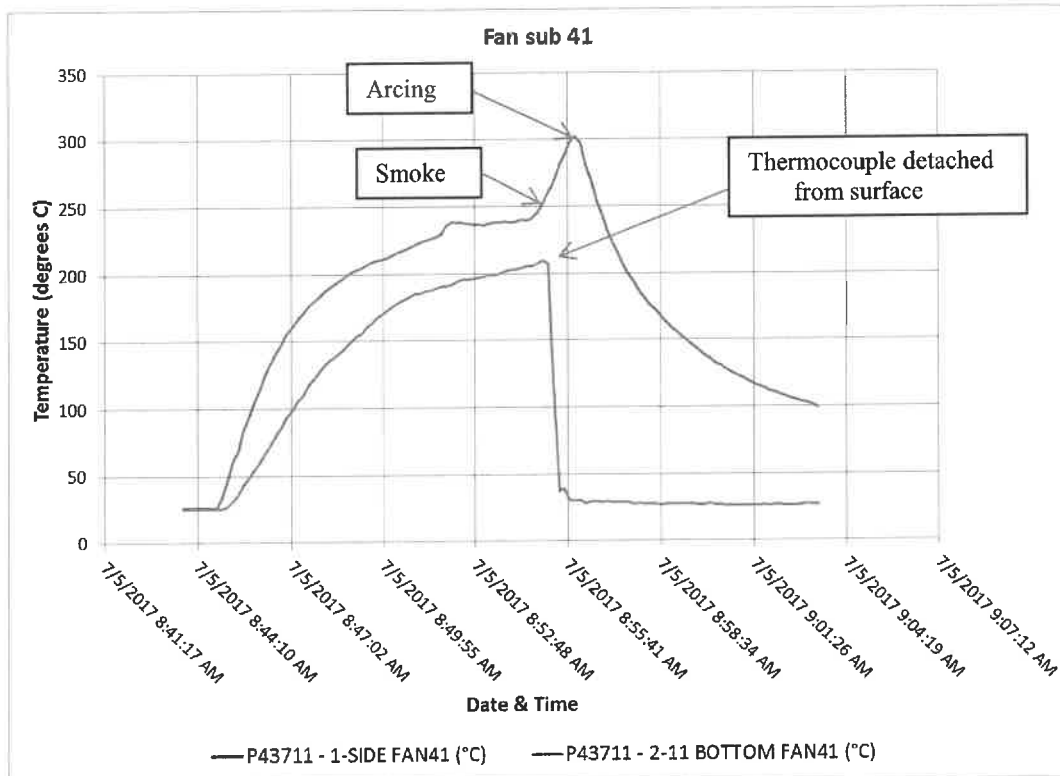
Figure 26. Temperature traces for Sub 41 Test Group 3 - Lock-Rotor Test on July 5, 2017

Staff allowed the fan to cool to room temperature before retesting. During the second lock-rotor test, the temperatures increased rapidly, and the unit began to smoke. The temperature suddenly increased and arcing could be heard. Suddenly the arcing ceased, and the temperature began to decrease. Figure 26 shows the temperature traces for the thermocouples during the lock-rotor test on July 5, 2017. The thermocouple located at the

TCO (blue trace) detached from the surface of the winding when the unit began to smoke, which resulted in a sudden drop in temperature. The elapsed time to maximum temperature was about 9 minutes, 50 seconds.

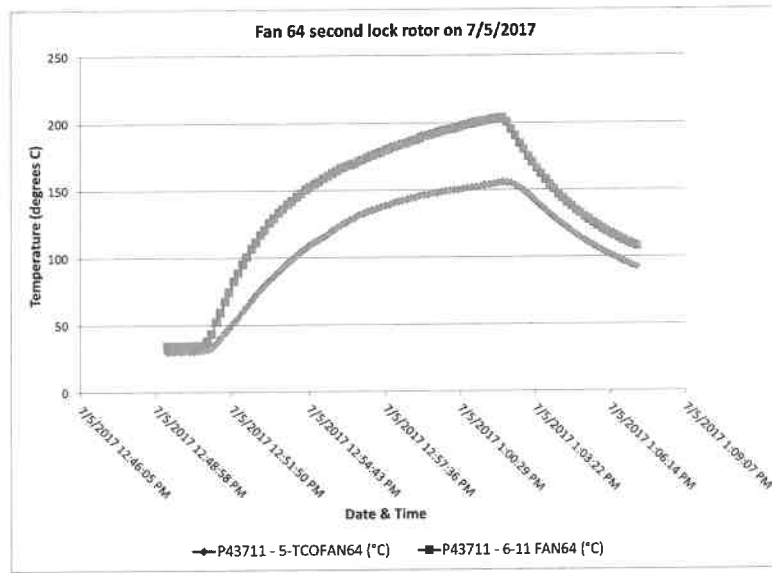
Figure 29. Temperature for Sub 64 Test Group 3 during Second Lock-Rotor Test

Staff allowed the fan to cool for 45 minutes (to approximately room temperature) before retesting. During the second lock-rotor test, the TCO activated. Figure 29 shows the temperature traces for the thermocouples during the second lock-rotor test. The TCO tripped after approximately 11 minutes during the second lock-rotor test.

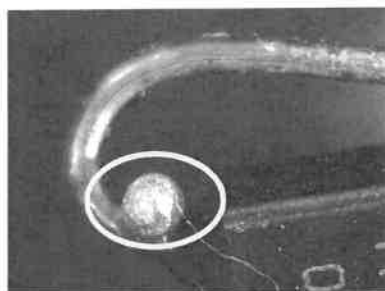
Figure 31. Microscopic images of the solder bead and solder in the cracks (Sub 64)

Post examination revealed a solder bead external to the TCO casing, as highlighted by the yellow circle shown in Figure 30. Microscopic images of the TCO show that the solder bead originated from inside the TCO because solder was located in cracks between the epoxy seal and the lead wire, as shown in Figure 31. Figure 32 shows the CT scans with the partially melted fusible link after the testing, thus, indicating the TCO did activate, but abnormally. Visible in the CT scan is the solder bead, highlighted by the yellow circles.

Solder bead

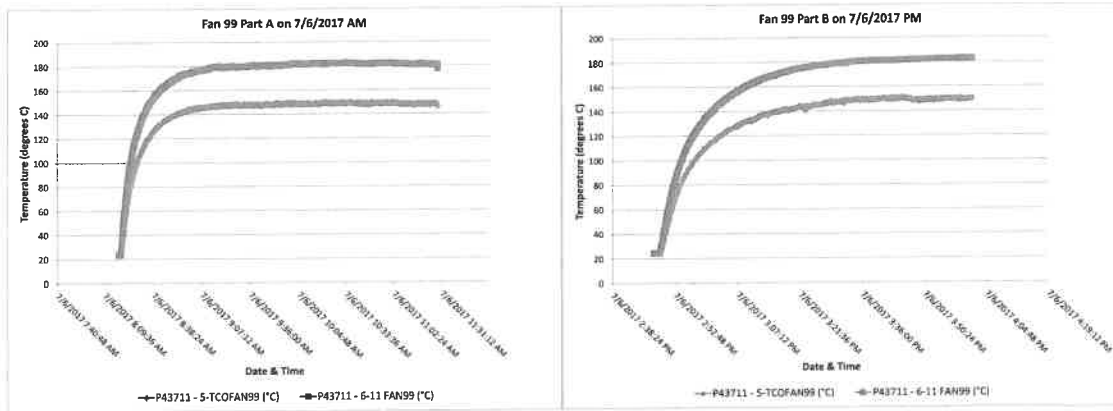
Figure 33. Segment Part A and B temperatures for Sub 99 Test Group 3 - Lock-Rotor Test

Post examination revealed the TCO had a solder bead external to the TCO casing. Figure 35 shows the CT scans with the partially melted fusible link after the testing, thus, indicating the TCO did activate, but abnormally. Microscopic images show that the solder originated from inside the TCO because of solder located within the cracks between the epoxy seal and the lead wires. Figure 36 shows the microscope images of the solder bead and solder in the cracks.

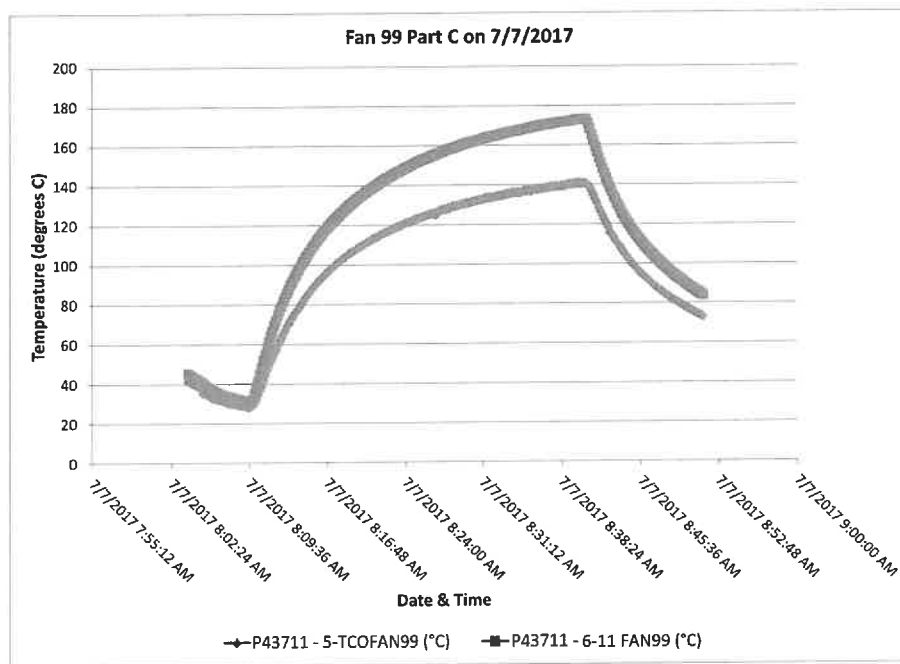
Figure 34. Segment part C temperature traces for Sub 99 Test Group 3 - Lock-Rotor Test

Staff conditioned the fan (sub 99) for 288 hours before being subjected to three lock-rotor test periods as summarized in Table 7. During the initial lock-rotor test (segment A), the TCO did not activate. During the second lock-rotor test (segment B), the TCO did not activate. The TCO activated during the third lock-rotor test (segment C). Figures 33 and 34 show the temperature traces for the thermocouples during the three segments of lock-rotor test. The TCO tripped after approximately 30 minutes during the third lock-rotor test, but after almost 5 hours of combined lock-rotor testing (sum of the test duration for all of the segments up to the activation).

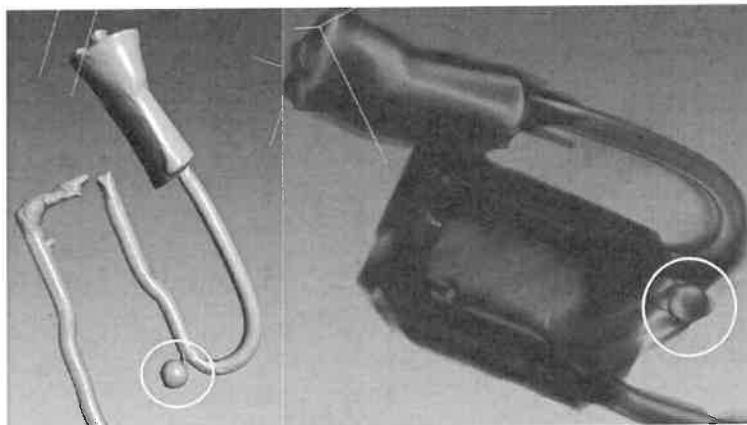
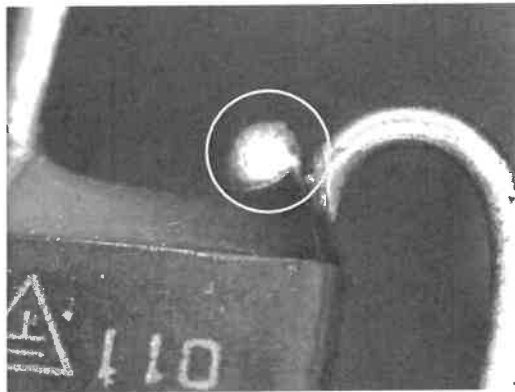
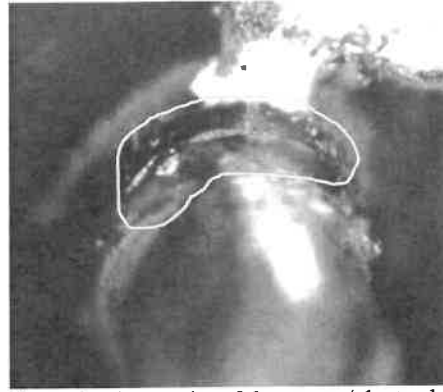
Figure 36. Microscopic images of the solder bead and solder in the cracks (Sub 99)

Solder bead

Solder in the cracks of the epoxy/electrode

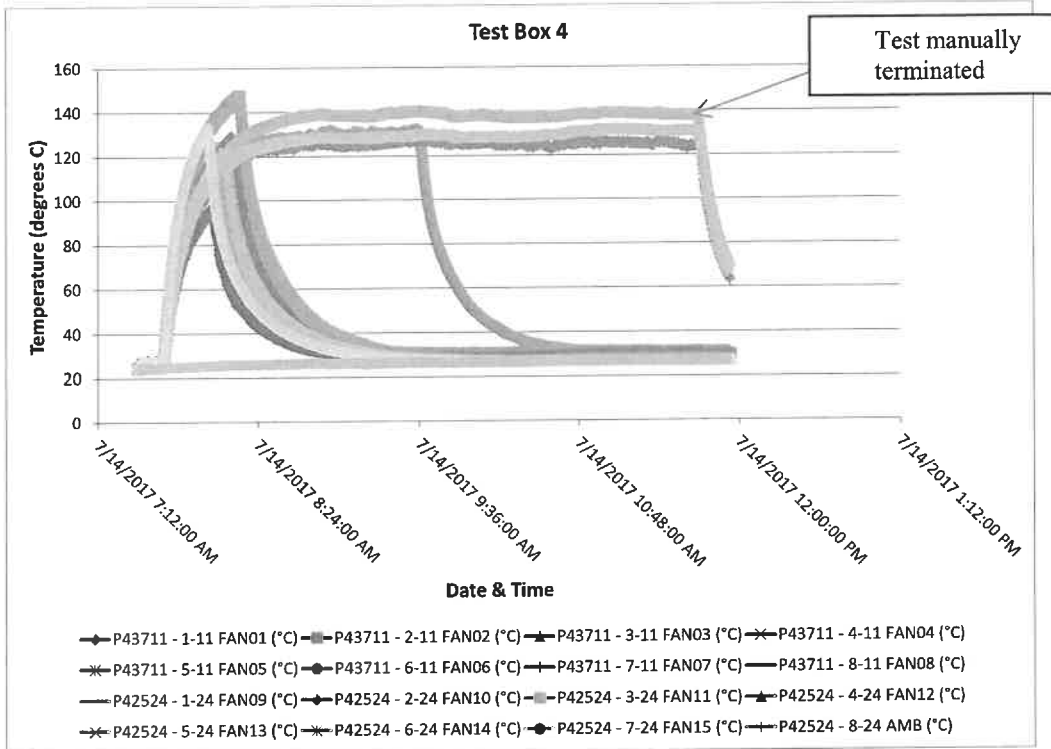
Figure 37. Temperature traces for Test Group 4 - Lock-Rotor Test

Test Group 4 had 15 fans. Staff placed the 15 fans in the conditioning oven at 2:30 p.m. on July 6, 2017. Staff set the conditioning oven at 105°C. After 165 hours (July 13, 2017 at 11:30 am), all 15 units were removed from the conditioning oven and installed in the large test frame. The fans were allowed to cool to room temperature before testing. A single thermocouple was placed on the side of the winding for each fan sample. The fans were tested in a lock-rotor condition on July 14, 2017. Figure 37 shows the temperature traces for Test Group 4 – Lock-Rotor Test.

Eleven of the 15 fans had the TCO activate in less than 45 minutes during the lock-rotor testing. One fan's TCO opened shortly after 2 hours (sub 58). Three of the 15 fans' TCOs (sub 6, 51 and 66) failed to activate or open after 4 hours of lock-rotor, and staff manually terminated the test. Table 8 lists the test results from Test Group 4 lock-rotor testing.

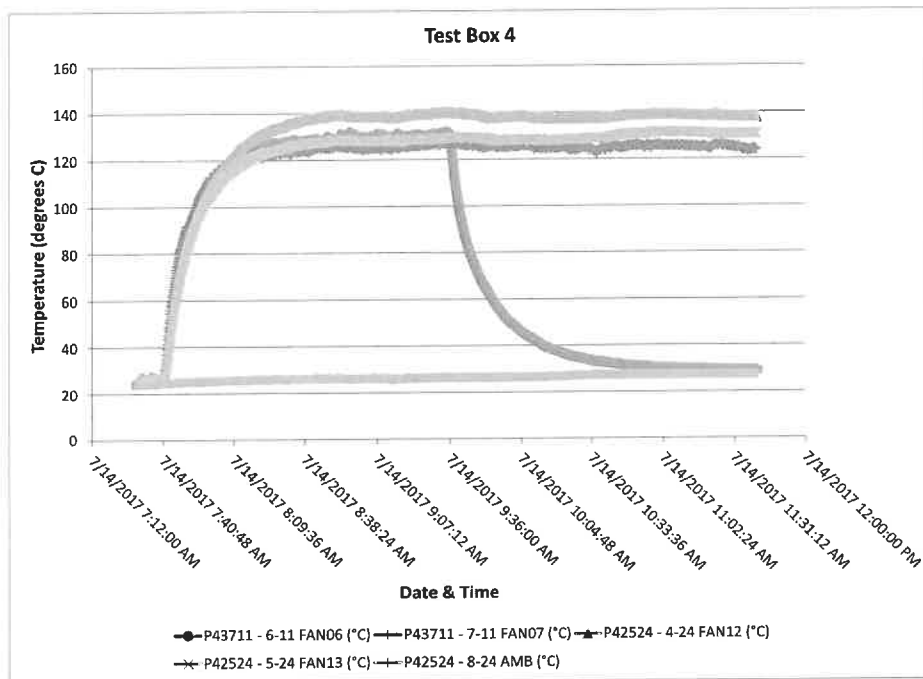
Figure 38. Temperature traces for Subs 6, 7, 12 and 13 (Test Group 4 - Lock-Rotor Test)

Figure 38 shows fan subs 6, 51, 58 and 66 temperature traces for Test Group 4 – Lock-rotor Test. These subs had a TCO that had activation trip times that were long or never tripped. The TCOs were x-rayed and CT scanned.

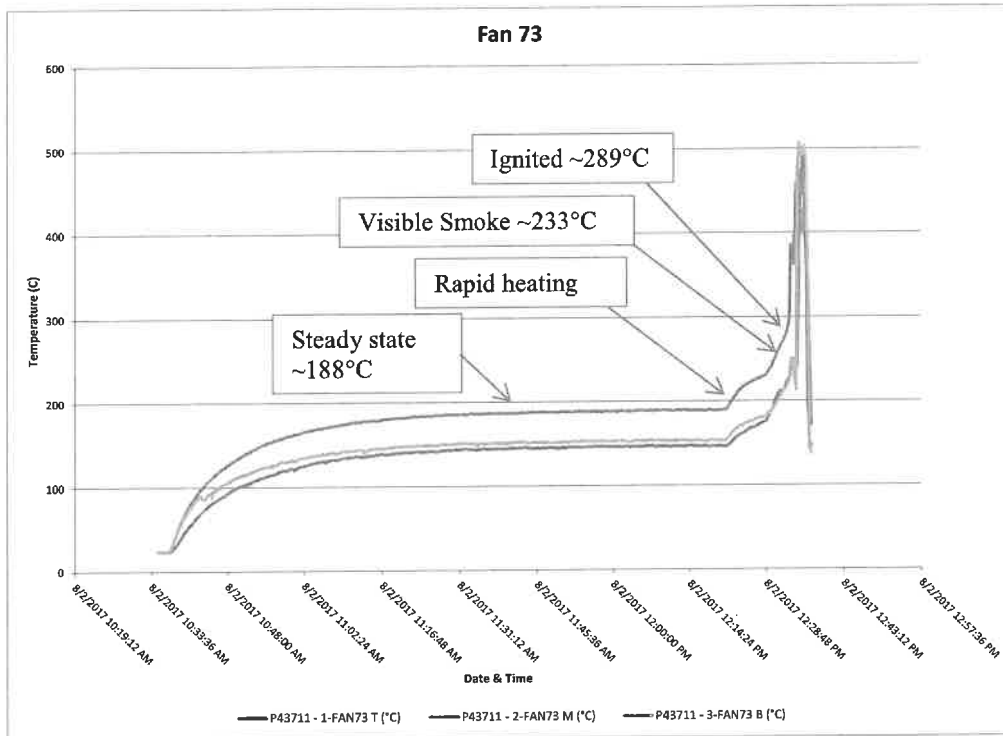
Figure 40. Winding temperatures during lock-rotor test for Fan sub 73

Fan sub 73 was in lock-rotor condition for about 1 hour and 56 minutes before the unit ignited, as shown in Figure 40. The fan's winding temperature was at a steady-state temperature (~188°C) above the TCO function temperature for about 1 hour, until the winding temperature began to increase rapidly. This rapid increase in temperature is an indication of shorting in the winding, which reduces the winding resistance and increases the current. Before ignition, with the winding temperature at about 233°C, the unit was producing visible white smoke. When the unit ignited around 289°C, there was a large flash and flames for a brief moment. It appears that the gaseous vapors driven off the winding coating ignited. The flames subsided slightly until the wrap around the winding and the coating on the windings started to burn, growing in intensity. The flames impinged on and ignited the plastic impeller. The burning impeller and bobbin resulted in dripping flaming plastic. Four layers of cheesecloth were placed under the fan to be used as an ignition indicator to verify that the dripping plastic continued to burn as it landed on the surface below. The dripping flaming plastic caused the cheesecloth to ignite, which indicates that the fan's plastic grill could also ignite in this type of situation. Figure 41 shows a sequence of photographs demonstrating the progression during lock-rotor testing on sub 73.

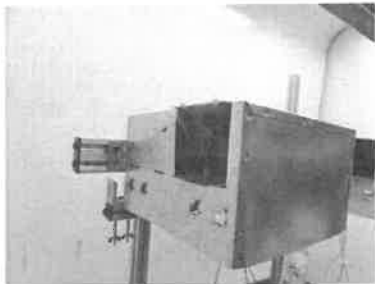
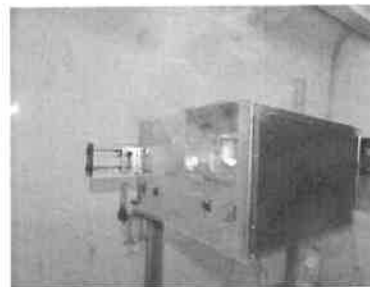
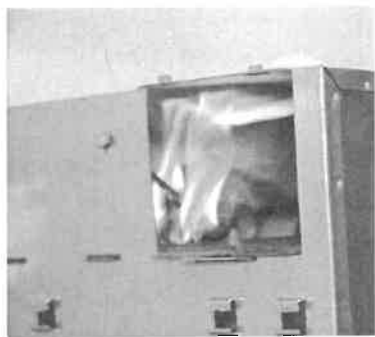
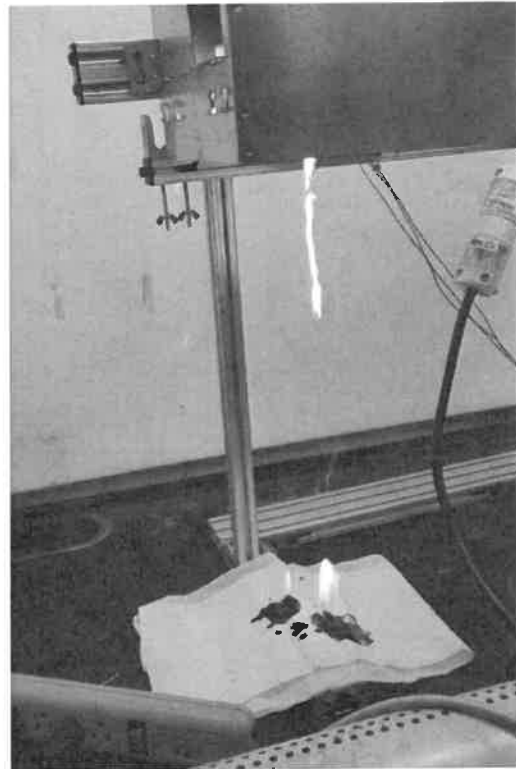
Figure 41. Fan sub 73 during lock-rotor test

At around 233°C, the fan begins producing white smoke

At sufficient temperatures, there appears to be an ignition of gases around the motor around 288°C

The impeller has ignited and begins to sag onto the motor

Dripping flaming plastic ignites the cheesecloth ignition indicator

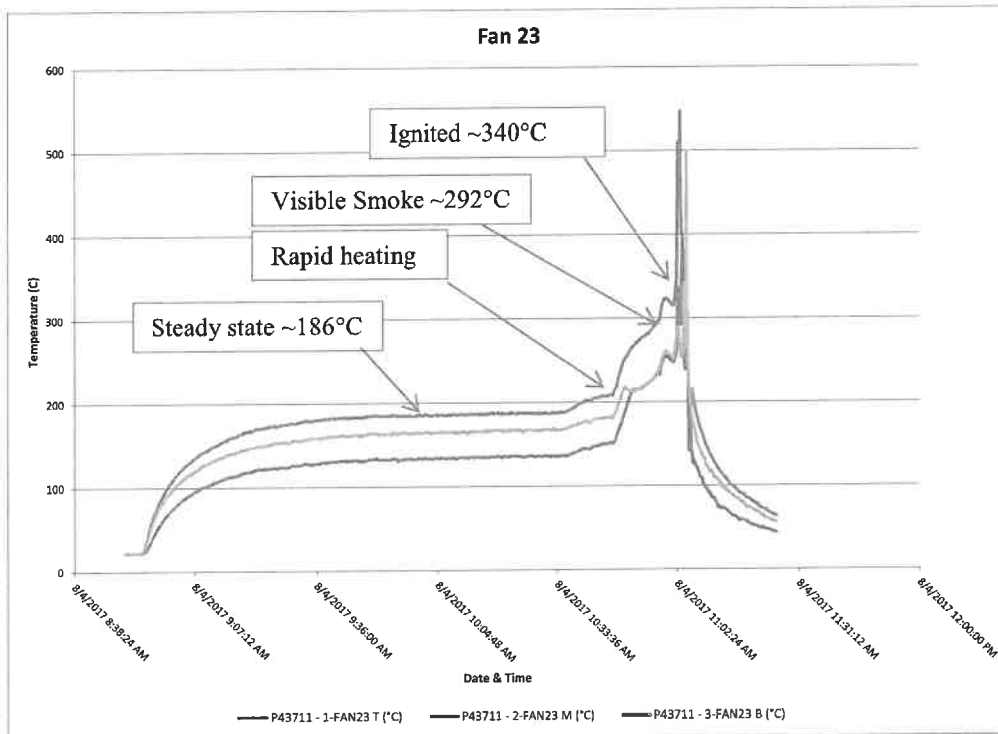
Figure 44. Winding temperatures during lock-rotor test for Fan sub 23

Fan sub 23 was in lock-rotor for about 2 hours and 40 minutes before the unit ignited, as shown in Figure 44. The fan's winding temperature,  $\sim 186^{\circ}\text{C}$ , was at steady state, above the TCO specified activation temperature, until the winding temperature began to increase rapidly. This rapid increase in temperature indicates shorting in the winding, which reduces the winding resistance. Before ignition, at about  $\sim 292^{\circ}\text{C}$ , the unit was producing visible white smoke. Similar to Fan sub 73, when the unit ignited at  $\sim 340^{\circ}\text{C}$ , it produced a large flash and flames for a brief moment. The large flames subsided slightly, until the flames ignited more of the wrap around the winding and/or the coating of the winding. The flames impinged on and ignited the plastic impeller. The burning impeller and bobbin resulted in dripping flaming plastic. Four layers of cheesecloth were placed under the fan to be used as an ignition indicator. The dripping flaming plastic ignited the cheesecloth, which indicates that the fan's plastic grill could also ignite in this type of situation. Figure 45 is a sequence of photographs during lock-rotor testing for sub 23.

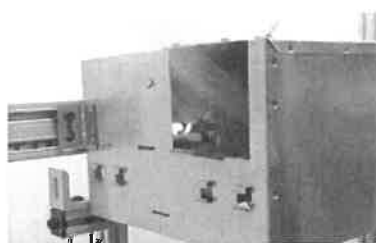
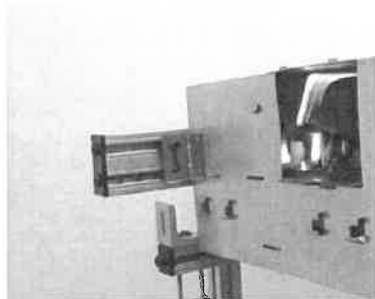
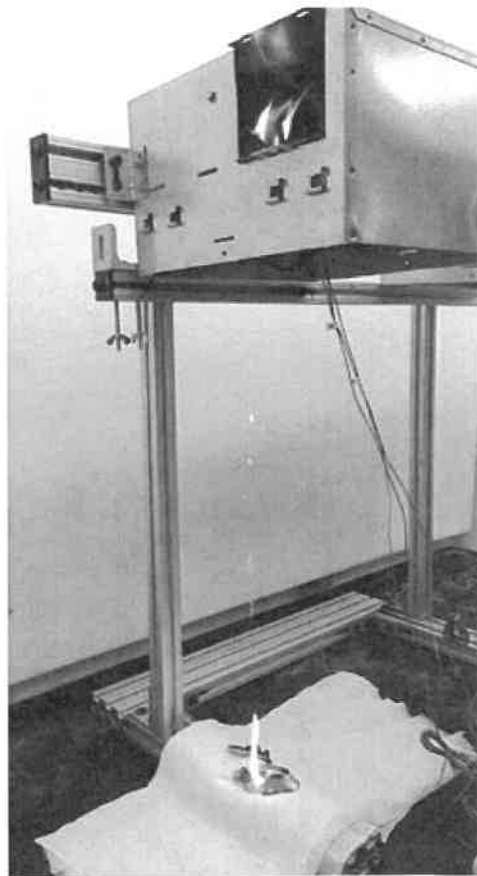
Figure 45. Fan sub 23 during lock-rotor test

The large flames subside and the winding wrap and/or the winding coating appears to be burning

The impeller has ignited and begins to sag onto the motor

Dripping flaming plastic ignites the cheesecloth ignition indicator

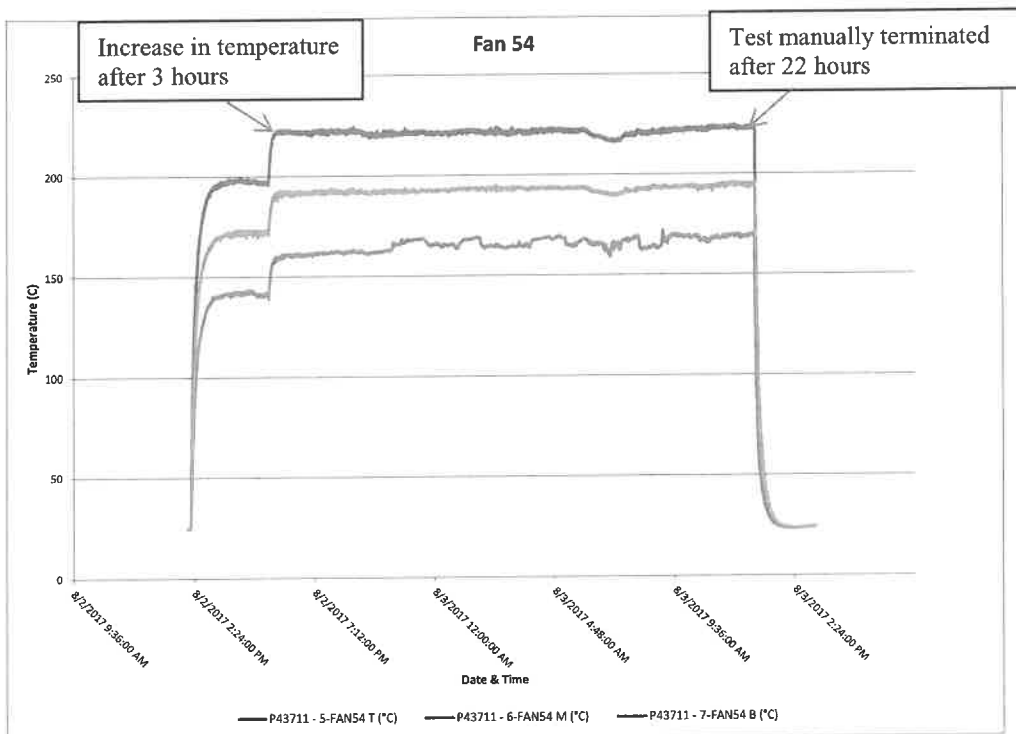
Figure 48. Winding temperatures during lock-rotor test for Fan sub 54

As previously indicated, fan sub 54 was tested in lock-rotor condition for 22 hours. After the initial 3 hours, the temperature increased and then leveled off. The fan maintained a steady temperature that was well above the TCO activation temperature for the majority of the testing, as shown in Figure 48. The TCO did not activate, and staff manually terminated the test after 22 hours. Figure 49 shows radiographs of the TCO after the test. The linkage appears to have thinned out, but is still intact. The figure shows a bead had formed outside the TCO casing.

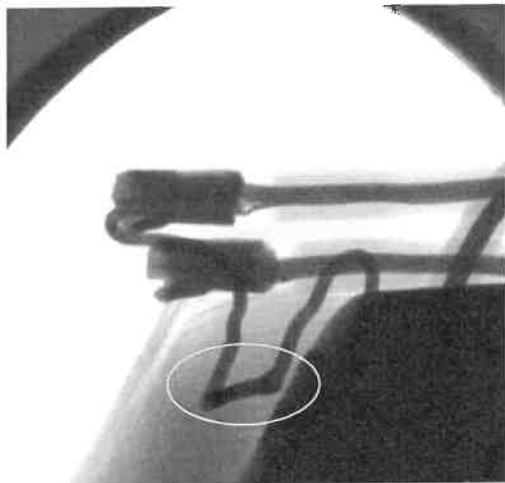
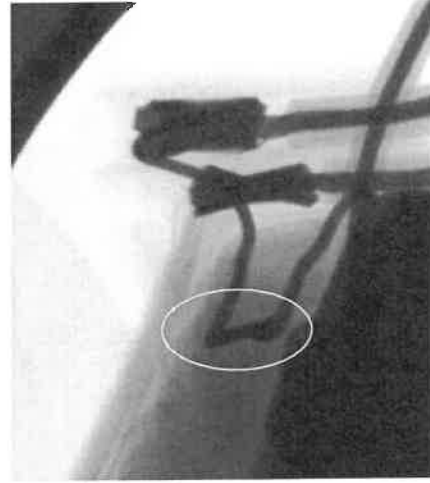
Figure 50. Radiograph of the TCO before and after the test (sub 54)

Figure 50 shows radiographs of the TCO before and after the test. From these angles, the thermal linkage appears not to have changed shape significantly, but depending on the viewing angle, the thermal linkage is thicker or thinner.

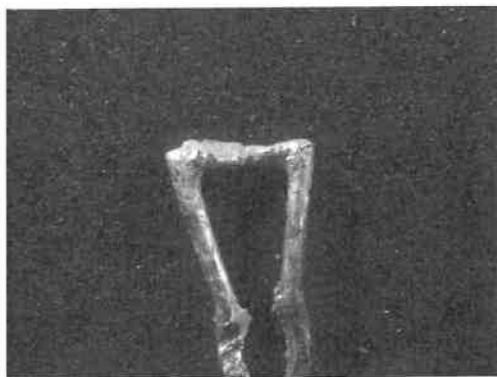
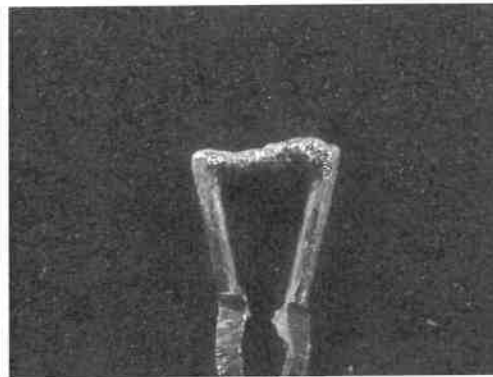
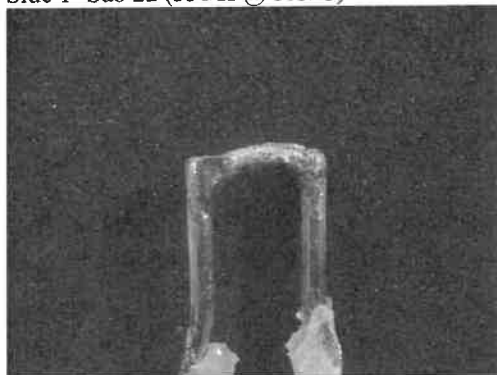
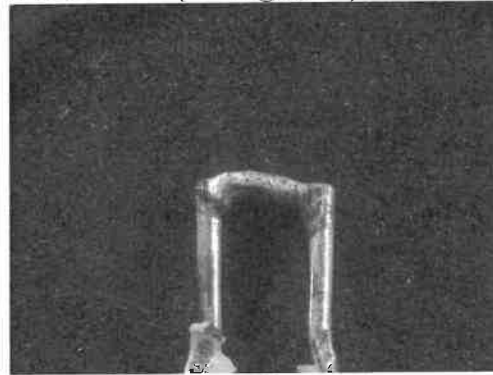
Figure 52. TCO solder link from Fan subs 22 and 59 (conditioned 330 hours @ 105°C)

Subs 22 and 59 (conditioned for 330 hours at 105°C) from Test Group 5 were reserved for analysis of the solder link within the TCO. The TCO casing was opened and the internal components were removed. For comparison, two TCOs, sub 74 and 85 (no conditioning), from Test Group 7 were also reserved for TCO analysis where the TCO casing was opened and the internal components removed. Figure 52 shows the solder links from Fan subs 22 and 59, which have been conditioned 330 hours at 105°C. Figure 53 shows the solder links from Fan subs 74 and 85, which have not been conditioned. Sub 85 shows some deformation in the solder link, where part of the solder link has flattened and formed to the interior of the TCO casing, but this was already present before any conditioning of the TCO. The mechanical structure of the solder linkage appeared unchanged as a result of the conditioning, when the before and after radiographs were compared.

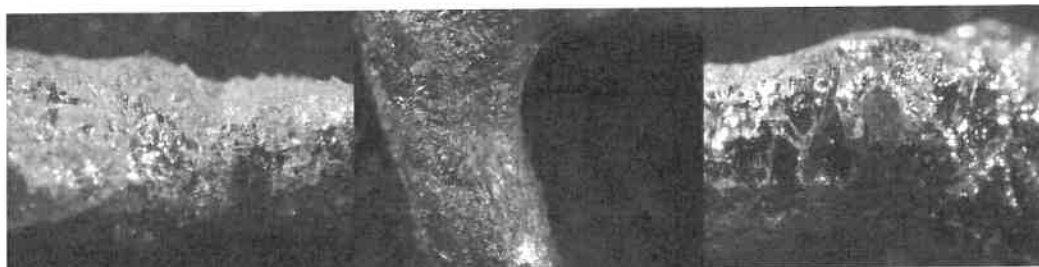
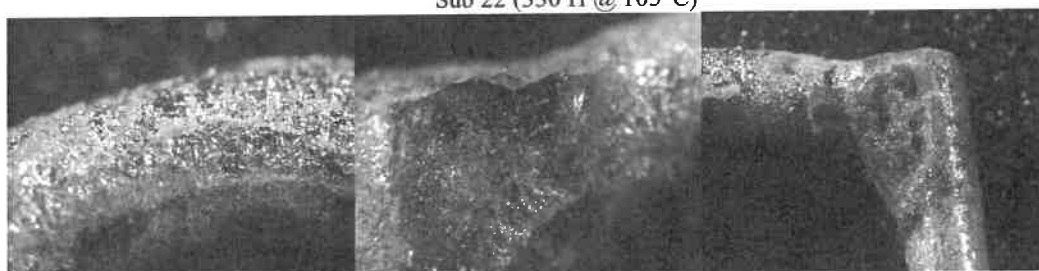
Figure 54. Close-up images of the TCO solder link (conditioned 330 hours @ 105°C)

Staff observed under a microscope that a yellowish substance was on the solder link, as shown in Figures 54 and 55. This was thought to be the special coating or flux material. Staff also observed that the conditioned TCOs appeared to have less of the yellowish substance than the TCOs that were unconditioned, but staff did not measure an actual mass content or volume of the substance for each sample.
