**From:** Soto, Rolando <ROSOTO@broward.org>  
**Sent:** Thursday, April 20, 2023 2:55 PM  
**To:** Madani, Mo  
**Cc:** Parks, Bryan; mbeck@coconutcreek.net; Ryan Banyas - Coconut Creek FCO  
**Subject:** Toilet exhaust fan fires.  
**Attachments:** Bathroom fan code amendment.docx; FW: Ventilation Bathroom Fan Fires; Eutectic-TCO-Report-6b6-cleared-cleaned-January-2018-version (1).pdf; google search.docx

Bathroom fan code amendment.

# CPSC Staff Assessment on Eutectic-Type Thermal-Cutoff Fuse Failures in Shaded-Pole Motors Used in Exhaust Fans

December 2017

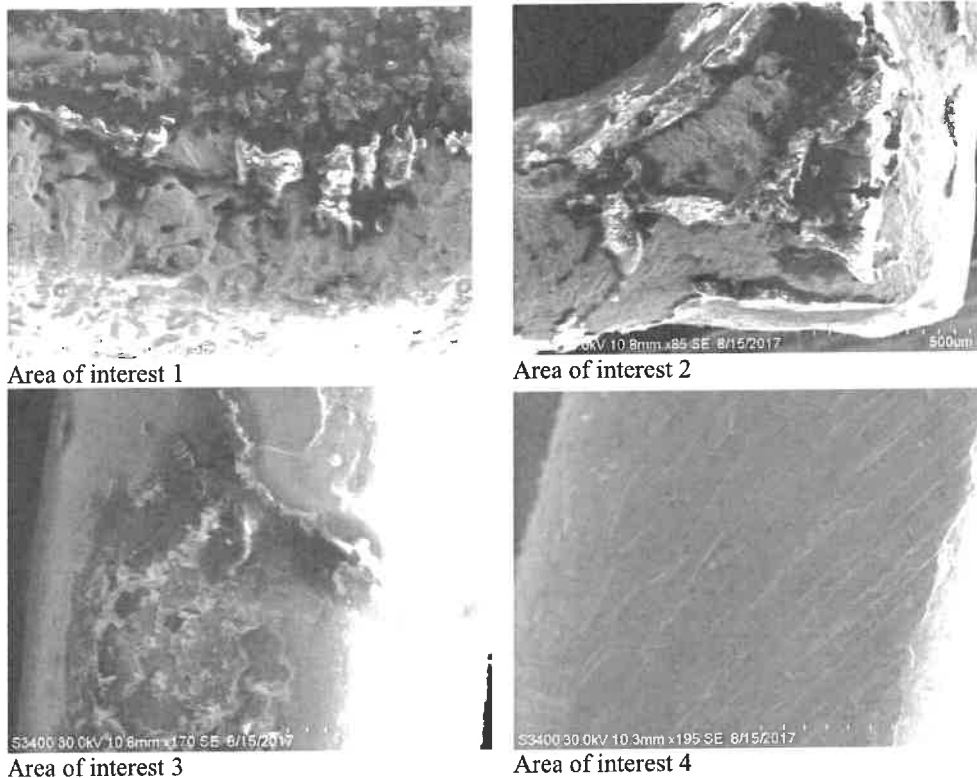
Figure 56. SEM scans for Sub 59

characterization. XRD is used to study nature of phases/microstructure and their crystal structure. Figure 56 shows SEM scans of the solder link and terminals. SEM and XRD analysis for sub 59, which was conditioned at 105°C, show that the wire leads are copper and the thermal linkage is comprised of mainly tin, indium, and lead.

Area of interest 2 is the solder link connection to the copper terminal. This is mainly comprised of C, O, In, Sn and Pb. There is a trace amount of silicon (Si) and copper (Cu). Copper shows up because it is the bulk material of the terminal.

Areas of interest 3 and 4 are the copper terminals. This is mainly comprised of Cu and Sn. There are lower amounts of C and O.

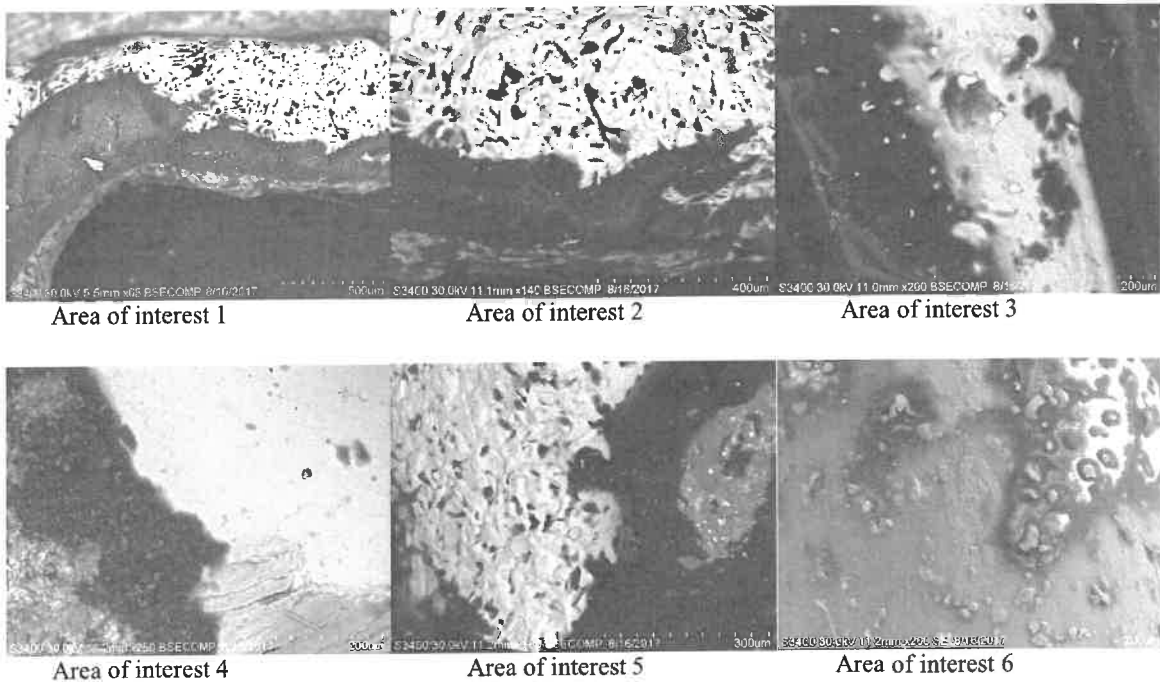
Figure 57. SEM scans for Sub 74

SEM analysis for sub 74, which was not conditioned, is shown in Figure 57. Area of interest 1 is the solder link. This is mainly comprised of C, In, Sn, and Pb. The Indium, Tin, and Lead are most likely the elements that make up the solder linkage. Carbon and Oxygen are most likely the elements that make up the special coating. Area of interest 2 is a close-up of an area from area interest 1. This is mainly comprised of C, O, In, Sn, and Pb. There is a trace amount of Si.

Areas of interest 3, 4, 5, and 6 are areas that had coating on the terminals or solder link.

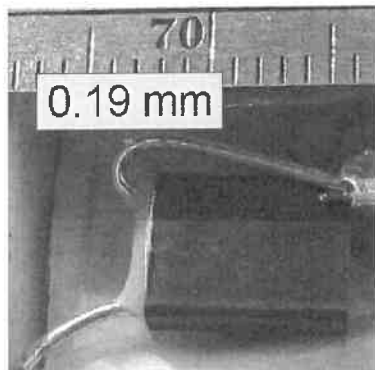
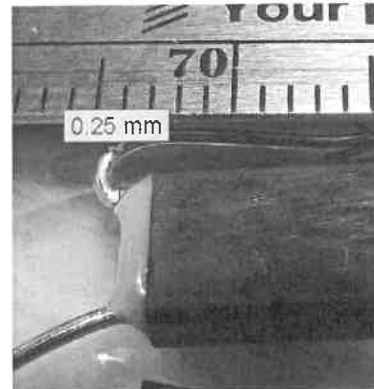
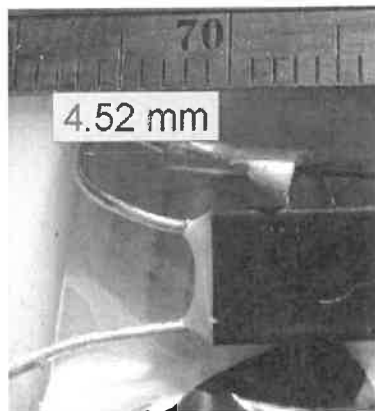
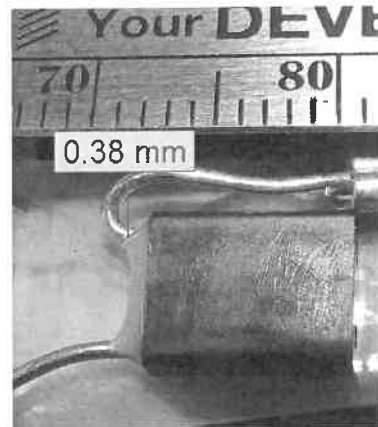
Figure 58. Wire bend lengths vary between TCOs in the Fan samples

Figure 58 shows the TCO wire lead bends can vary between fan motors. Even though sub 27 shows the wire lead bend greater than 3 mm, it appears that the base of the wire lead near the seal was not secured when the wire lead was bent, which is evident by the outward angle of the wire lead.

Wire lead with 0.19 mm length between the seal and bend (Sub 98)

Wire lead with 0.25 mm length between the seal and bend (Sub 26)

Wire lead with 4.52 mm length between the seal and bend (Sub 27)

Wire lead with 0.38 mm length between the seal and bend (Sub 79)

Improper bending of the wire lead may result in cracking of the epoxy seal, thus allowing solder to flow out and oxygen to enter the TCO and alter the functioning temperature of the TCO. Oxygen along with heat and time may also be a combination that could be accelerating the changes in the properties for the thermal linkage and the special compound.

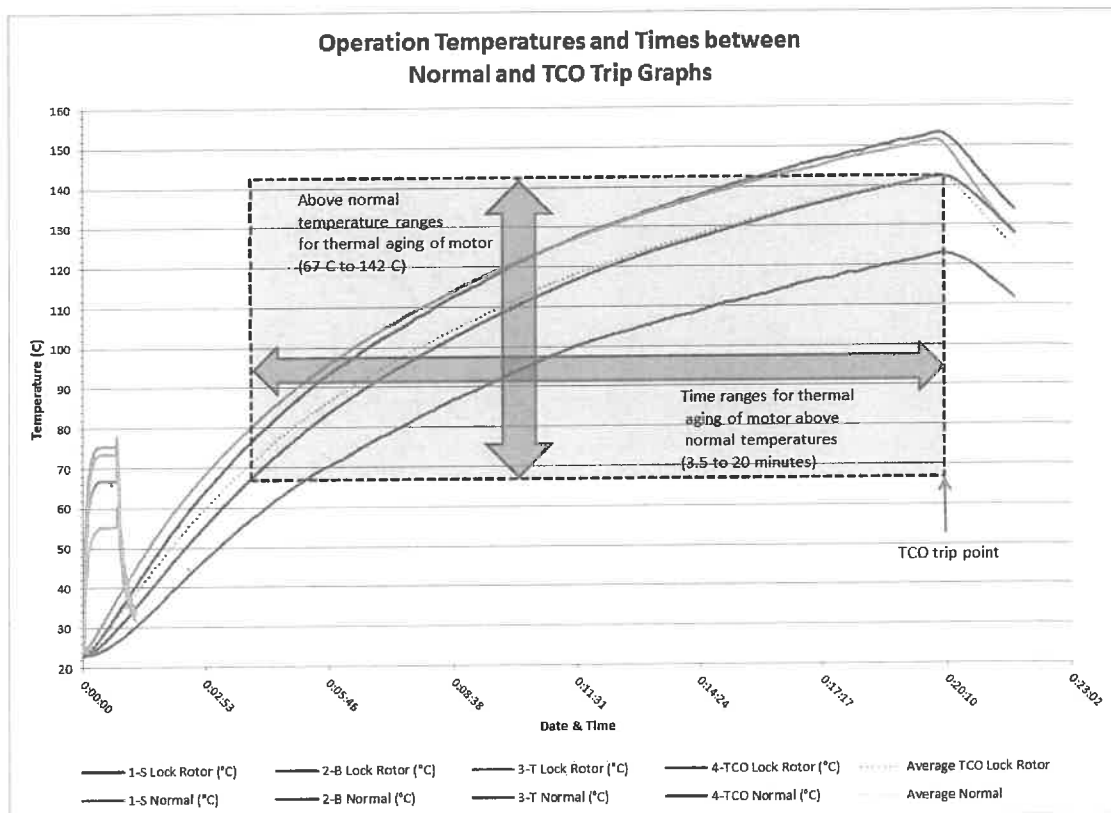
Figure 59. Potential thermal aging of the motor between normal and TCO trip conditions

Figure 59 shows Fan sub 60 temperatures for normal and lock-rotor operation. In normal operations, the TCO temperature stabilizes at around 68°C. For lock-rotor condition, the TCO activates at a TCO temperature around 142°C after 20 minutes. This would suggest that an exhaust fan that is in lock-rotor condition, but is operated for less than 20 minutes, can have the TCO heated to temperatures up to 142°C. If the exhaust fan is operated for more than 3 minutes, the TCO is experiencing temperatures above normal operation.
