Interim Report:

Survey and Investigation of Buildings Damaged by Category III, IV and V Hurricanes in FY 2022-2023 - Hurricane Ian

Project #: P0266604

Report No. 01-23
17 April 2023

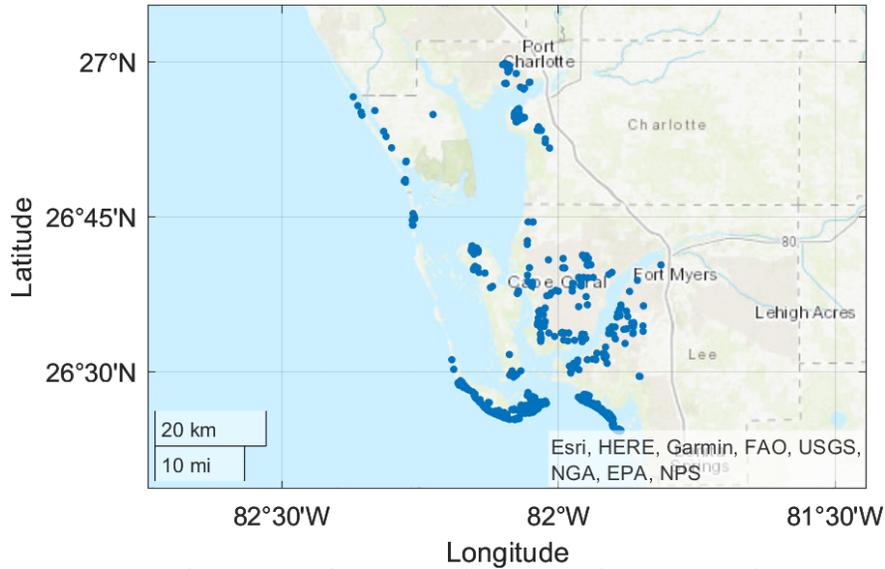
Figure 1. Locations of virtual assessment candidates showing the locations of 650+ buildings in the dataset.

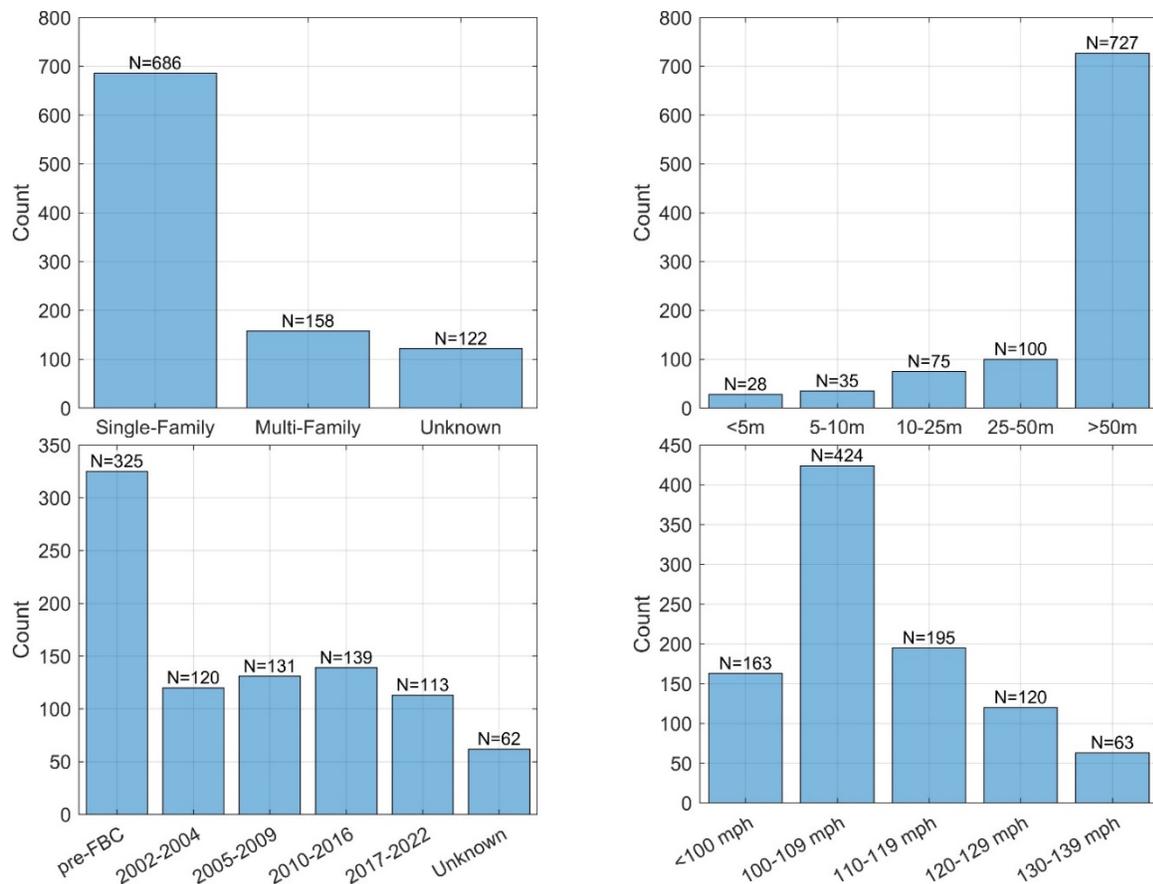
Figure 2. Distribution of samples across various stratification levels, including (a) occupancy class, (b) distance to nearest high-water mark, (c) building code construction era, and (d) estimated 3-second gust wind speed (33 ft height, open terrain).
