Final Report:

Survey and Investigation of Buildings Damaged by Category-III, IV & V Hurricanes in FY 2018-2019 – Hurricane Michael

Project #: P0091032

Report No. 01-19

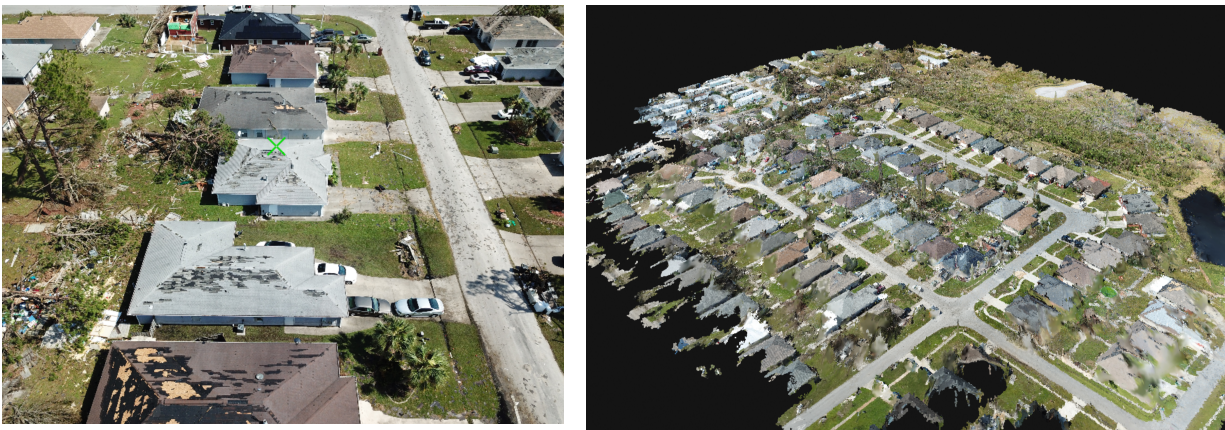
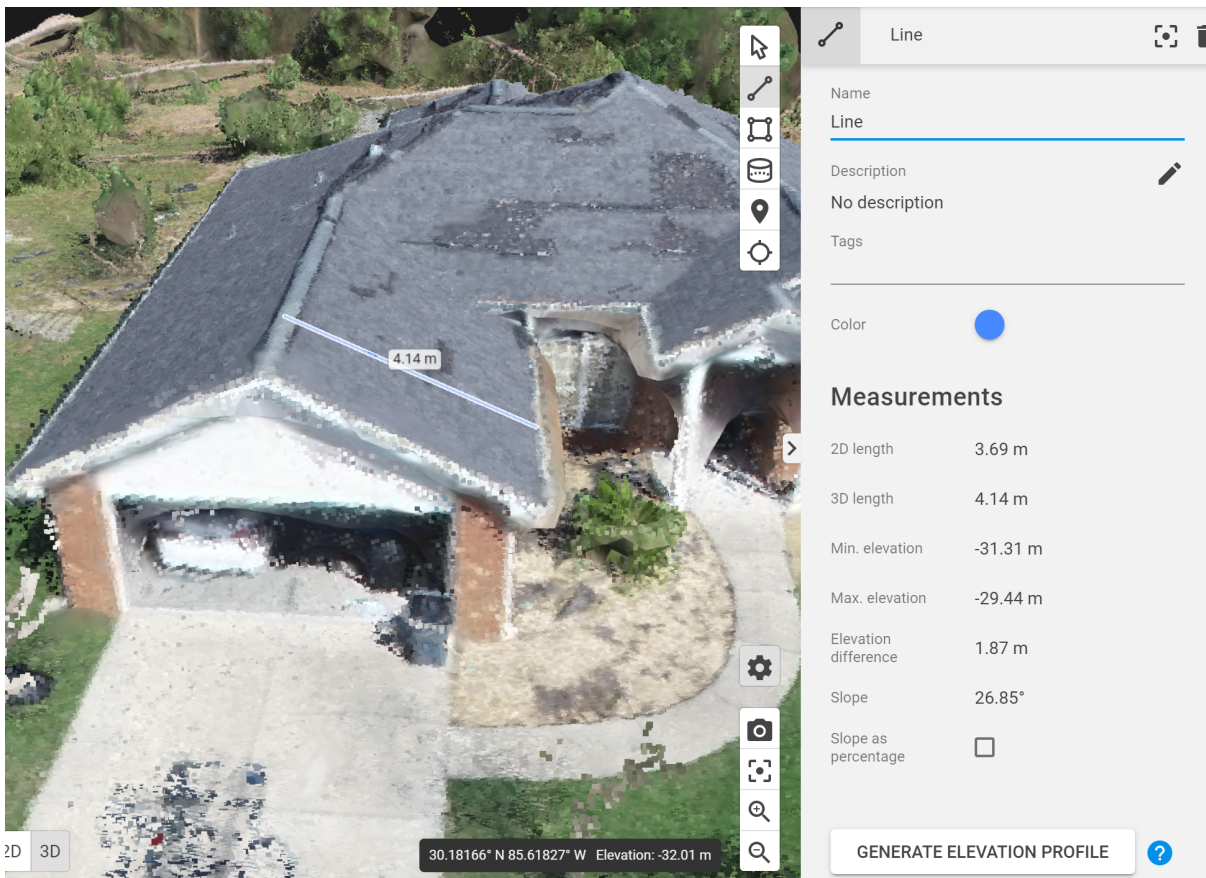
The densified 3D point clouds were used to corroborate damage observations from the field, extend assessments to views of the building not visible in the D2D assessments (e.g., roof, back walls), and measure key building parameters such as roof slope, as shown in Figure 5.

Figure 5. (Top Left) Single UAV photograph from the Cedar's Crossing dataset; (Top Right) Densified 3D point cloud of half of the Cedar's Crossing dataset, constructed from 392 photographs, resulting in a 2.5 cm (1 inch) ground sample distance; (Bottom) Roof slope measured using the 3D densified point cloud of Cedar's Crossing.

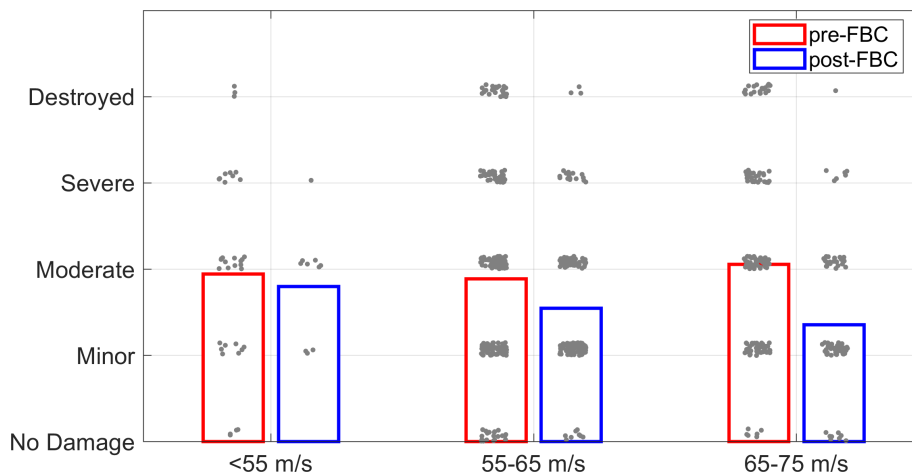
The following figures (Figure 17, Figure 18, and Figure 19) provide an overview of pre- and post-FBC wind performance stratified by peak gust wind speed for all buildings combined, single-family residences, and non-single-family residences respectively. Regardless of building type and peak wind speed, post-FBC buildings perform better or, in one case (single-family residences that experienced < 55 m/s gust wind speeds), nominally the same as pre-FBC buildings. However, an interesting trend demonstrated in the data is the non-progressive nature of the wind speed to damage relationship. Generally, it is expected that wind damage increases with wind speed, all else being equal. In this case, design wind speeds for the majority of the study region are nearly the same, negating that possible factor. It is unexpected then to see the average wind damage rating actually decrease for homes that experienced the highest wind speeds, relative to those that experienced the lowest or middle tier wind speed range. Further research into this trend is warranted, potentially with detailed review of permit records where available. It is possible that newer homes in the coastal areas that experienced higher wind speeds were more likely to invest in code-plus construction. The famous Sand Palace home is one example (Pino 2019), as well as the Habitat for Humanity

Figure 17. Distribution of wind damage ratings for all buildings, stratified by peak gust wind speed. Within each wind speed bin, the left bar is pre-FBC and the right bar is post-FBC, and indicates average damage rating. Grey circle markers represent the wind damage rating of each individual building in the dataset.

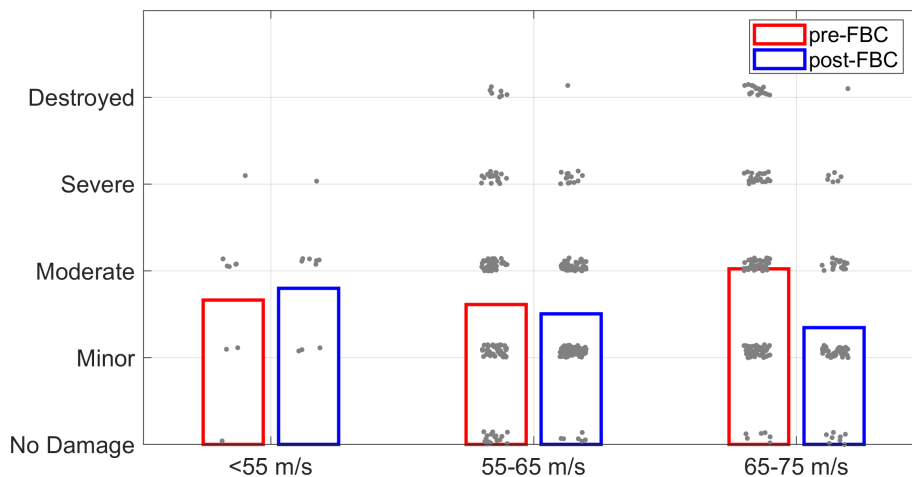
Figure 18. Distribution of wind damage ratings for single-family residences, stratified by peak gust wind speed. Within each wind speed bin, the left bar is pre-FBC and the right bar is post-FBC, and indicates average damage rating. Grey circle markers represent the wind damage rating of each individual building in the dataset.

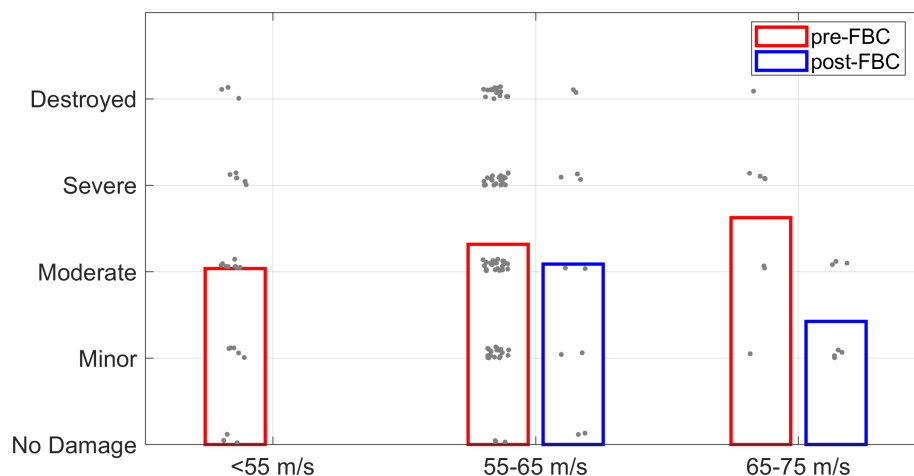
Figure 19. Distribution of wind damage ratings for non-single-family residences, stratified by peak gust wind speed. Within each wind speed bin, the left bar is pre-FBC and the right bar is post-FBC, and indicates average damage rating. Grey circle markers represent the wind damage rating of each individual building in the dataset.

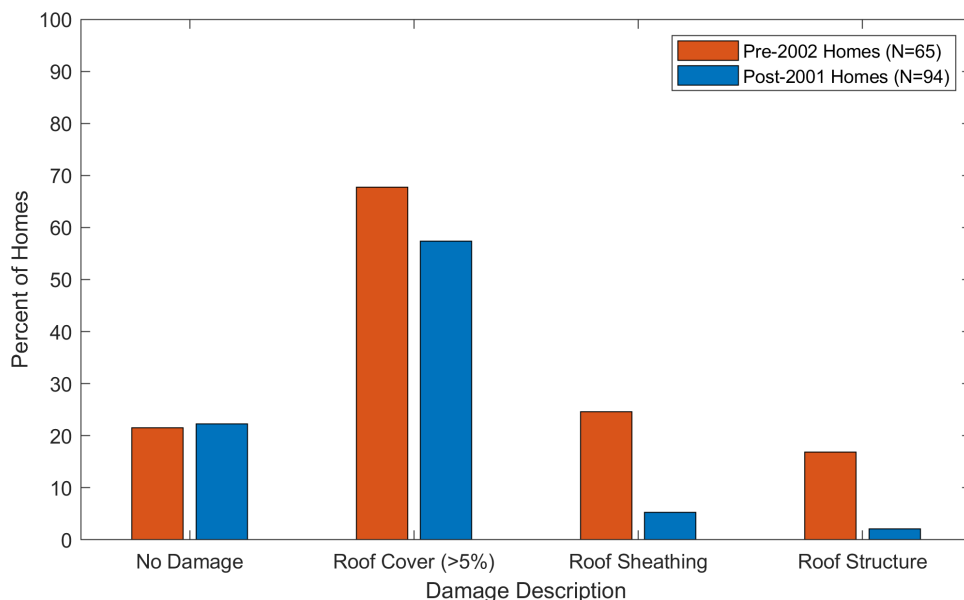
The following summarizes the performance of the pre- and post-FBC homes in the dataset of 171 homes for which the full DEQC protocol has been completed. Figure 20 and Figure 21 provide the relative distribution of roof and wall failures in pre- and post-FBC buildings. Roof cover damage occurred to the majority of pre- and post-FBC homes. If no secondary water barrier was present, this data also indicates that interior damage due to rainwater ingress was likely a significant driver of economic losses, as has been the case in past hurricane events. The research team did not directly observe any secondary water barriers in the inland study regions, so we do not expect that was commonly installed.

Figure 20. Percent of pre- and post-FBC homes experiencing no or very minor roof damage, roof cover damage, roof sheathing damage, or roof structure damage.

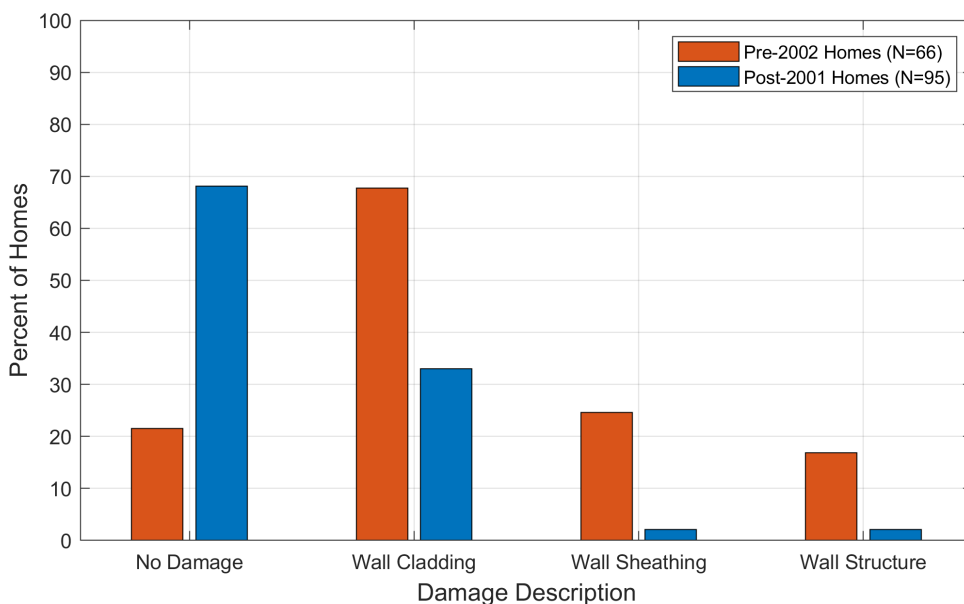
Figure 21. Percent of pre- and post-FBC homes experiencing no wall damage, wall cladding damage, wall sheathing damage, or wall structure damage.

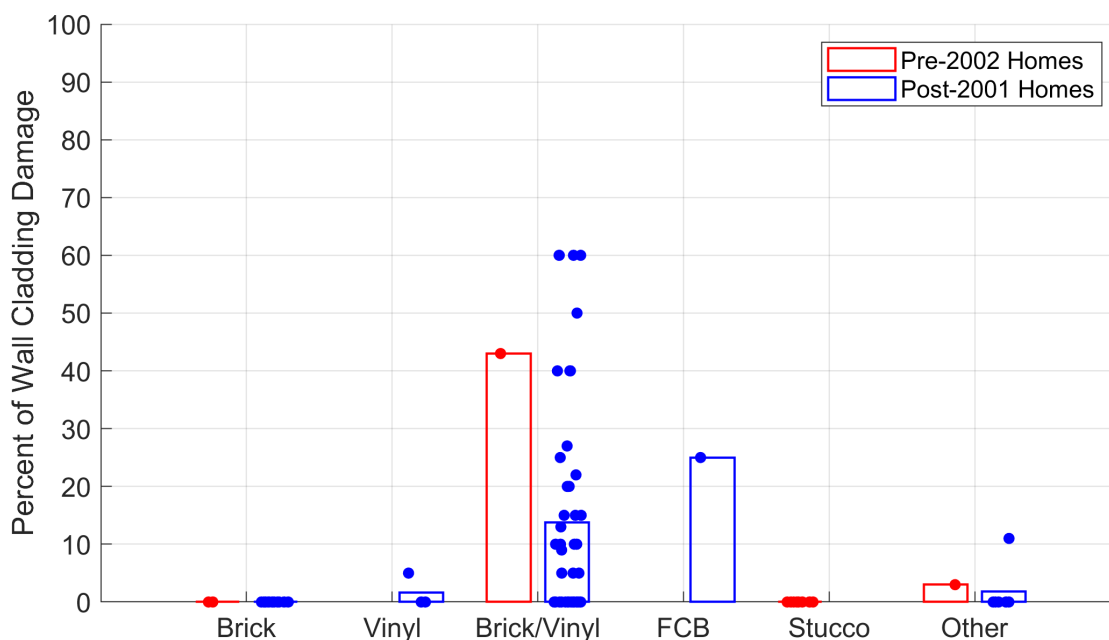
Figure 23 and Figure 24 provide more detailed assessments of wall cladding material by material type. The assessments are separated by wind speed, since the Gulf Aire and Beacon Hill subdivisions experienced significantly higher wind speeds than the inland neighborhoods in Panama City. In the Panama City neighborhoods, vinyl siding was the most frequently observed and damaged cladding system in post-FBC homes. Even considering only homes constructed in the past three years ($N = 18$), on average 30% of the vinyl siding cladding failed, with failure rates as high as 60% in four of the eighteen homes, and no visible failures in five of the eighteen homes. In the coastal neighborhoods in the detailed dataset, damage was on average the highest in pre-FBC vinyl siding systems, with minor failures observed in most other cladding systems. Post-FBC vinyl cladding systems performed well, albeit over a small sample size ($N=3$).

Figure 23. Wall cladding damage percentage by material type for homes experiencing peak gusts of approximately 57 m/s (Magnolia Hills, Brendwoods, and Cedar's Crossing Neighborhoods). Bars depict the mean percentage. FCB = fiber cement board.

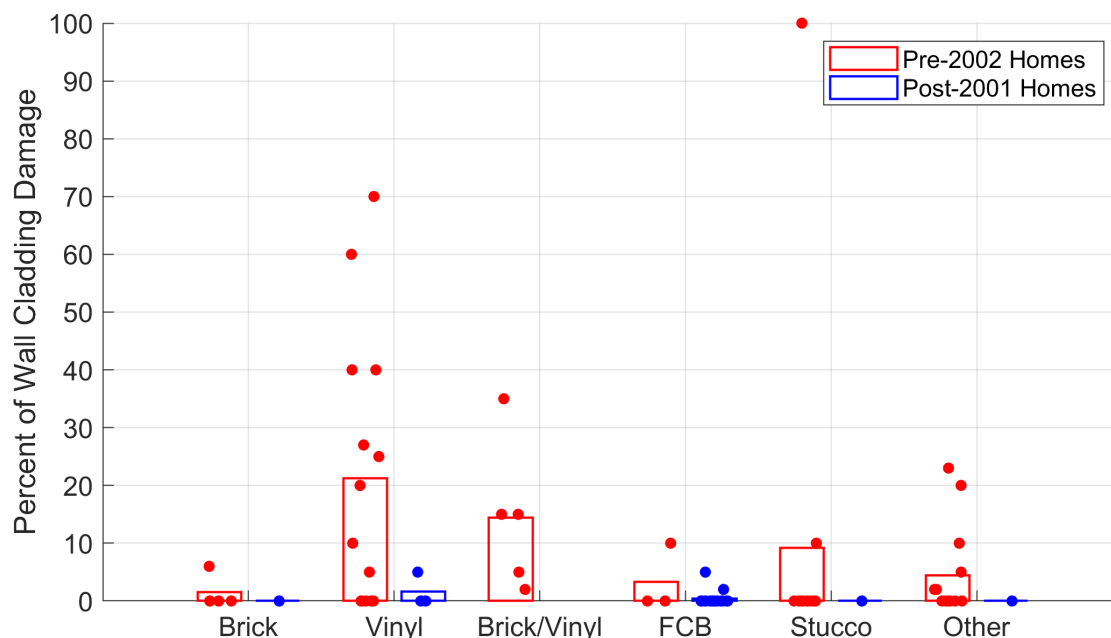
Figure 24. Wall cladding damage percentage by material type for homes experiencing peak gusts of approximately 68 m/s (Gulf Aire and Beacon Hill neighborhoods). Bars depict the mean percentage. FCB = fiber cement board.

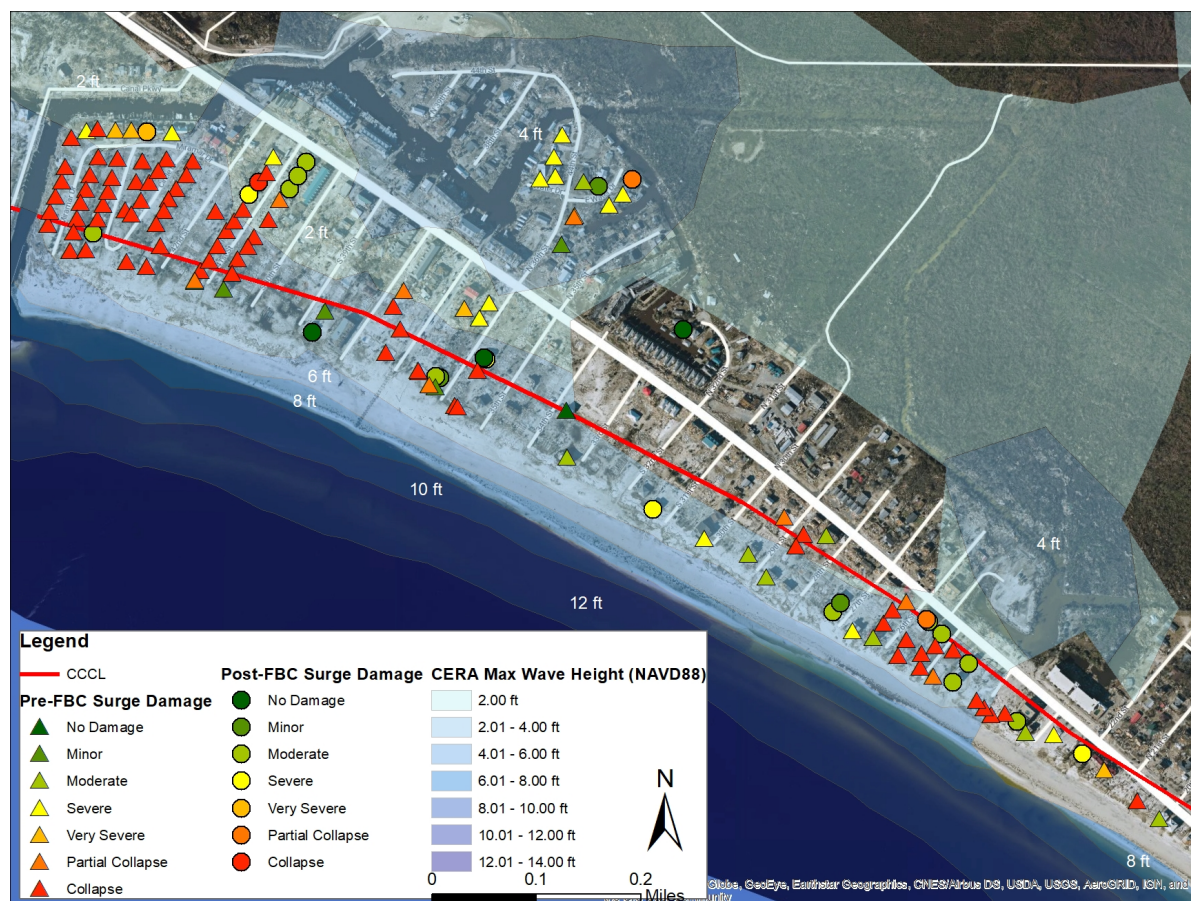
Figure 25. Surge damage assessments in Mexico Beach for pre- and post-FBC homes relative to the CCCL, and the estimated maximum wave heights relative to NAVD88. Triangles indicate pre-FBC buildings, and circles post-FBC.
