INDUSTRY UPDATE

Polymeric Cladding and Wind Performance 2020

Data, Observations and
Recommendations Moving Forward

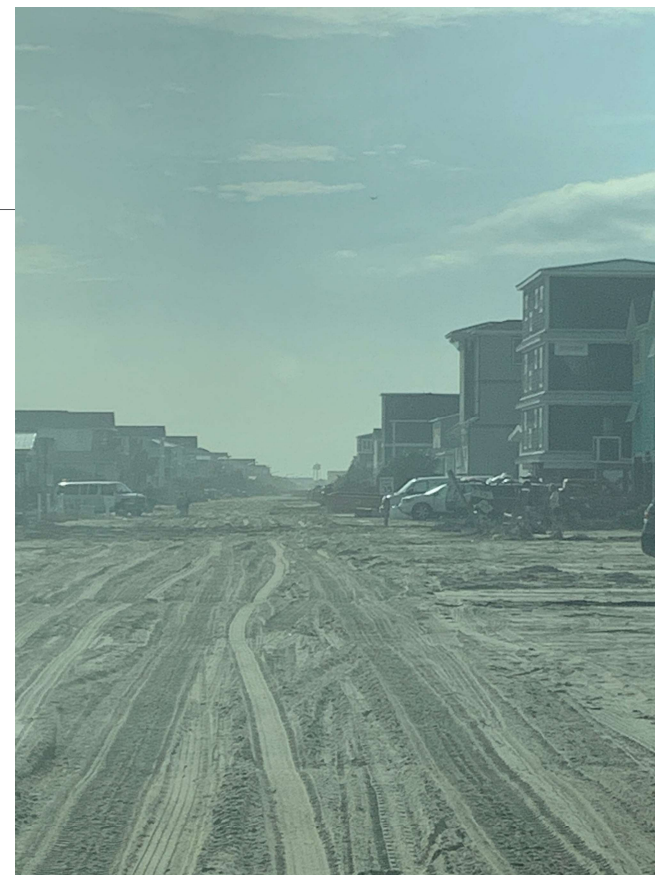
- Hurricane Isaias was a high-end Category 1 hurricane causing extensive damage across the Caribbean and the east coast.
- It was named on July 23, 2020. On August 1, 2020, the storm made landfall on North Andros, Bahamas and then made landfall near Ocean Isle Beach, North Carolina on August 4, 2020.

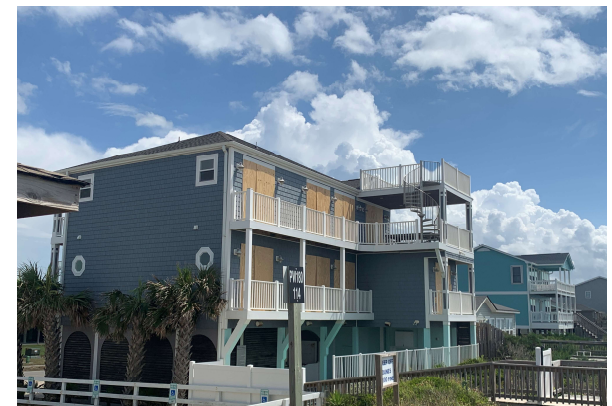
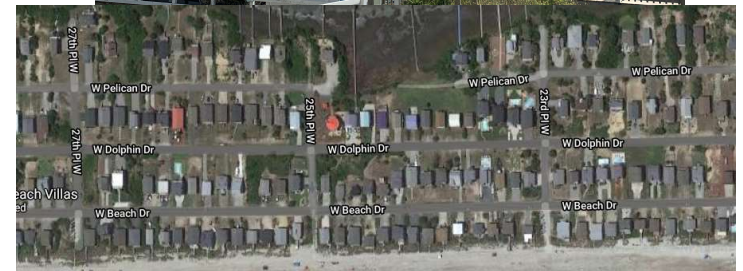
- Oak Island 400 to 500 East/West Beach Drive, Oak Island, NC
- -Approximately 70% to 80% of homes used polymeric cladding
- Holden Beach 100 to 150, Ocean Blvd East, Holden Beach, NC
- -Approximately 50% to 60% of homes used polymeric cladding

- Damage was both storm surge (water), wind and fire.
- Note only catastrophic / complete damage was fire related

- 40 (<10%) Oak Island
- 10 (<10%) Holden Beach
- Major damage (non-catastrophic) was storm surge related

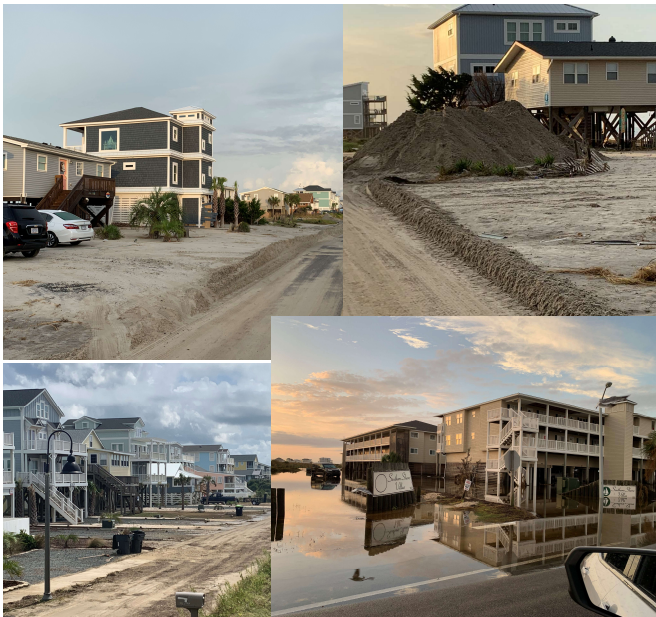
- Most noted failures were fascia related
- Soffit failures were noted and were more vulnerable when used in large porch ceiling applications and as a ceiling application under homes (homes are built using piles)
- Siding failures occurred more in residing applications than new construction
- Fastener corrosion contributed factor to siding failure in a number of cases
- Gable ends have more noticeable failures
- Instances of using J-channel without utility trim/punch locks or as starter strip were noted
- Still noticeable nonhigh-wind single nail hem products used

- Highlight need for use corrosion resistant fasteners
- Consider broadening soffit instruction to include more specifics on porch ceiling installation and bottom of home ceiling application, new code changes address this issue
- Consider highlighting fasteners that can be used without hitting stud (e.g. ring shank or screws)
- Study and provide stronger direction on fascia installation
- Continue focus on coastal applications and education of installers, builders, code officials

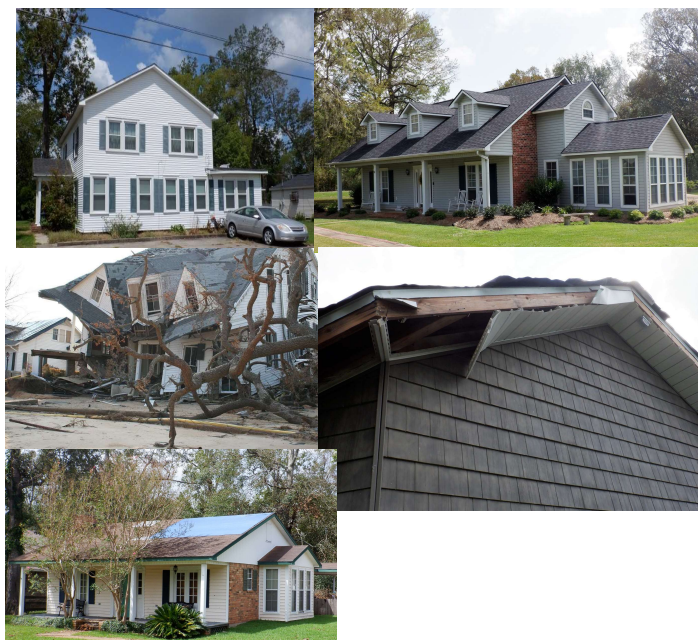
- Approximately 30%-40% of homes used polymeric cladding, 20% of which suffered minor damage.

- Approximately 30%-40% of homes used polymeric cladding, 20% of which minor damage.

- Approximately 40%-50% of homes used polymeric cladding, 10% of which minor damage.

- Approximately 30%-40% of homes used polymeric cladding, 80% of which minor to moderate damage.
- All construction types and cladding types were damaged.
- Some catastrophic damage, more related to falling trees than direct wind issues.

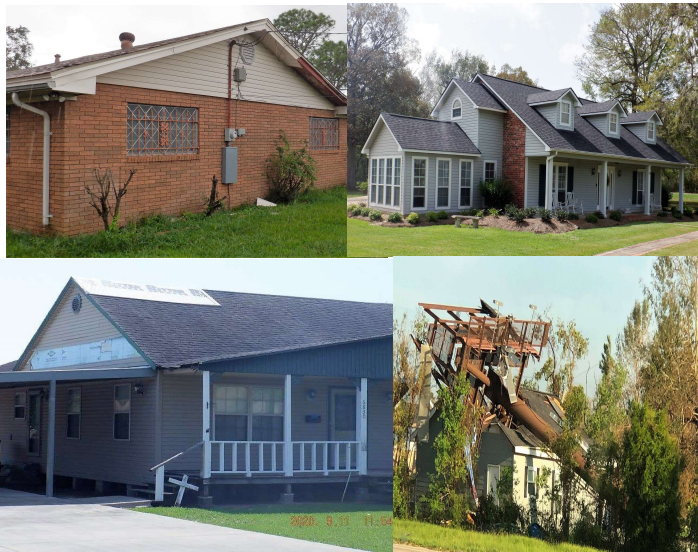
- Siding failures are the result of improper nailing patterns, often wider than 16-inches on center
- Instances of improper use of J-channel were noted
- Lack of solid sheathing, especially at gable ends and chimneys, may have contributed to siding blow off, as without solid sheathing (and at gable ends, also drywall) the siding becomes subject to more severe wind pressure without equalization
- Soffit failures were noted, most in combination with fascia failure, code changes correct this issue
- Non-high wind related product, improper specification
- All materials impacted in Lake Charles region, note multifamily construction and brick construction with major damage

- Education On Proper Installation / Inspections
 - Installers, Building Officials, Architects, Designers
- Focus on siding installation performance at gable ends, chimneys and other locations without interior drywall
- Highlight fasteners that can be used without hitting stud, for example as allowed ring shank nails
- Study fascia installation

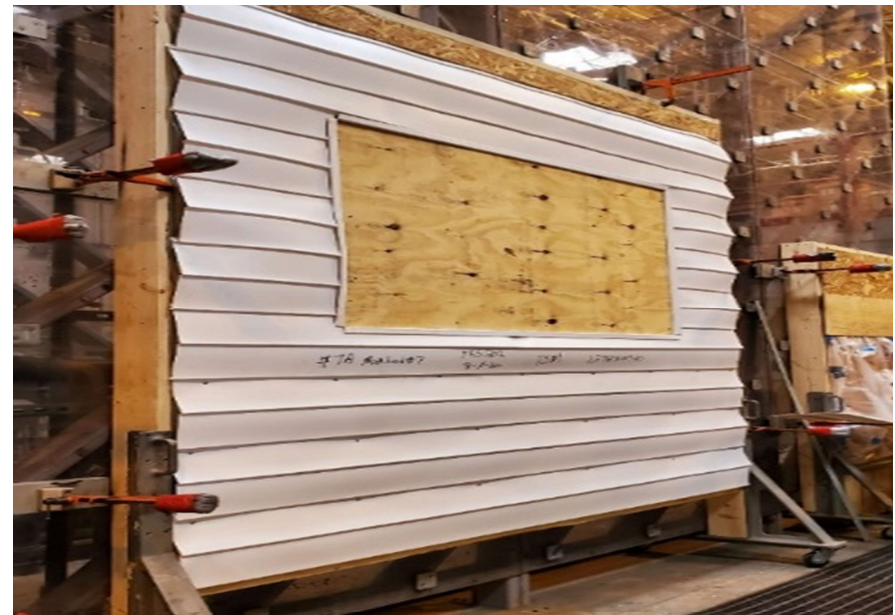
VSI Technical Committee conducted ASTM D5206 wind load testing at Intertek in York, PA in August 2020

- Testing provided insight on common installation and known installation errors
- Testing was conducted on standard product and coastal product

- “Economy panels” (non-coastal) are not as susceptible to nail withdrawal under normal wind conditions and therefore improper installation, meaning nails hitting studs, will be less problematic
- “Premium panels” (coastal) must be installed properly. Improper installation will result in fastener failures in high wind events. Alternative installation should focus on stronger fasteners as fastener withdrawal is the noted means of failure in high wind scenarios utilizing alternative fastener spacing
- J-channel cannot be used as a starter strip as doing so greatly reduces the wind performance of the system
- Current punch lock specifications are adequate for performance in coastal settings
