Final Report:

Survey and Investigation of Buildings Damaged by Category III, IV & V Hurricanes in FY 2022-2023 - Hurricane Ian

Project #: P0091032

Report No. 02-23 13 June 2023

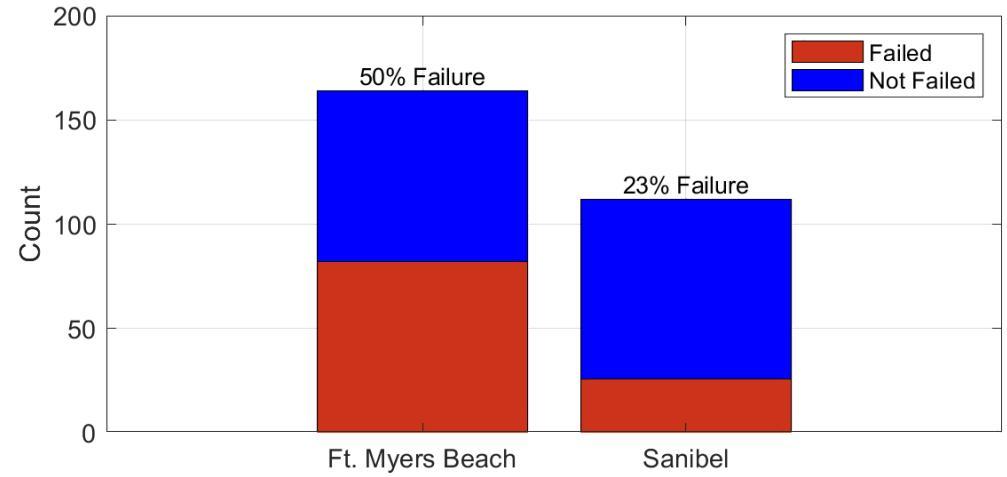
Figure 23. The proportion of breakaway wall failures (complete or partial failures) observed in Sanibel and Fortt Myers Beach among homes observed with breakaway walls.

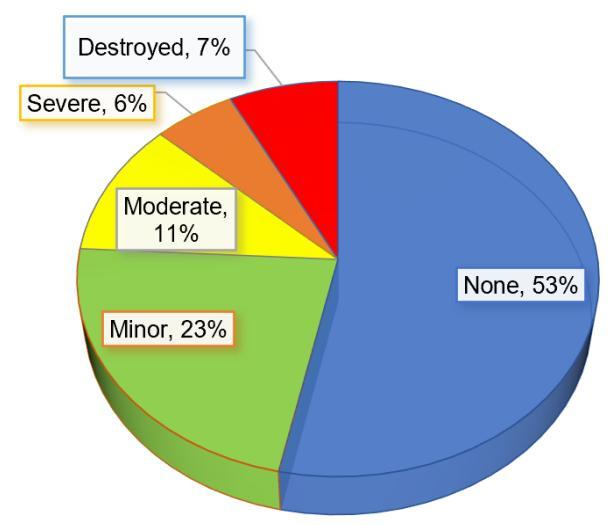
Hurricane Ian was far from a design-level event based on the wind field modeling performed by NIST/ARA, but wind damage² was still frequently observed in the study dataset as shown in Figure

27 and Figure 26. However, as illustrated in Table 6, nearly all the observable damage was related to the building envelope, specifically roof cover and wall cladding loss. Overall, 37% of buildings in the dataset were observed with damage to roof cover, and 13% of buildings were observed with wall cladding damage. Here it is assumed that all this damage is caused by wind, although it is possible that some of damage to both roof cover and wall cladding was induced by storm surge for some buildings on the barrier islands, primarily some located in the southern end of Fort Myers Beach, that saw inundation reach close to the eave height. Damage to the building envelope was most common in pre-FBC structures, but it was still commonly observed in post-FBC buildings (39% and 20% for construction eras of 2002-2011 and 2012-2022 respectively). While building envelope damage was common observed in approximately 5% of such structures), structural damage was uncommon even in pre-FBC structures, and no structural damage (roof or wall structure, roof or wall sheathing) was observed in post-FBC structures.

Figure 26. Distribution of wind damage ratings.

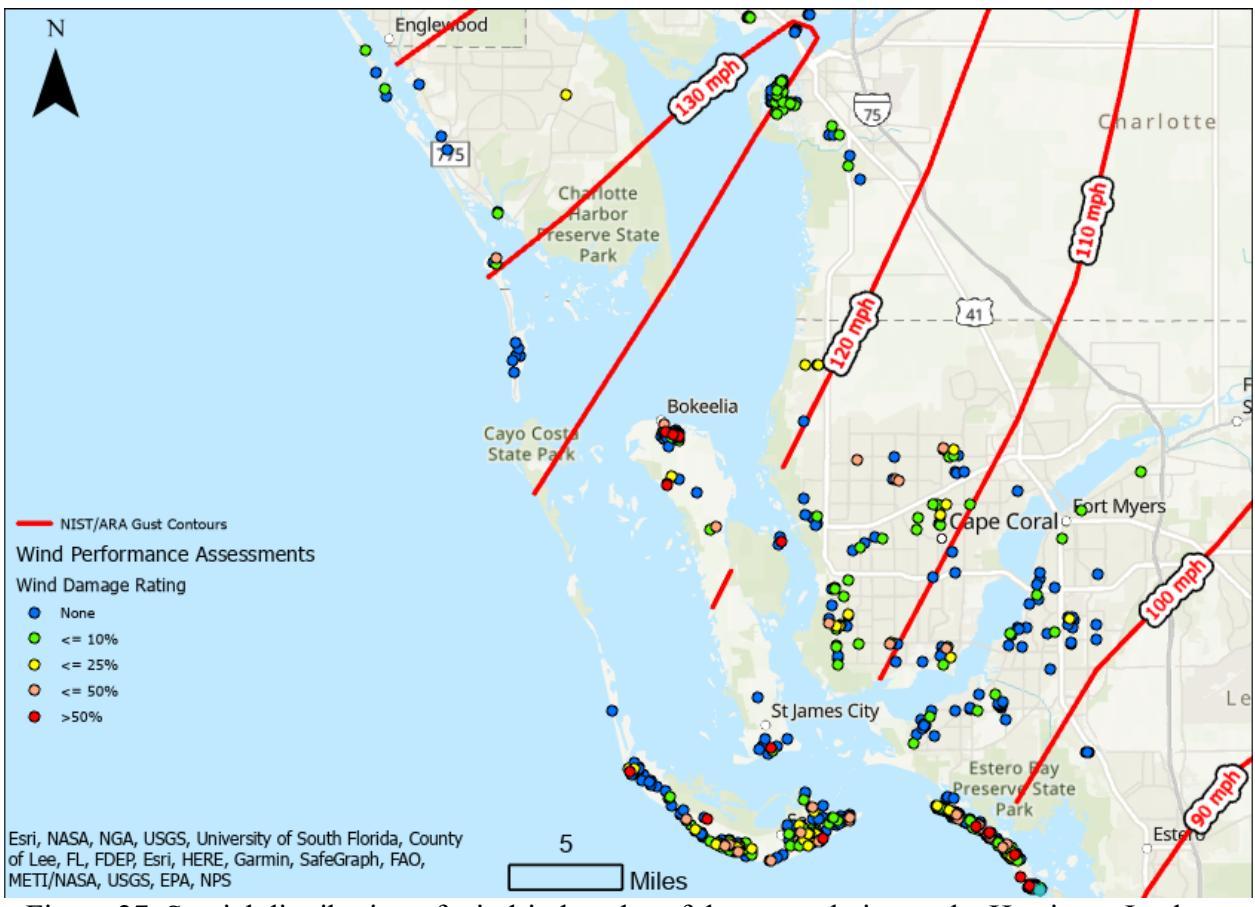
Figure 27. Spatial distribution of wind-induced roof damage relative to the Hurricane Ian best track and the estimated peak wind gust contours from NIST/ARA.

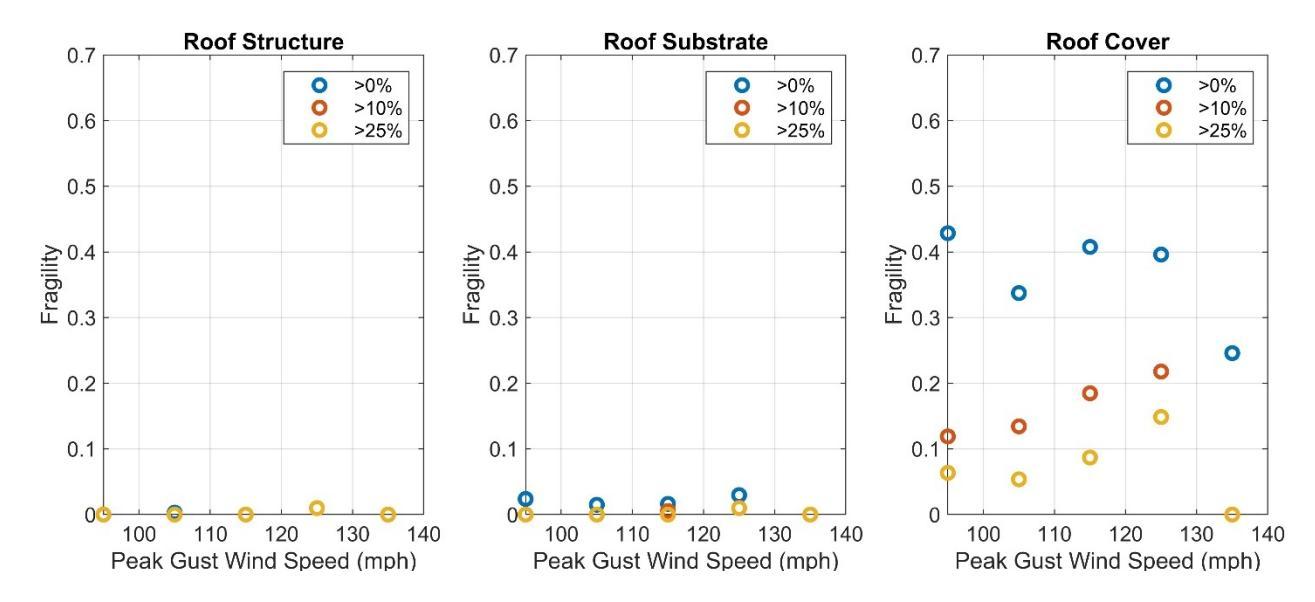
Wind damage was nominally correlated with the estimated gust wind speed (Figure 28), with increasing probability of exceeding roof cover damage limit states (e.g., 25% of roof cover loss). The enhanced probability in the lowest wind speed bin (80-100 mph) is possibly due to surge-induced damage in the southern portions of Fort Myers Beach, as inundation levels were close to or even greater than the eave heights of some slab-on-grade buildings.

Figure 28. Probability of experiencing more than the specified component-level roof damage as a function of the estimated peak gust wind speed.

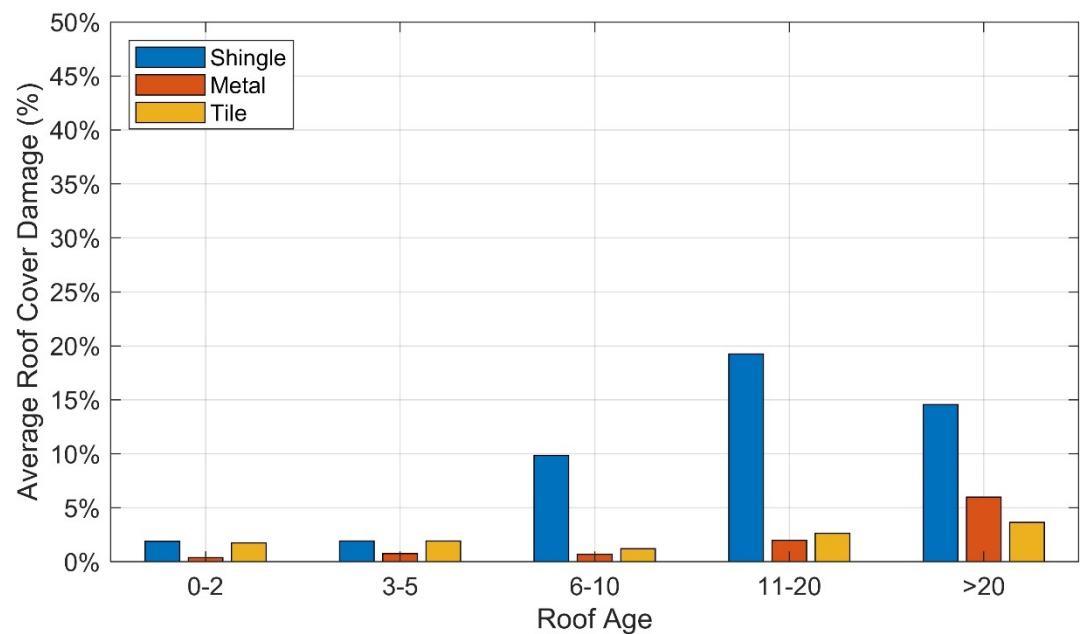
The results of the analysis show that for all roof cover materials, damage is rare within the first five years of installation (Figure 29). Metal and tile roofs show negligible increase in damage with age until the roof is greater than 10 years old. In contrast, asphalt shingles show a significant increase in average damage after just 5 years of service life. From a different perspective, beyond 5 years of service life, almost 50% of asphalt shingle roofs had at least 5% of visible damage, compared to around 10-15% for tile and metal roofs. This damage may be repairable but emphasizes the importance of effective secondary water barriers to minimize economic impacts of such damage. It should be noted that for roof ages beyond 20 years, the roof age is more uncertain as permit records do not go back that far on the county websites.

Figure 29. Average roof cover damage by roof cover material classification and age of the roof, obtained from building permits and county records.

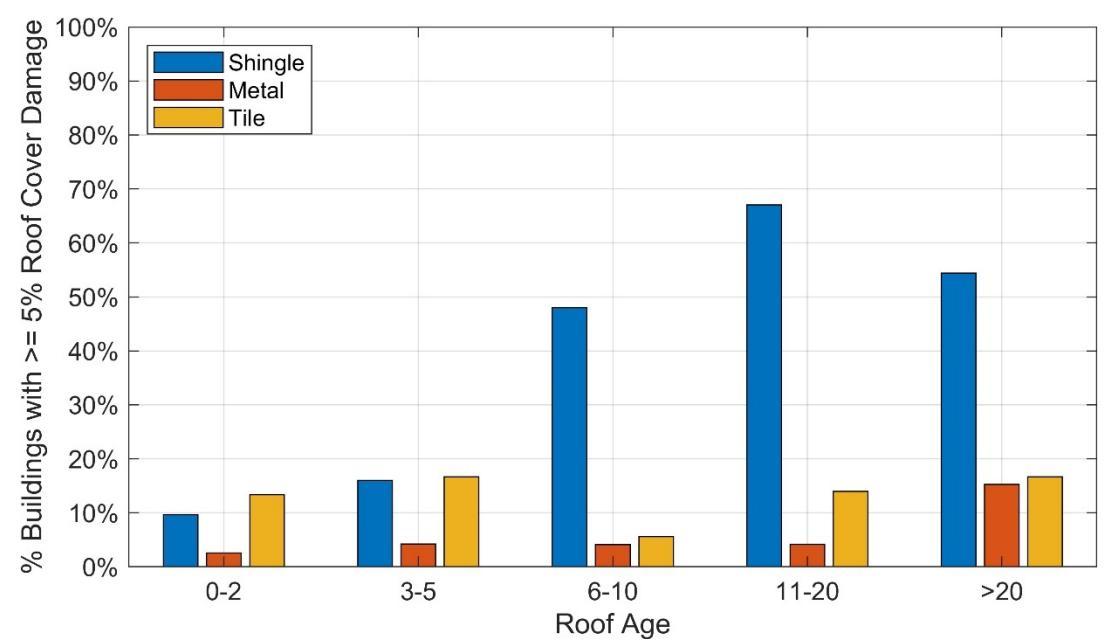
Figure 30. Percentage of buildings with at least 5% visible roof cover loss by material and roof age.

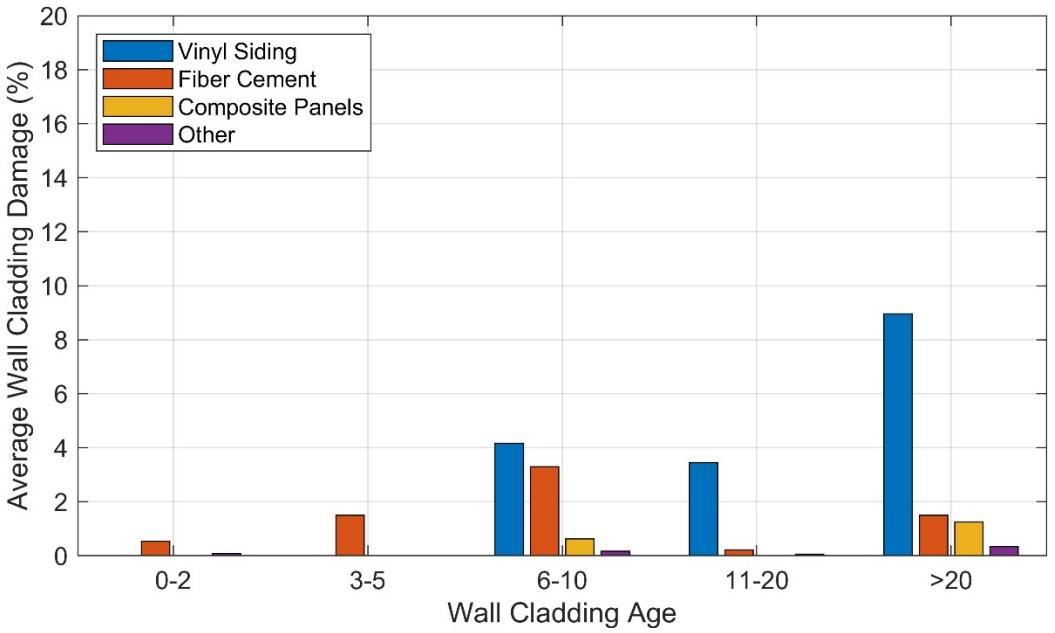
Regarding performance (Figure 31), a few recently built homes with fiber cement boards experienced minor wind damage, but most wall cladding in service for 5 years or less performed well in terms of visible exterior damage. It should be noted that there were no vinyl siding systems installed within the past two years in the study dataset. Some older (> 20 years old) vinyl siding systems experienced more significant damage, but these would have been installed pre-FBC if the age of the wall cladding matches the original year of construction of the material. As illustrated further in Figure 32, the wall cladding damage that does occur is generally minor. Less than 20% of buildings regardless of wall cladding system and age experienced more than 10% wall cladding loss.

In summary, wall cladding systems generally performed reasonably overall, but should be understood within the context of the estimated wind hazard, which was well below design levels. In a design level event, wall cladding damage would be much more widespread, even in post-FBC buildings, based on the observations from this study dataset.

Figure 31. Average wall cladding damage by material classification and age (in years) of the building.

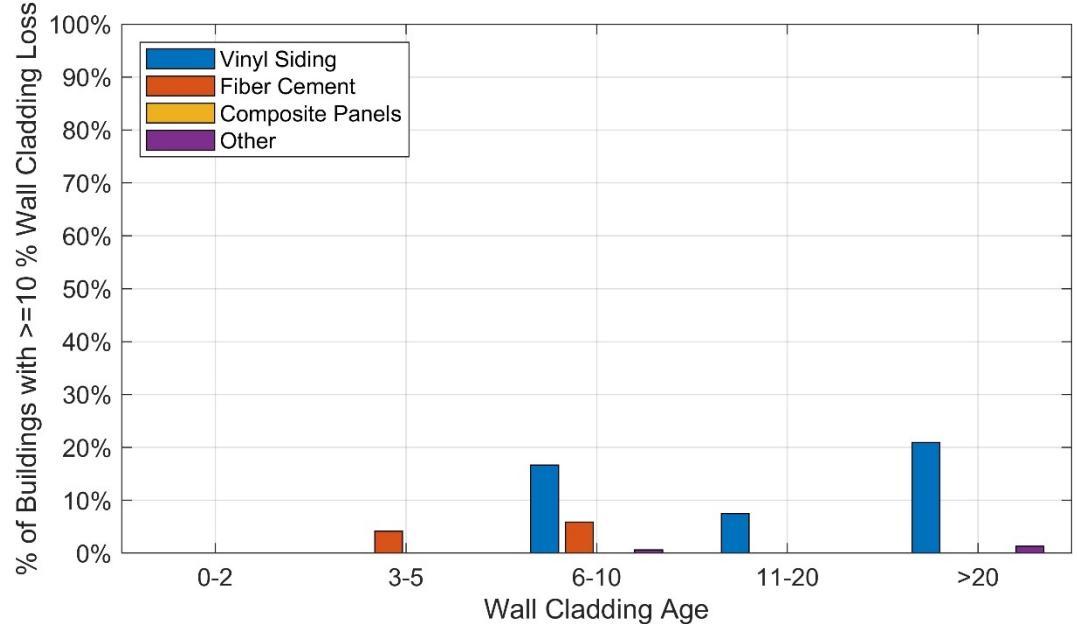
Figure 32. Percentage of buildings with at least 10% visible wall cladding loss by material and age of original construction (in years).
