# Final Report

## Survey and Investigation of Buildings Damaged by Category III, IV and V Hurricanes in FY 2024-2025 – Hurricanes Helene and Milton

Project #: P0362614

Report No. 02-25  
26 June 2025

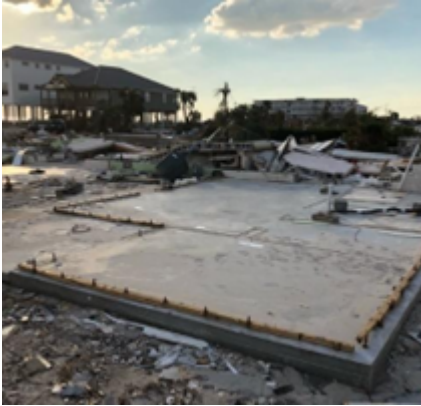
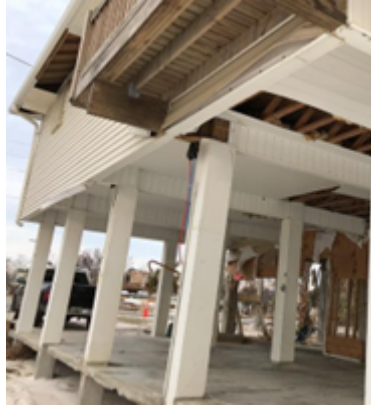
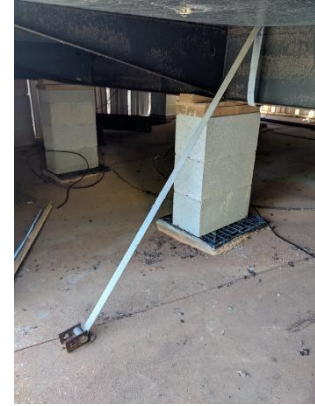
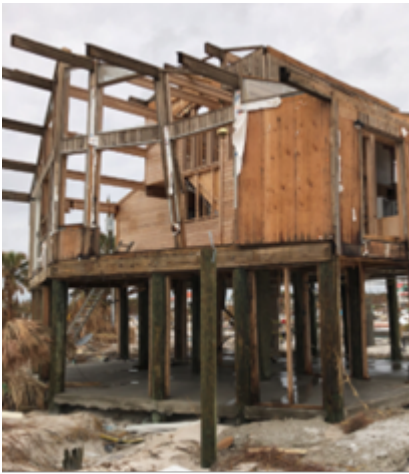
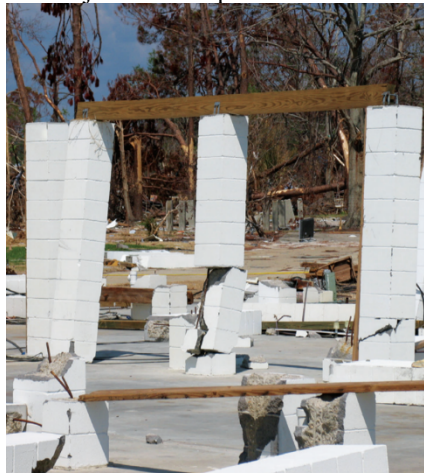
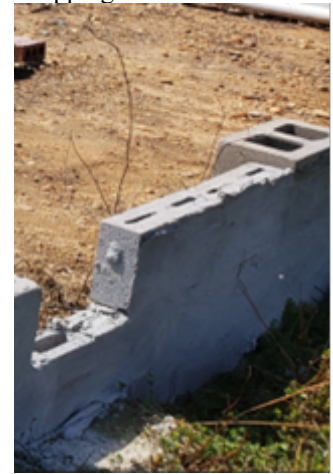
Figure 7. Examples of building foundation types (a) concrete slab-on-grade, (b) cast-in-place concrete piers, (c) ground anchors and strapping, (d) wood piers ( $\leq 8$  ft spacing), (e) reinforced masonry piers, (f) unreinforced masonry stem wall.

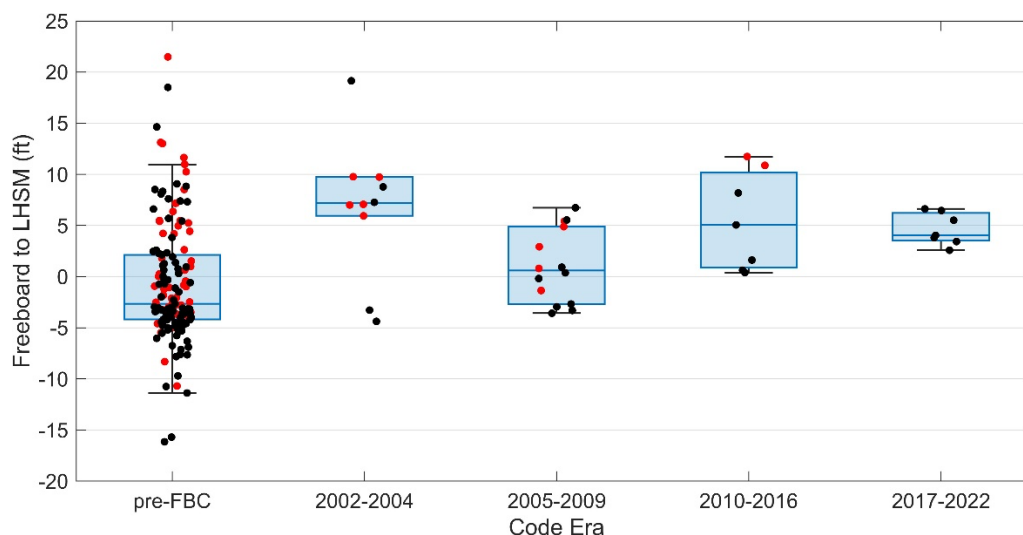
Figure 10. Elevation of the bottom of the lowest horizontal structural member relative to the current base flood elevation by code era and flood zone (red = Zone AE and black = Zone VE).

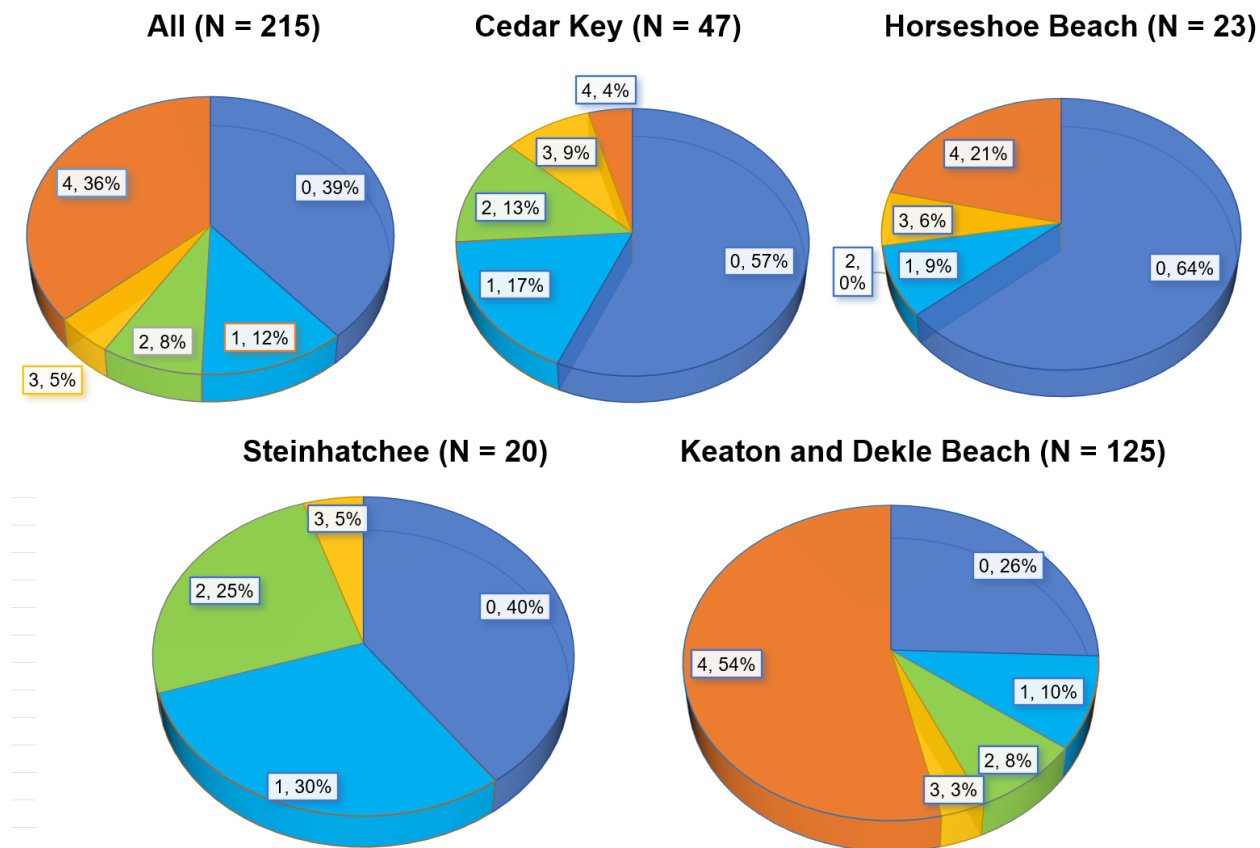
Of the 221 structures in the study that were subjected to coastal hazards, 39% experienced no observable damage to the main living areas (not accounting for failure of breakaway walls, access stairs, or similar), while 36% were destroyed. Damage was most widespread in the communities of Keaton and Dekle Beach, where over 50% of the structures were classified as destroyed, most washed completely off their foundations. Steinhatchee suffered the least damage despite experiencing higher inundation levels than Cedar Key and Horseshoe Beach. Located in an inlet, Steinhatchee is surrounded by natural features that could reduce the water flow velocity and wave action for a scenario like that experienced during Hurricane Helene (Figure 11).

Figure 11. Distribution of global performance ratings in coastal regions by community. The numbers in each chart label refer to the numeric value of the global performance rating as defined in Table 3 and provide the percentage of structures in the given community that experienced that performance rating.

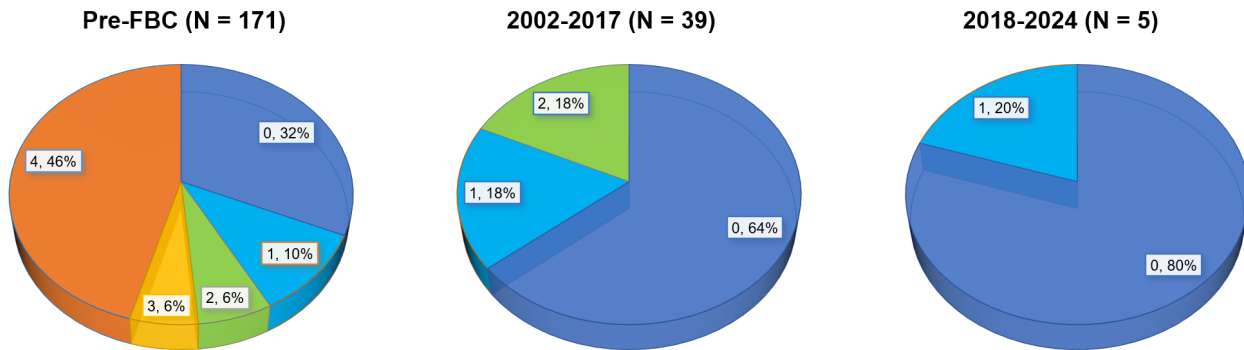
Examining the overall performance by code era (Figure 12), the effect of the Florida Building Code was obvious. There were 43 post-FBC<sup>2</sup> residential structures in the study, and none experienced any significant structural damage (Table 4). No structures built to the Florida Building Code suffered more than Moderate damage based on the criteria outlined in Table 3. Further, of the 78 structures that were observed to have collapsed, partially collapsed or shifted off its foundation, none were post-FBC homes. In contrast, 44% of pre-FBC homes were destroyed, most of them completely swept off their foundation. Only four structures in the study dataset were constructed to the 2017 Florida Building Code, but none suffered significant damage despite experiencing higher surge inundation (as estimated by the CERA modeling) on average relative to the other code eras. Several pre-2017 FBC structures did sustain significant non-structural damage due to water inundation and loss of wall cladding or roof cover.

Figure 12. Distribution of global performance ratings by construction era. The numbers in each chart label refer to the numeric value of the global performance rating as defined in Table 3, and provide the percentage of structures in the given community that experienced that performance rating.

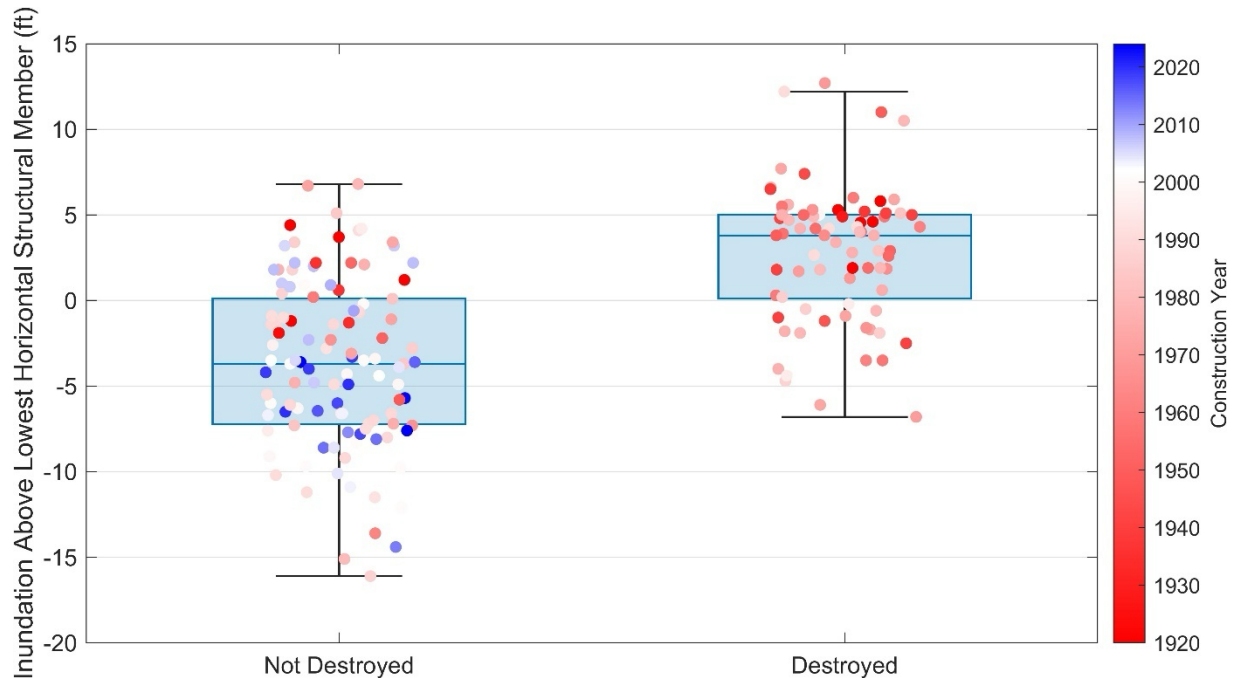
above the LHSM, and 17 of the 78 structures that were destroyed had an inundation less than the LHSM (Figure 13). A variety of reasons could explain the variability in performance, including uncertainty in the true inundation height above ground, the role of water flow velocity and wave height hazards on top of the inundation, poor performance of breakaway walls, and the construction era of the homes as discussed previously.

Figure 13. Inundation above the lowest horizontal structural member (LHSM) for not destroyed and destroyed structures identified by year of construction.

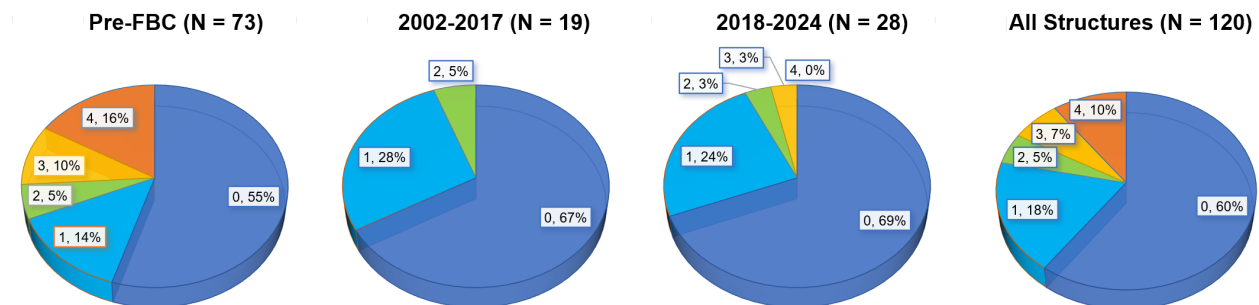
The distribution of assigned damage ratings across all residential structures within the study impacted by tornadoes is provided in Figure 23. The pre-FBC structures again tended to experience higher damage levels, with 26% of those structures classified with heavy damage or destruction, and 55% experiencing negligible to slight damage. In comparison, post-FBC structures overall were classified with heavy damage or destruction in only one home, and 68% experiencing negligible to slight damage.

Figure 23. Distribution of global performance ratings by major code eras. The numbers in each chart label refer to the numeric value of the global performance rating as defined in Table 3, and provide the percentage of structures in the given community that experienced that performance rating.

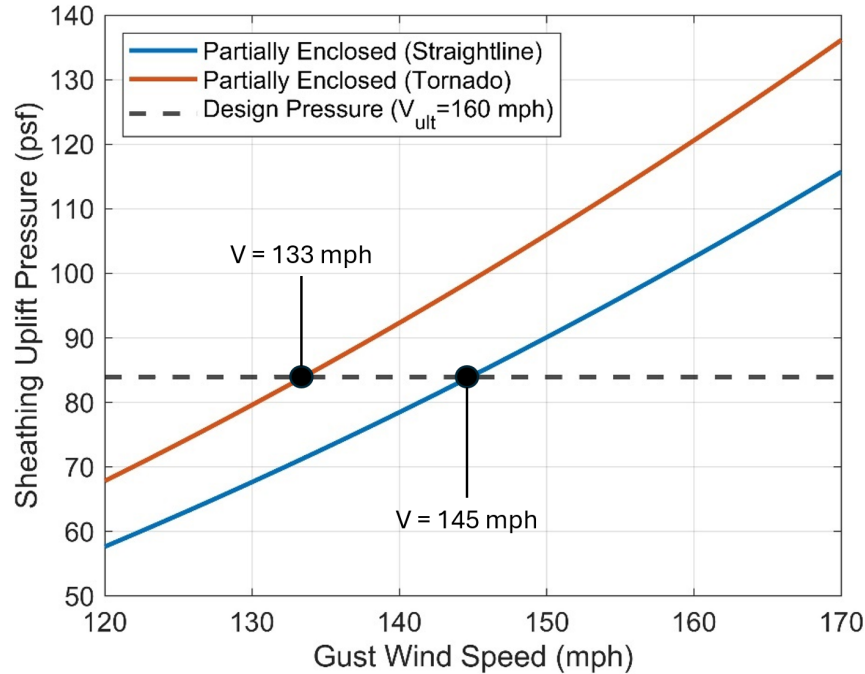
In the Cobblestone community, the garage door failures propagated to significant roof sheathing and structure damage. In site-built homes within the Spanish Lakes community, the garage door failures did not propagate to further structural damage. Research performed by the Insurance Institute for Business and Home Safety (BMS 2019) and others (Kovar et al. 2018; Roueche and Prevatt 2013) have shown that garage doors can act as damage amplifiers, as failures increase the positive internal pressure, increasing uplift pressure on the roof. The importance of garage doors can be illustrated by evaluating how the uplift pressure on a typical edge sheathing panel in a hip roof changes with wind speed and internal pressure condition (Figure 29). Similar effects could be expected for other roof shapes, pitches, and roof components.

Figure 29. Illustrative sheathing uplift design pressures for various wind speeds, enclosure, and hazard scenarios, assuming a hipped roof in Exposure C with a roof pitch of 4:12. Tornado and straightline wind loads are calculated using the provisions of ASCE 7-22. With the garage door failure and subsequent change in internal pressure, the sheathing uplift pressure associated with the design wind speed of 160 mph is exceeded prematurely – at gust velocities of 133 mph and 145 mph respectively for tornado and straight-line winds.

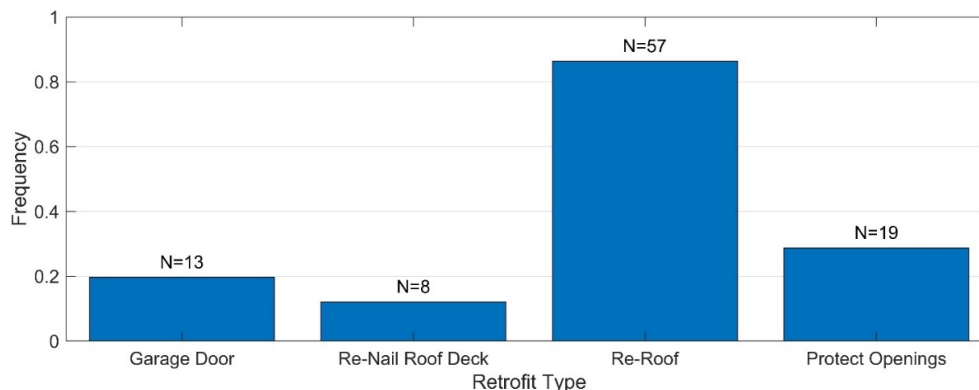
One of the tornadoes surveyed by the authors was an EF2 tornado that struck Stuart, FL in Martin County. The tornado destroyed several homes in Mariner Sands country club and adjacent neighborhoods just north, and the survey team evaluated the performance of 66 homes in this community. Martin County makes all permit data publicly available, which provides an opportunity to gauge the frequency and effectiveness of wind retrofit measures. For homes in the study dataset, permits were reviewed to capture when the permit was pulled and whether it was related to wind mitigation measures. The four classes of permits that were observed were the following: 1) re-roofing, 2) re-nailing the roof decking (associated with a re-roofing permit, though not all re-roofing permits also had a re-nailing permit), 3) installation of a new garage door, and 4) installation of impact resistant doors, windows, or shutters. Figure 30 provides a summary of the frequency of retrofits observed. All the permits related to re-nailing the roof deck occurred in 2015 or later.

Figure 30. Frequency of wind mitigation retrofits observed in homes in Martin County affected by the EF2 tornado.

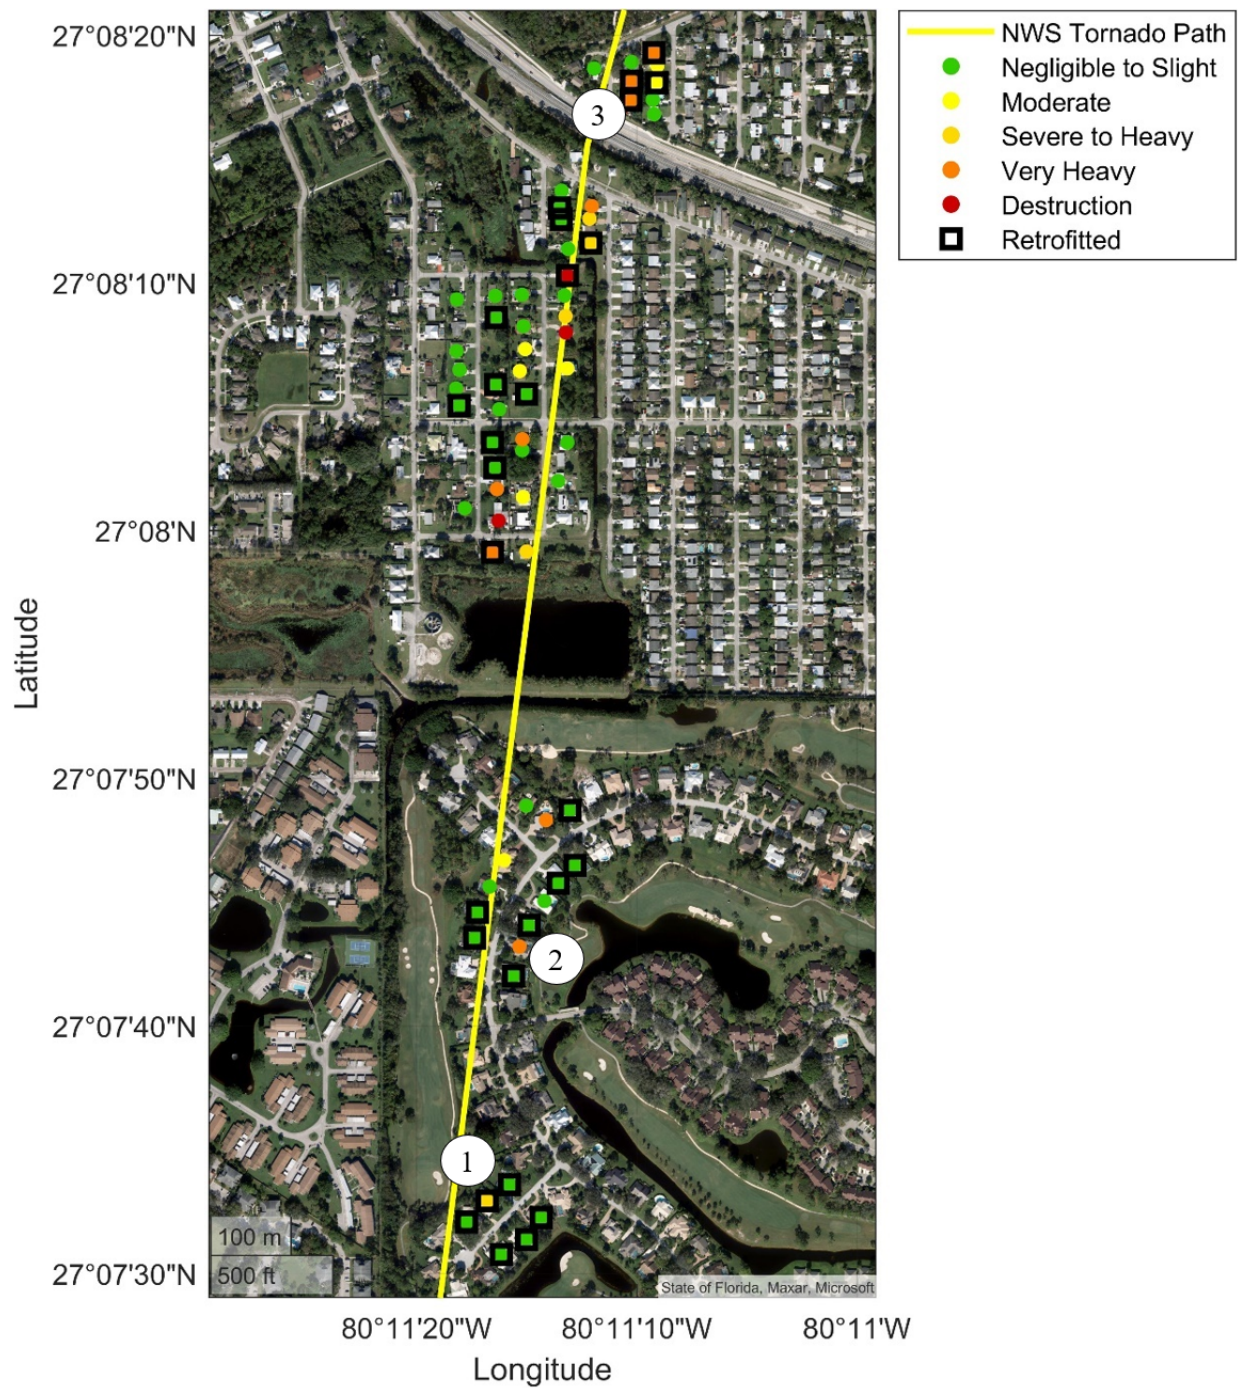
Performance of the homes with retrofits was mixed, as illustrated in Figure 31, which shows the overall damage state of buildings assessed in the tornado path. Homes that were retrofitted (including upgrading the garage door, re-nailing the roof deck, or adding impact resistant windows or doors) are marked with an open black rectangle. In site 1 of Figure 31, a home installed shutters in 2006, and installed a new garage door in 2017, but suffered major damage to the roof, including partial loss of roof structure, sheathing, and cover (metal roof). In site 2, a wood-frame home that was not retrofitted suffered almost complete loss of the roof structure, while the two homes adjacent to it did not suffer any evident structural damage. Both surviving structures were partially retrofitted, with one installing a new garage door in 2006, and the other replacing existing windows with impact resistant ones in 2021. All three homes were wood-framed and constructed between 1980 and 1982. In site 3 of Figure 31, multiple homes with retrofits suffered major damage, including a home constructed in 1970 that was retrofitted in 2017 and 2020 to install impact-rated windows, re-nail plywood roof deck, and install a metal roof. During the tornado, the home suffered damage to almost half the roof structure, including extensive loss of roof sheathing panels (Figure 32). Each of these examples are anecdotal, particularly since the damage occurred in a tornado, which can produce sharp wind speed gradients and rapid wind speed and direction changes that make interpreting damage much more complex than that from hurricanes. A broader study of the performance of wind-retrofitted structures under hurricane conditions would be needed to make conclusions about the actualized benefits of wind retrofits.

Figure 31. Locations of retrofitted homes (excluding roof cover replacement) with respect to the EF2 tornado in Stuart, FL.
