## MIAMI-DADE COUNTY PERFORMANCE TEST REPORT

AMARR GARAGE DOORS

PRODUCT: Coated Steel Door Skin Panels

Report No: C5463.01-106-18

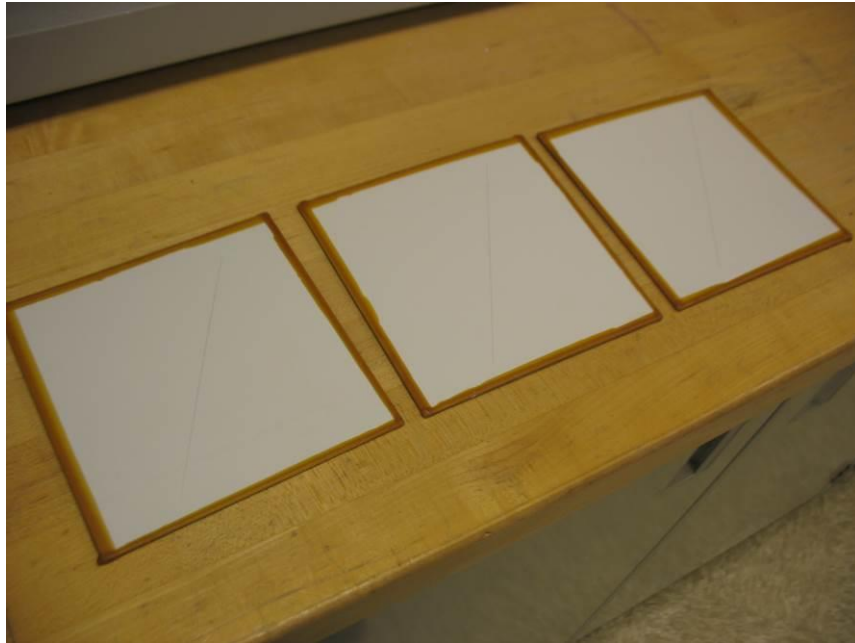
**Photo No. 1**  
**Sample Group A (G-40 [NCNGFJ])**

| Specimen Details | | Scribe Creepage | | Unscribed Area Blister Rating and Observations |
|---|---|---|---|---|
| <b>G-40<br/>Galvanized with Polyester Topcoat (NCNGFJ: white coat backing)</b> | <b>A-1</b> | Coating blistered away from scribe<br>no red rust present | <b>7</b><br>1/32" to 1/16" | Coating blistered away from scribe, no other blisters present |
| | <b>A-2</b> | | <b>0</b><br>5/8" or more | Coating blistered away from scribe, one other blister present |
| | <b>A-3</b> | | <b>3</b><br>1/4" to 3/8" | Coating blistered away from scribe, few other blisters present |

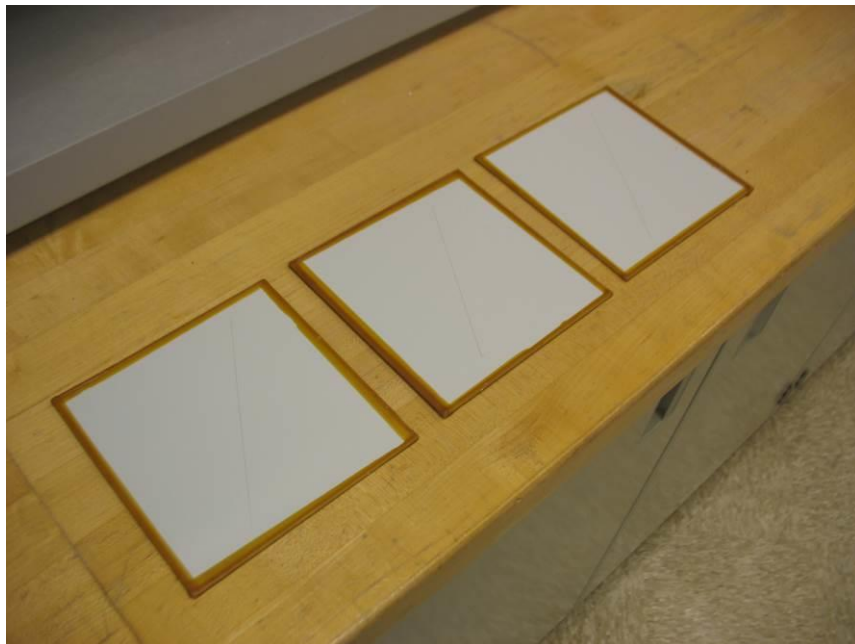
**Photo No. 2**  
**Sample Group B (G-30 [NCNDVP])**

| Specimen Details | | Scribe Creepage | | Unscribed Area Blister Rating and Observations |
|---|---|---|---|---|
| <b>G-30<br/>Galvanized with Polyester Topcoat (NCNDVP: green coat backing)</b> | <b>B-1</b> | Coating blistered away from scribe,<br>no red rust present | <b>0</b><br>5/8" or more | Coating blistered away from scribe, few other blisters present |
| | <b>B-2</b> | | <b>1</b><br>1/2" to 5/8" | Coating blistered away from scribe, no other blisters present |
| | <b>B-3</b> | | <b>2</b><br>3/8" to 1/2" | Coating blistered away from scribe, one other blister present |

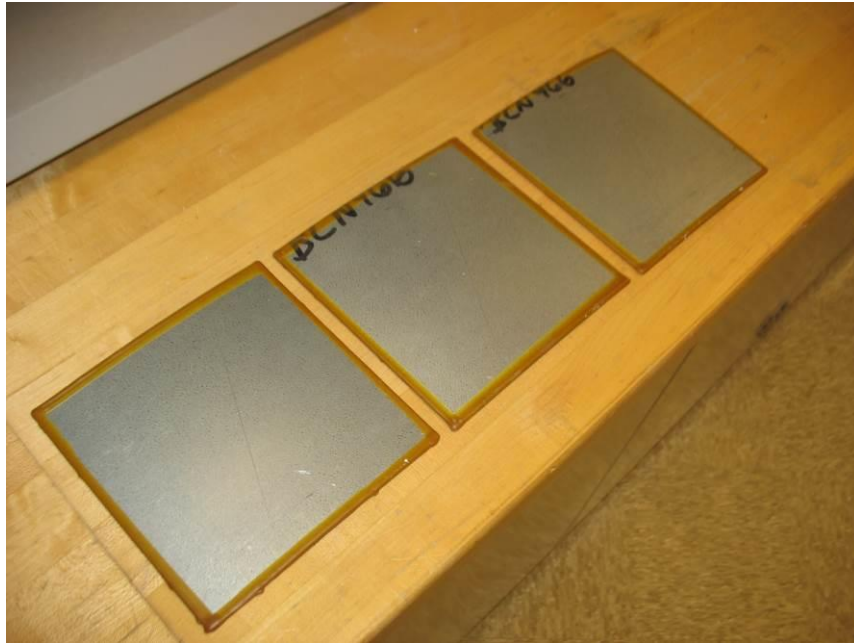
**Photo No. 3**  
**G-90 Control Sample Group**

| Specimen Details | | Scribe Creepage | | Unscribed Area Blister Rating and Observations |
|---|---|---|---|---|
| <b>G-90<br/>Galvanized Control Samples</b> | <b>C-1</b> | Heavy corrosion over entire specimen face (Scribe no longer visible) | <b>0</b><br>5/8" or more | No top coat to evaluate |
| | <b>C-2</b> | | <b>0</b><br>5/8" or more | |
| | <b>C-3</b> | | <b>0</b><br>5/8" or more | |
