Phase 2 Investigation of Potential Benefits from Sealing Building Cavities in Conditioned Space Used for Return Air Plenums in Existing Homes

Janet McIlvaine and David Beal
 Florida Solar Energy Center
 July 11, 2014

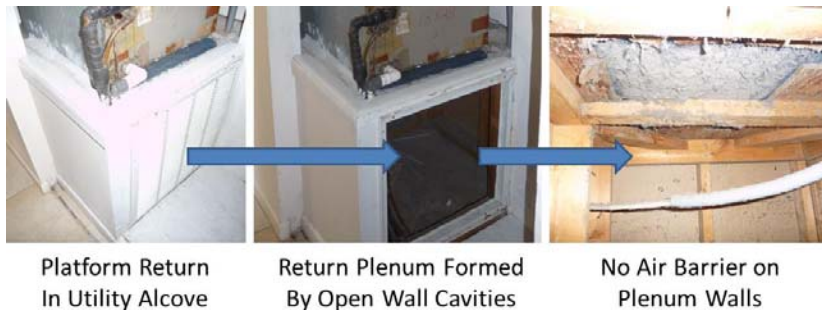
Figure 1 – Return plenum formed by unfinished frame walls and air handler support platform in a utility alcove.

By this definition, a return plenum located within a house’s the conditioned footprint, such as the one in Figure 1, appears to meet the definition because since they are within the whole house air barrier usually formed by a combination of interior and exterior finishes and detailing. However, in operation, return plenums formed by building cavities often *are not* separated from unconditioned spaces by an air barrier as illustrated in Figure 1. When the air handler operates, unconditioned air is pulled into the return plenum. Figure 2 shows the heat signature of attic air being pulled down the wall cavity during air handler run time.

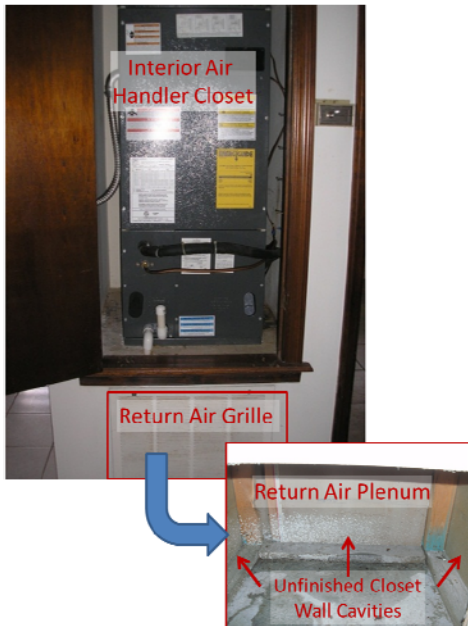
Figure 3. This air handler in an interior closet (left, top) is served by a return air plenum directly beneath (left, bottom) formed by the open, unfinished framing of the closet walls.

1. A framed platform supporting an up-flow air handler with through-wall filter-back return grilles (Figure 3) or
2. A metal or frame air handler stand where the closet functions as the return plenum with return air pathways through louvered doors or door mounted grilles (Figure 4).

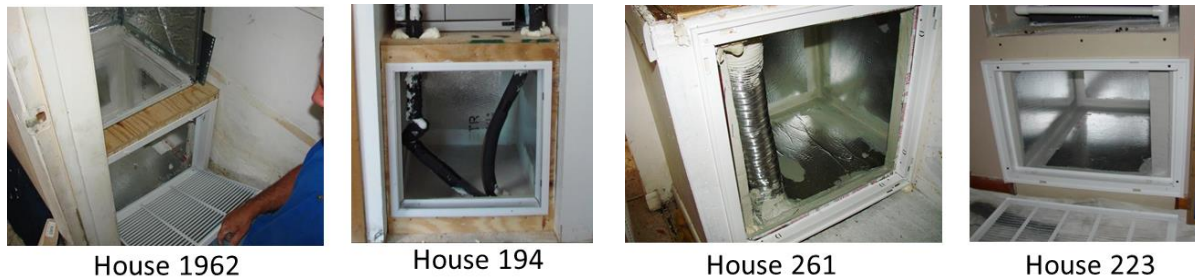
Figure 5-plenums Completed Phase 1 return plenums.

Phase 1 test results showed that the contractors' standard approach achieved post-retrofit return plenum air tightness on par with Florida new construction by constructing and sealing a dedicated return air path using duct board (Figure 5). Test results (Figure 6) show that contractors successfully isolated the return plenum from unconditioned space with normalized duct leakage outside conditioned space ($Q_{n,out}$) of 0.03 to 0.01 and in one case below the measurement threshold of the test equipment.

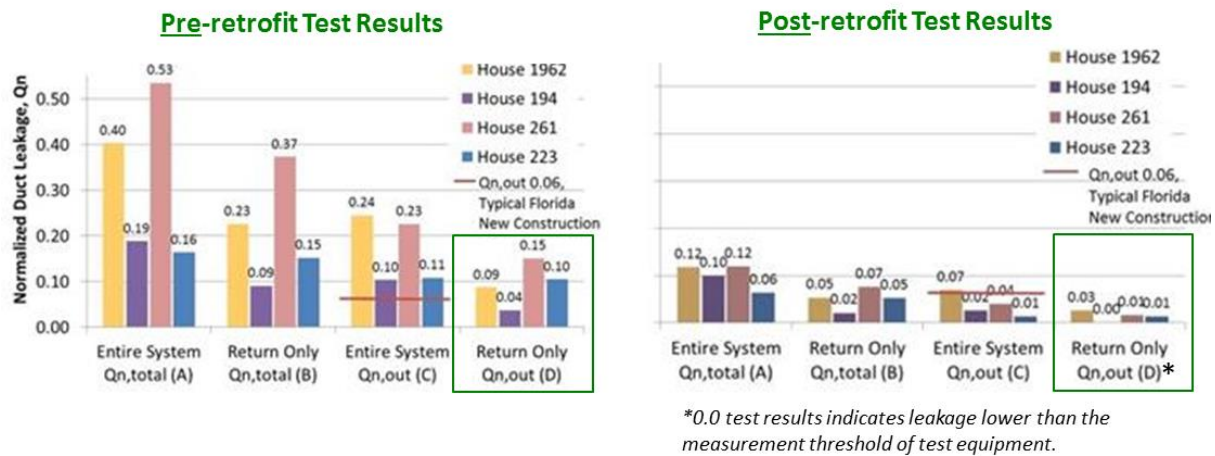
Figure 6 Phase 1 duct testing at pre-retrofit (left) and post-retrofit (right) show vast improvement.
