Final Report:

Water Resistance Performance of Exterior Building Envelope and Fenestration During Minimally High Wind Events in Hurricane Irma

Report No. 02-19
10 June 2019

Engineering School of Sustainable Infrastructure and Environment
Department of Civil and Coastal Engineering
University of Florida
365 Weil Hall
P.O. Box 116580
Gainesville, FL 32611-6580

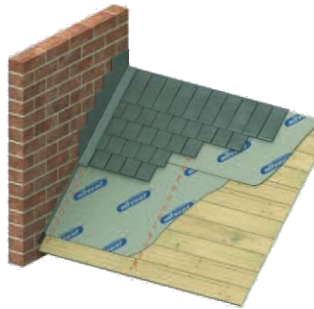
Roof secondary water barrier

Figure 3. Roof assemblies

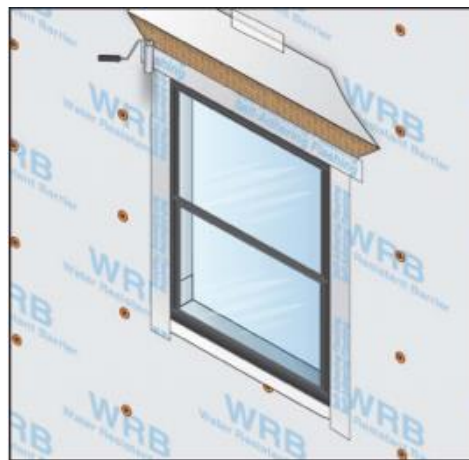
Self-adhering flashing

- Apply flashing of the window.
- Cut the jamb flashing and adhere the top end of the flashing.
- Use firm pressure to adhere the self-adhering flashing.

Figure 9. Flashing installation method (FMA/AAMA 100-12 2012)

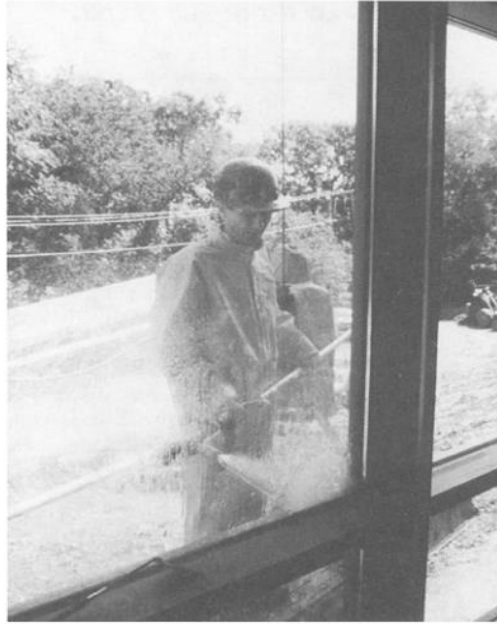
Hose tests is much simpler than other test. In order to perform a hose test, one only needs a diameter of 19 mm (3/4 in.) garden hose, a special nozzle, a valve to control the water flow, a water pressure gauge, and an observer stationed on the interior side of the test area to look for leaks.

Figure 14. Hose test (J.KUDDER and ERDLY 1998)

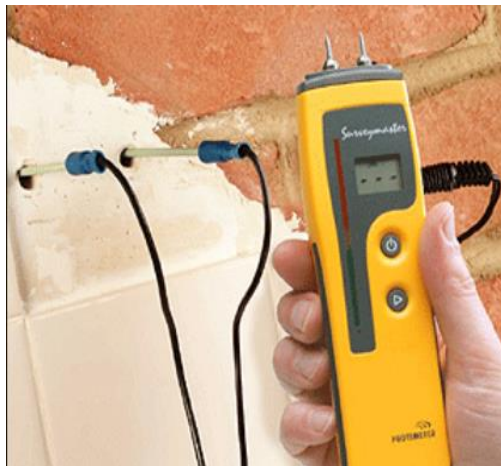
Probe method for moisture involves using a penetrating probe meter to test for moisture within the walls, floors or ceilings according to the electrical resistance. To do this, small holes-about 3/16 of an inch-must be drilled into the building material. The holes are small and undetectable.

Figure 15. Probe method (Laurenzi 2018)

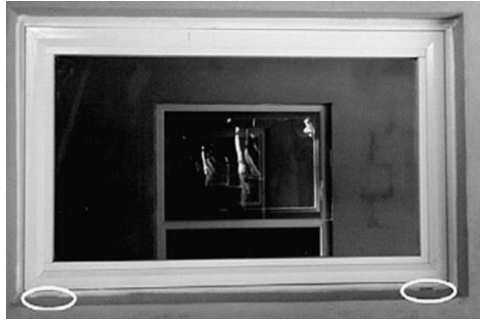
- According to Salzano et al. (2010) while water barrier method (Figure 18) performed well on the CMU walls, drainage method installation did not performed well.

Figure 18. Water barrier method

- Contrary to the water barrier method, the drainage method installations did not perform well on the concrete masonry unit wall specimens tested due to discontinuity between the water shedding surface and the exterior moisture barrier of the window-wall system.
- Windows installed into the wood frame walls, both water barrier and drainage installation methods provided sufficient water penetration resistance due to adequate continuity of the critical barriers.
- Low expansion foam seals prevent leakage for pressures up to 4788 Pa (100 psf), but only if the excess of foam is not trimmed.
- In fact, if the excessive foam is trimmed, it does not present any water resistance.
- Selecting an appropriate sealant is paramount to water penetration performance found to work the best.

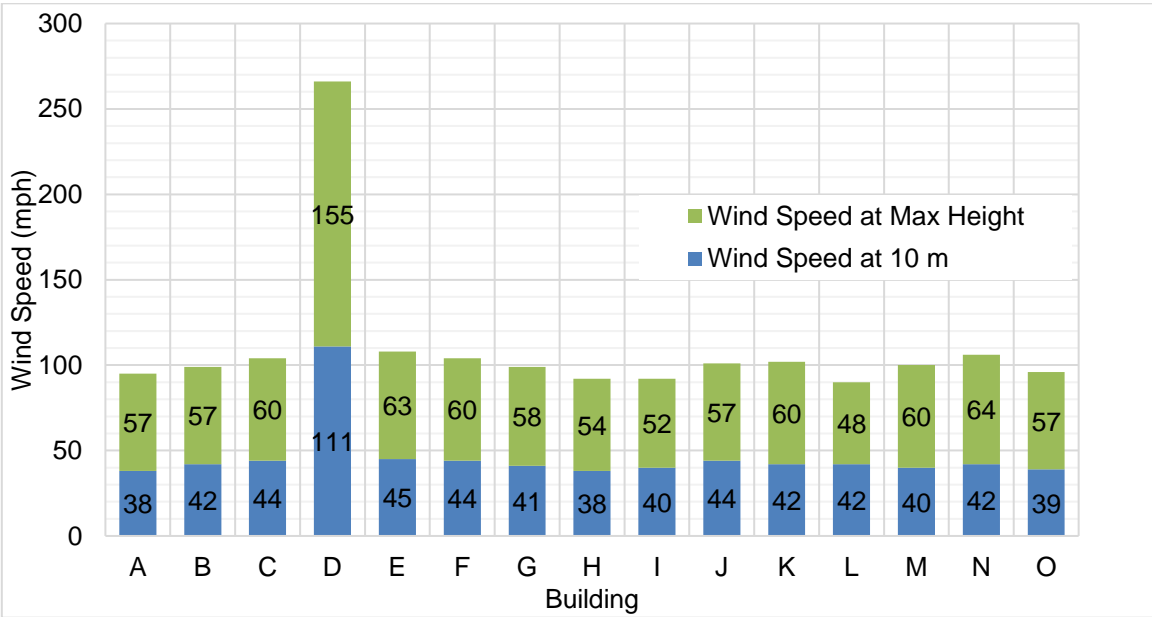
In Figure 22 the maximum expected wind speed per building at 10 m and at maximum height (assuming 8 ft of height per story) are shown per each one of the buildings considering the actual terrain. For buildings located in the same zip code, the maximum wind speed at 10 m is the same, however, the maximum speed at the maximum height is different due to the number of stories varies per building.

Figure 22. Maximum expected wind speed per building at 10 m and at maximum height

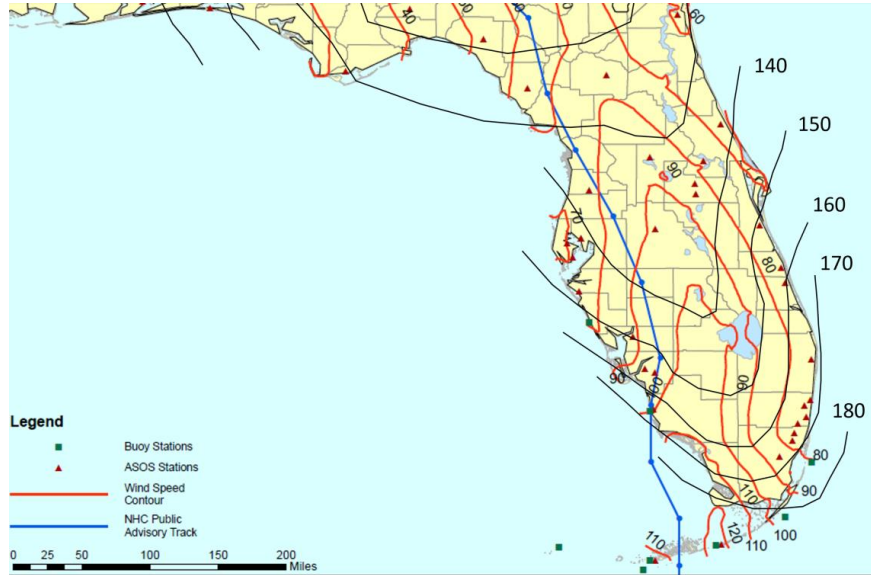
The Figure 24 compare the Florida’s Design wind speeds (category II, 3 sec. gust) in black, with the maximum wind speeds caused by hurricane Irma in 2017 in red. It is important to notice that registered wind speeds are lower than those provided by the current code. In general, wind speeds registered are lower than those provided by the code.

Figure 24. State of Florida’s Design Wind Speed vs. Irma winds Category II (3sec.gust)

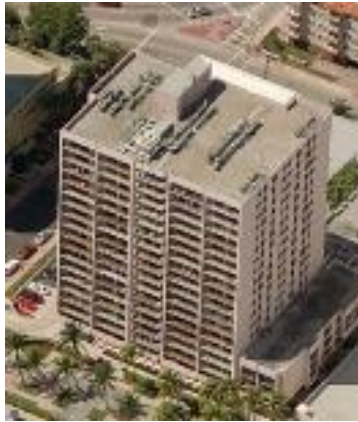
Closed building

- The buildings are classified as open or closed buildings to estimate wind vulnerability.

Figure 25. Closed and Open MHR buildings

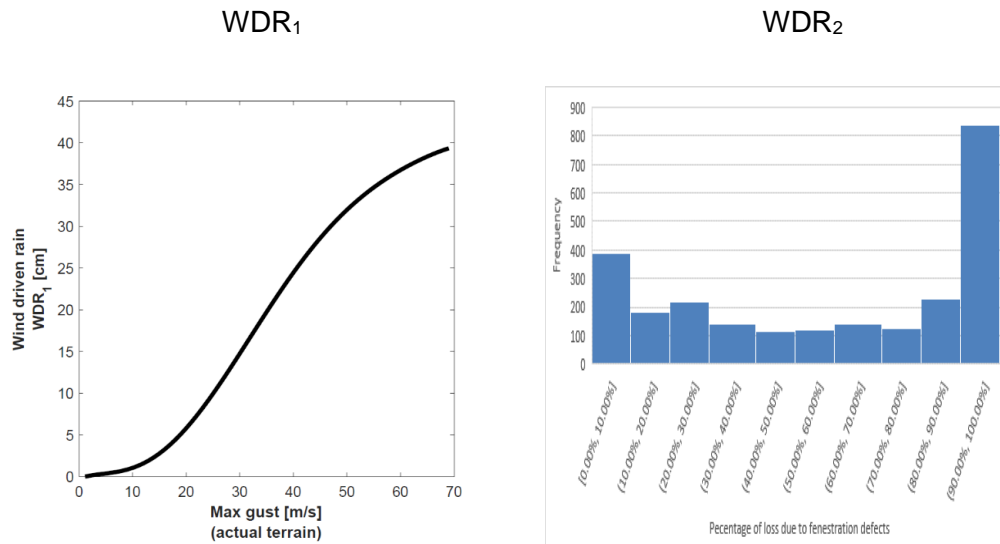
- A probabilistic hurricane rain model assesses accumulated wind-driven rain as a function of maximum wind speed.
- WDR_1 is the wind-driven rain accumulated before the maximum wind speed occurs. WDR_2 is the remaining wind-driven rain accumulated between the moment that maximum wind speed occurs to the end of the storm.

Figure 27. Mean accumulated impinging rain

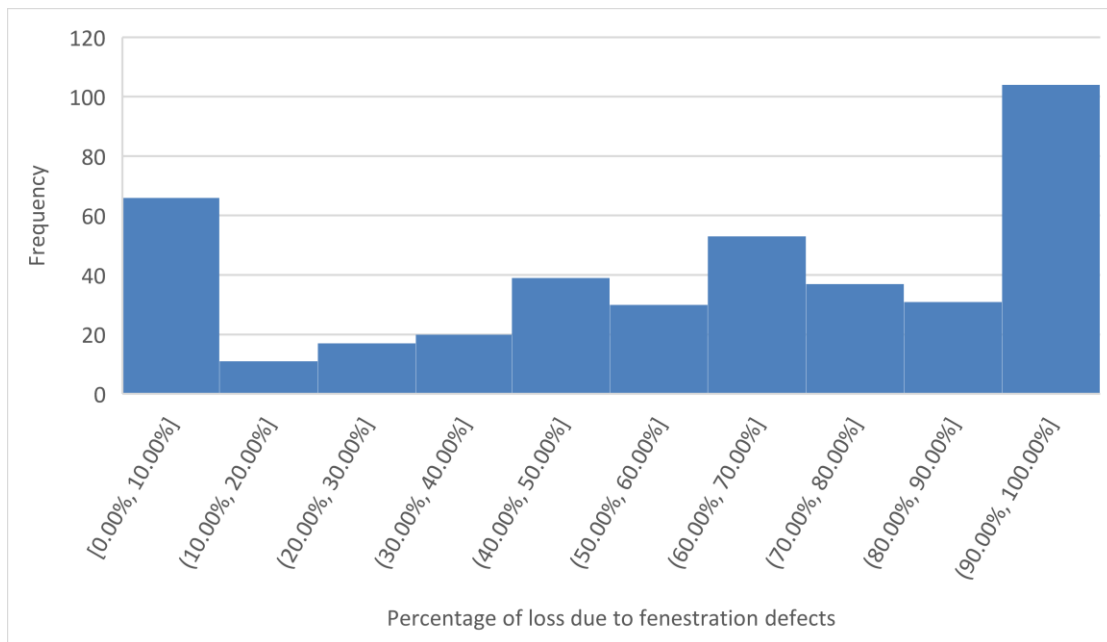
The results of Irma scenario loss and AAL are divided into 8 groups of pre or post 2002 buildings and less or more than 10 stories. Figure 33 to Figure 40 illustrate histograms for each group.

Figure 34. Histogram of losses due to defects in Irma scenario post-2002 less than 10 stories

- Percentage of scenario loss due to fenestration defects can be up to 100%. In other words, in many cases, in areas with low intensity wind speeds, like many counties

for hurricane Irma, the entire loss can be due to the defects (see Figures 33 and 34). Notice the prevalence of darker colors on many east-coast counties, with lower wind speeds, in Figure 31.

- The histograms show that there is little difference between pre- and post-2002 buildings regarding the influence of fenestration defects on the losses. In other words, there has been no improvements in that respect with the implementation of the FBC.

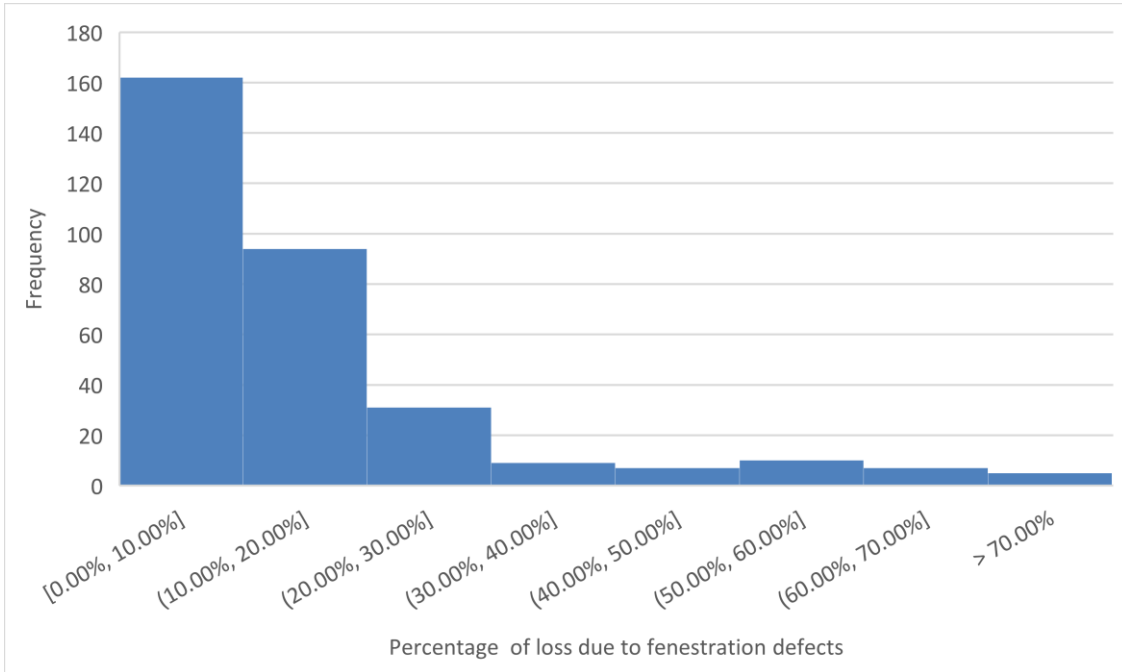
Figure 35. Histogram of losses due to defects in Irma scenario pre-2002 more than 10 stories

- Statistical conclusions regarding the buildings with more than 10 stories vs. the building with less than 10 stories are less clear, given the relatively small number of these buildings in the portfolio. The histograms show that the percentage of loss due to fenestration defects in the Irma scenario losses are less for building with more than 10 stories. The absolute amount of loss due to defects for taller buildings can be higher, but these buildings upper floors will be subjected to higher wind speeds, resulting in envelope damage, so that these defects-induced losses never reach 100% of the loss.

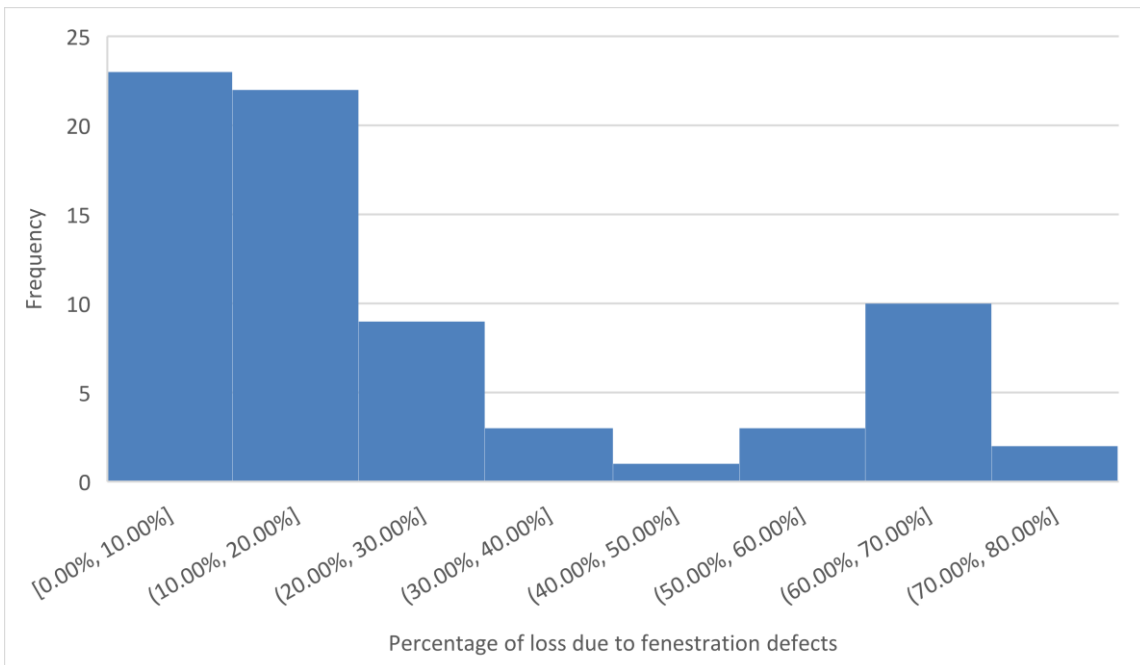
Figure 36. Histogram of losses due to defects in Irma scenario post-2002 more than 10 stories

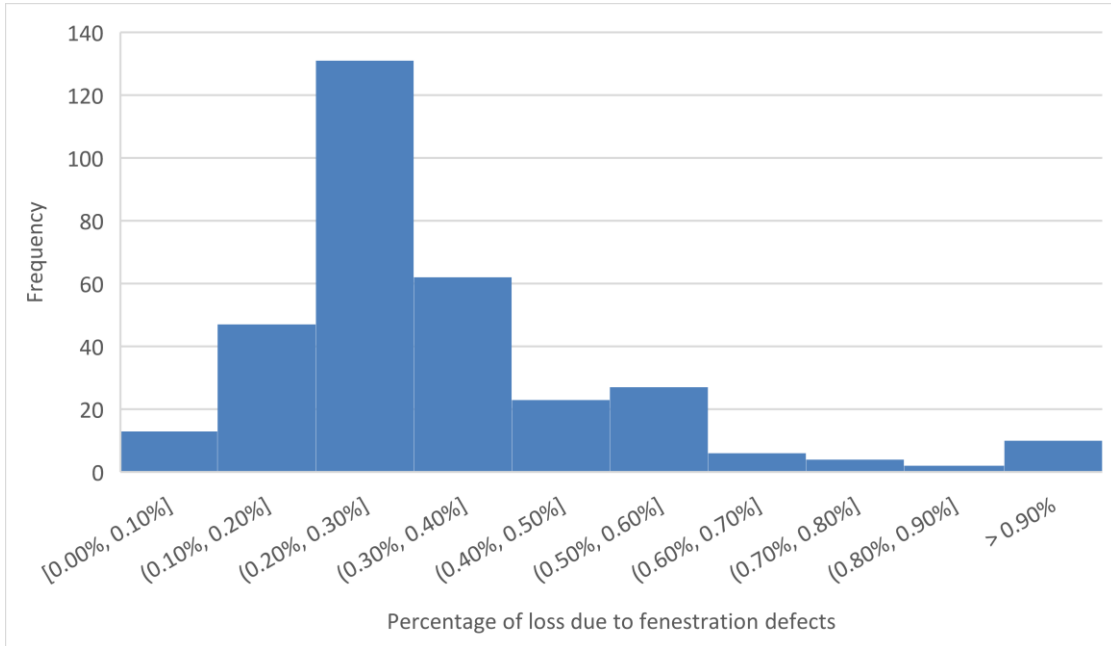
Figure 39. Histogram of AAL due to defects pre-2002 more than 10 stories

- Percentage of AAL due to defects can be up to 16.4%, with the vast majority of the policies at less than 7%, because the stochastic sets include hurricane from categories 1 to 5 where the actual building damage becomes prevalent. In other words, for design events, the influence of the defects becomes negligible, since the envelope breach mechanism take precedence.
