**Scope of Work**  
**Evaluation of Concrete Pile Foundations During Hurricane Michael**

Proposal to the Florida Department of Business and Professional Regulation  
Florida Building Commission (FBC) Hurricane Research Advisory Committee (HRAC)

Taylor Engineering Research Institute (TERI) and the School of Engineering (SoE)  
University of North Florida

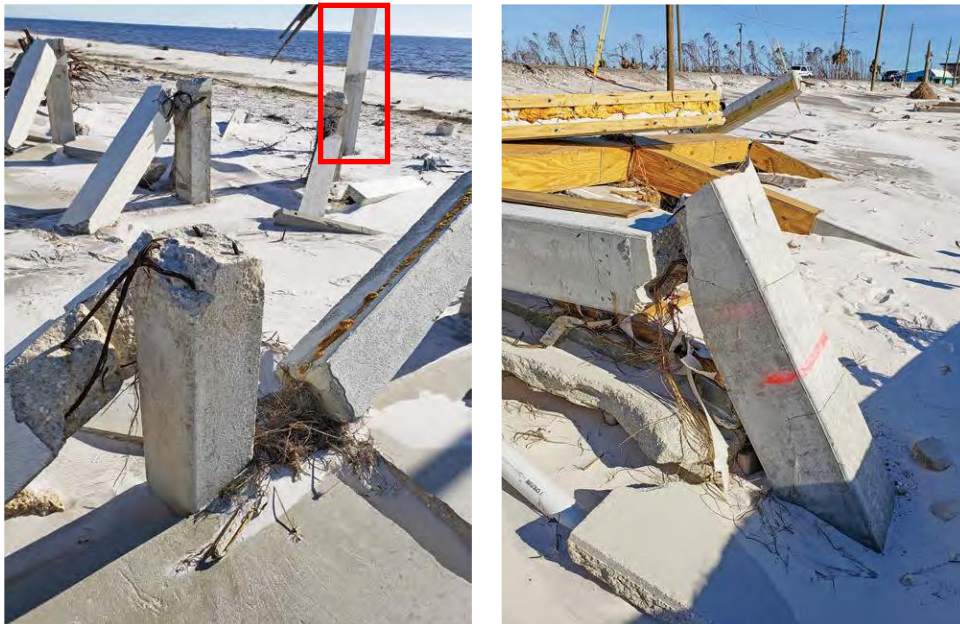
Figure 1. Examples of failed concrete piles during Hurricane Michael (adapted from FEMA [1]). Note that the pile closest to the shoreline (pile boxed in red) did not fail.

The left image in Figure 1 shows broken columns that appeared to fail near the location of a concrete slab. The right image of Figure 1 shows lateral cracks (i.e., stress fractures) on the gulf-fronting pile that was possibly attributed to surge or wave action. As pointed out by FEMA [2], concrete piles should not be failing in these manners. Further complicating matters, embedment depths for piles that failed these ways were often unknown. FEMA [2] recommended analysis to determine what caused these failures and how these failures could be prevented in the future. As FEMA [1] pointed out, several failure mechanisms are possible including slab undermining, insufficient number and size of grade beams, erosion and scour, insufficient material strength, inadequate embedment depth, inadequate spacing and size, inadequate connections, wind loads, water loads, and alterations. The overall goal of the research proposed herein is to determine which of these failure mechanisms or combinations thereof led to the structural failures associated with Figure 1 and to develop preliminary mitigation measures to help prevent these sorts of failures from occurring in the future.

To assist with orientation, the pile boxed in red in Figure 1 is believed to correspond to the pile boxed in red in Figure 2. An image of this same location is also available from June of 2015 and is shown below in Figure 3. In addition, data from FEMA [1] appeared to indicate that the peak surge elevation in this location was approximately 19 feet above mean sea-level (MSL). Elevation data from Google Earth [5] indicated that this structure was built approximately 12 feet above MSL. Thus, it would appear that 7 feet of water flooded the structure – likely filling the carport beneath the house and possibly flooding part of the house’s first floor. This approximate elevation is noted in Figure 3.

Taken together, these preliminary data suggest that the failure mechanism shown in Figures 1 and 2 was due to a combination of wind load, surge/wave loading, and load amplification due to air/water/structure interaction. The wind would have imparted significant lateral loads on roughly the top half of the structure directly. Similarly, the surge and associated wave action would have imparted forces upon the structure’s piles directly. In addition to this, some air would have been trapped between the carport and the structure’s first floor. This trapped air pocket may have amplified wave loading in a manner similar to the mechanism that caused several bridge collapses during hurricanes. These bridges include several high-profile structures like the Escambia Bay Bridge after Hurricane Ivan in 2004, several Gulf Coast bridges after Hurricane Katrina, and most recently, the Pensacola Bay Bridge after Hurricane Sally in 2020. The trapped air under a structure like this tends to cause a high-frequency oscillatory force upward and laterally that may be as high or higher than water forces alone.

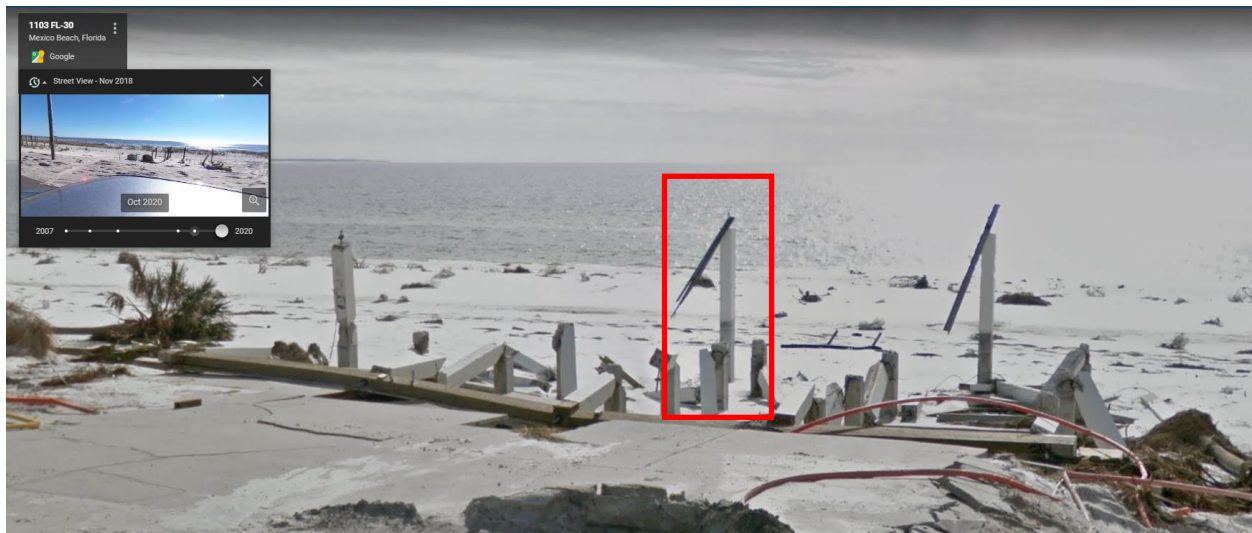
*Research Approach:* A preliminary analysis using Google Earth [5] showed that the photographs presented by FEMA [1] and reproduced in Figure 1 were likely taken from 1100 FL-30 in Mexico Beach as shown below in Figure 2:

Figure 2. Google Earth [5] image showing 1100 FL-30 in Mexico Beach from October 2020

Preliminarily, simple analysis of Figure 2 and Figure 3 gives some clues as to the likely failure mode. It would appear from these figures that after scour, the ground-level slab acted as fixity point for the piles and incorrectly provided some level of lateral restraint. Repeated extreme loading appears to have caused the piles to fail at this point of fixity.
