CABANA BEACH CLUB

OF THE SAWGRASS MARRIOTT HOTEL

ADA WAIVER ON VERTICAL ACCESSIBILITY FOR AN EXISTING BEACHSIDE RESTAURANT

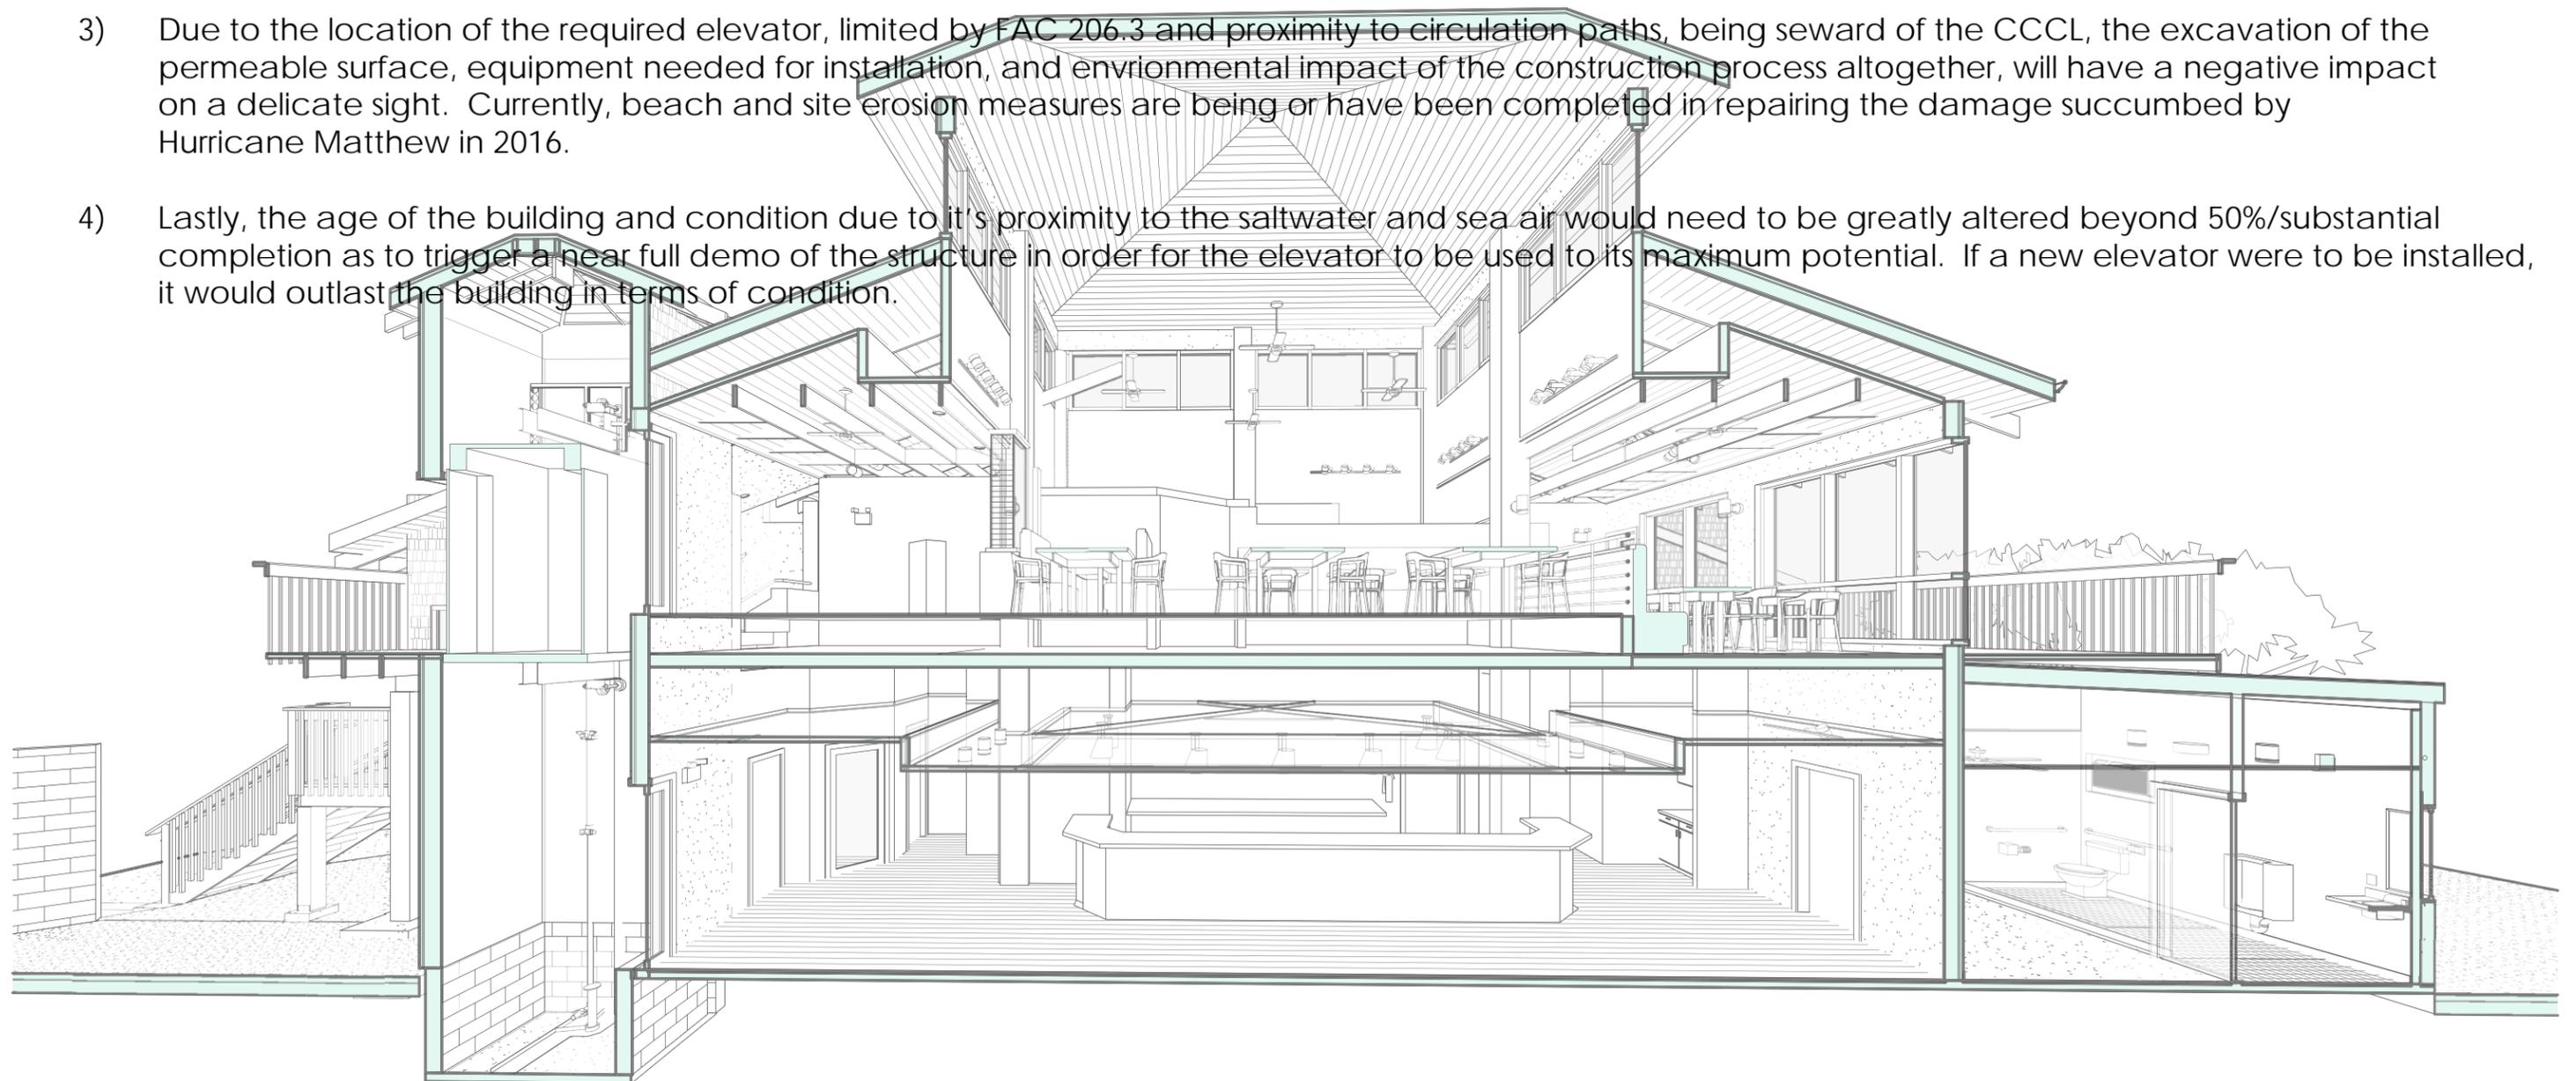
- 1) The elevator will require substantial foundations due to it's location seaward of the CCCL, having to use approximately 30'-0" structural piles as explained previously in the Introduction (slide 3).

- 2) Even with a low-profile elevator, a shallow pit will be needed for the installation. This pit will be a minimum of 3'-0" and, according to it's location on site at + 12.8' NAVD (southwest facade adjacent to entry stairs) which would place the finished floor of the pit at approximately +9.8' NAVD. This new elevation would be a 5.1' difference from the new 100-year storm surge. By having a pit at this location and low of an elevation, the building and it's elevator would be at risk of a maintenance-heavy accessible route which could impede the occupants per Advisory FAC 2012 407.1 and respective Federal Laws.

- 3) Due to the location of the required elevator, limited by FAC 206.3 and proximity to circulation paths, being seaward of the CCCL, the excavation of the permeable surface, equipment needed for installation, and environmental impact of the construction process altogether, will have a negative impact on a delicate sight. Currently, beach and site erosion measures are being or have been completed in repairing the damage succumbed by Hurricane Matthew in 2016.

- 4) Lastly, the age of the building and condition due to it's proximity to the saltwater and sea air would need to be greatly altered beyond 50%/substantial completion as to trigger a near full demo of the structure in order for the elevator to be used to its maximum potential. If a new elevator were to be installed, it would outlast the building in terms of condition.

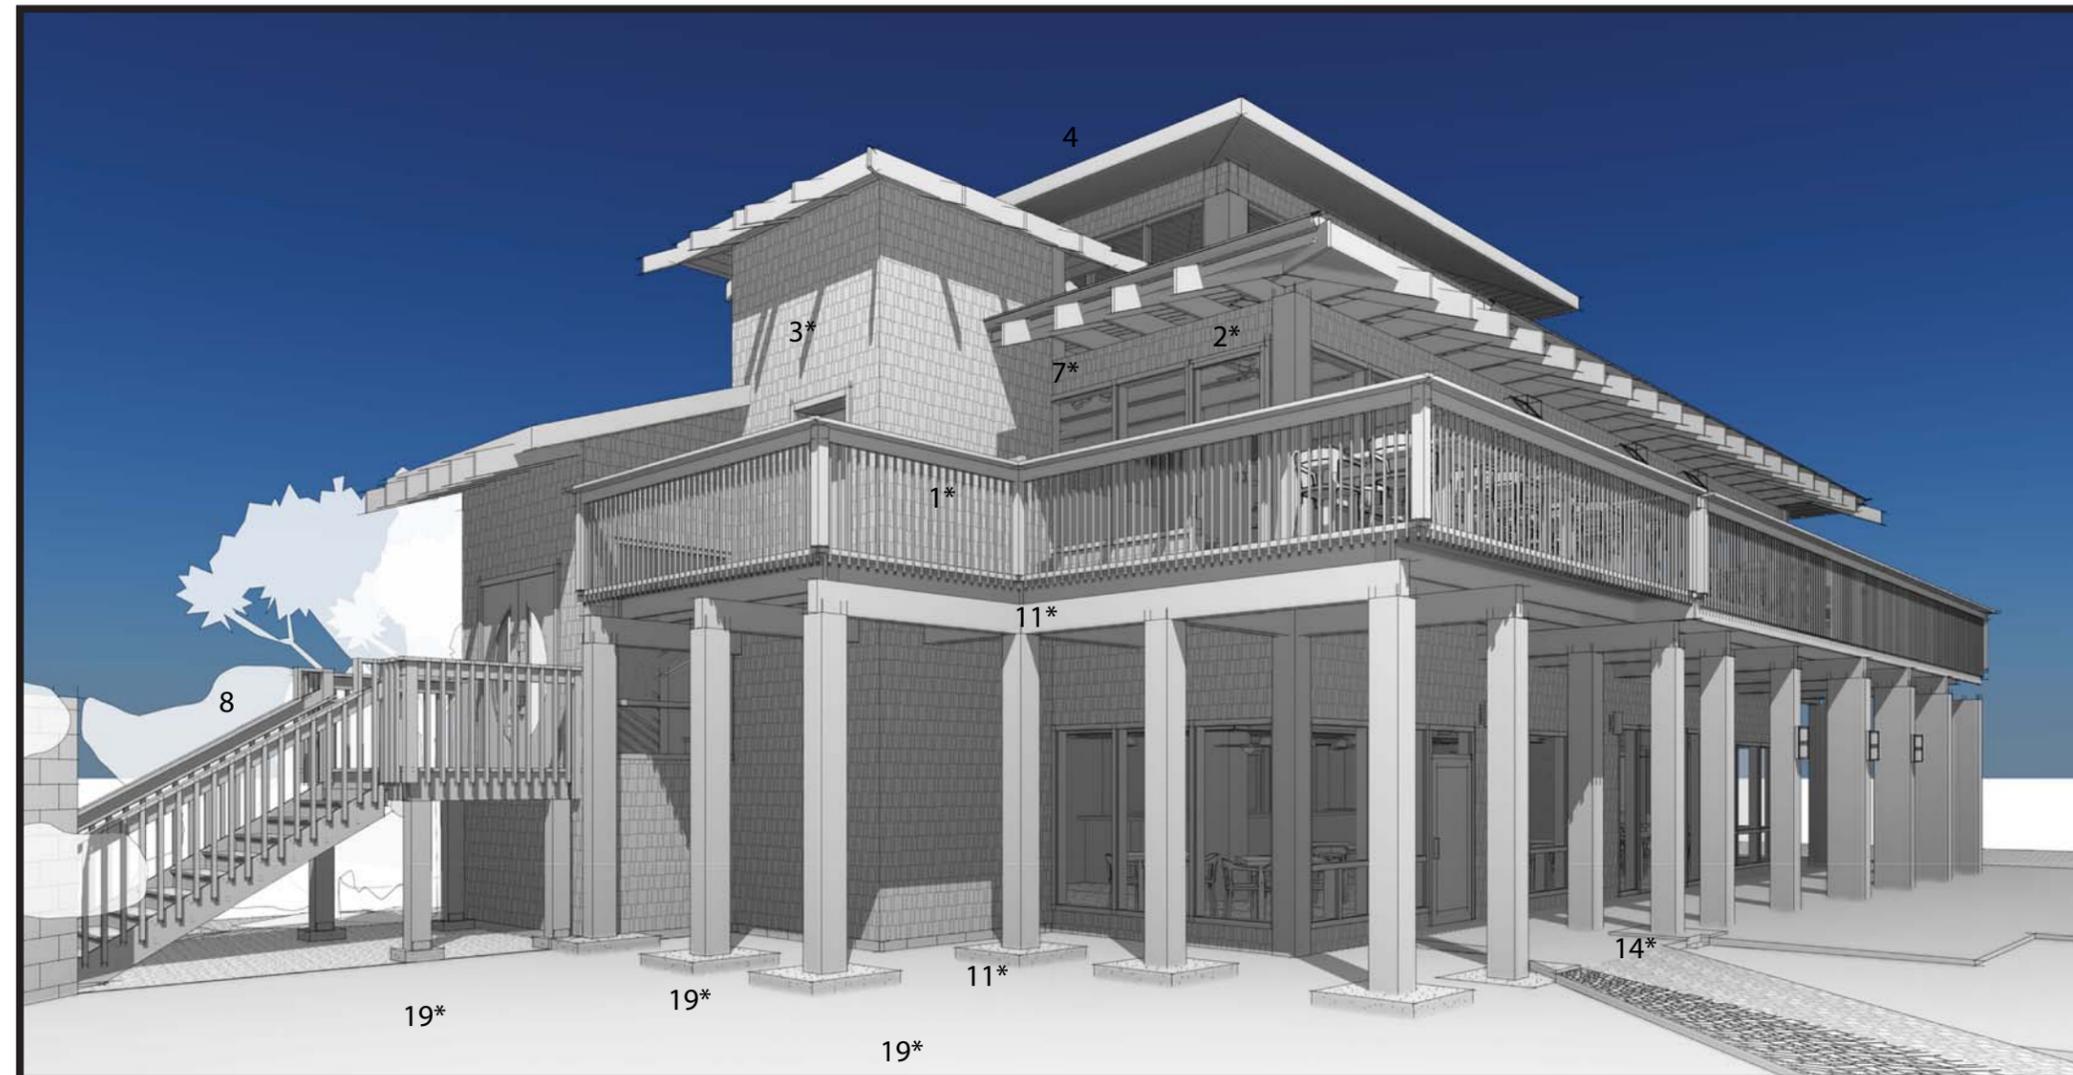
Second Floor

- 1* New deck extension
- 2* New door at previous window opening
- 3* New detached Elevator Shaft w/ Roof
- 4 Roof repair
- 5 New exterior lighting
- 6 Existing deck repair
- 7* New wall opening at previous window locations
- 8 New entry stair replacement
- 9 New handrail replacement
- 10 New awning replacement

First Floor

- 11* New deck extension support
- 12* New door at previous window opening
- 13* New detached Elevator Shaft w/ Elevator
- 14* Removal of pavers for deck extension support
- 15* Relocation of existing downspout
- 16 New exterior lighting
- 17 Replacement of pavers
- 18* New wall opening at previous window locations
- 19* Removal of three (3) palm trees
- 20 New ADA unisex restroom

* = vertical accessible item-related scope

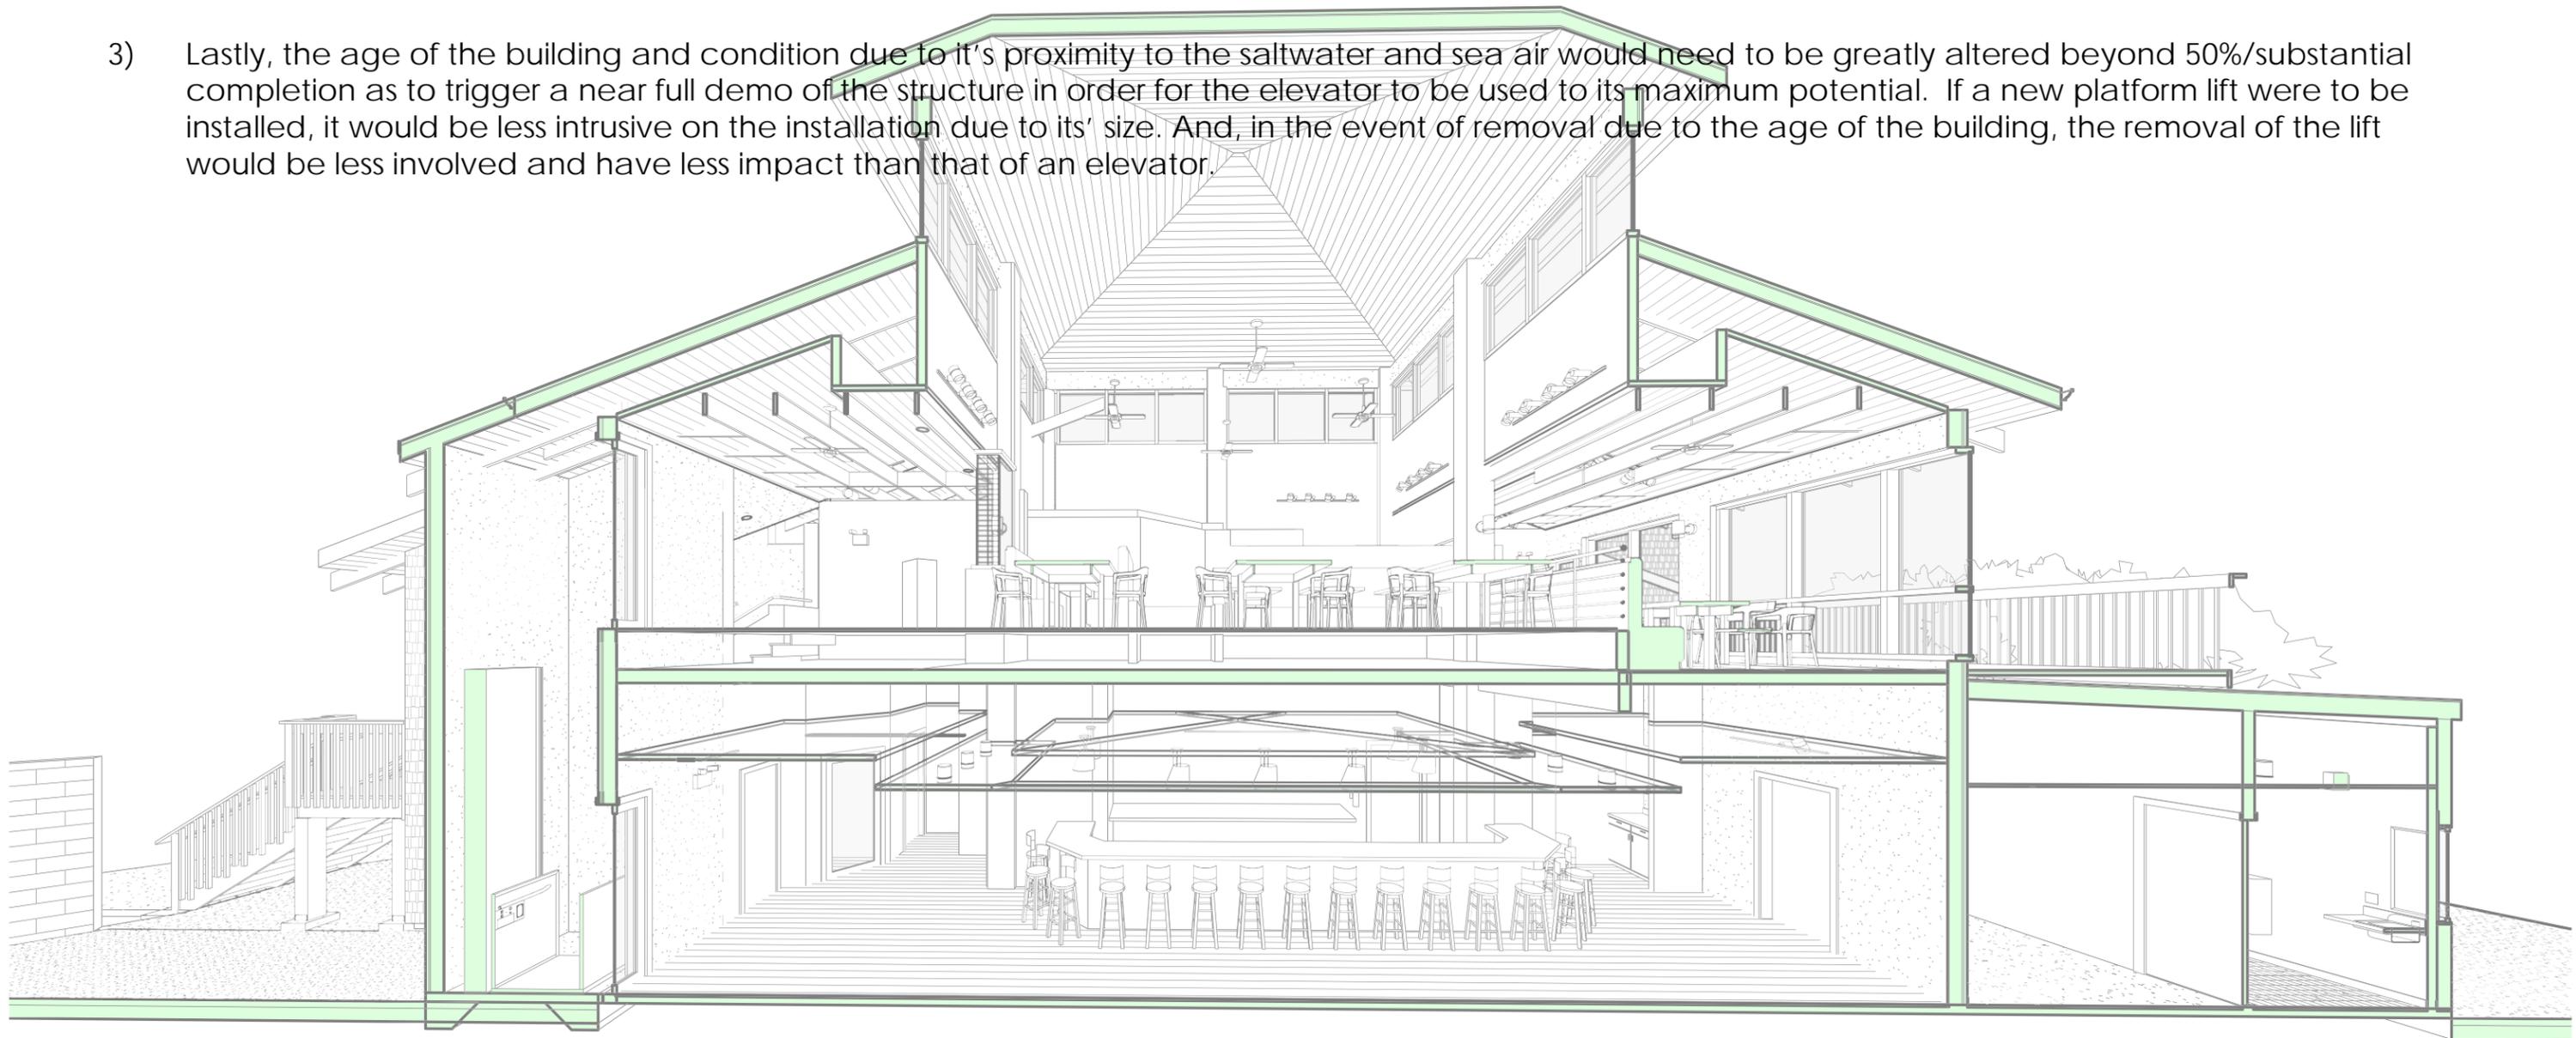
- 1) A shallow pit will be needed for the installation of any standard passenger elevator. This pit will be a minimum of 3'-0" and, according to its location on site at + 12.8' NAVD (southwest facade adjacent to entry stairs) which would place the finished floor of the pit at approximately +9.8' NAVD. This new elevation would be a 5.1' difference from the new 100-year storm surge. By having a pit at this location and low of an elevation, the building and its elevator would be at risk of a maintenance-heavy accessible route which could impede the occupants per Advisory FAC 2012 407.1 and respective Federal Laws.

- 2) The lift can be customized with little extra cost to provide a 90° entry/exit while such requests for an elevator increases significantly. This 90° entry/exit is so that the deck would not have to extend further and wrap around the lift shaft thus not having to terminate into the existing glazing and host exterior wall.

- 3) An equipment room would not be needed due to less electrical and mechanical items required for operation.
- 3) Lastly, the age of the building and condition due to its proximity to the saltwater and sea air would need to be greatly altered beyond 50%/substantial completion as to trigger a near full demo of the structure in order for the elevator to be used to its maximum potential. If a new platform lift were to be installed, it would be less intrusive on the installation due to its' size. And, in the event of removal due to the age of the building, the removal of the lift would be less involved and have less impact than that of an elevator.

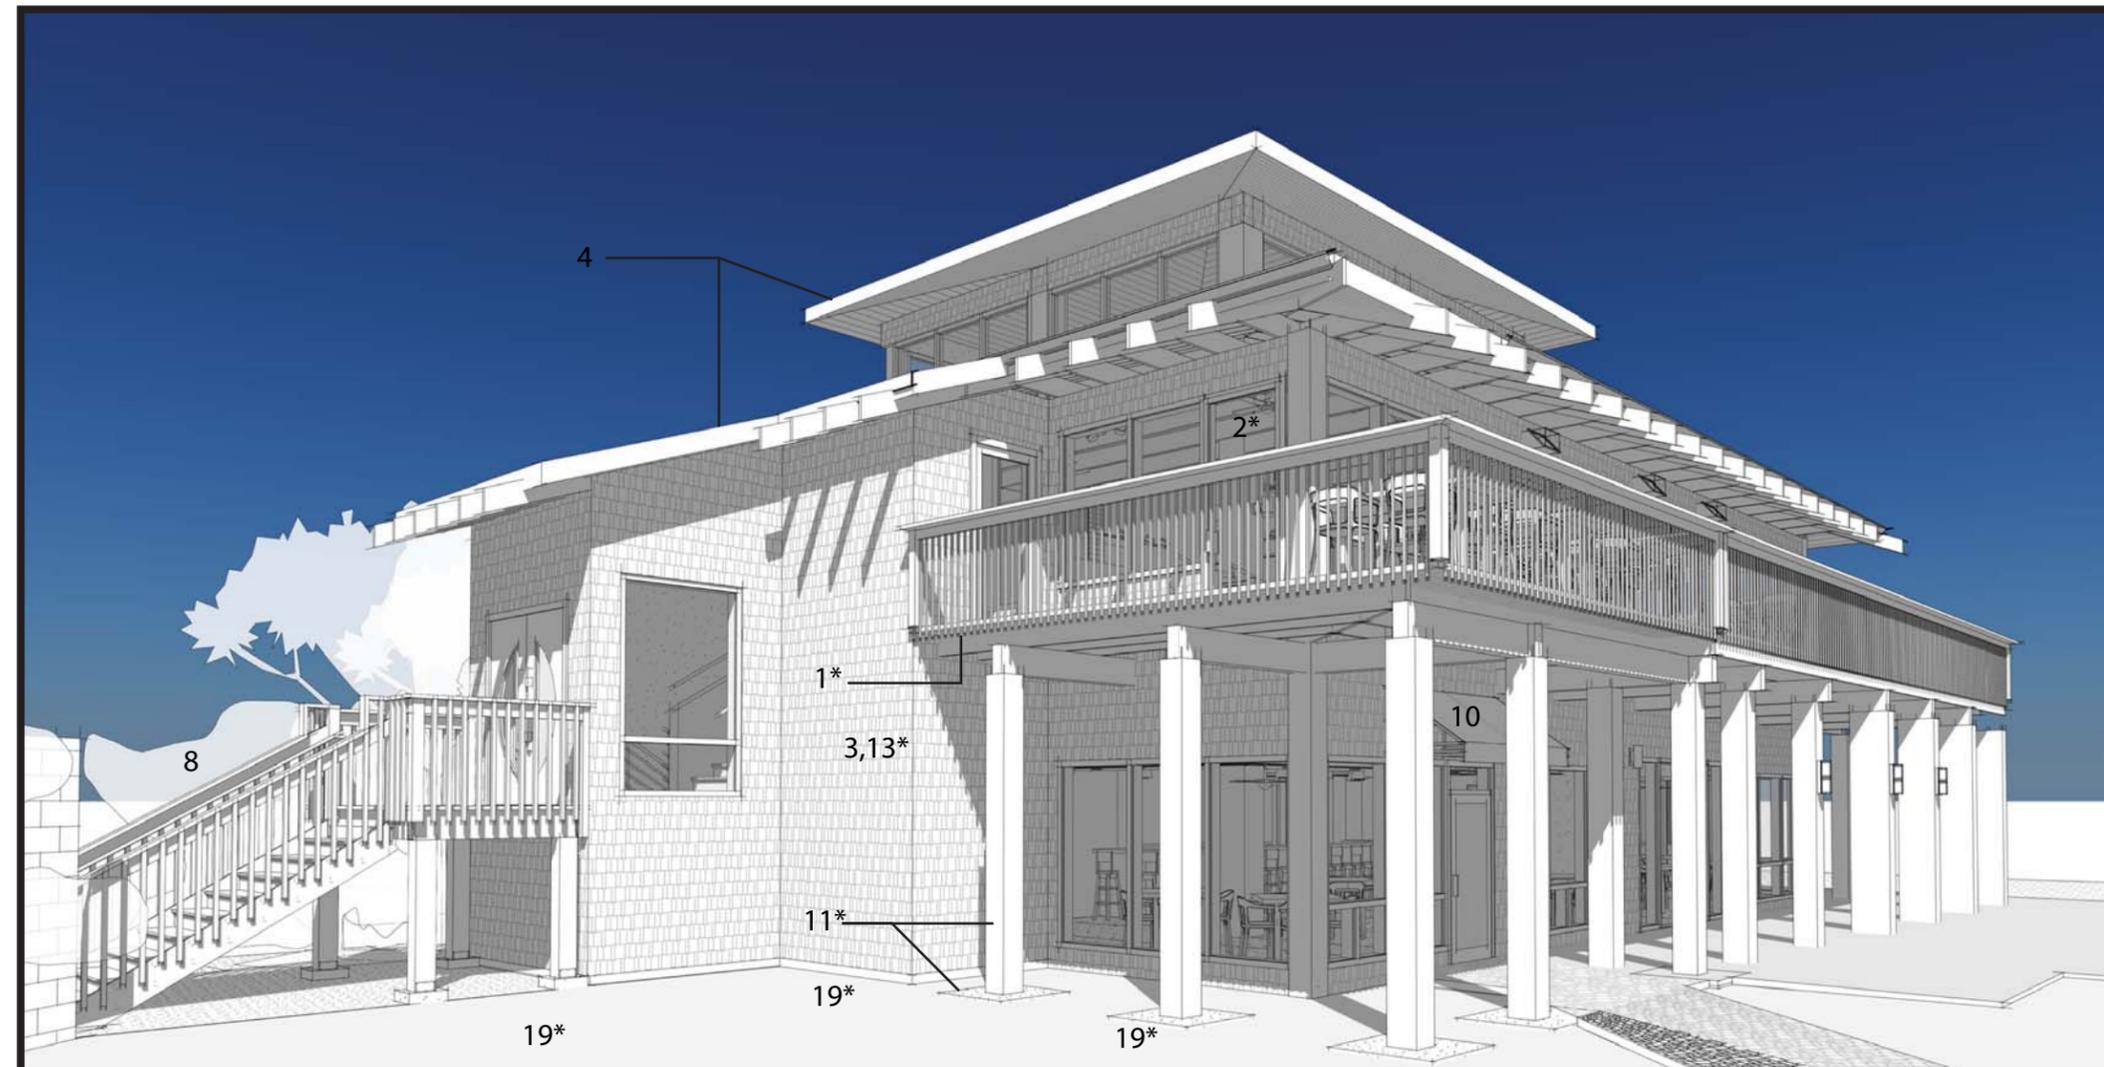
Second Floor

- 1* New deck extension
- 2* New door at previous window opening
- 3* New detached Platform Lift Shaft w/ Roof
- 4 Roof repair
- 5 New exterior lighting
- 6 Existing deck repair
- 7* New wall opening at previous window locations
- 8 New entry stair replacement
- 9 New handrail replacement
- 10 New awning replacement

First Floor

- 11* New deck extension support
- 12* New door at previous window opening
- 13* New detached Platform Lift Shaft w/ Lift
- 14* Removal of pavers for deck extension support
- 15* Relocation of existing downspout
- 16 New exterior lighting
- 17 Replacement of pavers
- 18* New wall opening at previous window locations
- 19* Removal of three (3) palm trees
- 20 New ADA unisex restroom

* = vertical accessible item-related scope

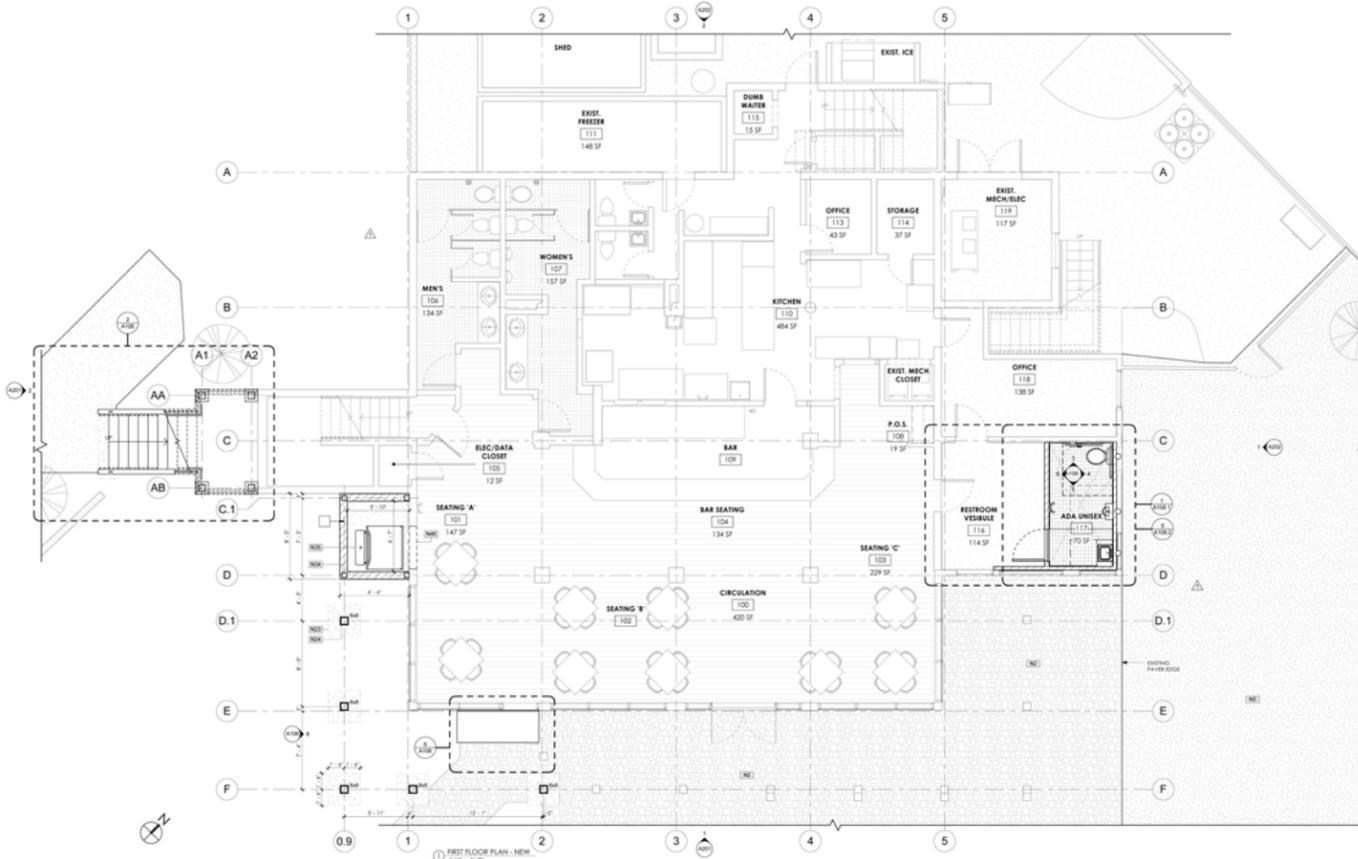
PLAN - FIRST FLOOR

SUPPORTIVE DRAWINGS FROM EXHIBIT B
