As we approach the December 13-14 Commission meeting in Daytona Beach Shores, I am providing the enclosed documents that I believe provide important information. They pertain to FRSA code modification requests R10093 and R10175 dealing with roofing underlayment.

Digging Deeper into Ian's Destruction

Timeline for the Development of FRSA's Tile Underlayment Positions and Modifications

INSTALLING SELF-ADHERING UNDERLAYMENTS DIRECT TO DECK: PROS AND CONS

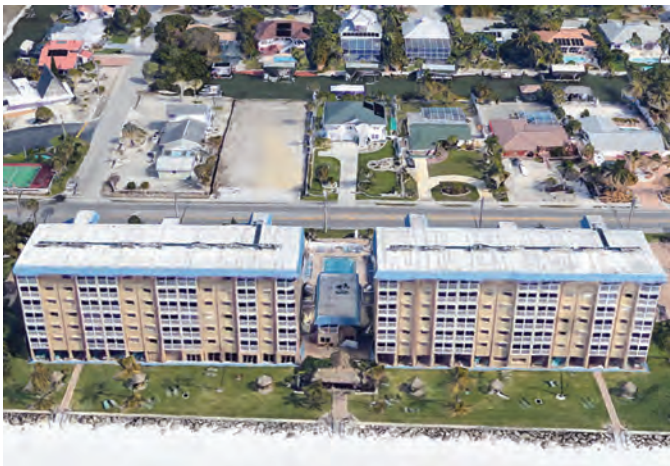
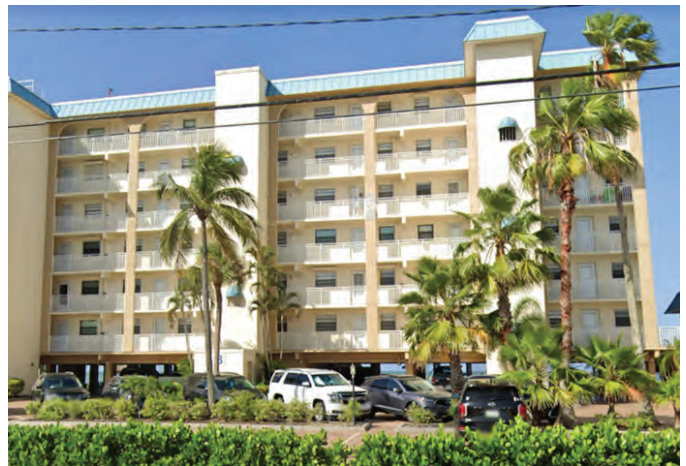
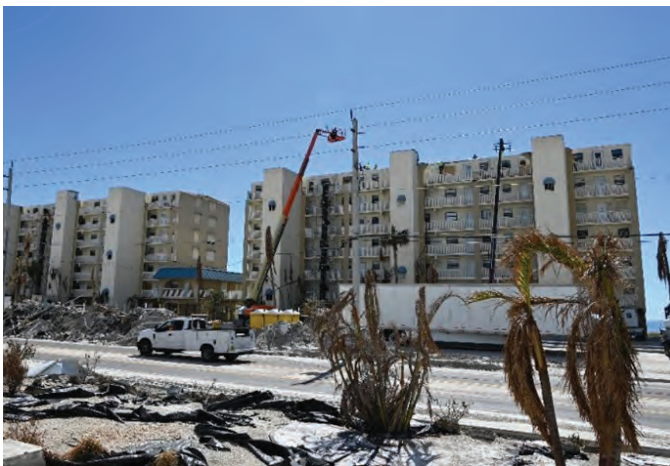
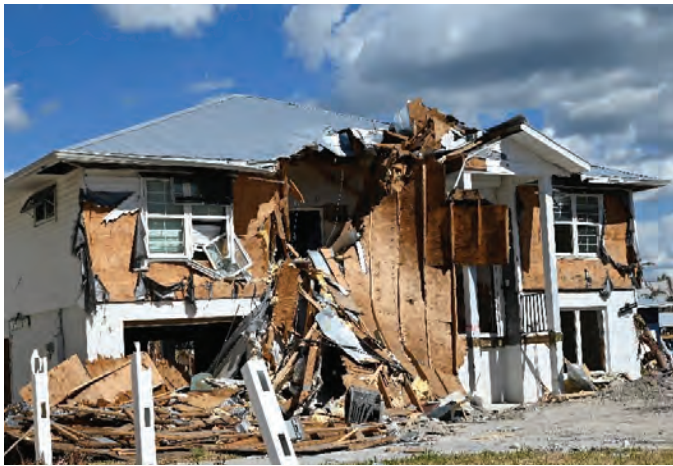
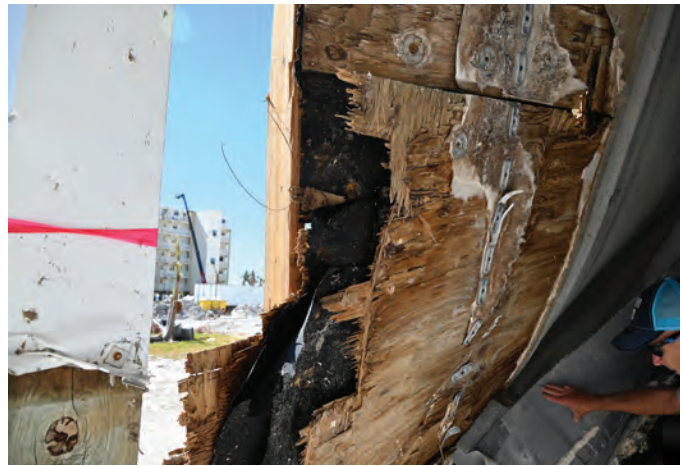
aside to open up streets to traffic or moved to parking lots for staging. One house across the street had already been demolished and hauled away. However, some of what appeared to be the condo building's roof assembly was still laying on several of the houses.

The roof section that remained was unusual for several reasons. For one, there were two layers of plywood sheathing with an asphalt-based roof covering in between and a mechanically attached single-ply roof covering on top. I expected to see wood joists but instead was seeing trusses. I thought from seeing the walls that remained that it would probably be joists construction and that the roof-to-wall connection might have been an issue. After reviewing some Google Earth pre-hurricane pictures, it became obvious that the buildings did actually have trusses that incorporated mansards and soffits around the perimeter. All of this was now gone or at least not where it was supposed to be.

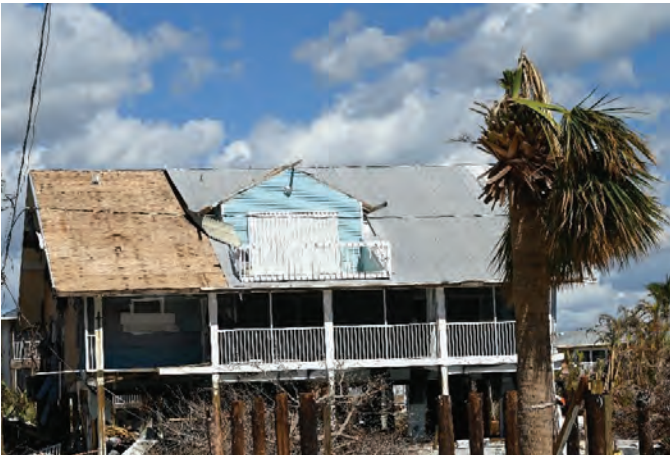
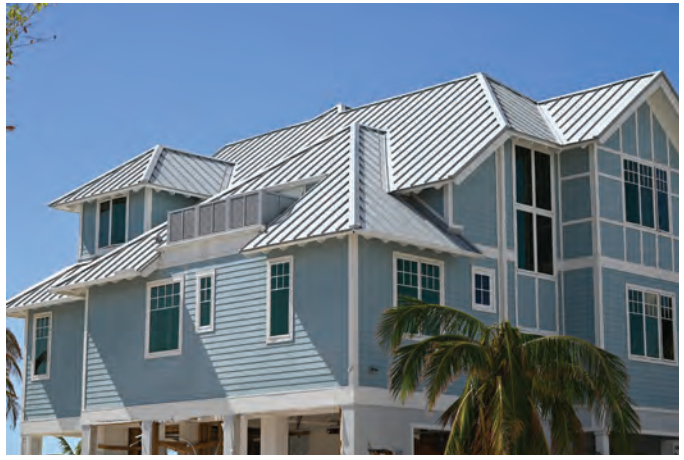
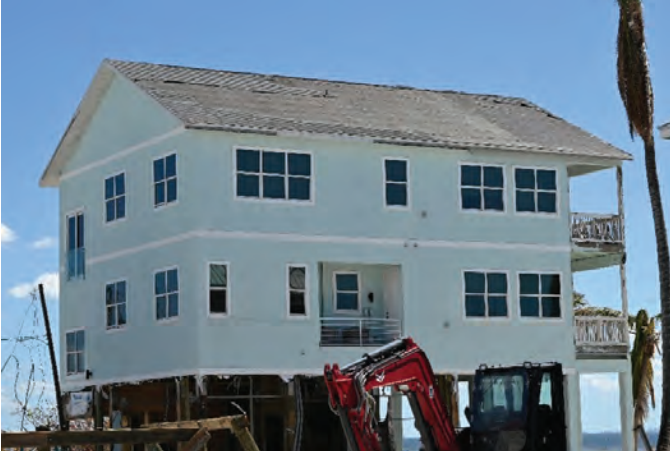
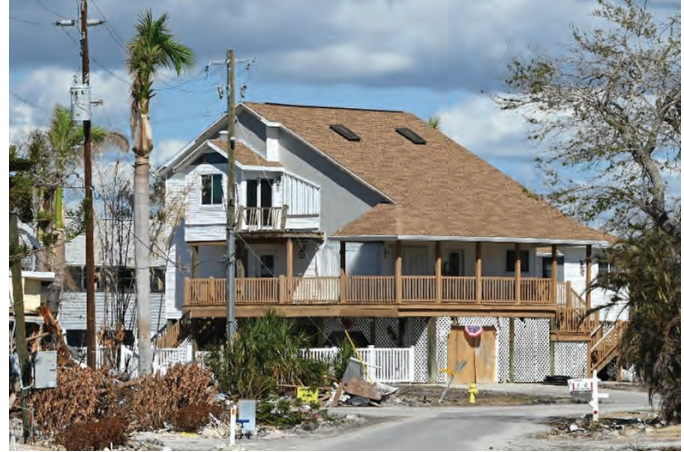
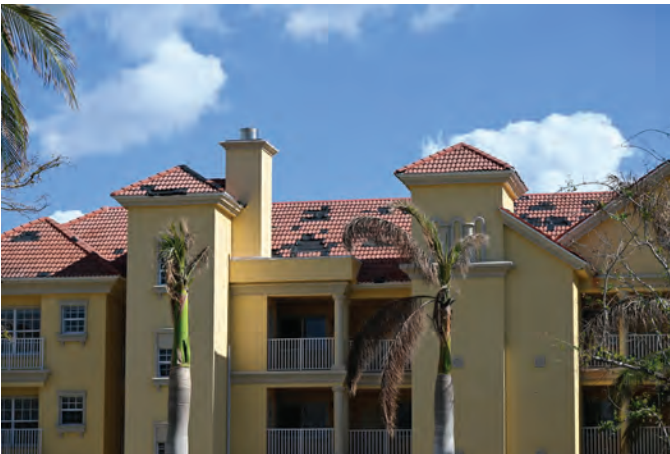
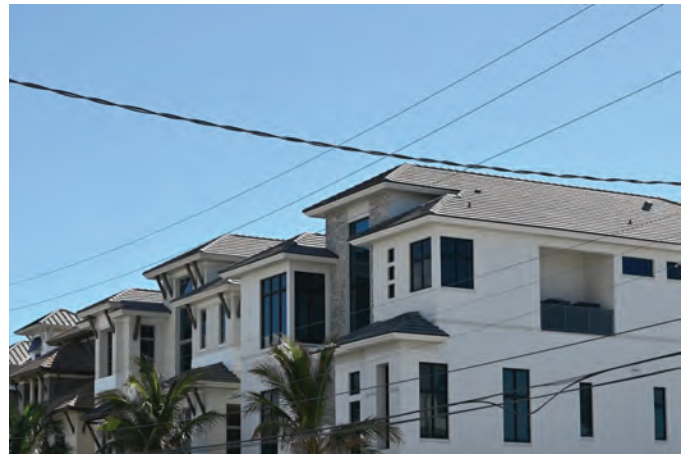
As I said earlier, roofs that have been installed since the wind resistance requirements of the FBC have been increased did very well overall regardless of roof type. With that said, many older roofs also did well, but they were outliers when looking at roofs that were approximately 20 years or older. We observed many severely damaged shingle, tile and metal roof coverings from that period. The damage to older roofs was often more catastrophic with wood exposed. Exposed wood is much less common with newer roof

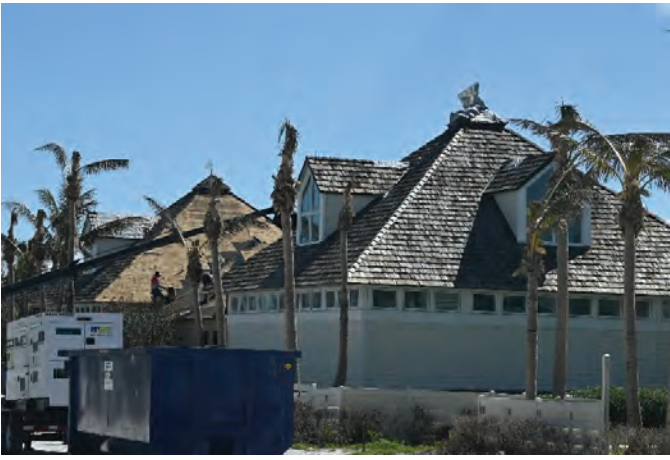
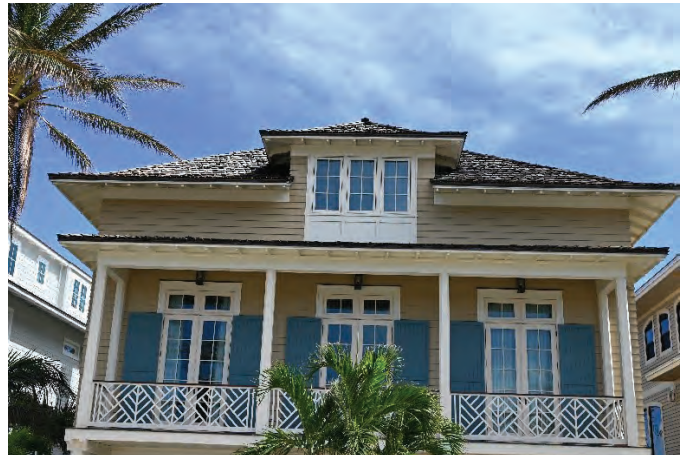
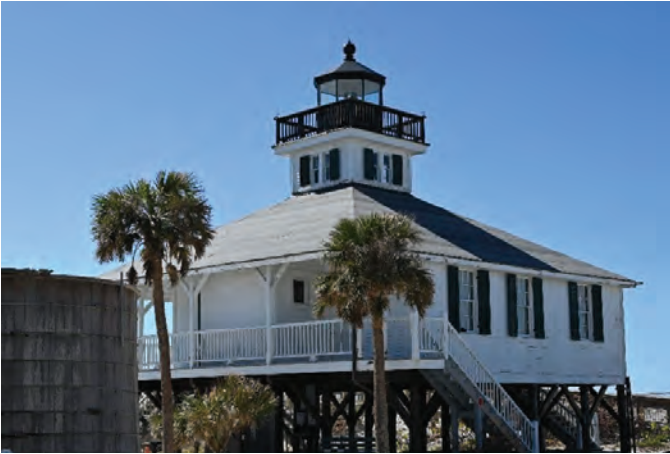
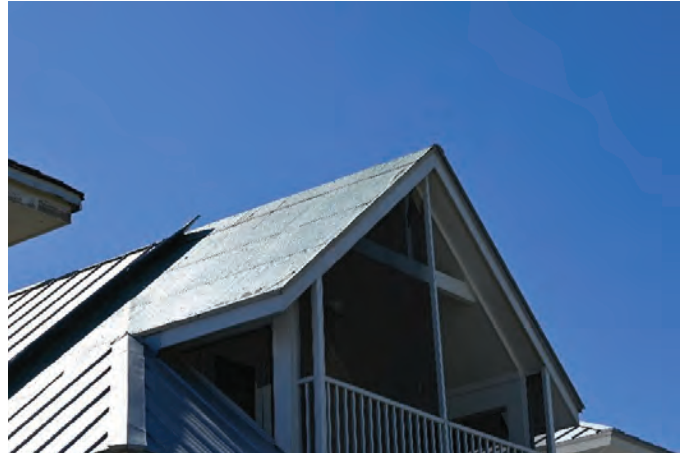
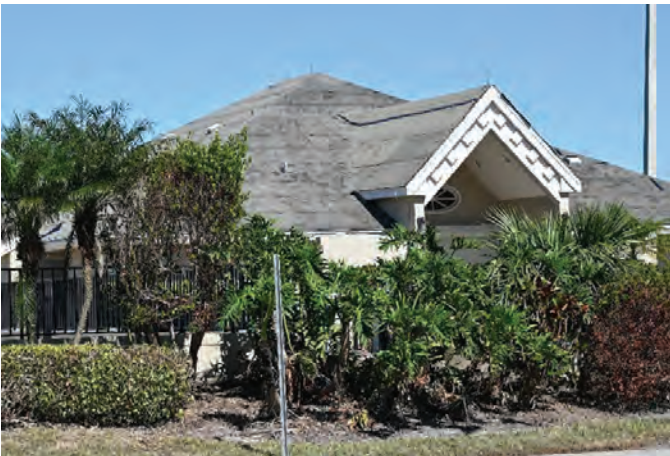
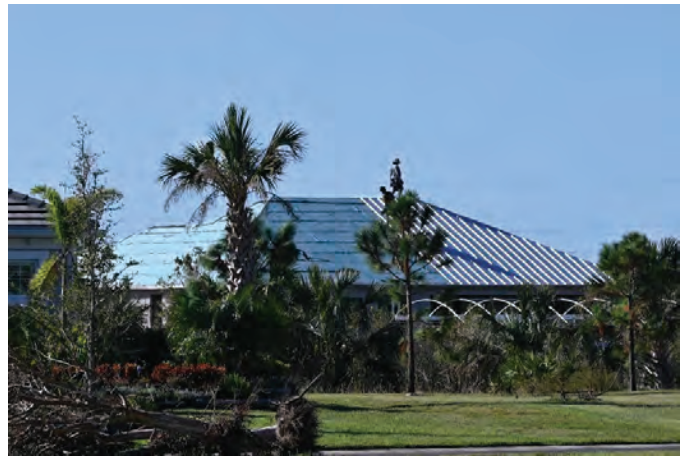
coverings, even when missing portions of the field of the roofs. This is possibly attributable to improved underlayments – or secondary water barrier – resistance. Several roofs were observed with very little of the primary roof covering still left in place but where a self-adhered underlayment applied direct-to-deck was present and was still providing protection from major water intrusion.

One trend was very clear from my observations. Many of those who suffered major roof damage are opting to have a self-adhered underlayment installed direct-to-deck when replacing their roofs regardless of the type of roof covering chosen. Even the historic Boca Grande Pass Lighthouse is getting the added protection that such a system provides. It seems that

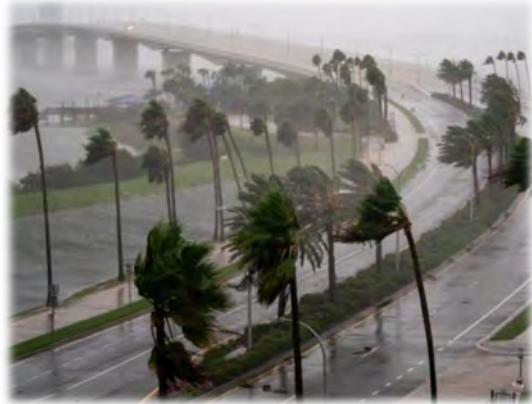
The recent landfall of Hurricane Ian in Southwest Florida was a stark reminder of the perils that face homeowners in South Florida. We've all witnessed scenes of widespread damage to roof coverings of all types – tile, metal panels, asphalt shingles, etc. Thus, the topic of how to protect the roof deck and the building below it when the roof covering is damaged or blown off becomes critical. One of the best ways to provide protection from water intrusion into the structure is to install a self-adhering underlayment directly to the roof sheathing. After all, these products are designed and tested to be adhered directly to wood sheathing, not to #30 felt or synthetic underlayments.

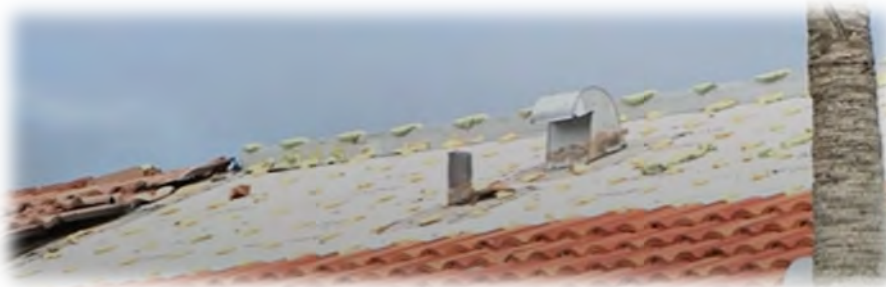
If this home is in the High Velocity Hurricane Zone, the underlayment requirements are prescriptive and would require that the underlayment meet the requirements of TAS 103. Section 7 of this test protocol stipulates that (4) 8 foot by 8 foot test decks are constructed and underlayment is applied directly to the plywood (which doesn't reflect permissible conditions in the HVHZ). Then a 5 foot by 5 foot chamber is placed over the underlayment and negative pressure (suction) is applied to the deck, starting at 15psf. The 15psf pressure is maintained for one minute, then it is increased by 15psf and held for one minute. This process is repeated until the pressure reaches 90psf. If the underlayment is still adhered after one minute at 90psf, the test deck passes. If all four decks pass this test, the product is considered as compliant with the uplift testing requirements.

Now contrast the TAS 103 uplift requirements with the requirements from the *FRSA/TRI Florida High Wind Concrete and Clay Tile Installation Manual*. According to Table 1A of the Tile Manual, for a roof in even the lowest wind speed area of the HVHZ with the same characteristics, the underlayment would be required to attain an uplift resistance of 102.8psf. This uplift resistance rating would be achieved by testing to failure using one of two testing protocols: FM 4474 or UL 1897. These protocols utilize the same procedure of starting with a negative pressure of 15psf and holding for one minute, then increasing by 15psf and holding for every minute until the product fails. A 2:1 safety factor is then applied to the last pressure at which the product passed. Thus, a product that meets the 102.8psf uplift requirements would need to pass at a minimum 205.6psf pressure. That is more than double the pressure that is required by Section 7 of TAS 103.
