LABORATORY TEST REPORT

Product Name:	Alhambra®	Manufacturer:	Zion Tile Corp.
Date Received:	February 26, 2015	Sampling:	M. C. Harry Associates
PRI Project No.:	MCHA-001-02-01	Test Dates:	Feb. 27 – Mar. 17, 2015

M. C. Harry Associates ASTM C 1167 for Alhambra® Page 2 of 5

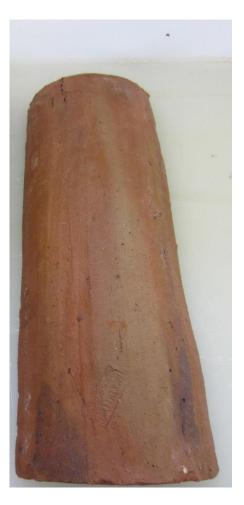
Evaluation: Upon receipt of the test articles, samples were prepared, photographed and measured for overall dimensions and mass. Photographs of the test articles prior to testing are shown in Figures 1 and 2 below. Dimensions and Masses are shown in Table 1 below.

Figure 1. Alhambra® barrel tile prior to testing
