**Final Report for Project Entitled:**

**Project #5  
Feasibility Study for In-Home Storm Shelters in Florida Residential Homes  
PO Number A95F33**

Florida Building Commission  
State of Florida Department of Business and Professional Regulation

Forrest J. Masters, Ph.D., P.E., [masters@ce.ufl.edu](mailto:masters@ce.ufl.edu), (352) 392-9537 x 1505, Principal Investigator  
Kurtis R. Gurley, Ph.D., [kgurl@ce.ufl.edu](mailto:kgurl@ce.ufl.edu), (352) 392-9537 x 1508  
David O. Prevatt, Ph.D., P.E. (MA), [dprev@ce.ufl.edu](mailto:dprev@ce.ufl.edu), (352) 392-9537 x 1498

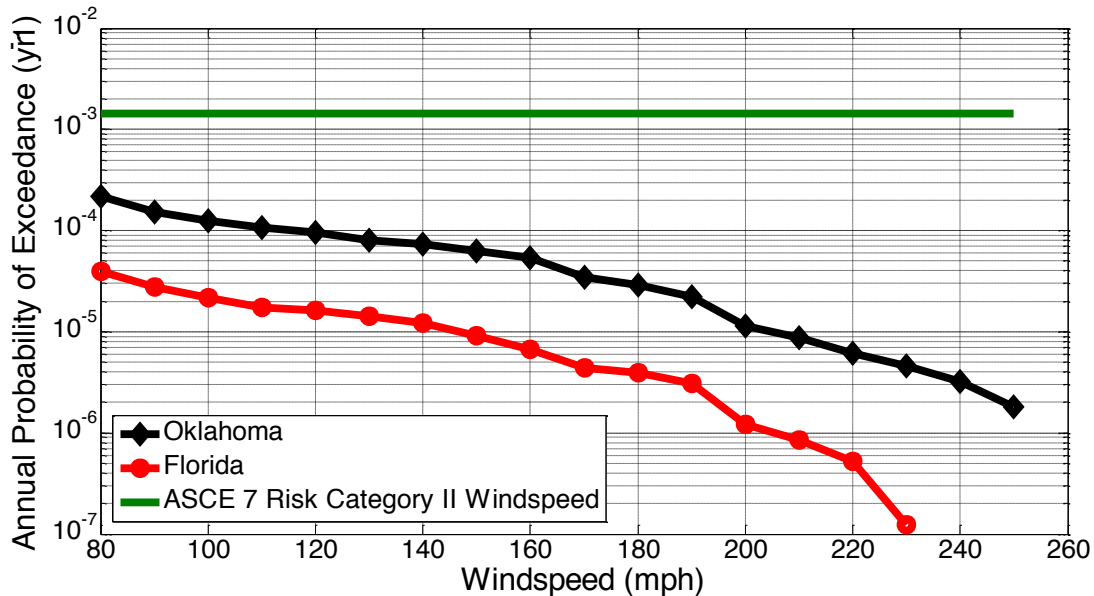
Figure 7: Annual Probability of Wind Speed Exceedance due to Tornadoes (Note: ASCE 7 Windspeed POE is based on geographic location (i.e. contour lines) and the tornado POE are for the entire state.)

The Probabilities of exceedance seen in Figure 7 suggest that the residential shelter design wind speed of 250 mph recommended by the current shelter standards used in Florida are overly conservative if only

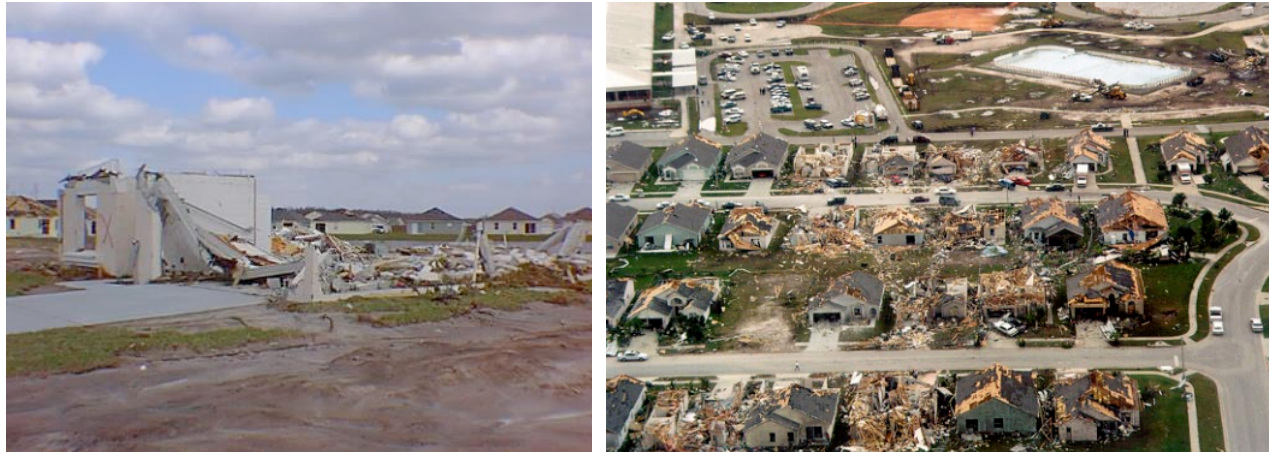
Figure 11: (Left) A destroyed concrete block and stucco home in Kissimmee, FL during 1998 F3 tornado (<http://www.srh.noaa.gov/mlb/?n=kissimmeepics>), (Right) Damaged homes in Lakeside subdivision in Kissimmee, Florida. The 1998 F3 tornado moved from the upper right to the lower left, narrowly missing a school. (<http://www.nws.noaa.gov/os/assessments/pdfs/cntrfl.pdf>)

During the FBC Structural TAC meeting, Joe Belcher mentioned that the damaged masonry house shown in Figure 11 was of a Phase 1 house from a Kissimmee neighborhood. He mentioned that Phase II homes in that development were constructed to newer building codes and fared much better during the tornado strike.

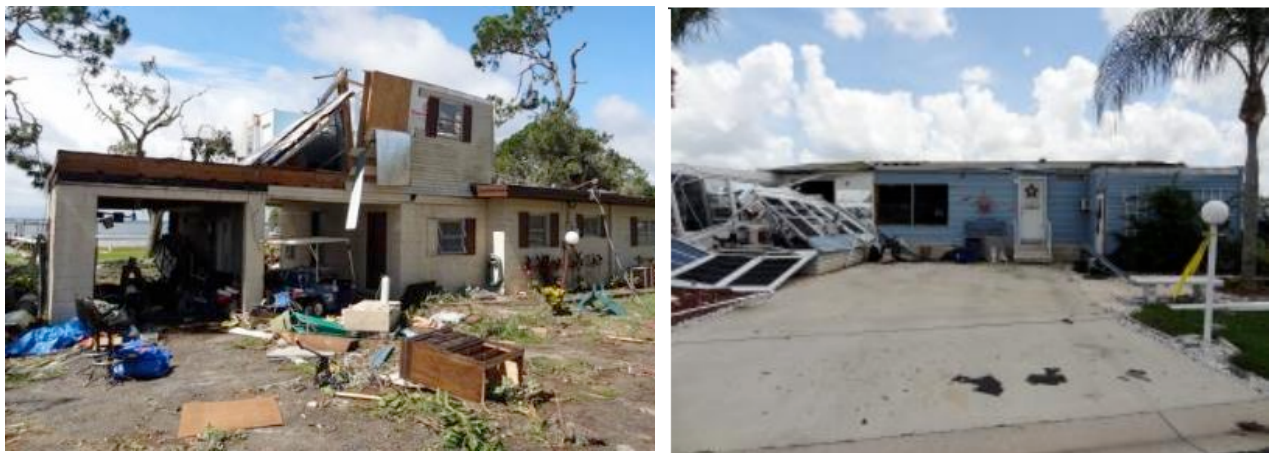
Figure 12: Post-2012 Lake Placid (Highland County) tornado damage showing EF2 damage (left) Post-2012 Vero Beach (Indian River County) tornado damage showing EF1 damage (right)

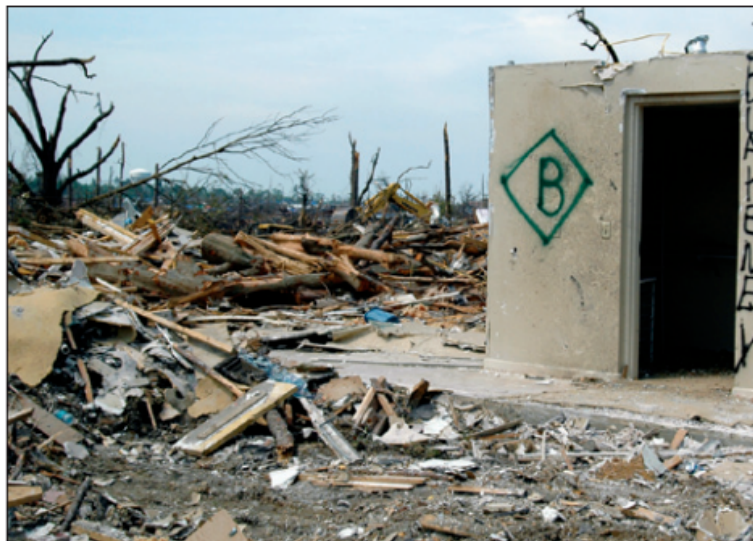
Figure 16: A hardened room in a residence Tuscaloosa, AL whose door failed in the April 27, 2011 tornado (source: FEMA (2012))

Following the 2011 tornado season, FEMA (2012) presented a study of safe rooms, hardened areas, and tornado refuge areas in residential structures. All of the safe rooms that they observed were built before the adoption of the 2009 International Building Code and IRC, which codified the requirements of ICC 500. Many storm shelters had at least one of the following deficiencies: doors and door hardware not designed or constructed to meet known wind and wind-borne debris impact criteria for life-safety protection (Figure 16), inadequate anchorage, and inadequate ventilation. There were numerous accounts of homeowners seeking shelter in basements, interior rooms or hallways which were not a safe option.

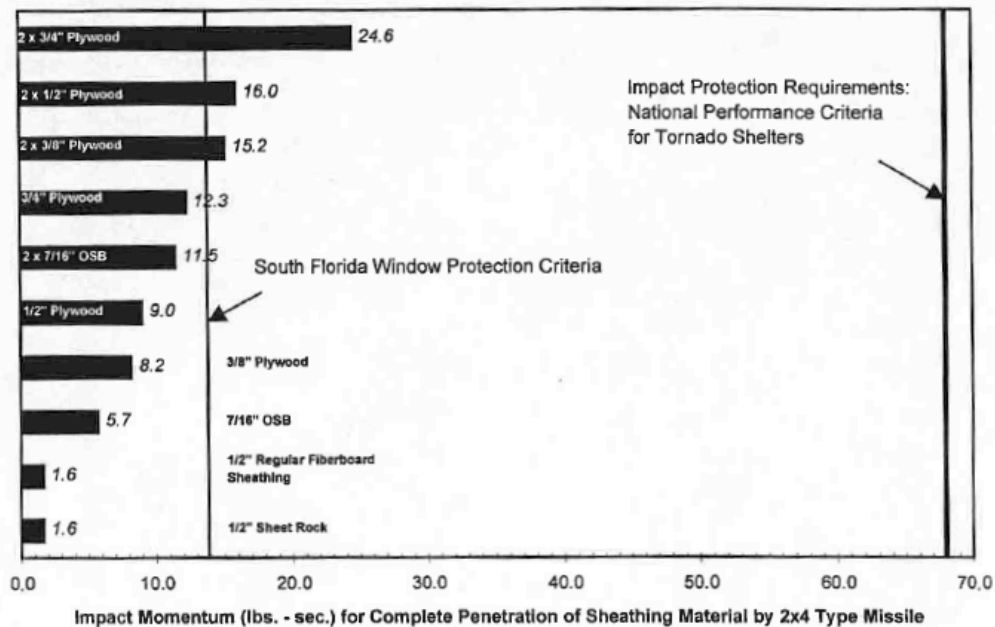
Figure 17: Impact Momentum for a 2x4 Wood Member Missile to Penetrate Common Sheathing Materials (impact perpendicular to sheathing surface) from Clemson University, 2000.

The level of protection provided by any wall siding material can be compared with that prescribed by the ICC500 /NSSA guidelines. Figure 17, excerpted from the Clemson University report, presents the relative protection afforded by several wall materials versus that of a FEMA near-absolute protection storm shelter wall section.

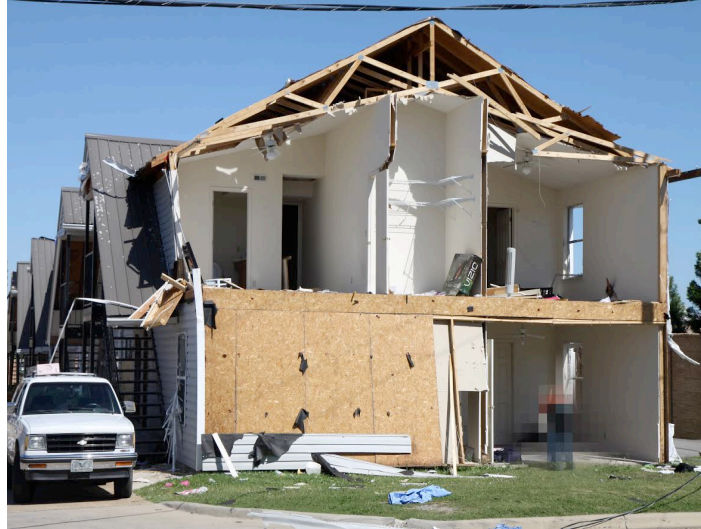
Figure 21: Wall connection failures from tornado damage

The analysis of damage investigation data from residential houses in tornadoes and hurricanes have shown a problem of a lack of robustness in the current design performance of houses subjected to high winds. Robustness as defined by Taguchi et al. (1986) is the ability of a structure to withstand (loading) events like wind or seismic forces, impact or the consequences of human error, without being damaged to an extent disproportionate to the original cause. In extreme wind events – Cat 3 hurricanes and above, and in EF3 to EF5 tornadoes – the loss of a roof structure can result in near complete collapse of the entire house. At its worst, a house structure may be “swept clean” from its concrete slab and foundation. One of the consequences of wall collapse when the roof is lost is that the number of fatalities and injuries significantly increase. Historically, very few deaths occur in commercial structures (European Union 1991).
