Code Administration

Proposed Code Modifications

TAC: Code Administration

Home Fire Sprinkler Cost Assessment

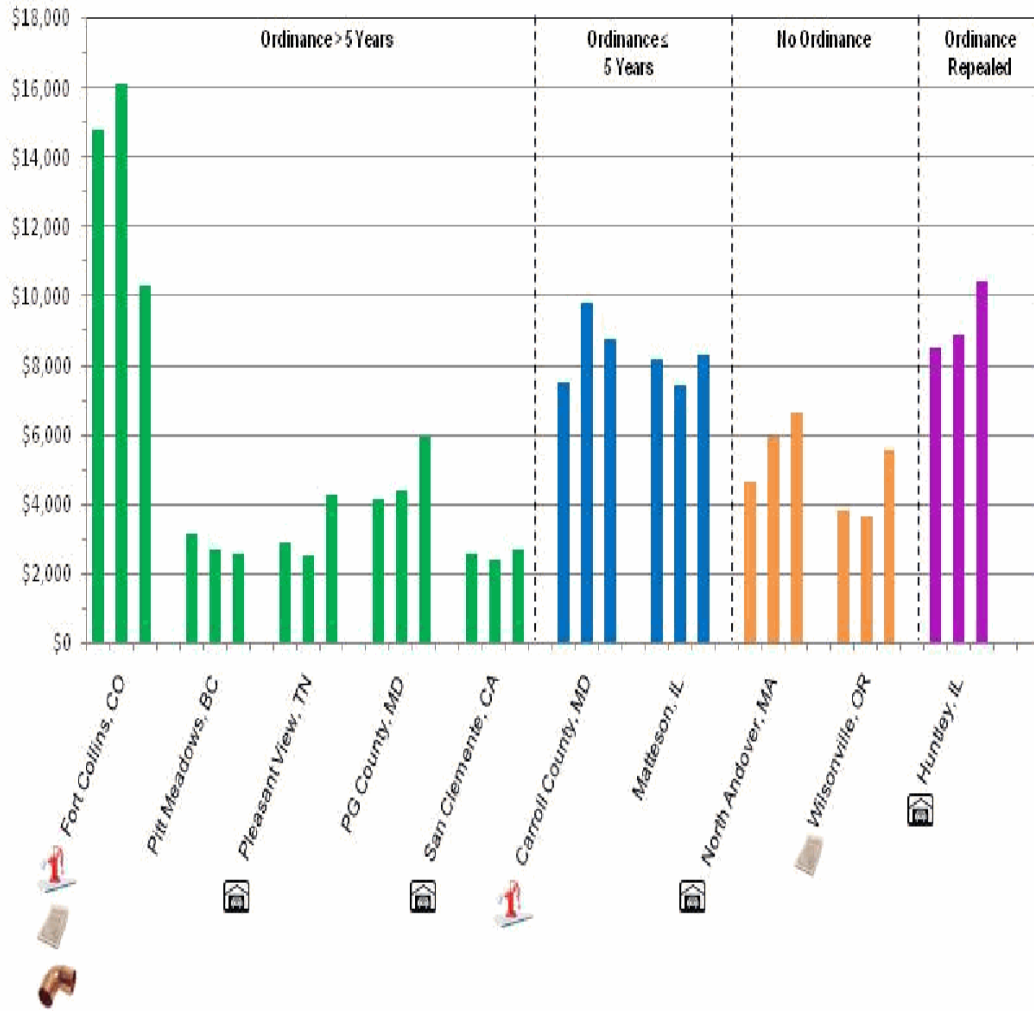
Total Installation Cost

In addition to the cost of sprinklers per unit of space, the total cost per house is also an important metric. The following graph relates the total cost of the sprinkler system to the builder for all thirty house plans, with price-influencing variables noted for each community.

It should be noted that the variables identified in the graph above, such as the use of copper piping, were identified as significant factors in the overall price of the sprinkler system through discussions with the builder or contractor, and more detailed cost data in some cases. However, given the small size of the data set and other limitations, this research did not attempt to specifically quantify the pricing influence of variables like copper piping or well water systems for use on a broader basis. Several system variables, including those identified on the graph, are discussed and summarized below. Many of these factors are discussed further in the Individual Community Analysis section of this report.
