## Farabaugh Engineering and Testing Inc.

Project No. T141-19

### UL 580 / UL1897 UPLIFT RESISTANCE TESTING

GEORGIA RIB ROOF PANEL  
36" WIDE X 26 GA STEEL

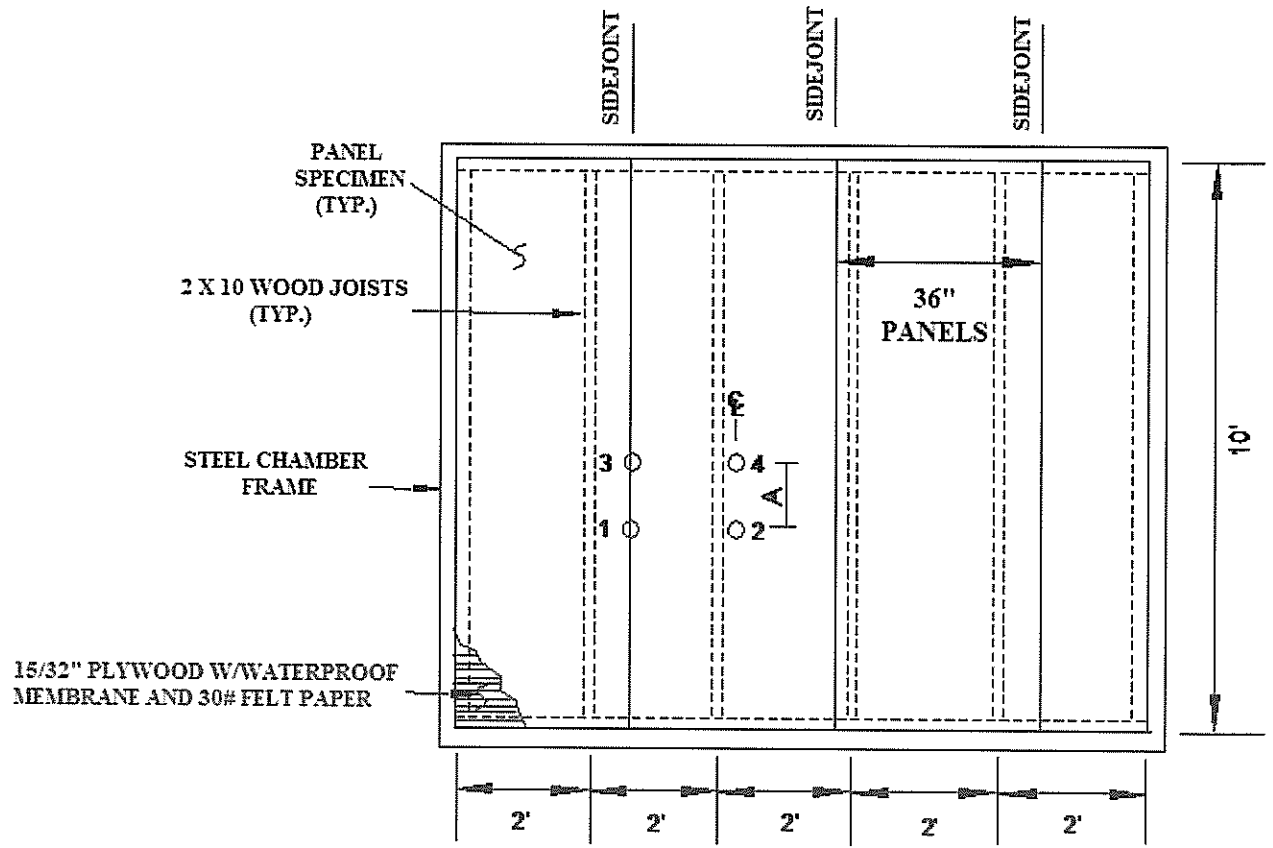
## PLAN VIEW

NOTE: DEFLECTION POINT 1  
AT FASTENER  
A = FASTENER SPACING/2

○ - DEFLECTION POINT

**Class 30 Deflection Measurements**

| Total Uplift Pressure (psf) | Time Duration (min.) | #1 (in) | #2 (in) | #3 (in) | #4 (in) |

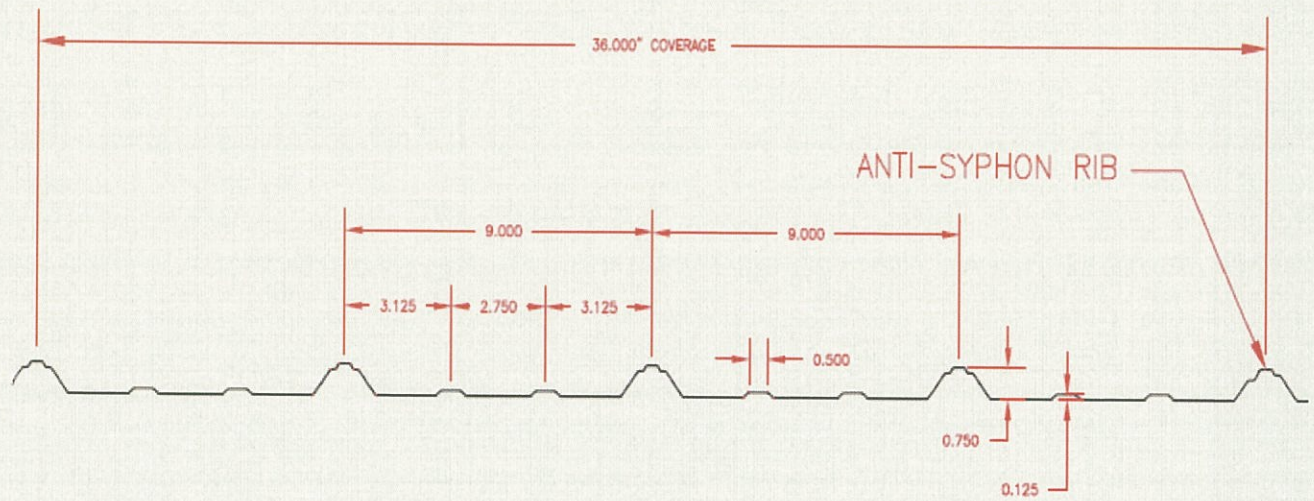
## PANEL DETAIL

FASTENING DETAIL AT  
FIXED END SUPPORT

FASTENING DETAIL AT  
INTERIOR SUPPORTS

- The 15/32" plywood was attached to the wood joist supports using 8d ring shank nails at 6" on center around the perimeter and at interior supports.
- A layer of Self Adhering Waterproof Membrane was on top of the plywood sheathing substrate.
- A layer of A layer of 30 lb felt paper was on top of the waterproof membrane.
- The metal roof panels were attached to the wood deck substrate using #10 X 1-1/2" hex head Wood Binder screws with 7/16" dia. seal washer spaced as shown on the attached drawings. The panels were attached to the perimeter of the wood deck using the same wood screws with 7/16" dia. seal washer (8 per panel at panel ends and 6" on center at longitudinal sides).
- A plastic barrier was located between the panels and the underlying substrate.
