Project No. T221-21

## UL 580 / UL1897 UPLIFT RESISTANCE TESTING

**ELITE RIB ROOF PANEL  
3'-0" COVERAGE X 29 GA. STEEL  
(FASTENERS INTO PINE PURLINS @ 24" O.C.  
WITH FASTENER PATTERN OF 9/9/9/6)**

ELITE METAL MANUFACTURING, LLC.  
10121 88<sup>TH</sup> TRACE  
LIVE OAK, FL. 32064

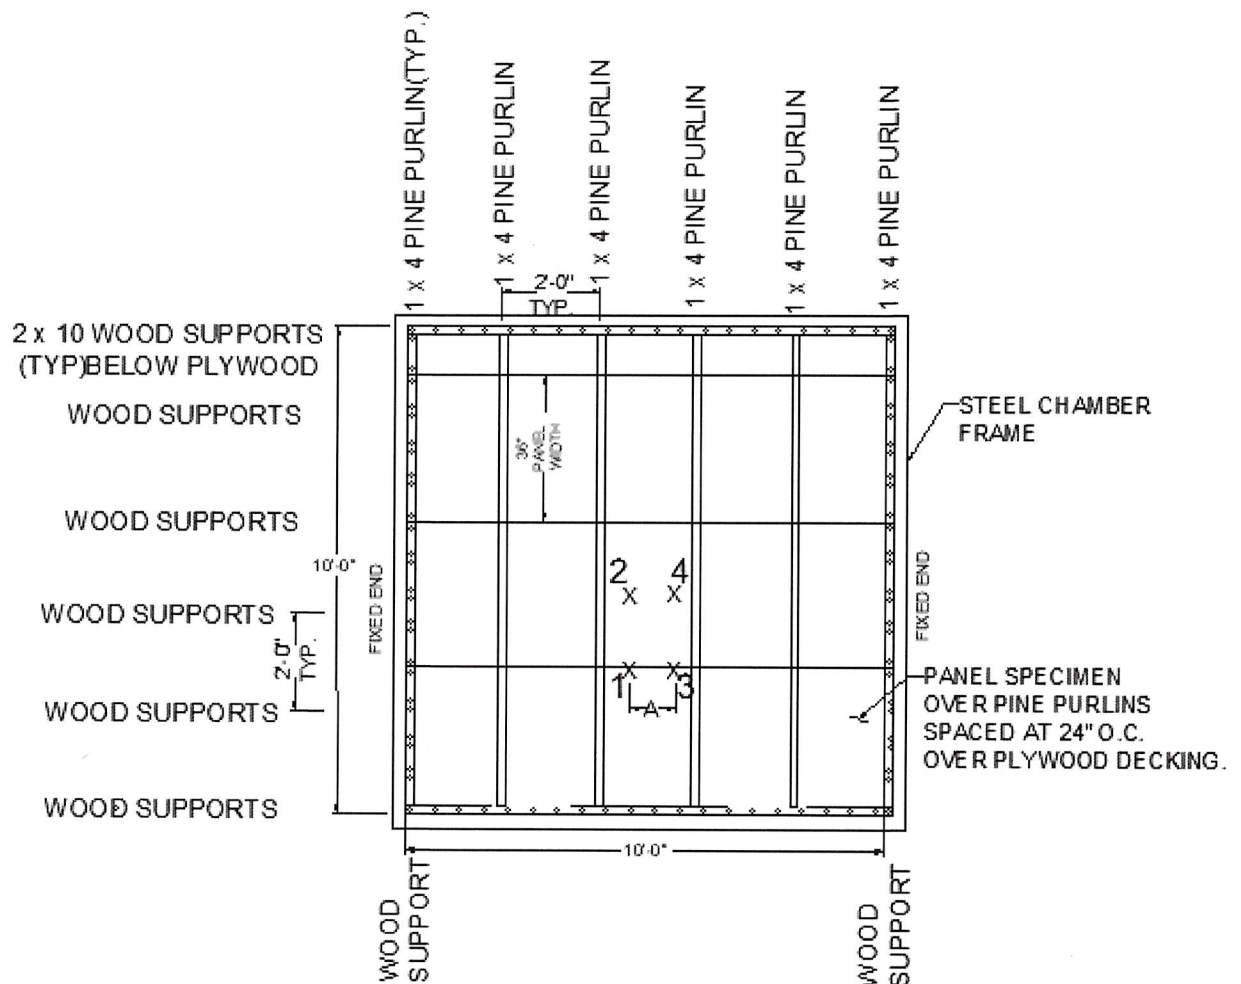
## TEST SET UP

NOTE:- DEFLECTION POINT #1 AT FASTENER LOCATION  
 A = FASTENER LOCATION / 2  
 (FASTENERS AT PINE PURLIN LOCATION OF 24" O.C.)

X - DEFLECTION LOCATION

*Test Chamber:* The test chamber consists of three sections: a top section to create a uniform vacuum, a center section in which the roof assembly is constructed, and a bottom section to create a uniform positive pressure.

- The 15/32" plywood was attached to the wood joist (2x10) supports (spaced at 2'-0" o.c.) using 8d ring shank nails at 6" on center around the perimeter and at interior supports.

- 1 x 4 pine purlin spaced at 24" o.c. was attached with (2) #9 x 3" deck screws at 24" o.c. along the length of the purlin thru the plywood and into the wood joists.

- The metal roof panels were attached to the pine purlin substrate using #10-12 X 1-1/2" long, hex head wood screw, type 17 point, w/1/2" steel sealing washer. The screws were attached with a specified spacing pattern across the width of the panel with a fastening spacing of 24" o.c. along the length of the panel. The panel sidejoint was lap joint. The outer perimeter of the assembly was secured with perimeter fastening as required to maintain a periphery seal. See fastening pattern for location of fasteners across width of panel.

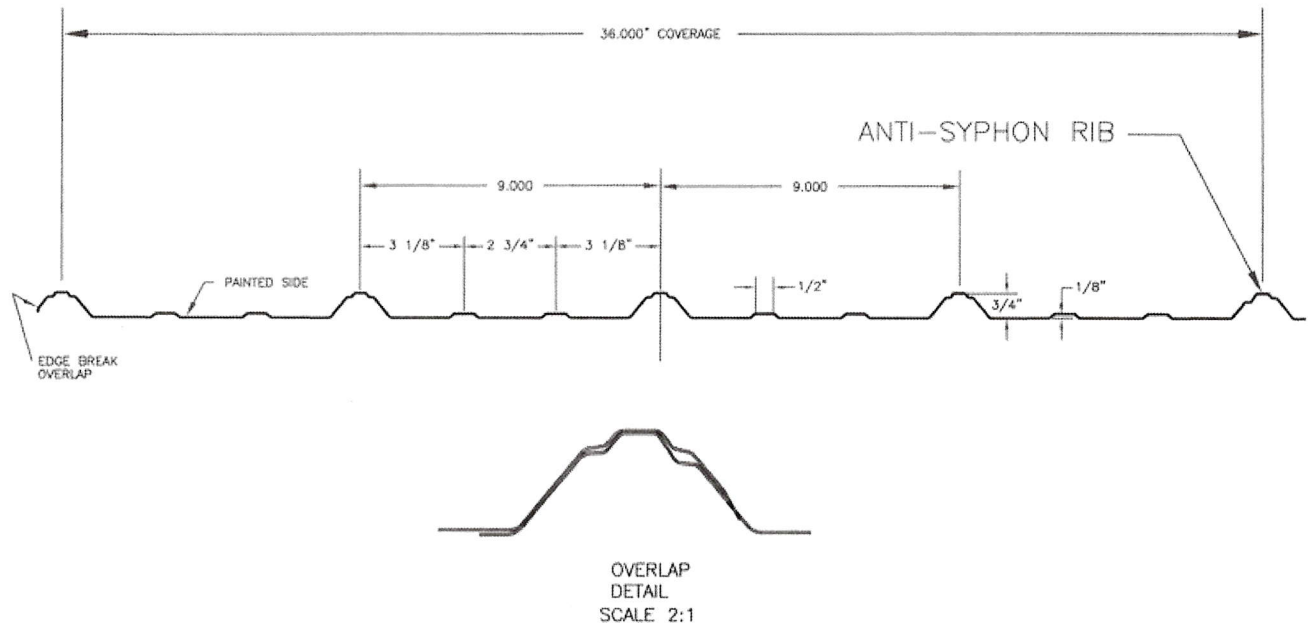
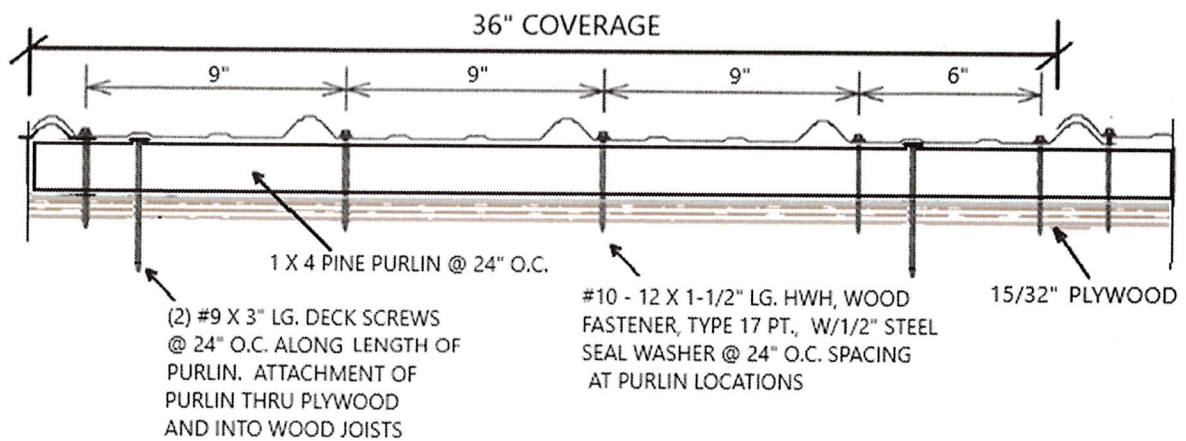
## PLAN VIEW OF PANELS

## ELITE RIB PANEL

**FASTENER PATTERN 9/9/9/6 INTO PURLINS@ 24"**  
**O.C. ALONG LENGTH OF PANEL**
