Project No. T222-21

### UL 580 / UL1897 UPLIFT RESISTANCE TESTING

**ELITE RIB ROOF PANEL  
3'-0" COVERAGE X 29 GA. STEEL  
(FASTENERS INTO PINE PURLINS @ 24" O.C.  
WITH FASTENER PATTERN OF 6/3/6/3/6/3/6)**

ELITE METAL MANUFACTURING, LLC.  
10121 88<sup>TH</sup> TRACE  
LIVE OAK, FL. 32064

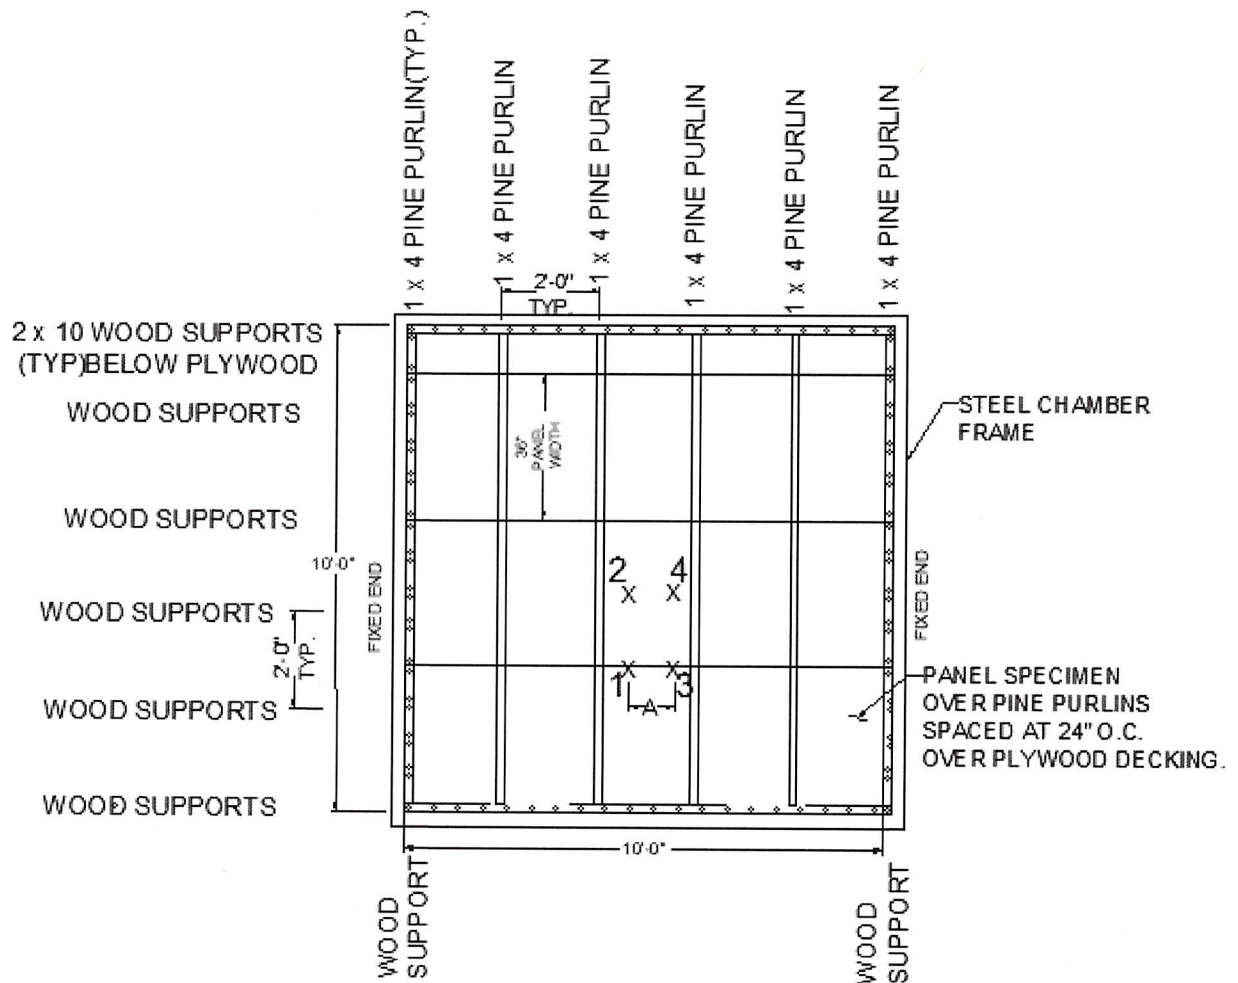
## TEST SET UP

NOTE:- DEFLECTION POINT #1 AT FASTENER LOCATION  
 A = FASTENER LOCATION / 2  
 (FASTENERS AT PINE PURLIN LOCATION OF 24" O.C.)

X - DEFLECTION LOCATION

*Test Chamber:* The test chamber consists of three sections: a top section to create a uniform vacuum, a center section in which the roof assembly is constructed, and a bottom section to create a uniform positive pressure.

- The 15/32" plywood was attached to the wood joist (2x10) supports (spaced at 2'-0" o.c.) using 8d ring shank nails at 6" on center around the perimeter and at interior supports.

- 1 x 4 pine purlin spaced at 24" o.c. was attached with (2) #9 x 3" deck screws at 24" o.c. along the length of the purlin thru the plywood and into the wood joists.

- The metal roof panels were attached to the pine purlin substrate using #10-12 X 1-1/2" long, hex head wood screw, type 17 point, w/1/2" steel sealing washer. The screws were attached with a specified spacing pattern across the width of the panel with a fastening spacing of 24" o.c. along the length of the panel. The panel sidejoint was lap joint. The outer perimeter of the assembly was secured with perimeter fastening as required to maintain a periphery seal. See fastening pattern for location of fasteners across width of panel.

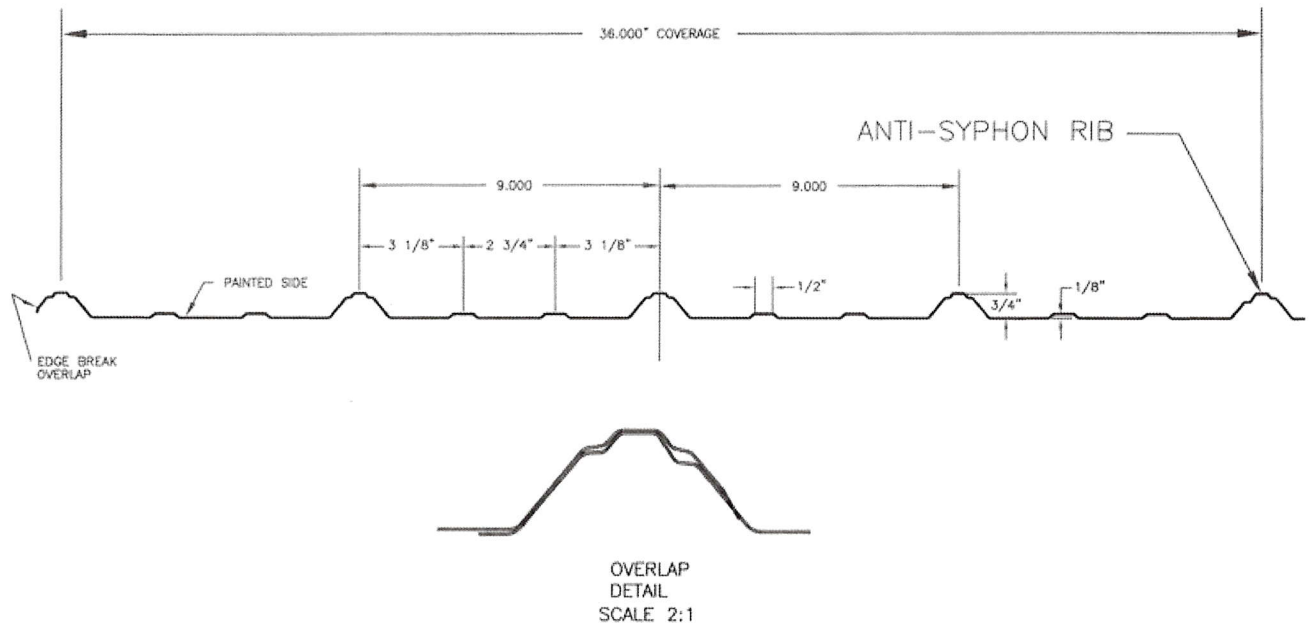
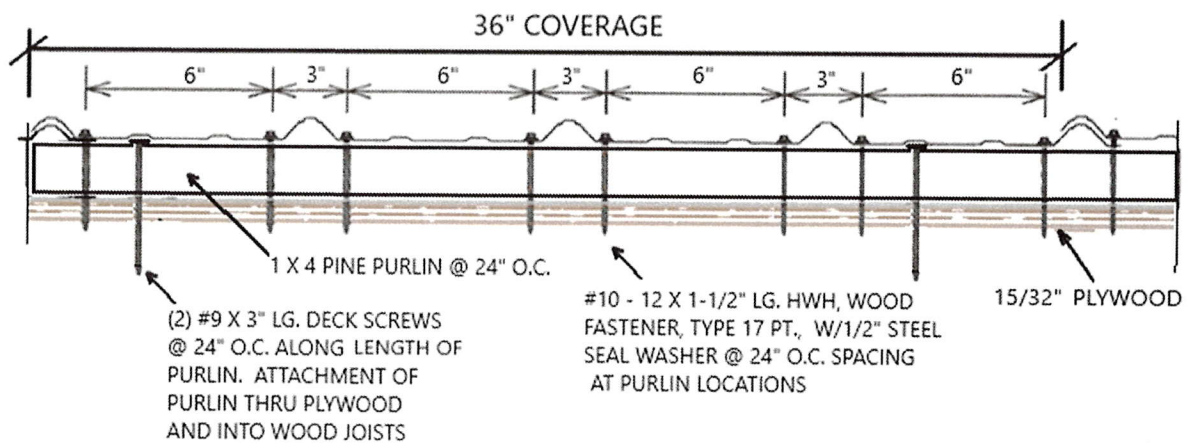
## PLAN VIEW OF PANELS

## ELITE RIB PANEL

**FASTENER PATTERN 6/3/6/3/6/3/6 INTO PURLINS@  
24" O.C. ALONG LENGTH OF PANEL**
