## **STRUCTURAL TEST REPORT**

**NCTL-110-20685-1**

**PRODUCT TYPE: DUAL ACTION DOOR**

**SERIES/ MODEL: "PIXEL"**

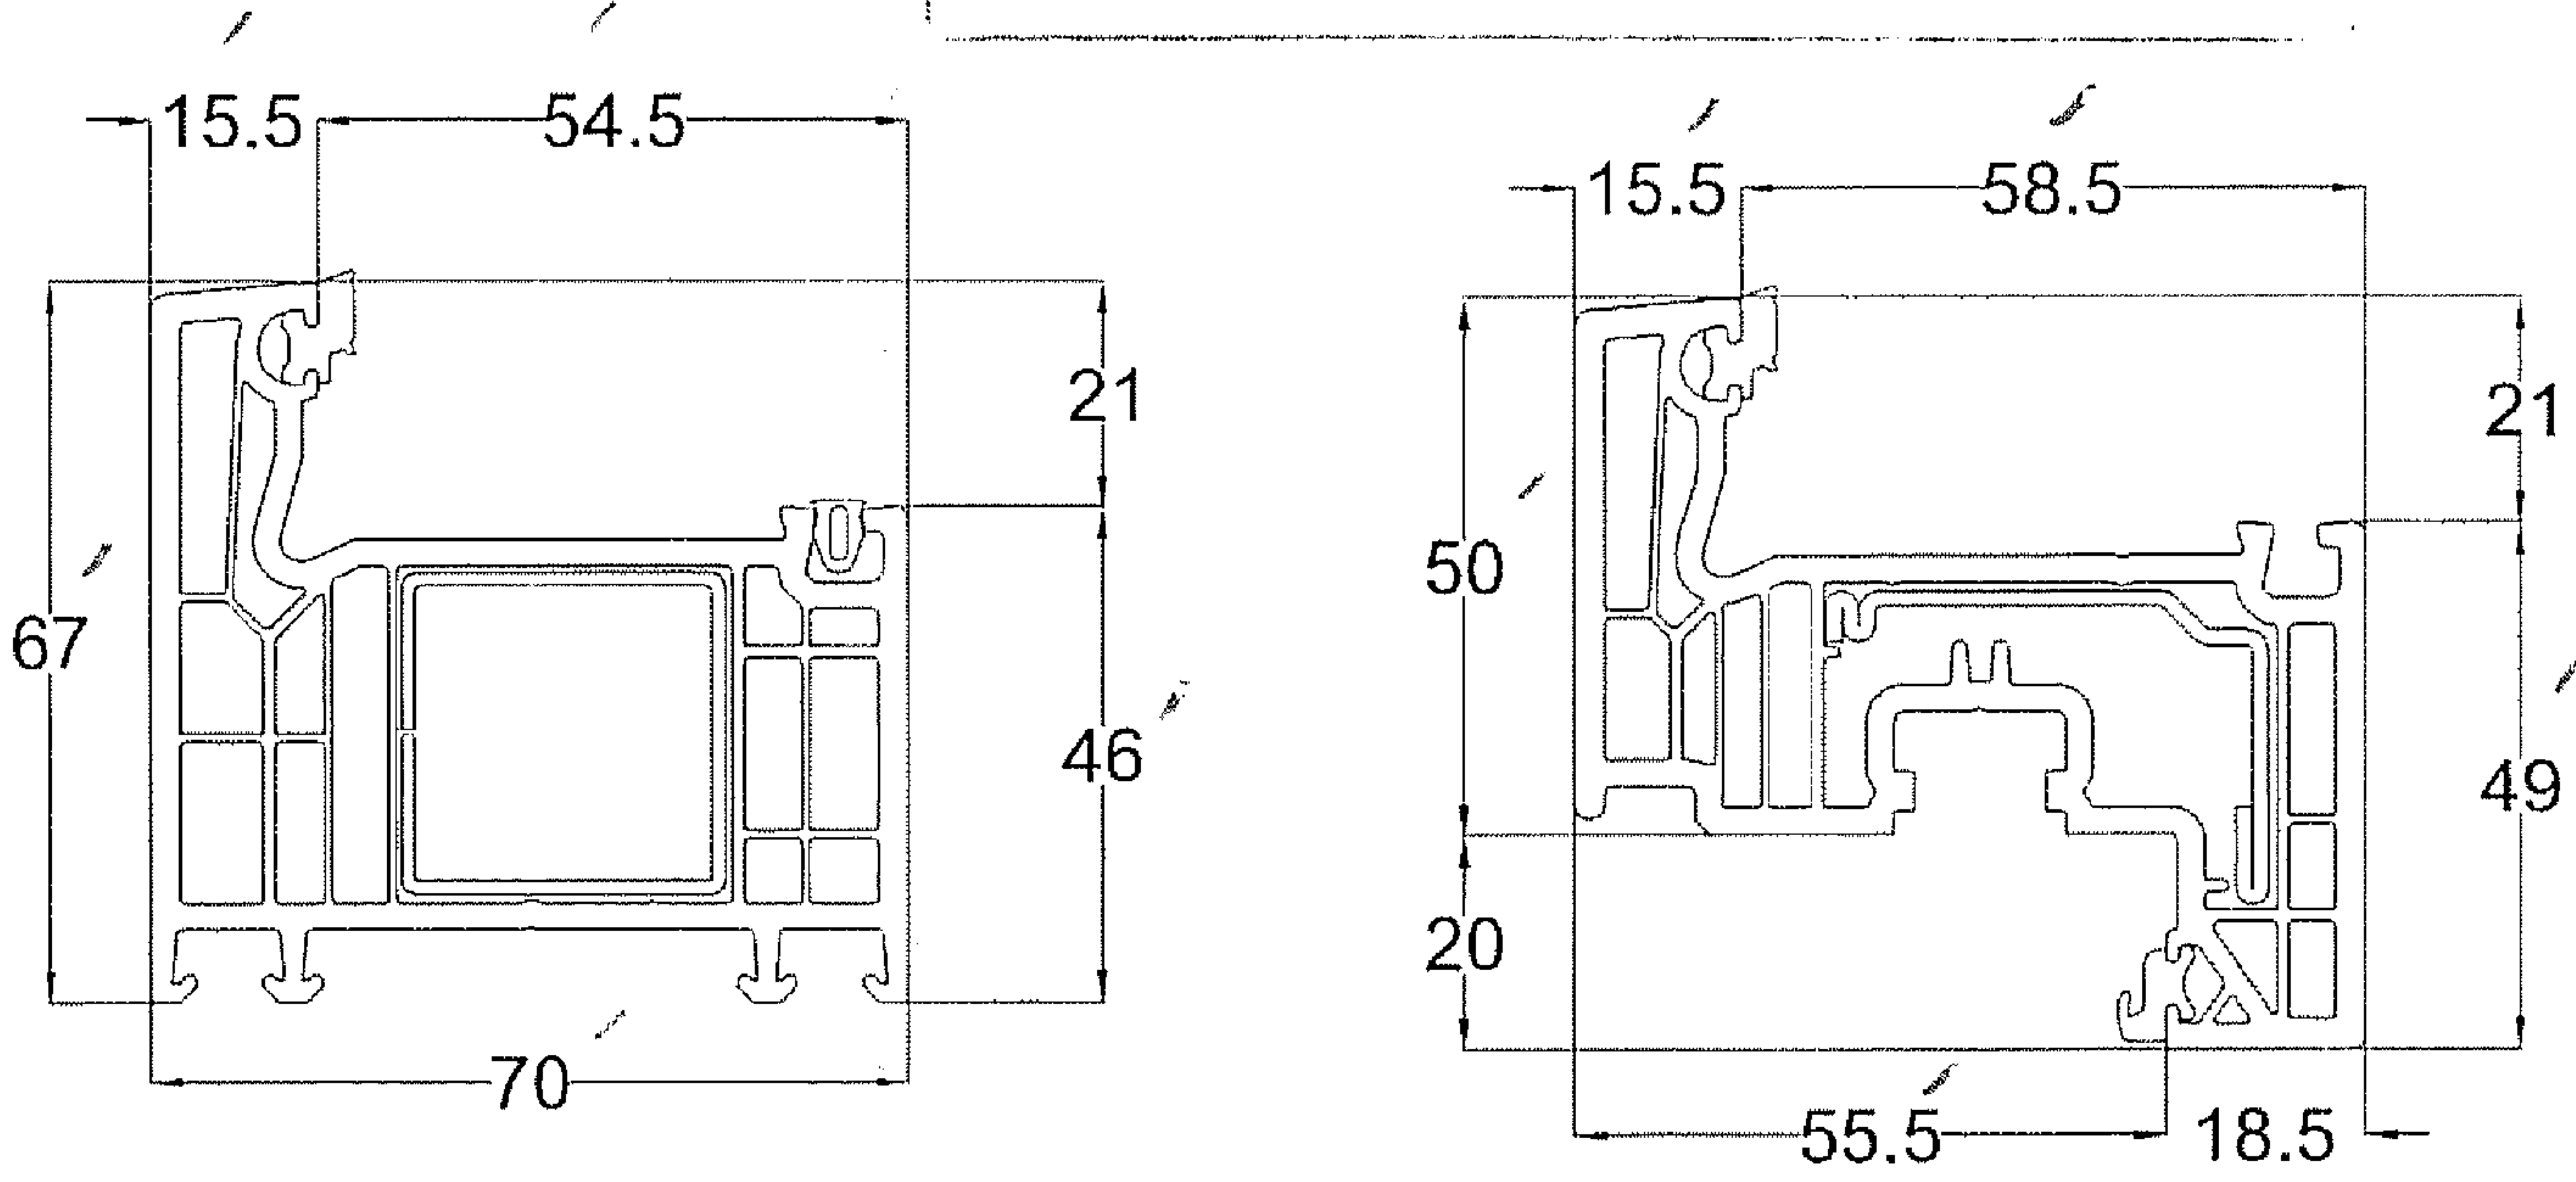
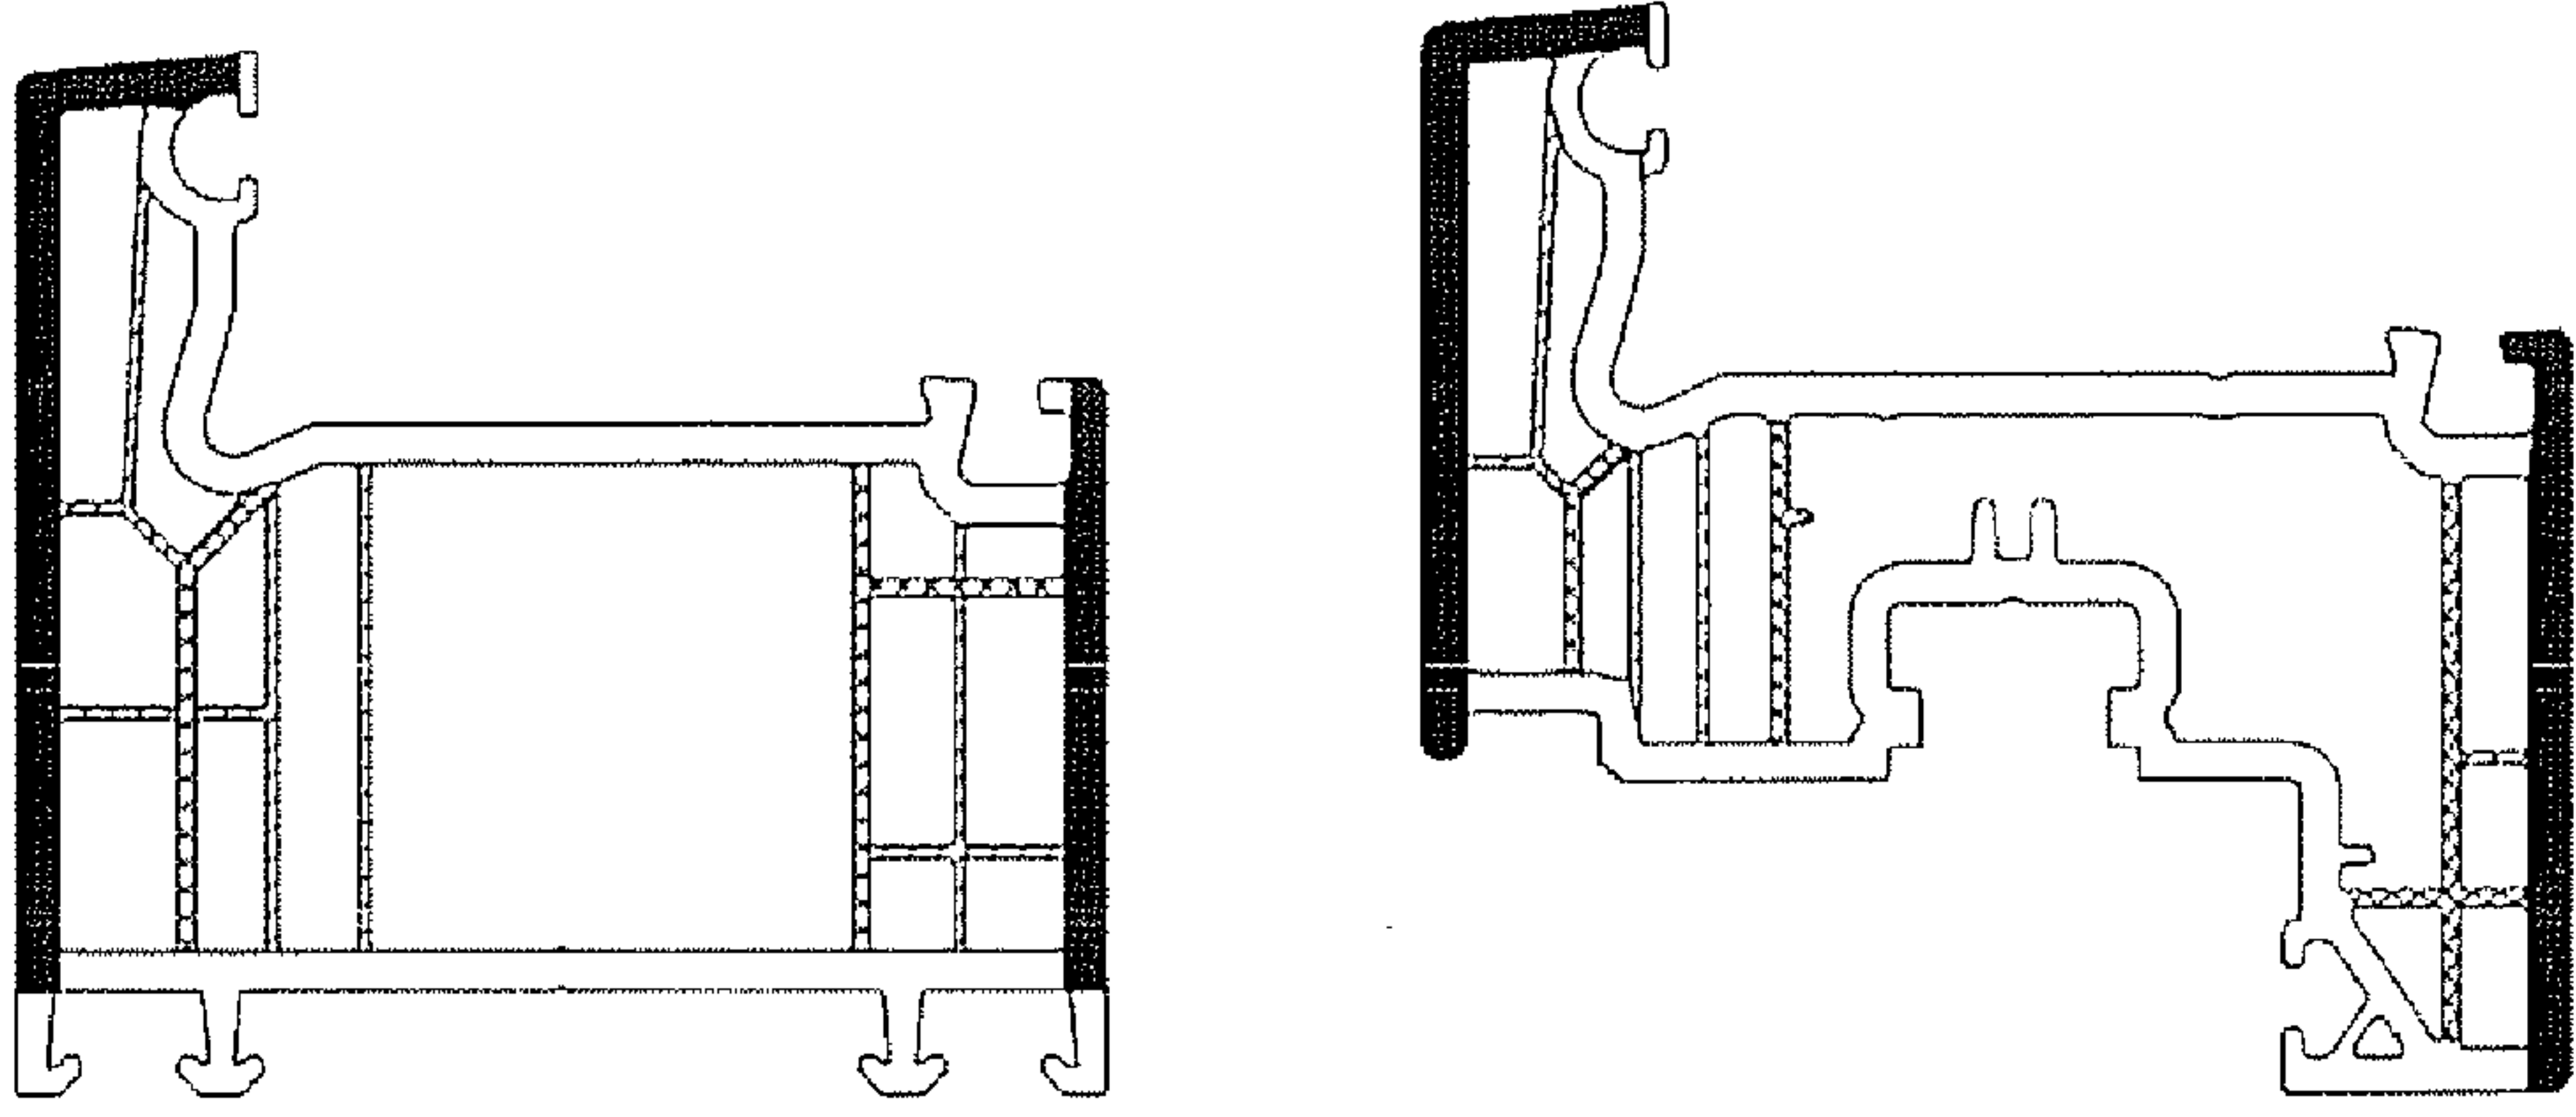
| TYTUŁ:<br>PIXEL 1020X2110 1678981 poz. 2 | | |

TEST SPECIMEN COMPLIES  
WITH THESE DETAILS.  
ANY DEVIATION IS NOTED  
REPORT NO. NCTL-110- 20855-1  
TEST DATE 12/13/17

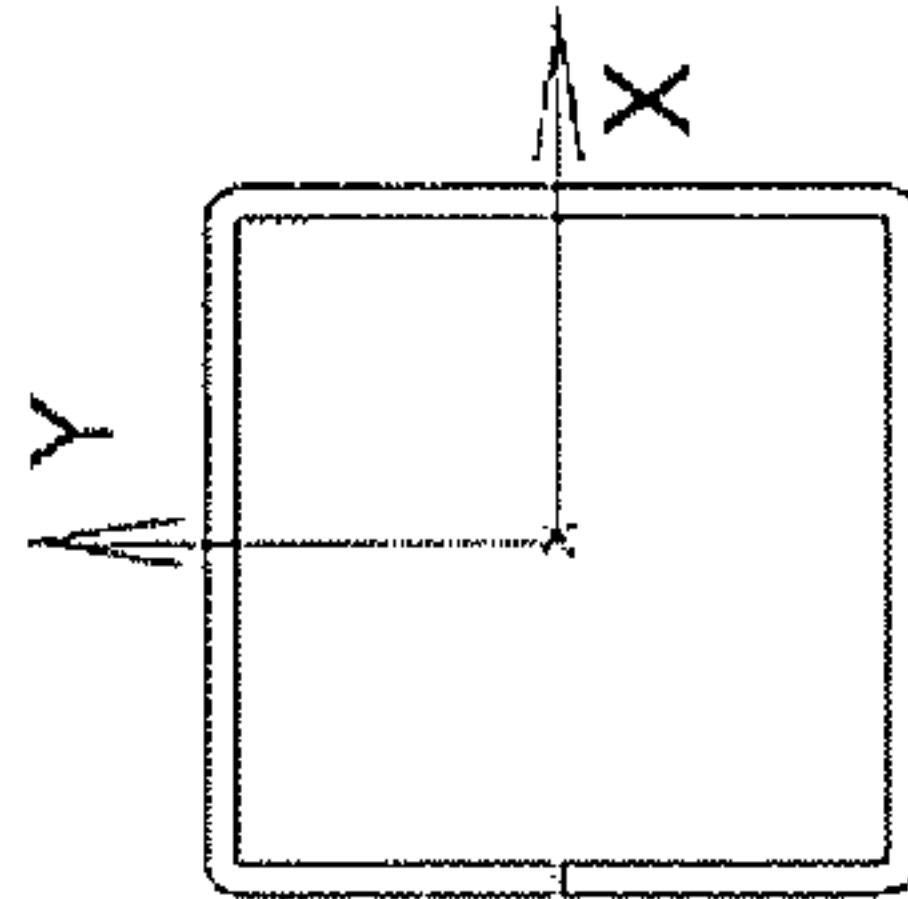
MOMENT OF INERTIA:

Ix: 1,94 cm^4

Iy: 1,94 cm^4

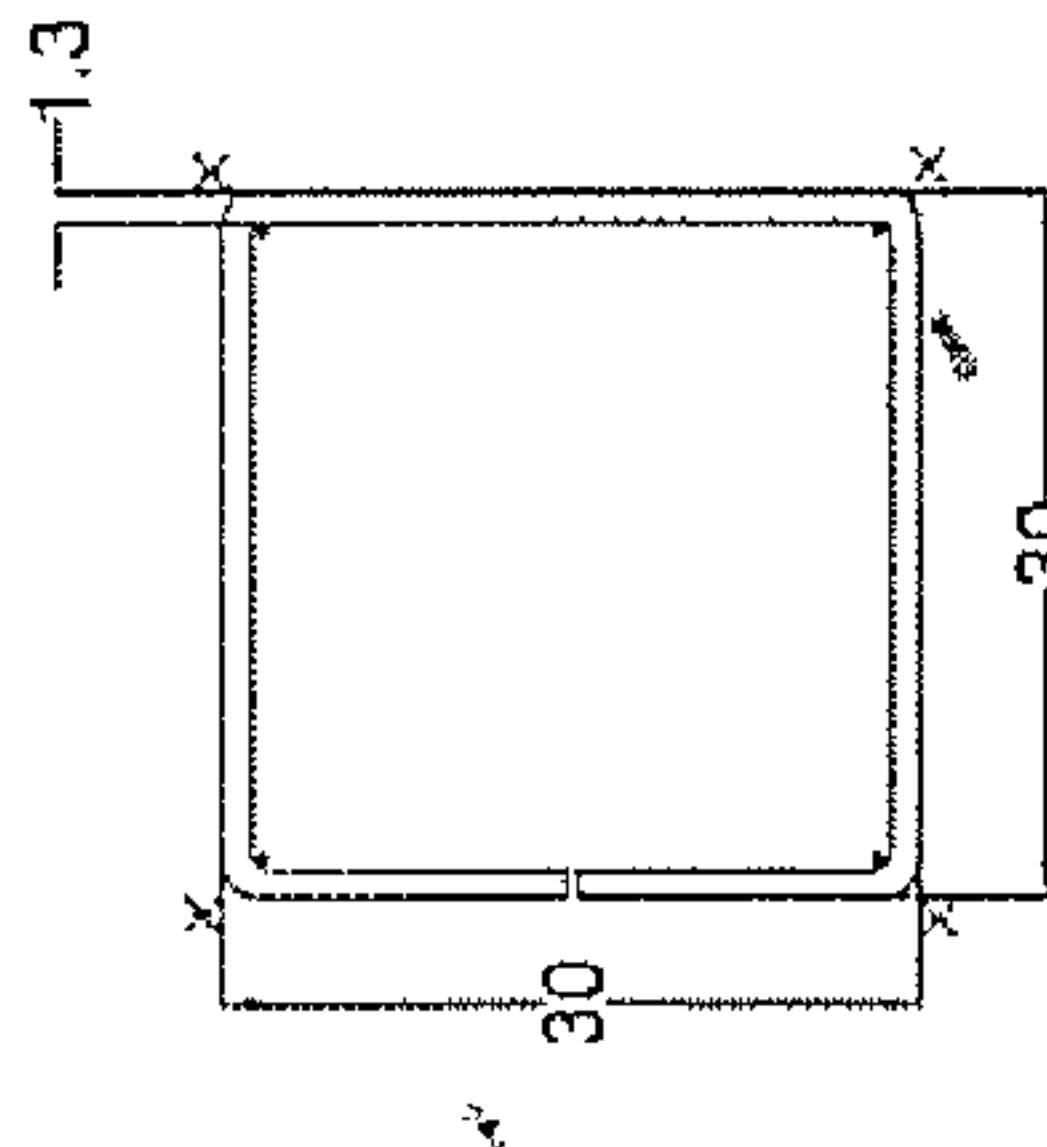
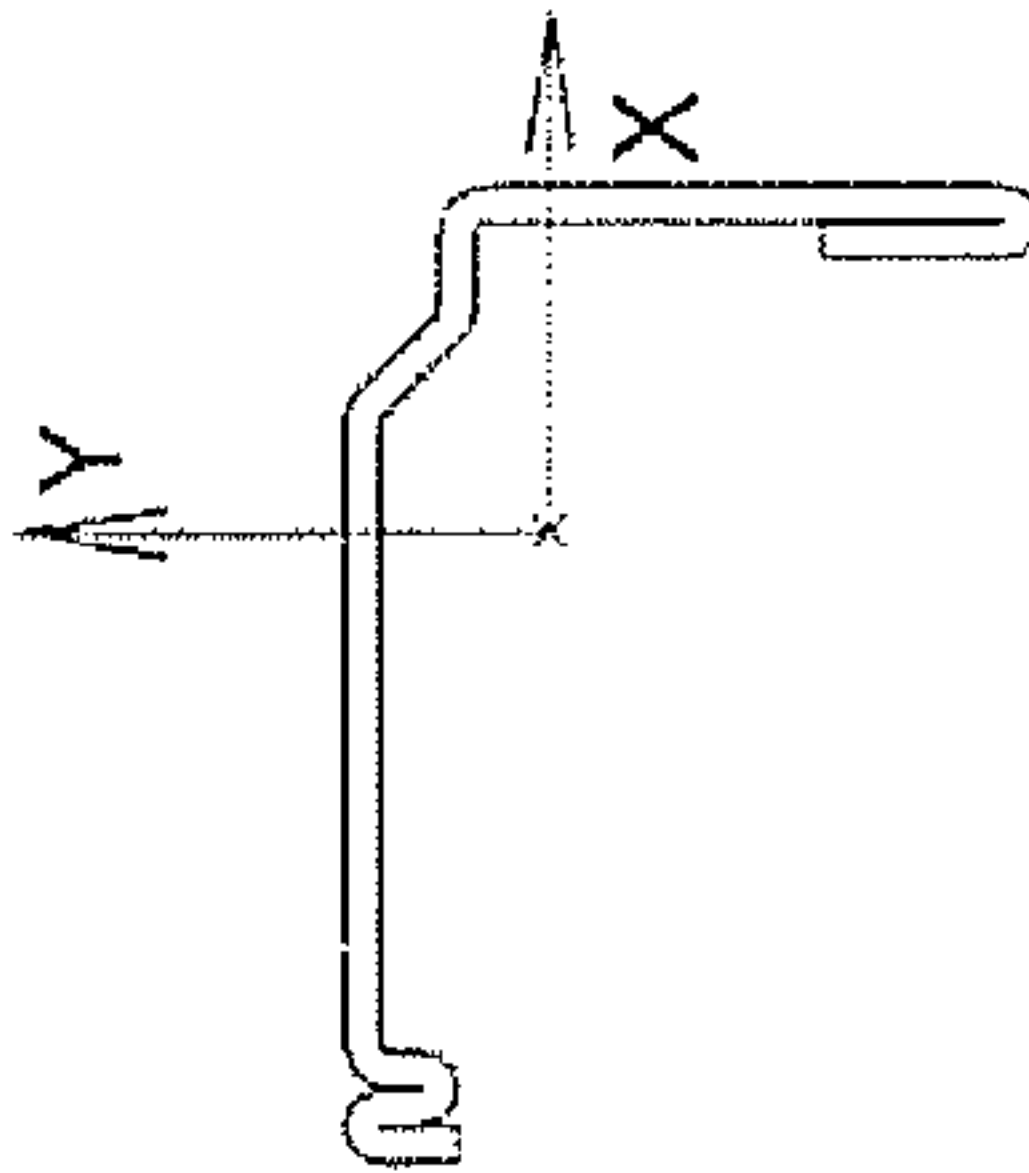
113.025

x r= 1,5 mm

. r= 0,5 mm

MOMENT OF INERTIA:

Ix: 1,13 cm^4

Iy: 2,70 cm^4

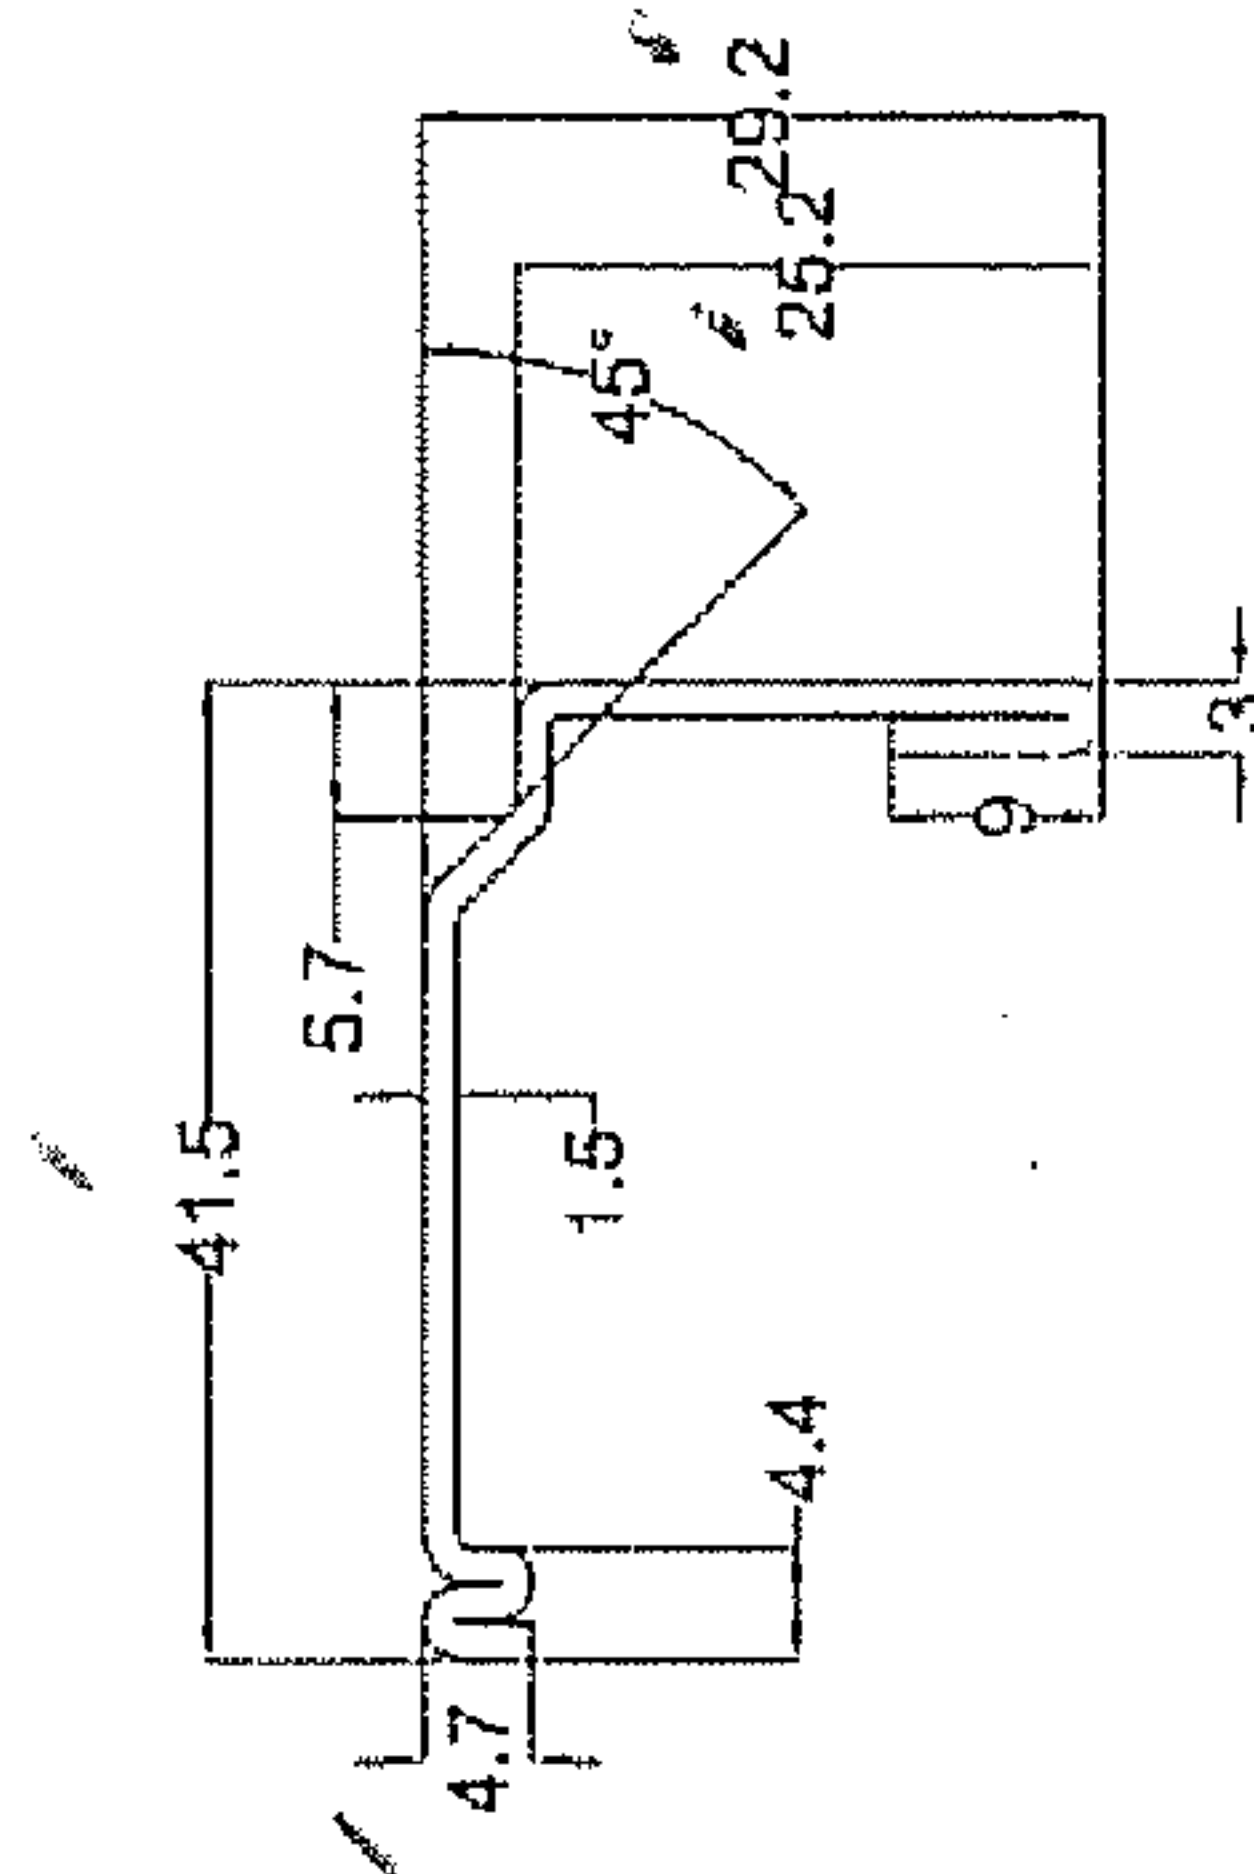
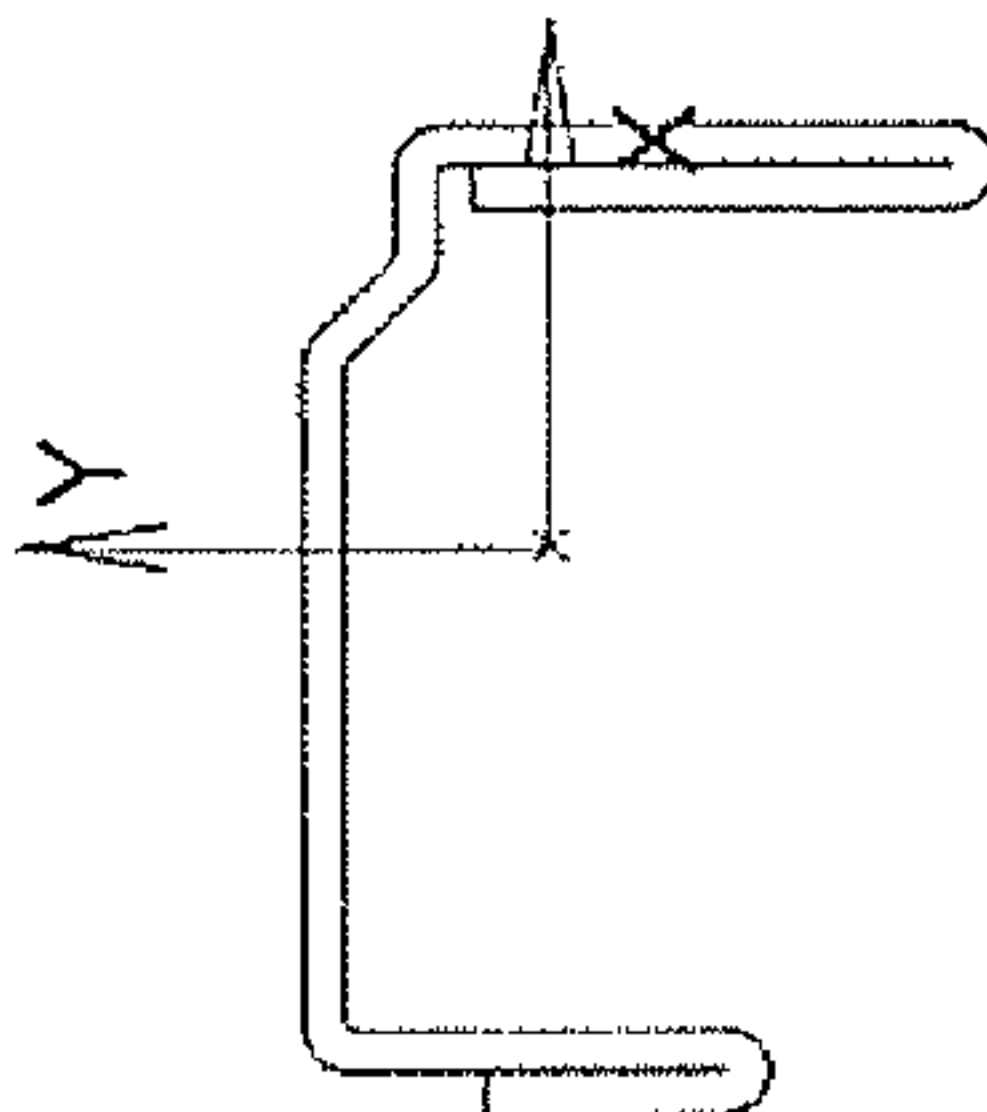
113.370.52

MOMENT OF INERTIA:

Ix: 1,42 cm^4

Iy: 5,50 cm^4
