## Farabaugh Engineering and Testing Inc.

Project No. T336-22

### UL 580 UPLIFT RESISTANCE TESTING

**1-1/2" SNAPLOCK STANDING SEAM PANEL  
16" WIDE X 26 GA. STEEL  
(WITH MODIFIED SEAM)**

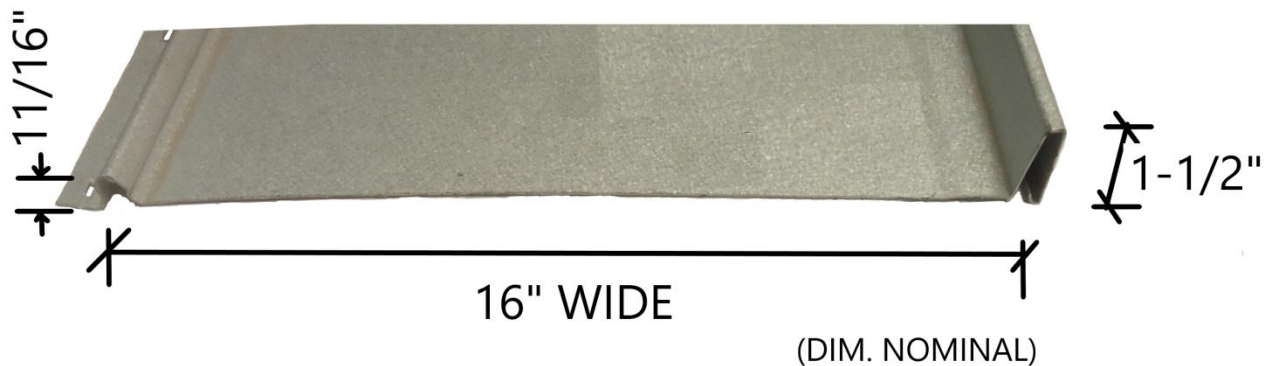
**1-1/2" SNAPLOCK STANDING SEAM PANEL**  
**(MODIFIED SEAM)**

## TEST SET UP

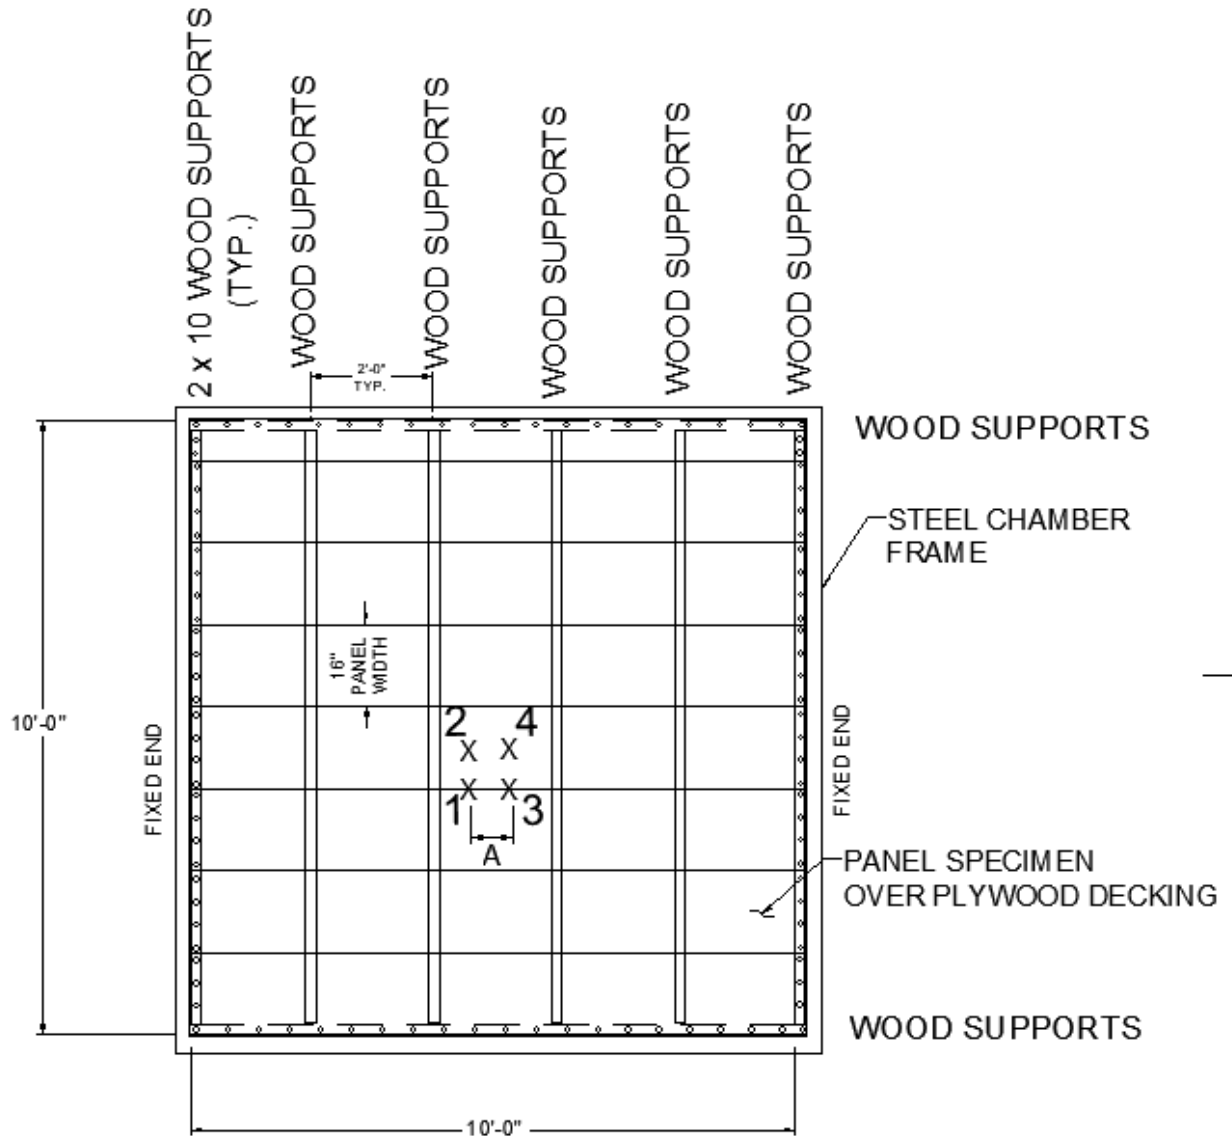
## PLAN VIEW OF PANELS

NOTE:- DEFLECTION POINT #1 AT FASTENER LOCATION  
A = FASTENER LOCATION / 2

X# - DEFLECTION LOCATION
