## Farabaugh Engineering and Testing Inc.

Project No. T330-24

### UL 580 / UL1897 UPLIFT RESISTANCE TESTING

**ELITE RIB ROOF PANEL  
3'-0" COVERAGE X 26 GA. STEEL  
(FASTENERS INTO PINE PURLINS @ 24" O.C.  
WITH FASTENER PATTERN OF 6/3/6/3/6/3/6/3)**

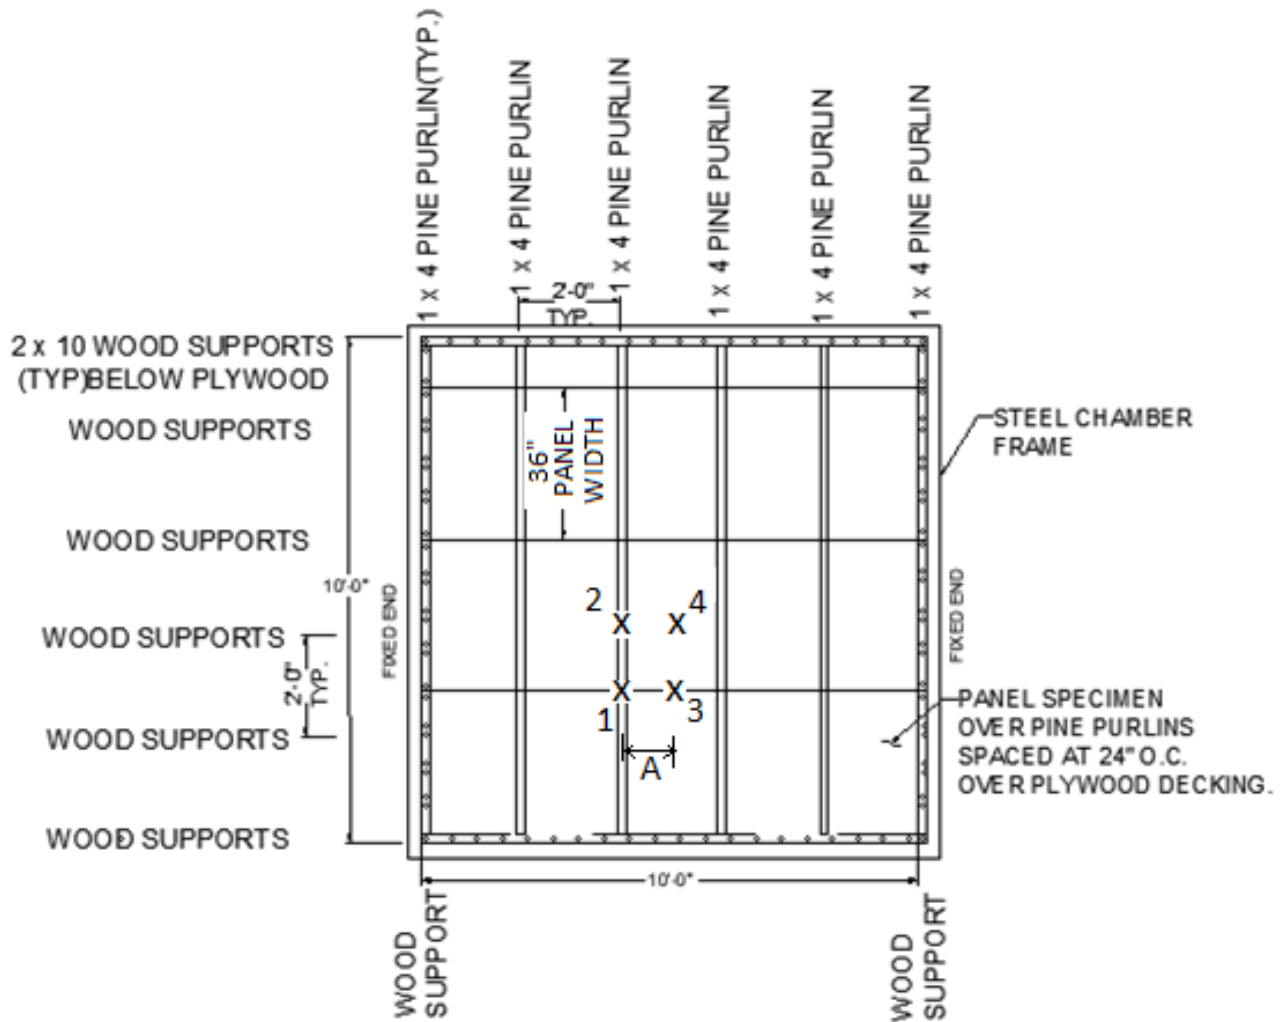
## TEST SET UP

NOTE:- DEFLECTION POINT #1 AT FASTENER LOCATION  
 A = FASTENER LOCATION / 2  
 (FASTENERS AT PINE PURLIN LOCATION OF 24" O.C.)

X - DEFLECTION LOCATION

*Test Chamber:* The test chamber consists of three sections: a top section to create a uniform vacuum, a center section in which the roof assembly is constructed, and a bottom section to create a uniform positive pressure.

*Pressure Chamber:* The air pressure in the pressure chamber was measured at five points. Each of four points were located 42” from chamber corners at a 45 degrees angle, with the fifth tube located 18” from the center of the air inlet opening. The end of each tube was 7” above the chamber floor. The tubes were connected to a manifold that, in turn was connected to a manometer.

*Vacuum Chamber Measurement:* The air pressure in the vacuum chamber was measured at five points. Each of four points was located 18” from chamber corners at a 45 degrees angle and 8” above the chamber floor. The fifth tube located 12” from the center of the exhaust opening and 6” below the opening. The tubes were connected to a manifold that, in turn was connected to a manometer. The pressure in the vacuum chamber was controlled by an automatic damper. The damper door was moved by means of an air motor hooked to an air line and controlled by pressure switches located in the control console. An additional pressure line from the manifold to pressure switches controlled the automatic damper.

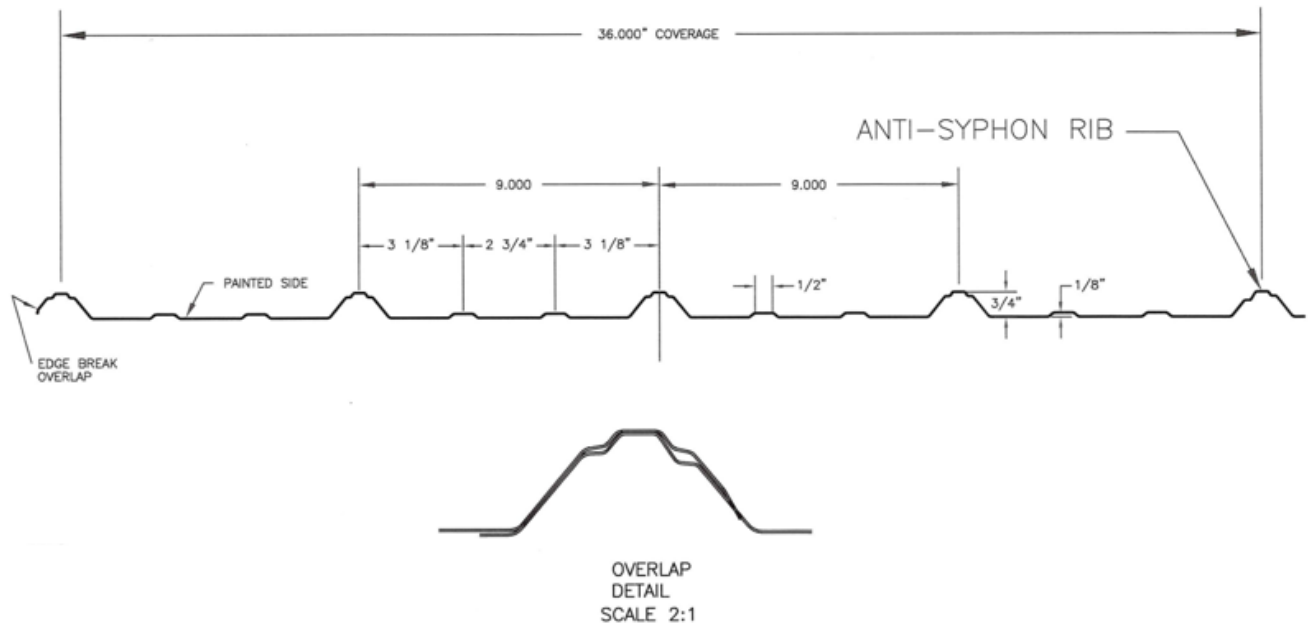
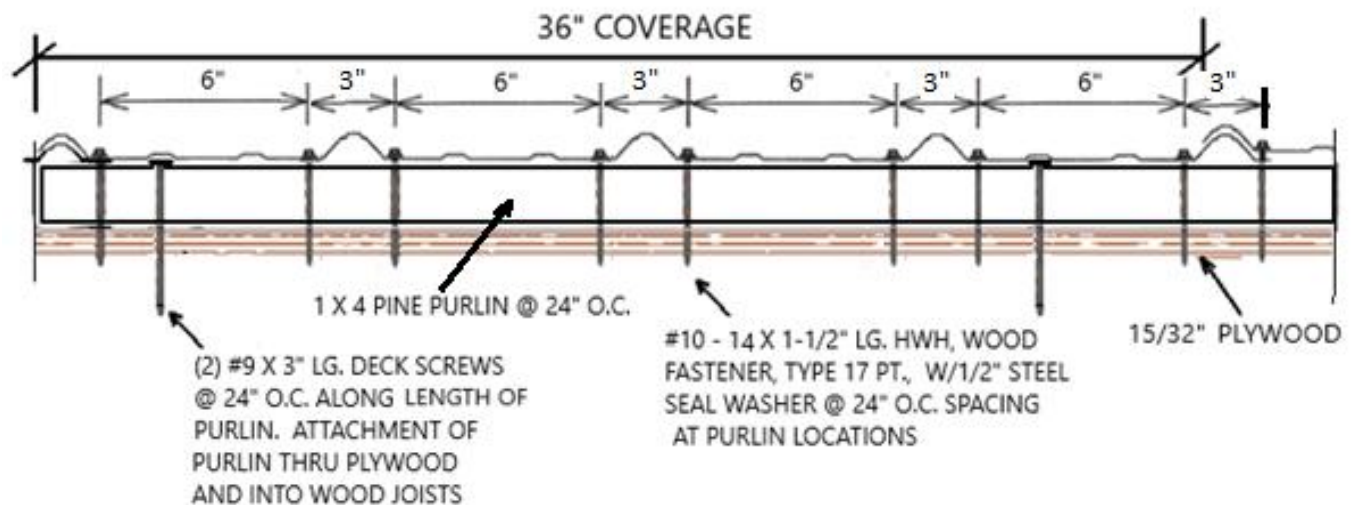
## PLAN VIEW OF PANELS

## ELITE RIB PANEL

STRIP WIDTH = 40.875

FASTENER PATTERN 6/3/6/3/6/3/6/3 INTO PURLINS@  
24" O.C. ALONG LENGTH OF PANEL

- The metal roof panels were attached to the pine purlin substrate using #10-14 X 1-1/2" long, hex head, Hi-Lo, wood screw, type 17 point, w/1/2" steel sealing washer. The screws were attached with a specified spacing pattern across the width of the panel with a fastening spacing of 24" o.c. along the length of the panel. The panel sidejoint was lap joint. The outer perimeter of the assembly was secured with perimeter fastening as required to maintain a periphery seal. See fastening pattern for location of fasteners across width of panel.
