**PERFORMANCE TEST REPORT**

**GLASSCRAFT DOOR COMPANY**

**PRODUCT TYPE: 6' x 8' Double Outswing Hardwood Door  
with Half Circle Transom**

Report No.: 64138.01-801-44  
Revision 1: 07/27/10  
Test Dates: 04/04/06  
Through: 07/24/06  
Report Date: 08/08/06  
\*\*Record Retention End Date: 07/24/10

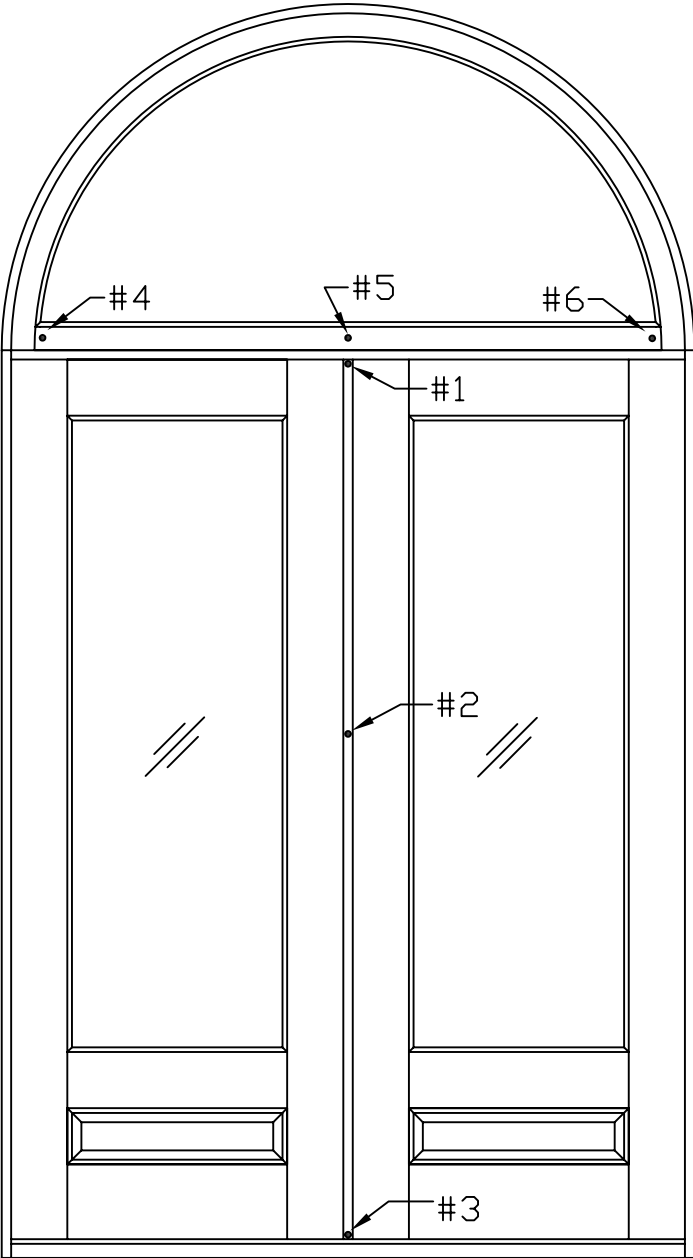
SKETCH #1

**Note:** See Architectural Testing Sketch #1 for indicator locations.

Uniform Load Deflection per ASTM E 330 (Deflections were taken on the astragal) 36.2 psf (positive) (load held for 30 seconds) 45.7 psf (negative) (load held for 27 seconds)	<u>Indicator Number</u>			Net
	1	2	3	
	0.02"	0.05"	<0.01"	0.04"
	0.67"	1.08"	0.25"	0.62"

Uniform Load Deflection per ASTM E 330 (Deflections were taken on the transom sill) 36.2 psf (positive) (load held for 30 seconds) 45.7 psf (negative) (load held for 27 seconds)	<u>Indicator Number</u>			Net
	4	5	6	
	0.20"	0.30"	0.22"	0.09"
	0.34"	0.41"	0.37"	0.06"

Uniform Load Structural per ASTM E 330 (Permanent sets were taken on the astragal) 54.3 psf (positive) (load held for 10 seconds) 68.6 psf (negative) (load held for 10 seconds)	<u>Indicator Number</u>			Net
	1	2	3	
	<0.01"	<0.01"	<0.01"	<0.01"
	0.13"	0.02"	0.09"	0.09"

Uniform Load Structural per ASTM E 330 (Permanent sets were taken on the transom sill) 54.3 psf (positive) (load held for 10 seconds) 68.6 psf (negative) (load held for 10 seconds)	<u>Indicator Number</u>			Net
	4	5	6	
	0.02"	0.02"	0.02"	<0.01"
	0.05"	0.03"	0.08"	0.04"

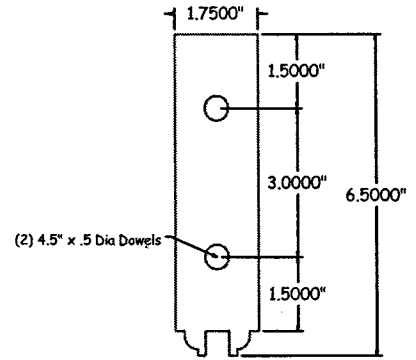
Top Rail

**Leaf Construction:** The door leaf was constructed of 1-3/4" thick hardwood and utilized a glued cove and bead joint, reinforced with 1/2" diameter by 4-1/2" long wood dowels. Two dowels were located at the top and middle rail to stile joint, and four dowels were located at the bottom rail to stile joint.

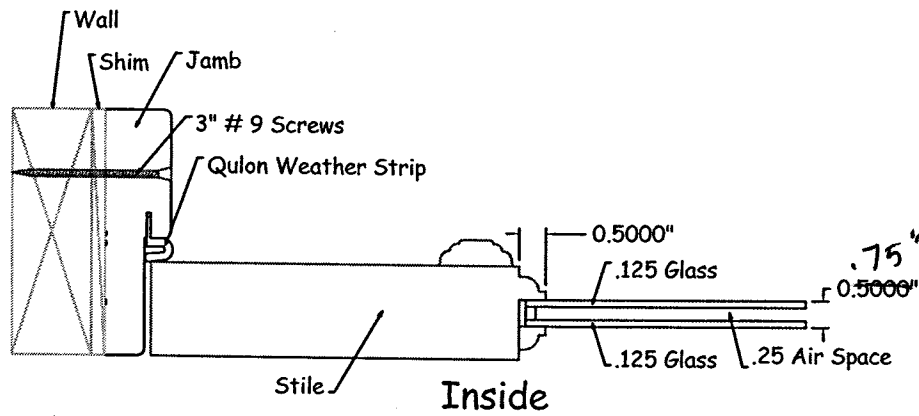
## C Glass

**Glazing Type:** Sealed insulating glass comprised of one sheet of 1/8" thick tempered glass at the exterior and one sheet of 1/8" thick tempered decorative textured glass at the interior. The sheets were separated by a 1/2" aluminum spacer system providing a 3/4" overall thickness.

**Glazing Details:** Interior glazed with double-sided butyl tape and a wood glazing bead secured by 1" x 0.040" x 0.050" rectangular shank 0.050" x 0.080" head brad nails (18 gauge brad nail) 1" from each corner and on 6" spacing thereafter.
