PERFORMANCE TEST REPORT

GLASSCRAFT DOOR COMPANY

**PRODUCT TYPE: 6' x 8' Double Outswing Hardwood TDL Door
with Half Circle TDL Transom**

Report No.: 81838.01-801-44

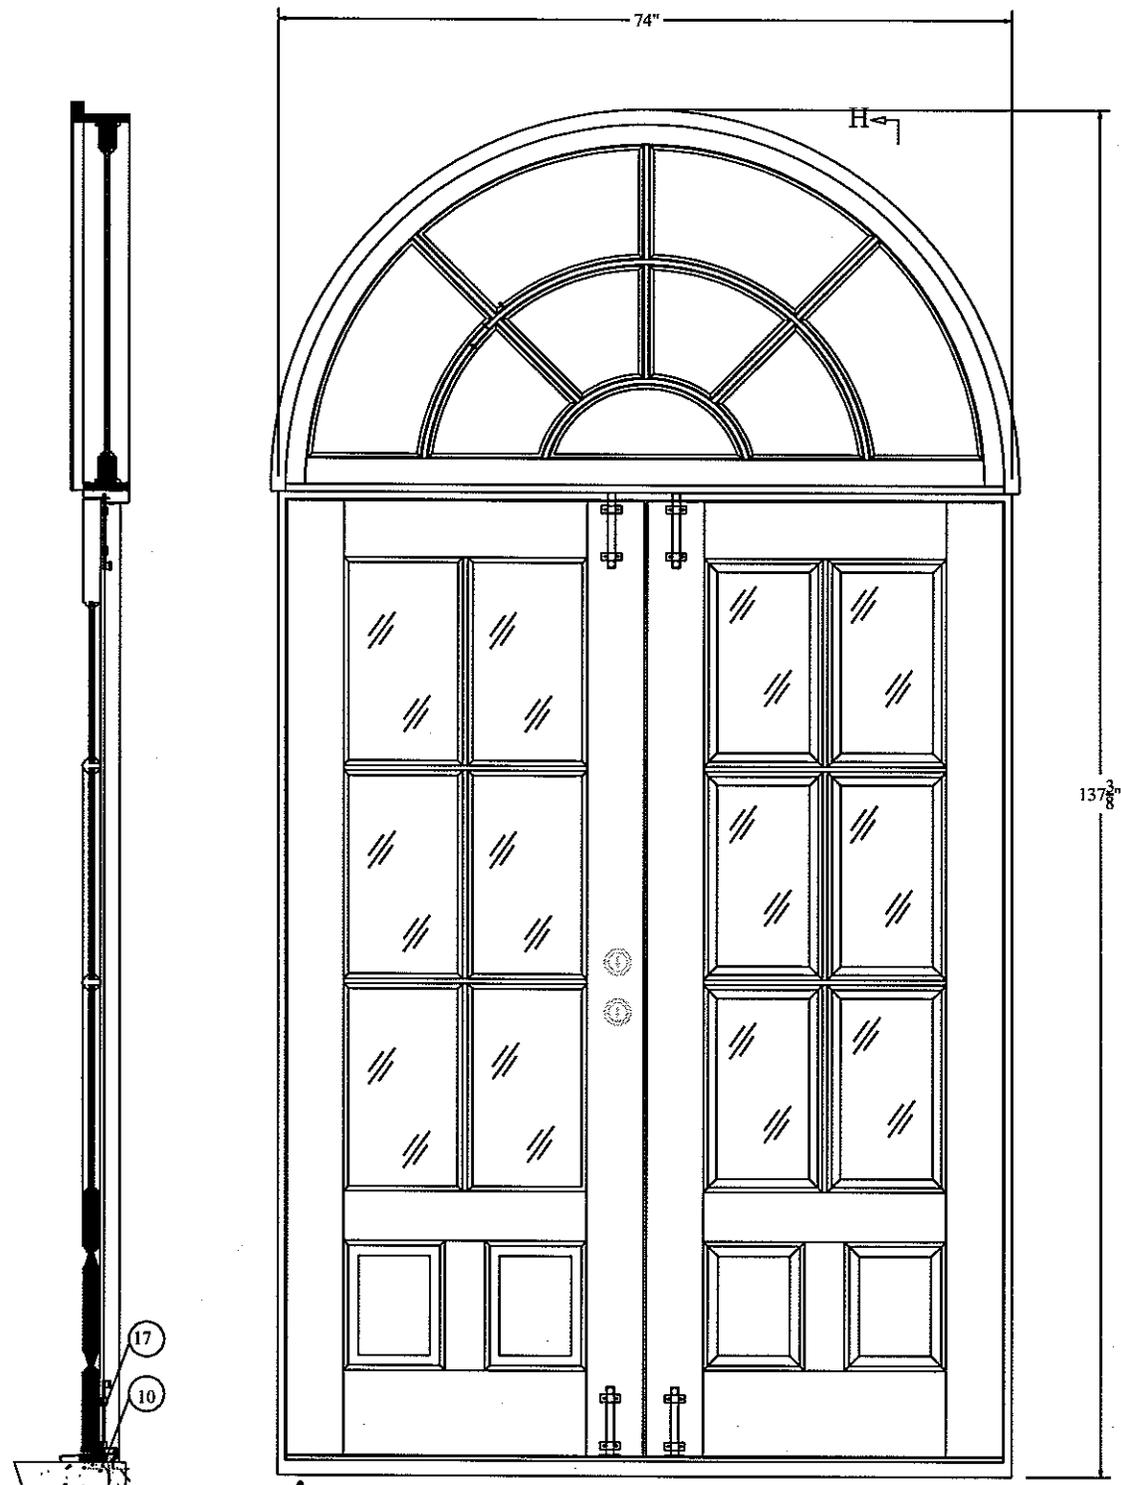
Section
Glass*Craft

Hardwood Double Glass Doors/Transom

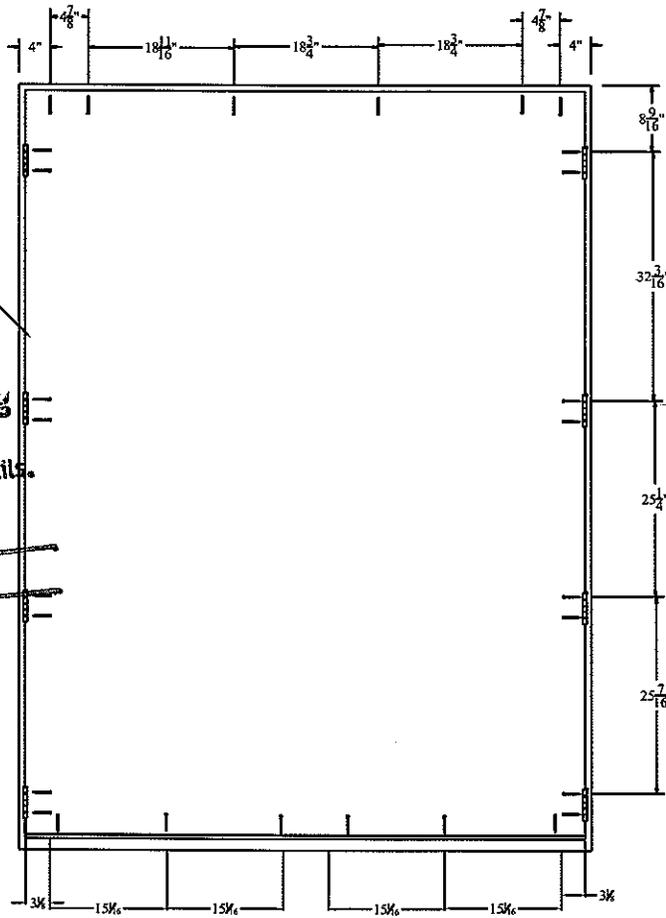
ANCHORING DIMENSION

Hardwood Double Glazed Doors/Transom

Installation: The jambs were secured to a #2 Yellow Pine 2x12 test buck with two #8 x 3" screws at each hinge (16 total). The unit was secured through the jambs with #8 x 3" screws located 2" from the bottom of each jamb and on 12" centers thereafter.

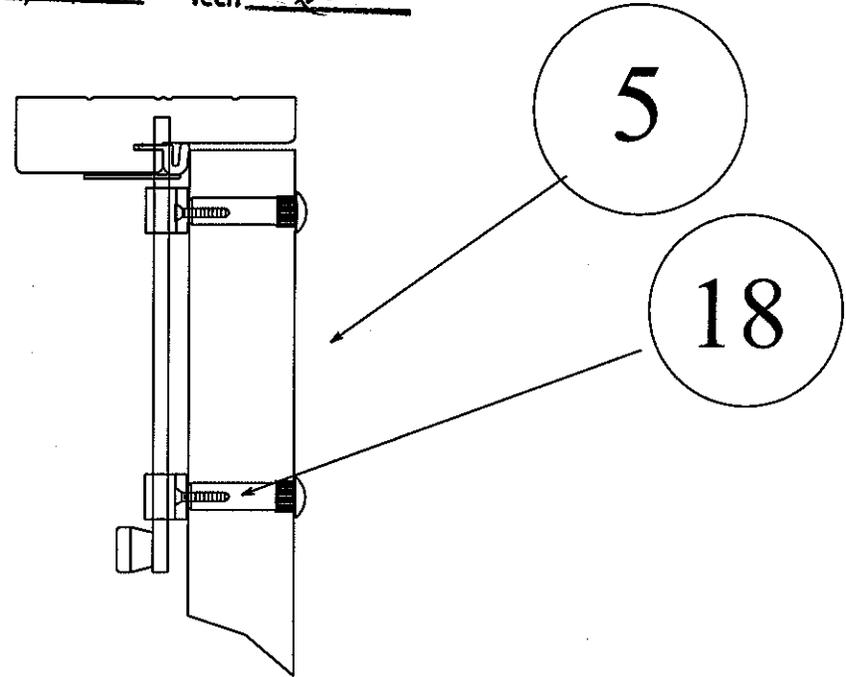
(F)

Rockwood 580 Surface Bolt

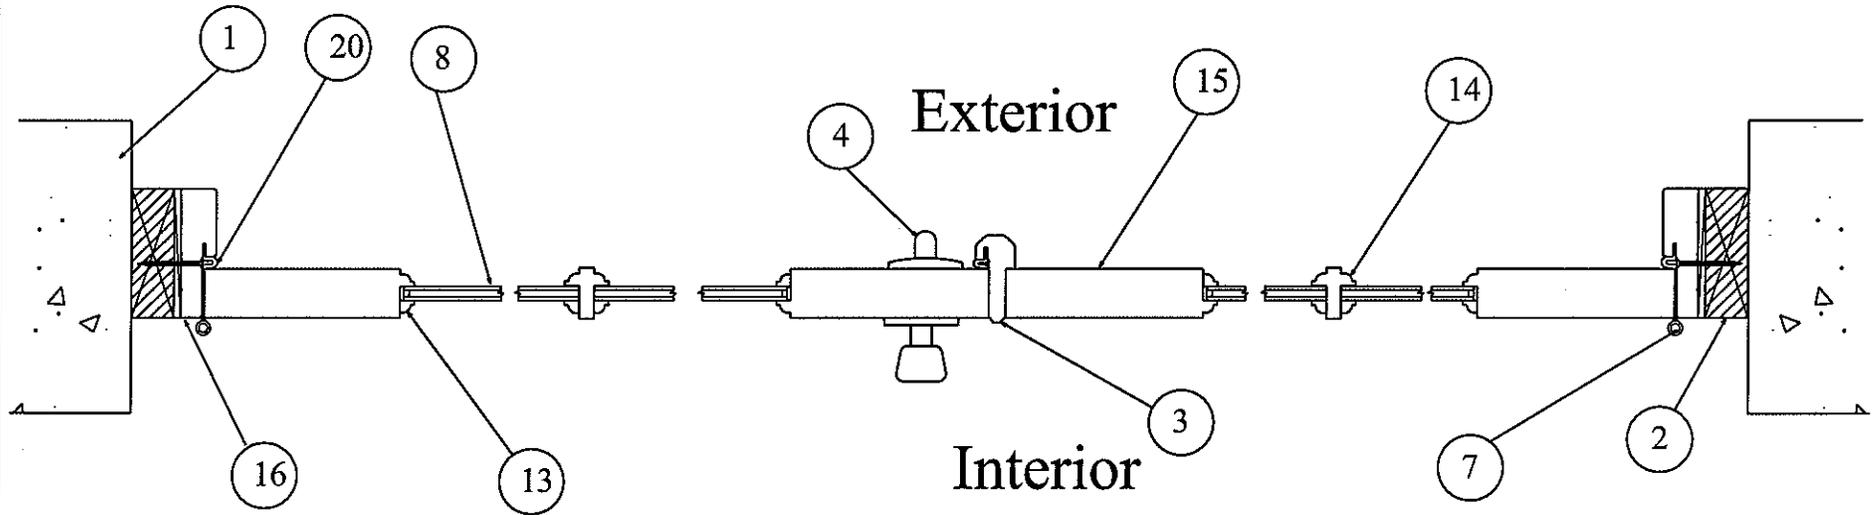
Horizontal Cross Section

Hardwood Double Glazed Doors

Frame Construction: The door frame was constructed of 4-5/8" by 1-1/4" hardwood head and jambs, a 3-1/4" by 1-3/8" hardwood T-astagal and included an adjustable extruded aluminum and composite threshold. The head and jambs were kerfed to accept the weatherstripping. The corners were coped and butted and secured with two #8 x 1-1/2" and five #8 x 3" screws at the threshold; and four #8 x 1-1/2" and two #8 x 3" screws at the head. The astragal was attached to the inactive panel with sixteen 2" x 0.040" x 0.050" rectangular shank 0.050" x 0.080" head brad nails located 1" from each end and on 8" spacing.

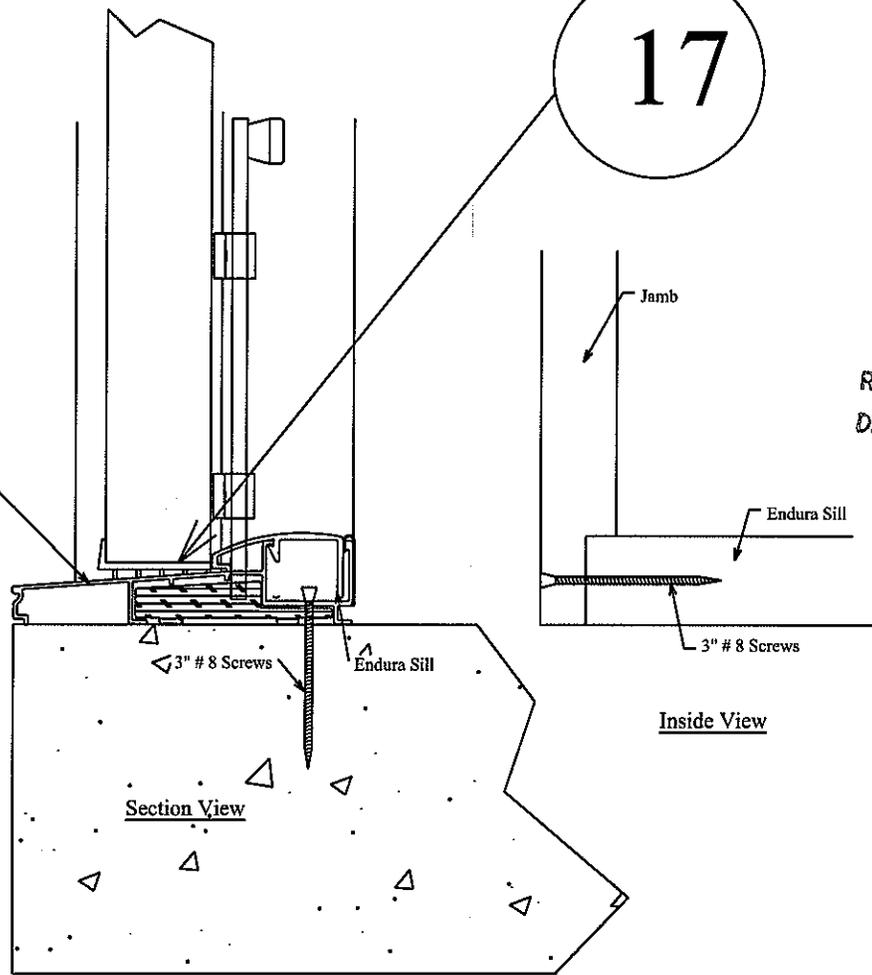
(A) Threshold Out Swing

Section View

Inside View

Endura Sill
ZAIL 5866 / O/S

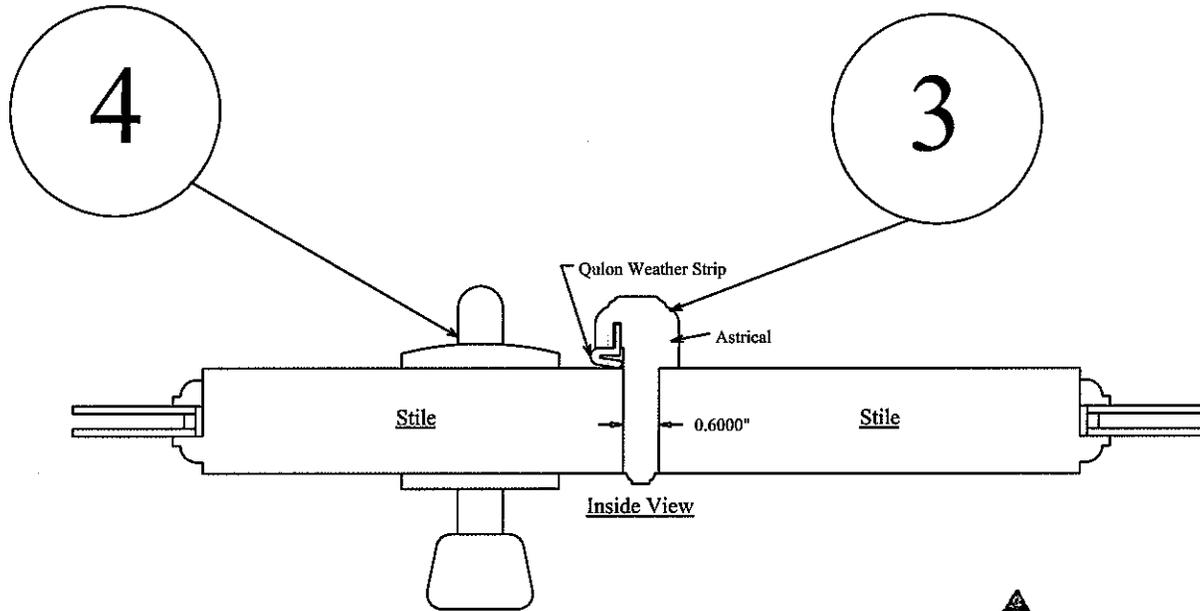
Ⓒ Astrical

Endura Sill
ZAIL 5866 / O/S

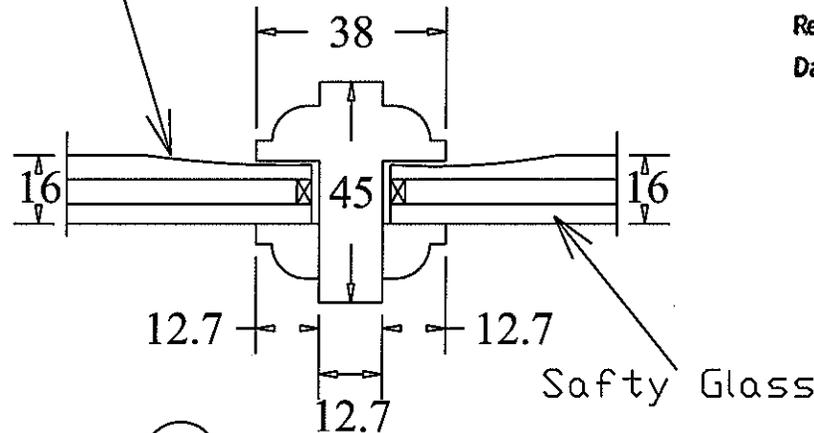
(C) CROSS SECTION

Beveled Safety Glass
