# KAWNEER COMPANY INC FLORIDA BUILDING CODE TEST REPORT

ASTM E330, ASTM E1886/1996, TAS 201, TAS 202, AND TAS 203  
TESTING ON 1600 WALL SYSTEM™ 1 CURTAIN WALL

I7021.02-550-18 R0

**Series/Model:** 1600 Wall System™ 1 Curtain Wall

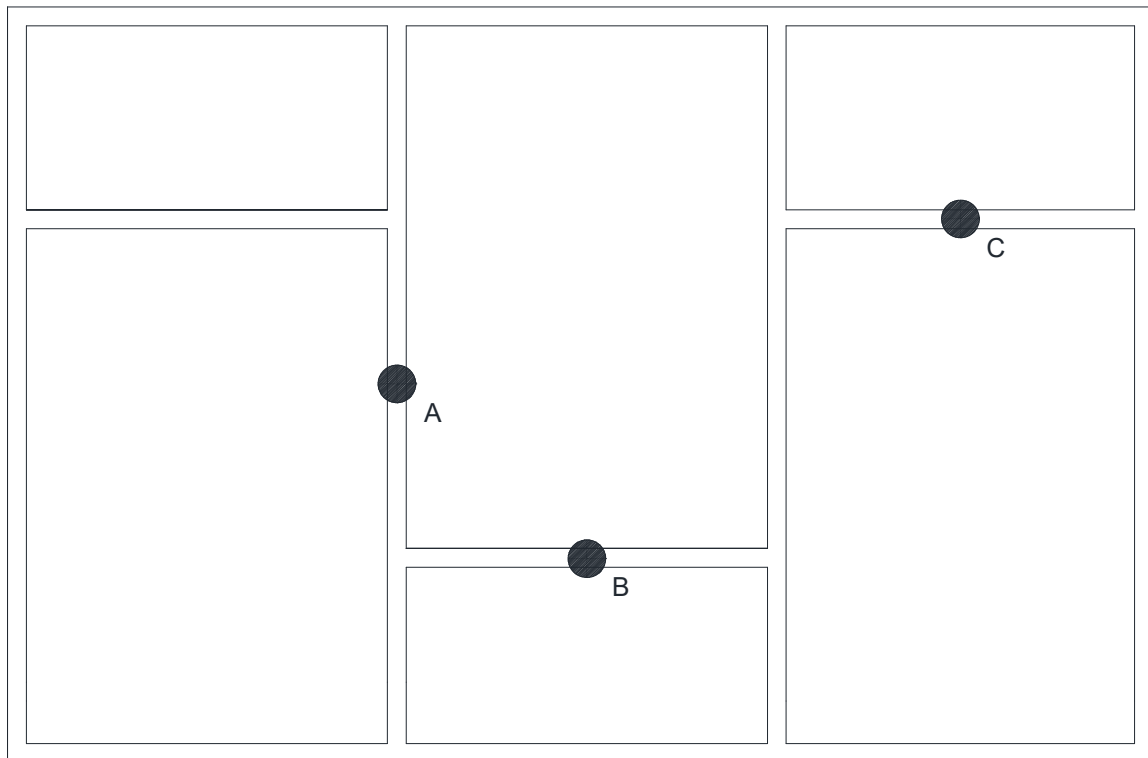
**Sketch No. 1**  
**Deflection Locations**

**Note 3:** See Sketch #1 for indicator locations. Deflection/permanent set reported is the overall deflection between three points (longest unsupported span) which accounts for support movement.

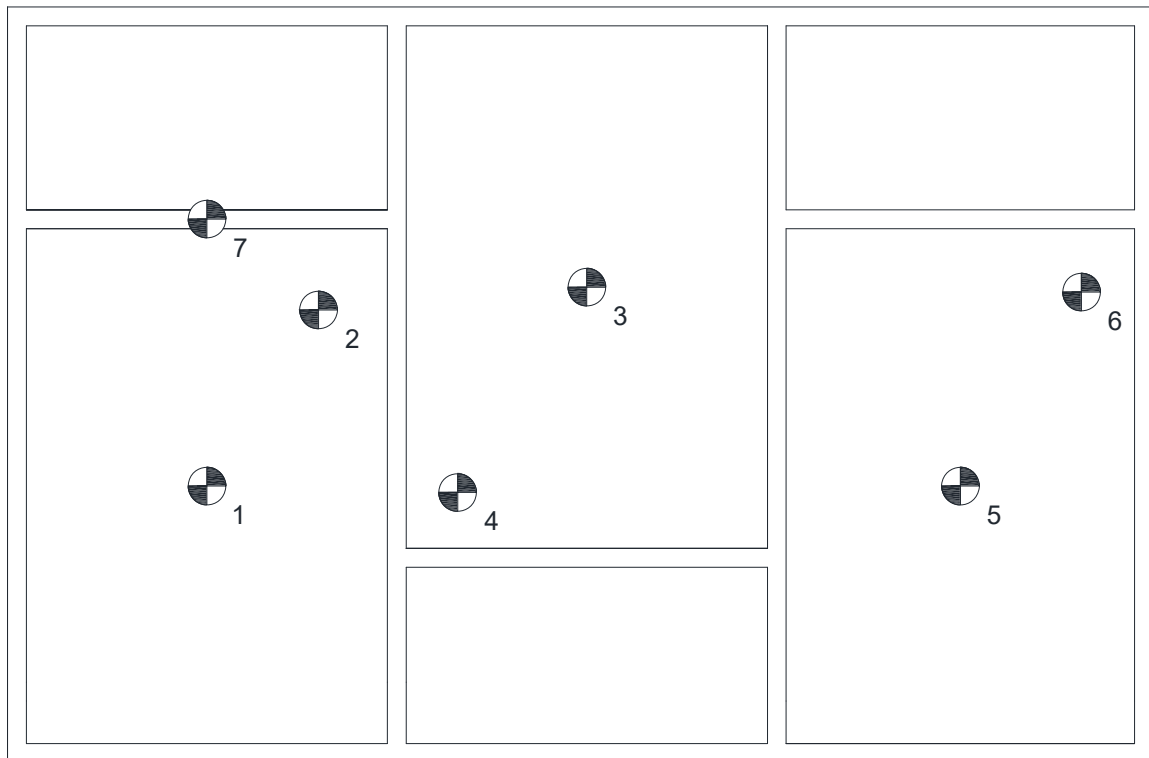
**Sketch No. 2**  
**Impact Locations**

**Note 4:** See Sketch #2 for impact locations.

The large missiles impacted each intended target. Each impact location was carefully inspected. No signs of penetration, rupture, or opening after the large missile impact test were observed; as such, each test specimen satisfies the large missile requirements of TAS 201 and ASTM E1996. Upon completion of testing, specimens tested for TAS 201-94 met the requirements of Section 1626 of the Florida Building Code, Building.
