## Farabaugh Engineering and Testing Inc.

Project No. T240-20

### UL 580 / UL1897 UPLIFT RESISTANCE TESTING

**BOSS RIB METAL ROOF PANEL  
3'-0" COVERAGE X 26 GA. STEEL**

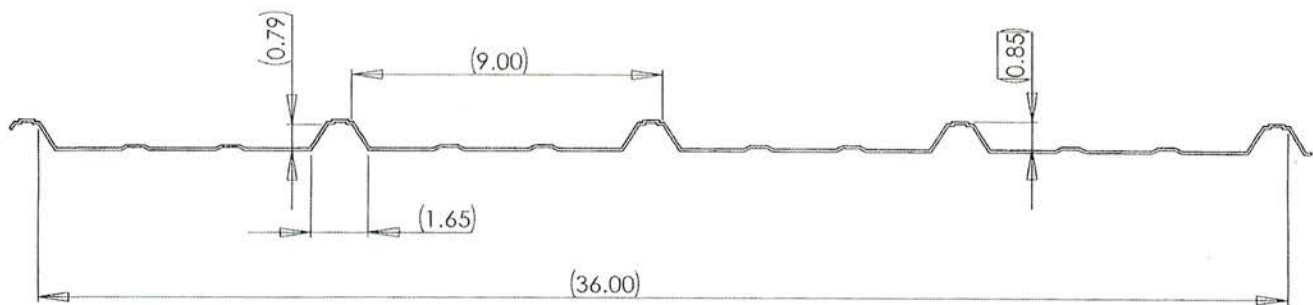
**BOSS RIB PANEL PROFILE**

Panel: Boss Rib Panel, 3'-0" coverage Width, x 26 ga. steel

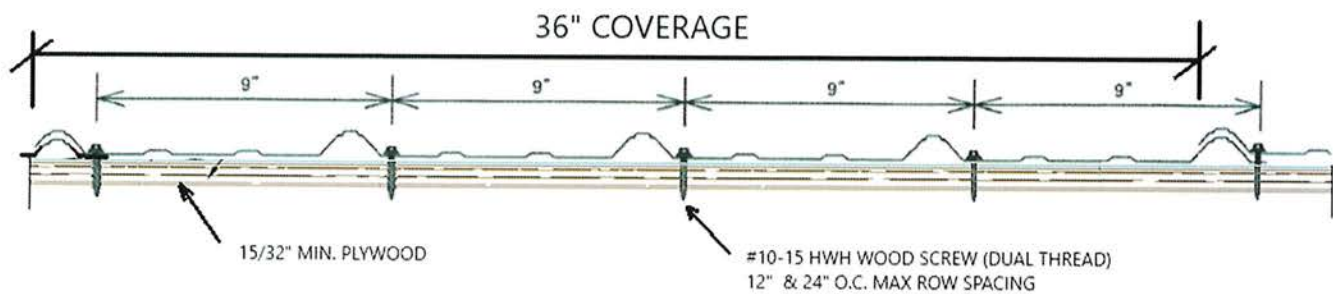
**FASTENER PATTERN 12" OR 24" O.C.**

- The 15/32" plywood was attached to the wood joist (2x10) supports (spaced at 2'-0" o.c.) using 8d ring shank nails at 6" on center around the perimeter and at interior supports.
- The metal roof panels were attached to the wood deck substrate using #10-15 X 2" long, HiLo Wood ZAC screws. The screws were attached at 9" o.c. across the width of the panel with a fastening spacing of either 12" or 24" o.c. along the length of the panel. The panel sidejoint was lap joint. The outer perimeter of the assembly was secured with perimeter fastening as required to maintain a periphery seal.
- A plastic barrier was located between the panels and the underlying substrate.
