Project No. T214-21

## UL 580 / UL1897 UPLIFT RESISTANCE TESTING

**ELITE RIB ROOF PANEL  
3'-0" COVERAGE X 29 GA. STEEL  
(FASTENERS @ 12" O.C. OVER 15/32" PLYWOOD)**

ELITE METAL MANUFACTURING, LLC.  
10121 88<sup>TH</sup> TRACE  
LIVE OAK, FL. 32064

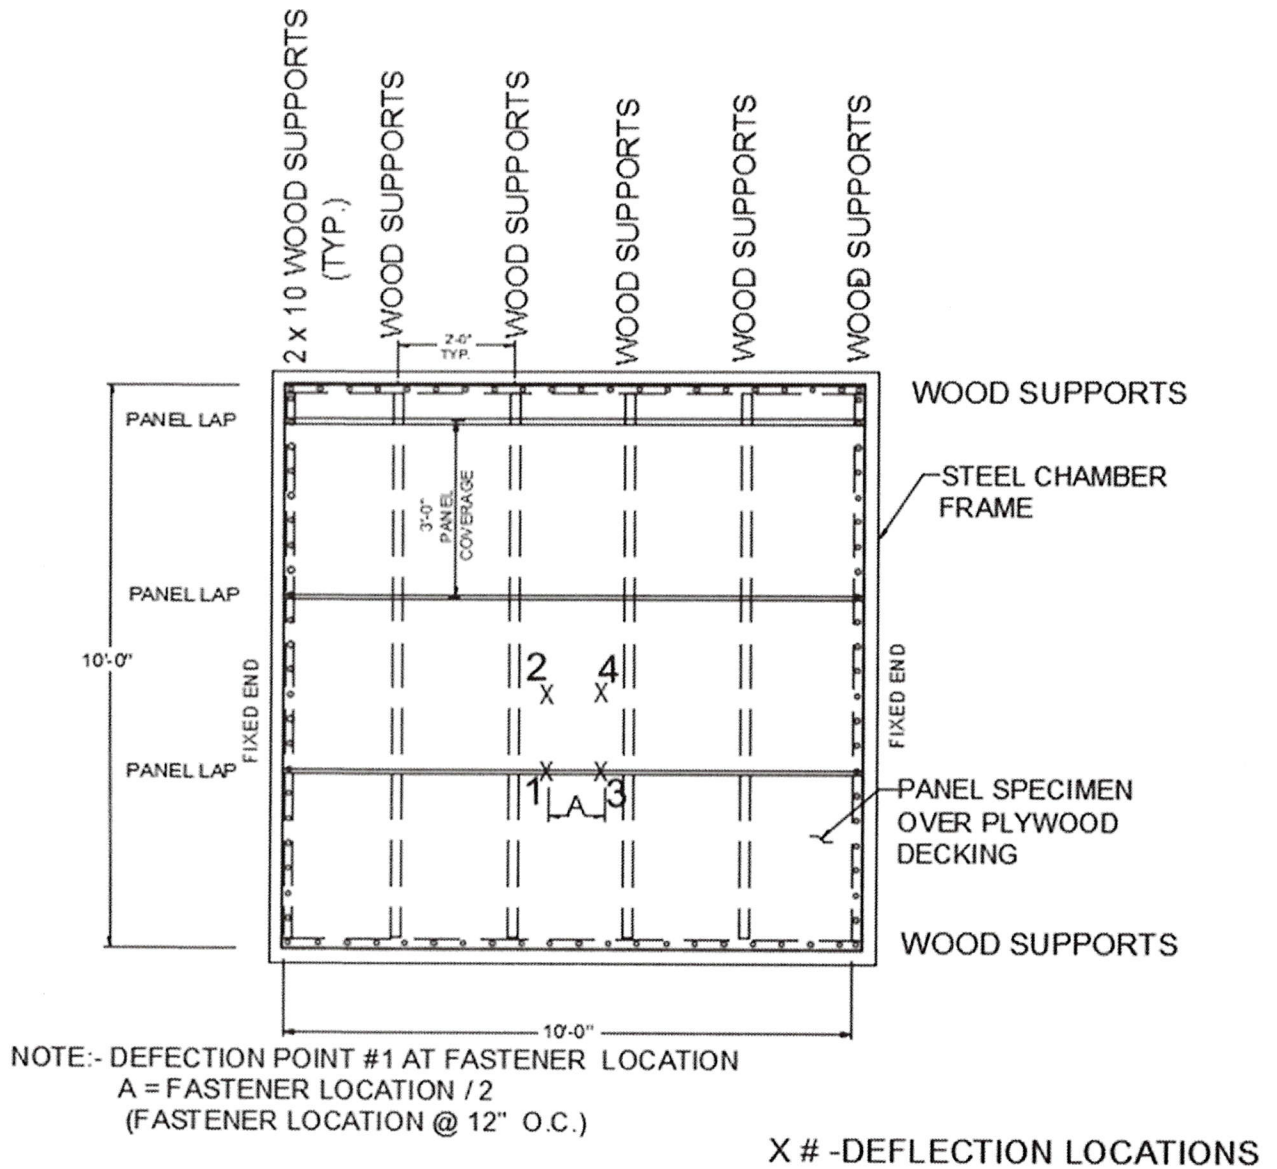
## TEST SET UP

### **Installation**

- The 15/32" plywood was attached to the wood joist (2x10) supports (spaced at 2'-0" o.c.) using 8d ring shank nails at 6" on center around the perimeter and at interior supports.
- The metal roof panels were attached to the wood deck substrate using #10-12 X 1-1/2" long, hex head wood screw, type 17 point, w/1/2" steel sealing washer. The screws were attached with a specified spacing pattern across the width of the panel with a fastening spacing of 12" o.c. along the length of the panel. The panel sidejoint was lap joint. The outer perimeter of the assembly was secured with perimeter fastening as required to maintain a periphery seal. See fastening pattern for location of fasteners across width of panel.
- A plastic barrier was located between the panels and the underlying substrate.

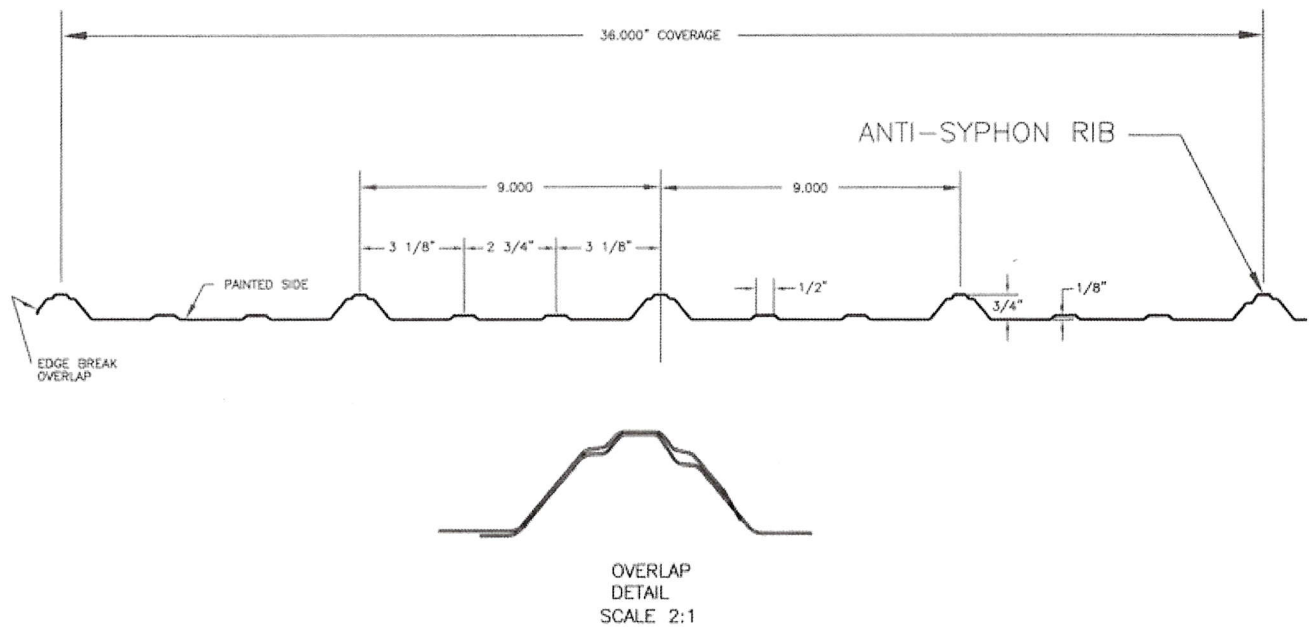
## PLAN VIEW OF PANELS

FASTENER PATTERN 6/3/6/3/6/3/6 @ 12" ALONG LENGTH OF PANEL

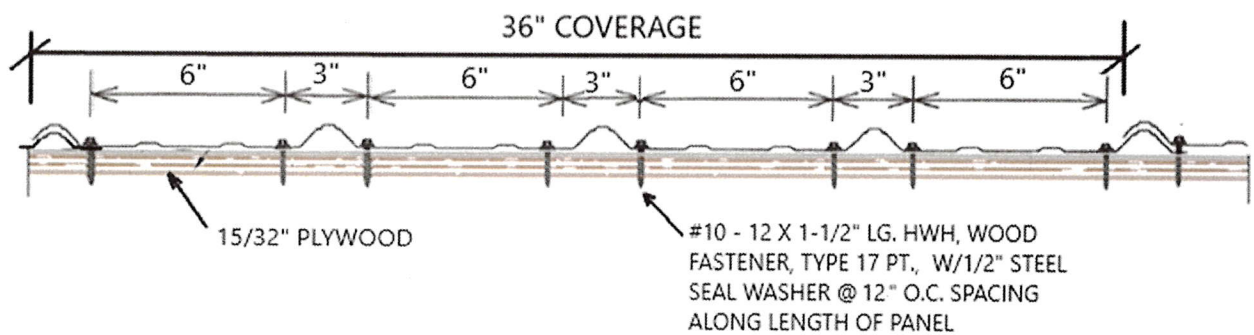
## ELITE RIB PANEL

STRIP WIDTH = 40.875
